**NEPP Electronics Technology Workshop
Greenbelt, MD
June 23-26, 2015**

**Use of Cu Wire in Plastic Encapsulated Microcircuits
– Preliminary Data**

**Gary Downing – Analytical Solutions
Sultan Ali Lilani - Integra Technologies LLC**

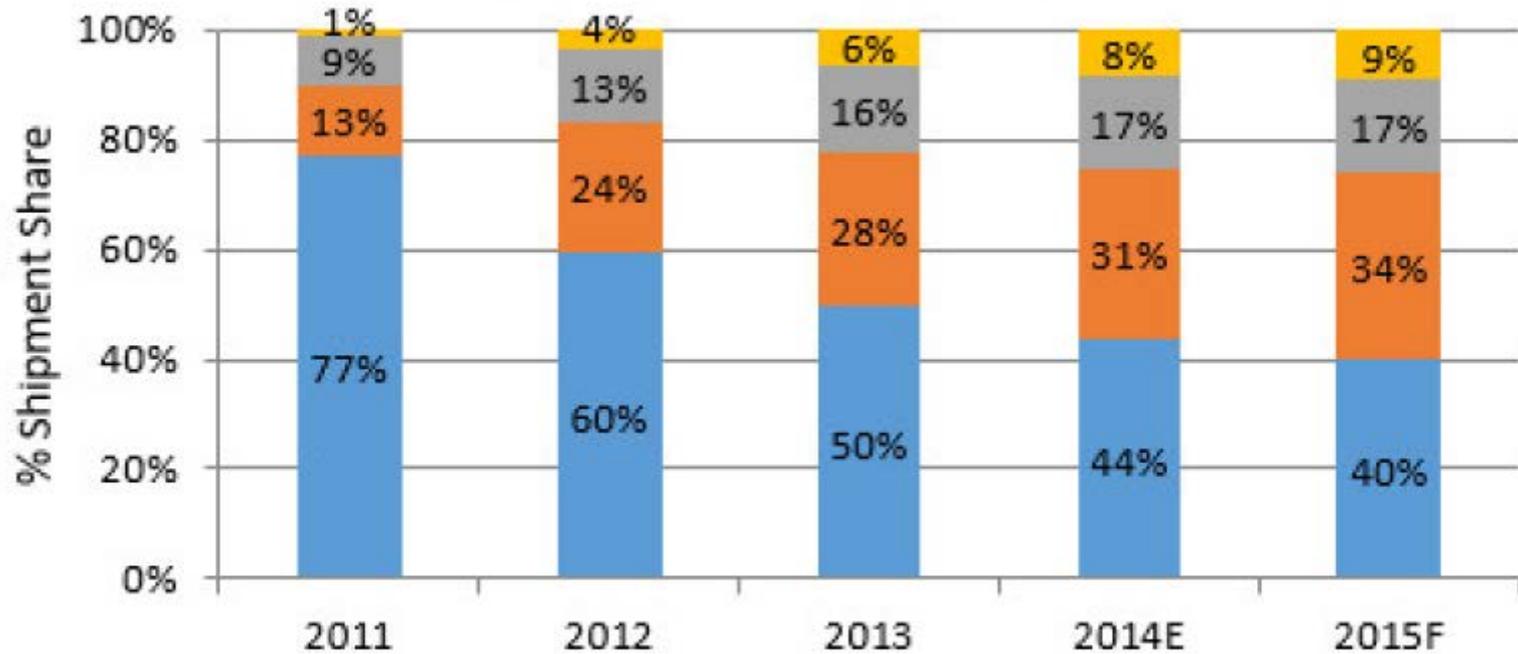
Bonding Wire Shipment Share by Type

Source: SEMI

■ Au ■ PCC ■ Cu ■ Ag

PCC= Palladium-coated Copper

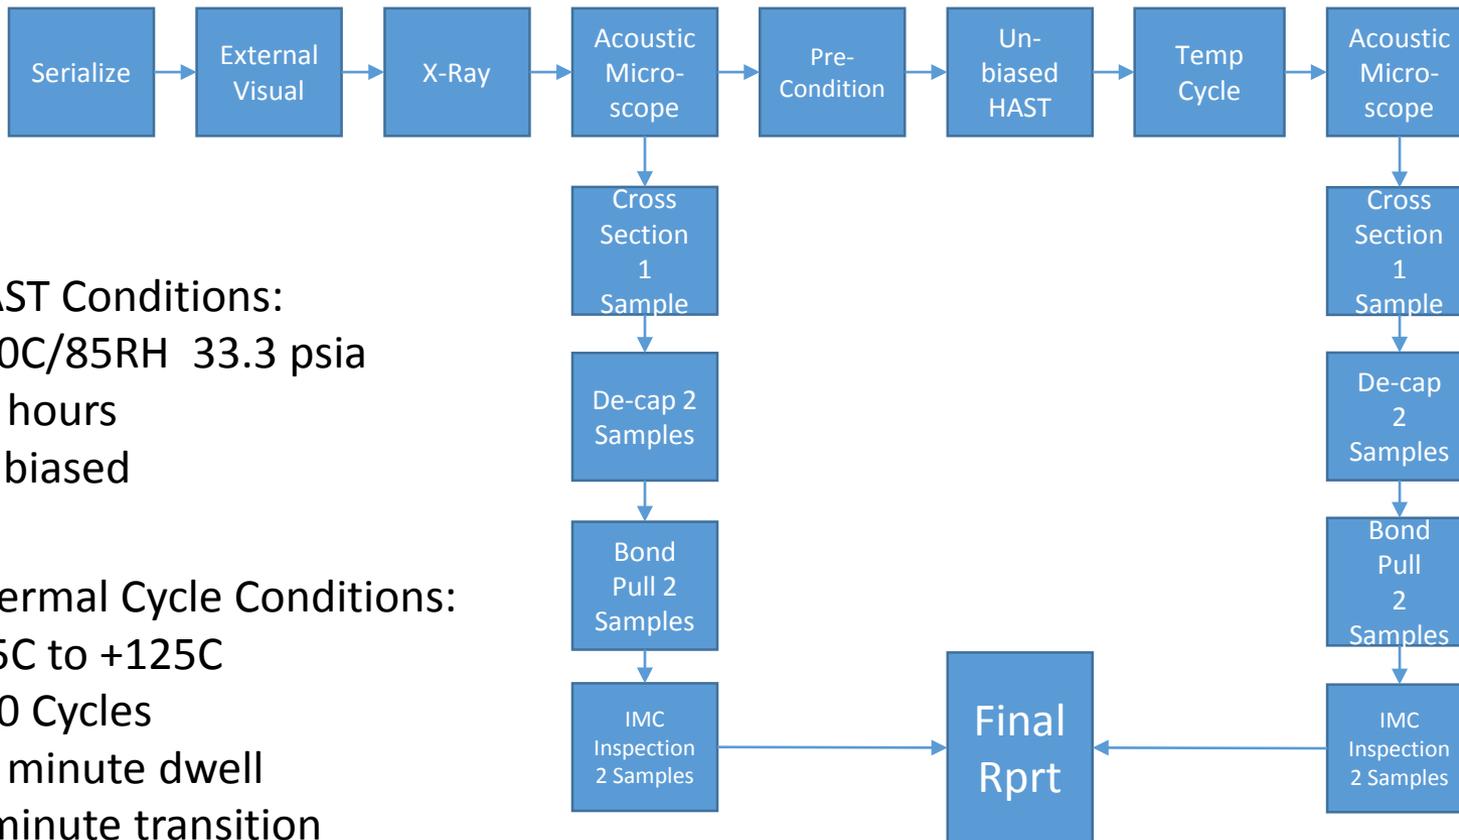
Process Flow for Phase 1

HAST Conditions:
130C/85RH 33.3 psia
96 hours
Unbiased

Thermal Cycle Conditions:
-55C to +125C
100 Cycles
10 minute dwell
1 minute transition

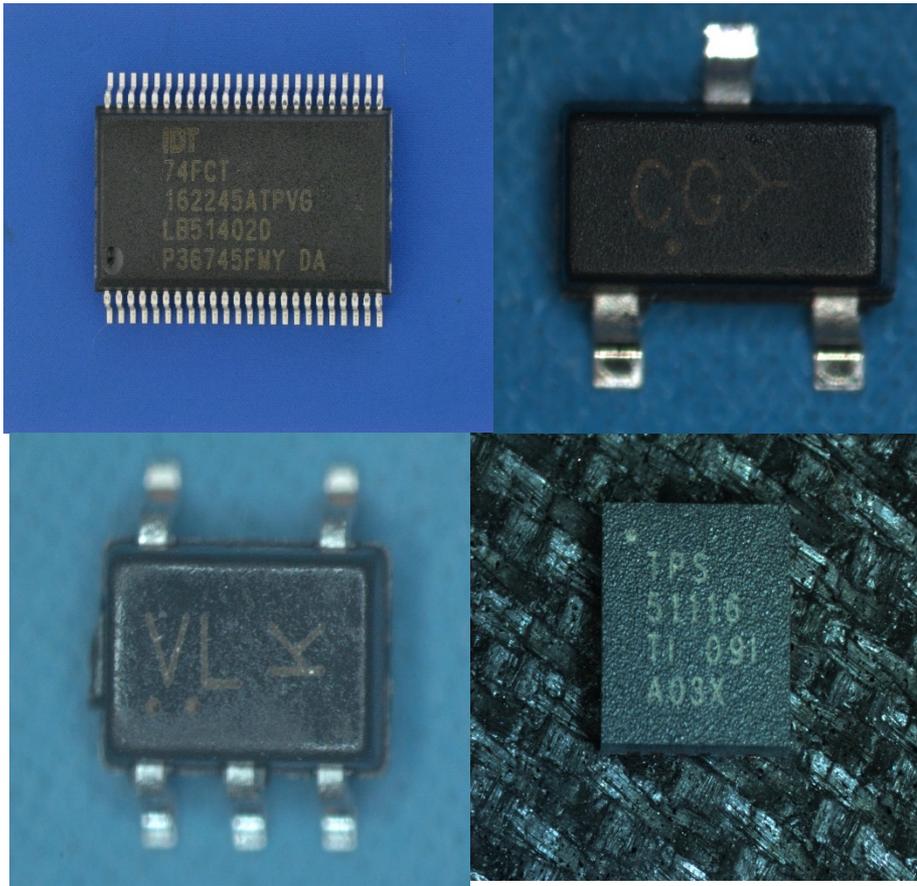
Initial Conditions of the Parts

- Devices were purchased from Authorized distributor.
- All devices were inspected and found to be in good condition.
- No indication of improper storage that might effect reliability study.
- Minor oxidation was seen on the leads post stress.
- No cracks or package related defects were noted post stress.

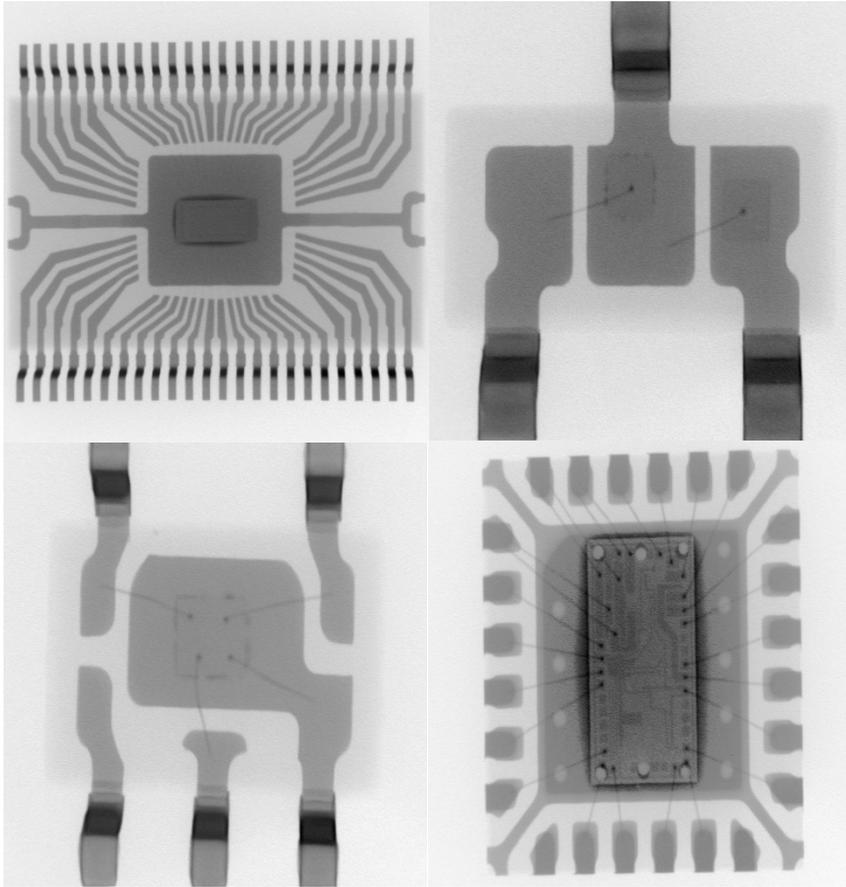
X-Ray Results

- All devices were inspected and found to be acceptable.
- Copper wire bonds were noted in X-Ray and confirmed in cross section

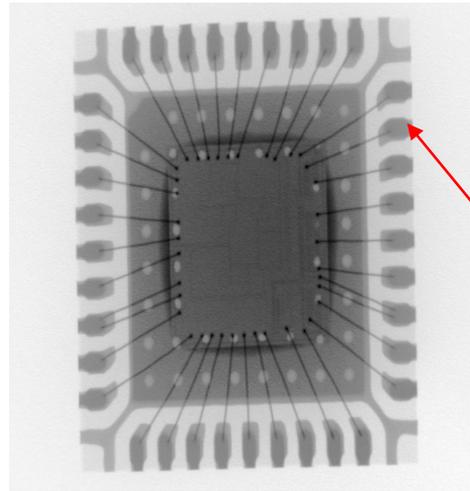
Gold Wire bonds
Gold has higher radio density making it darker when viewed in X-Ray.

- Image to the left shows copper vs gold wire bond comparison. Both parts are TPS40140RHH. Top part has gold bond wires and was built in the 5th month of 2011. Bottom part is copper wire bonded built in the 9th month of 2013.

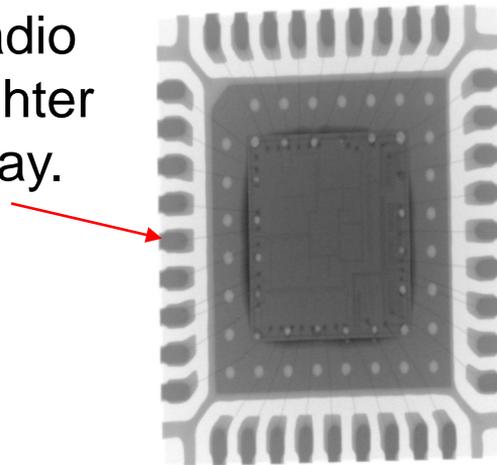
Copper Wire Bonds
Copper has lower radio density making is lighter when viewed in X-Ray.

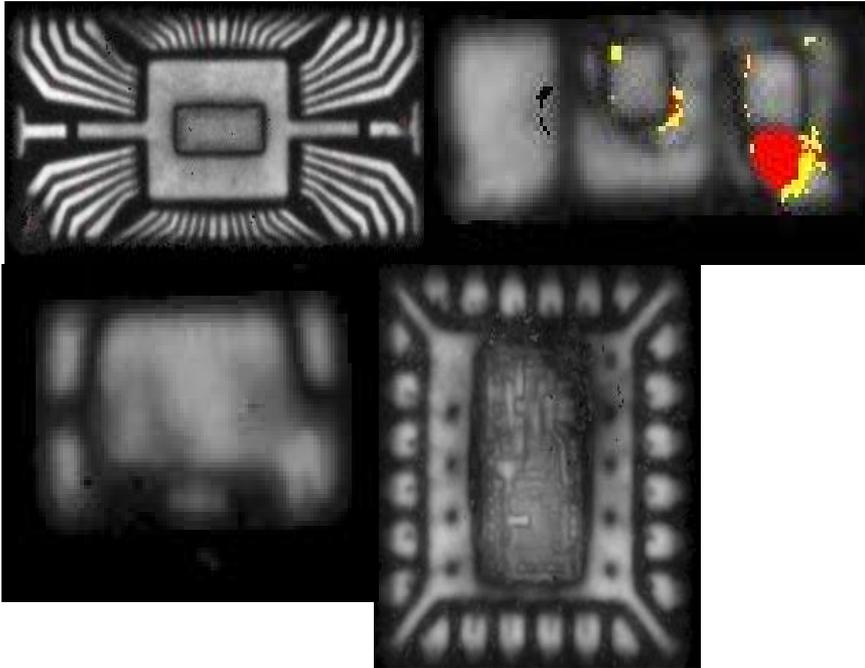
- Molding compound to lead frame showed some areas of delamination which is consistent with what was noted on previous lots.
- No delamination was noted on the active surface of the die.
- Delamination was worse after stress as expected. No cracks in the molding compound were identified.

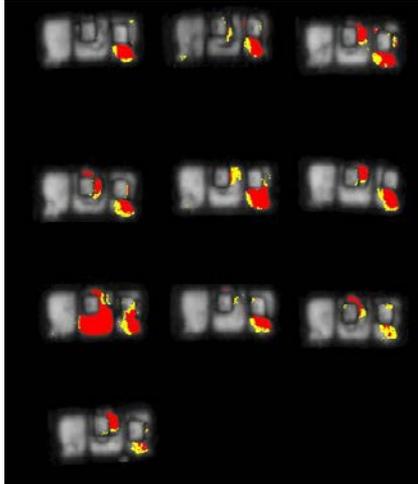
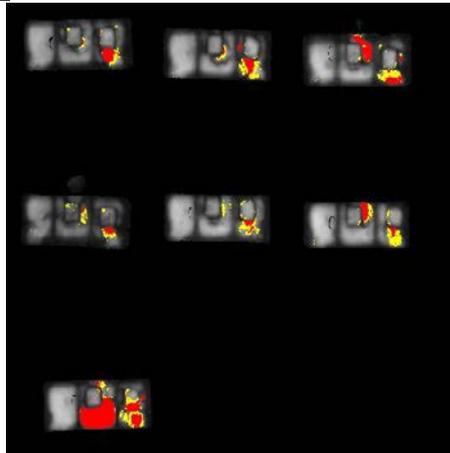
Scanning Acoustic Microscopy (continued)

- Worst case was BAS70-04LT1G.
- Delamination indications were present pre and post stress.
- Delamination change was less than 5% from pre-to-post.
- Pre-stress upper left image. Post-stress lower right. S/N 8-10 were used for pre-stress cross section, bond pull, internal visual inspection and IMC Inspection.

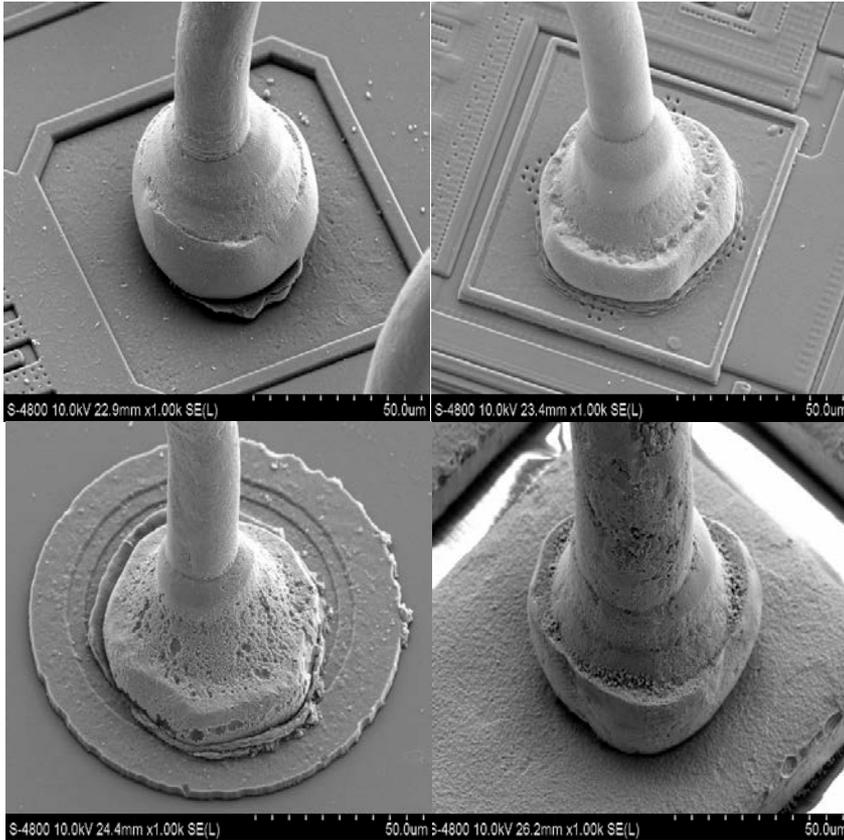
De-Capsulation

- No single method is best when de-encapsulating copper wire bonded parts.
- Analytical Solutions utilizes several methods based on observations seen in cross section.
- Some degradation of the copper wire bond is expected during de-encapsulation. This degradation must be minimal to properly evaluate bonding.

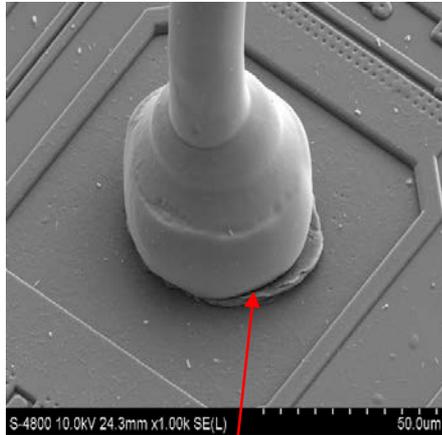
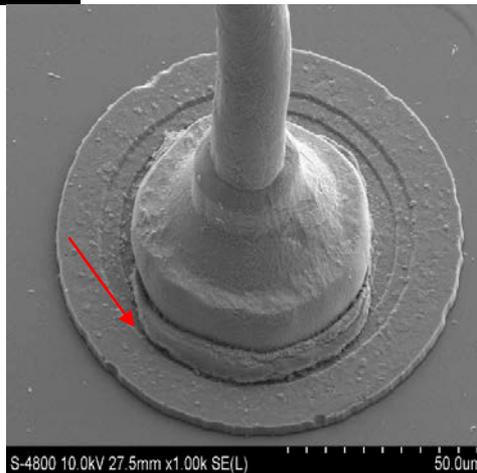
Aluminum Splash

- No device exhibited quality issues.
- No differences visually identified pre-to-post stress.
- Bonds remained relatively in tact. Some minor attack was noted.
- Aluminum splash was seen on all devices with copper-to-aluminum interface. See left image.

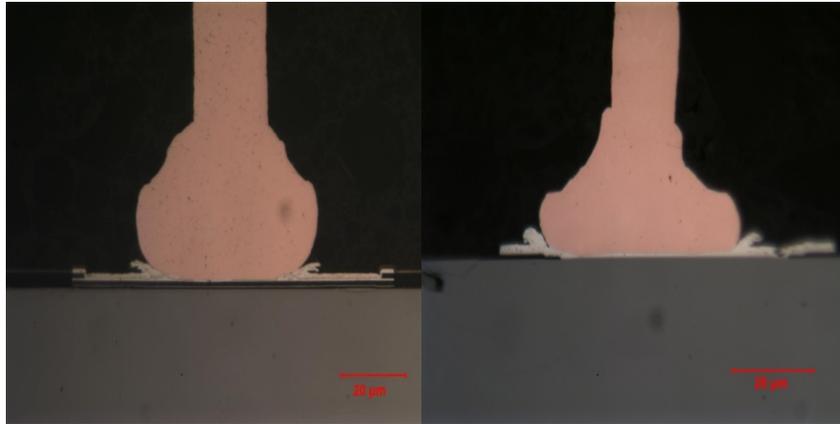
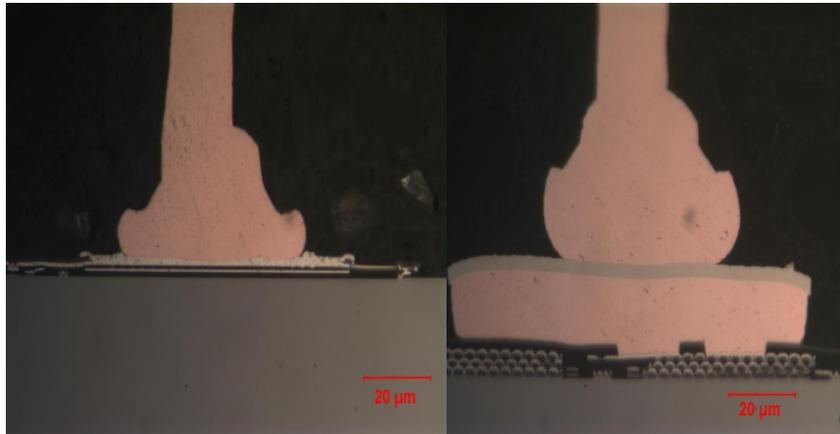
Cross Section

- Cross section was performed to obtain the following:
 - Confirm use of copper wire bonds
 - Determine the metal stack up
 - Measure the intermetallic pre and post stress
 - Identify any additional concerns about the devices that might affect the outcome of the experiment.
- No cratering was present
- Bonds were well formed
- Aluminum splash was present but appeared to be acceptable.
- No visible change from pre-to-post at this magnification.

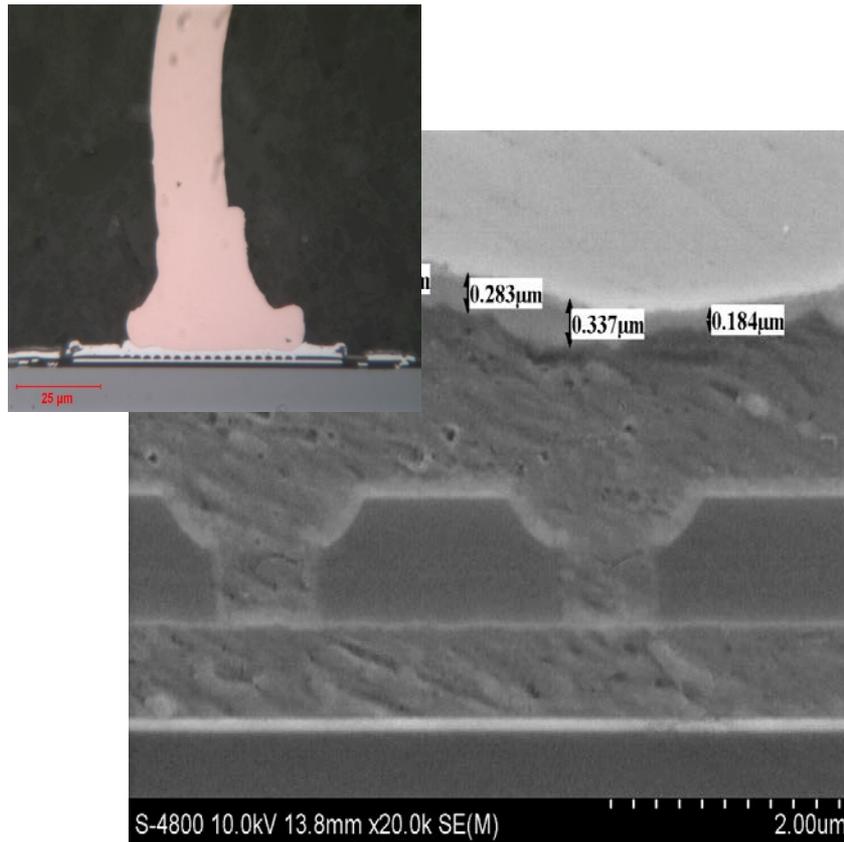
IMC Inspection Cross Section

- Cross Section and measurement of IMC.
- No cracking or voiding of IMC was observed on any device.
- IMC growth was observed with Cu/Al interface but was not observed on Cu/Pd interface.
- IMC was not able to be measured on Cu/Pd interface.
- Only 1 bond per device was analyzed. Additional samples will be analyzed in Phase 2.

- Au/Pd intermetallic on the TPS51116RGET was not measurable due to thickness and slow diffusion with this metal stack.
- While there appeared to be an increase with the On Semiconductor parts there appears to be a decrease with the IDT device.
- Larger sample sizes are required to obtain a statistically significant indicator of rate of growth. This will be accomplished in phase 2.

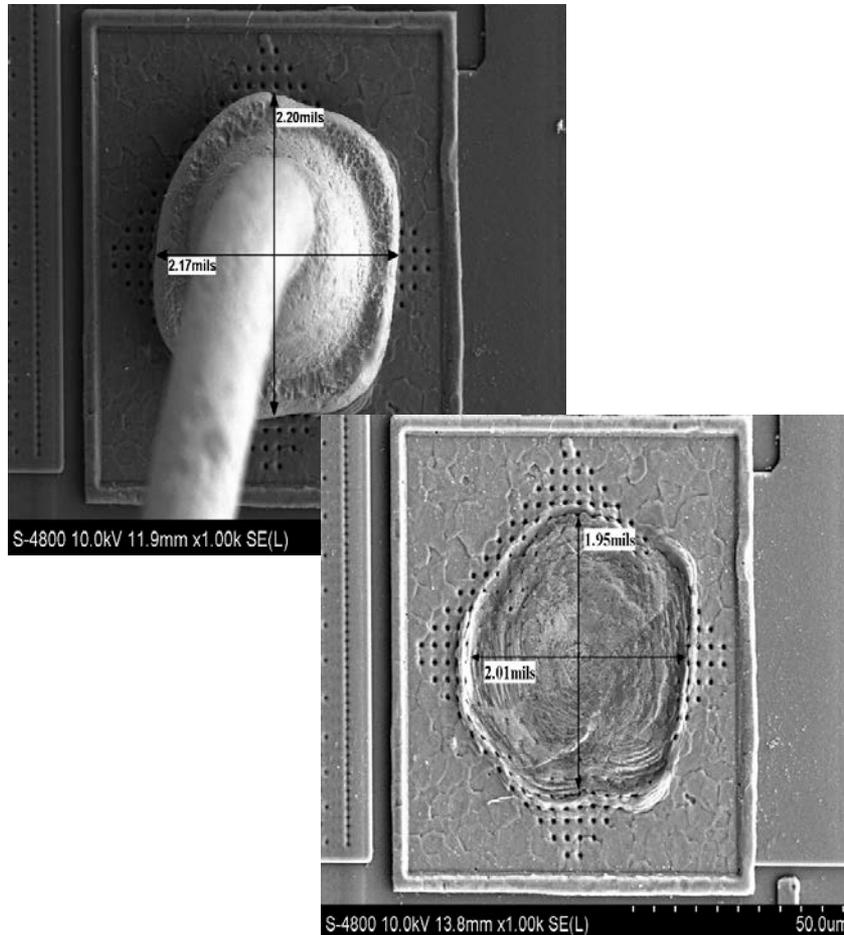
IMC Inspection Etched

- Method used to remove copper wire bonds was a proprietary process developed at Analytical Solutions.
- Exposure time of the etch varied between 1 and 5 seconds.
- Not all bonds were removed but greater than 80% of bonds removed from each device.
- Area of intermetallic in relation to the ball bond was compared between pre and post stress and was determined to be between 2% and 6% greater on post stress devices.
