**NEPP Workshop at NASA Goddard
June 13, 2016**

**PEM update and Cu Bond Wire Update-
Documentation and Data**

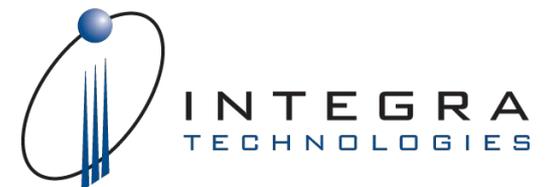
A Case of False Positive CSAM

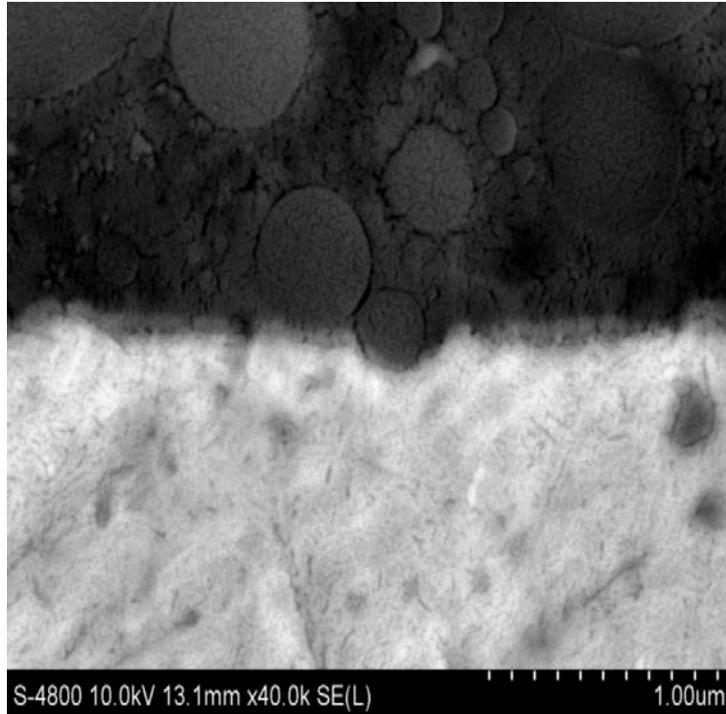
- Some residual separation between the filler material and the molding compound can be seen.
- No delamination was observed between the lead finger and the molding compound.

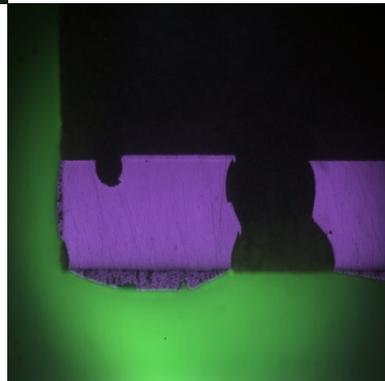
Dye Penetrant
Pre
Qualification

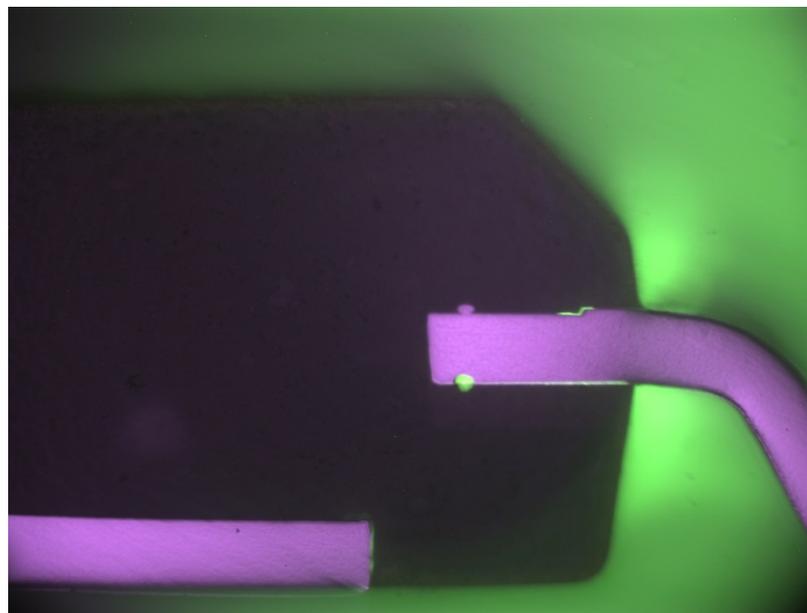
Pin 2 (Die Penetrant shows delamination)

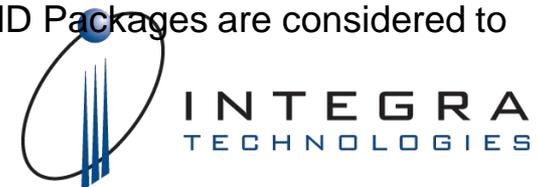
Cu Bond Wire TASK Team Update

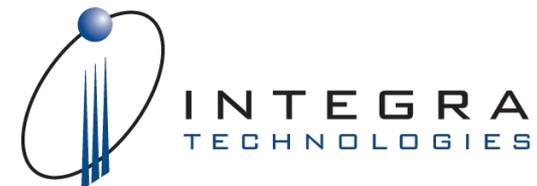
3. Data gathered to date on Cu-wire Failures in test and the field.

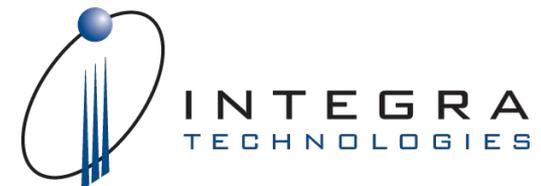
- Only direct cause understood at present
- Two returned components destructively examined
- Microampere level current leakage was within the device, based on initial failure analysis of returned part.
- Crack was found through oxide layer at pin bond pad internal to part, likely incurred during wire bond to pad.
- Crack can provide conductive path to adjacent bond pad causing current leakage
- Short between pins affected voltage levels
- Other shorts affected performance

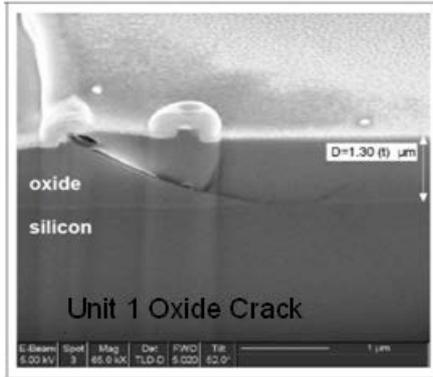
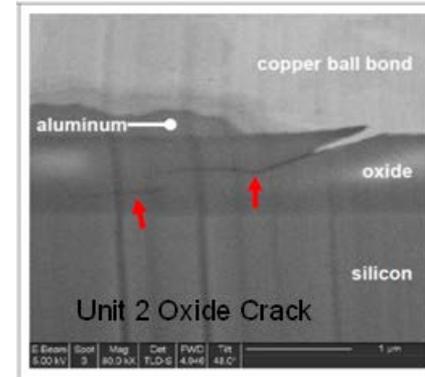
Cratering/pad structure micro cracking

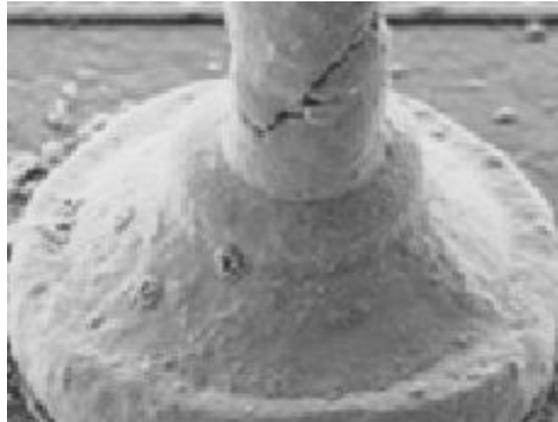
Wire break above ball bond, cause intermittent field failure

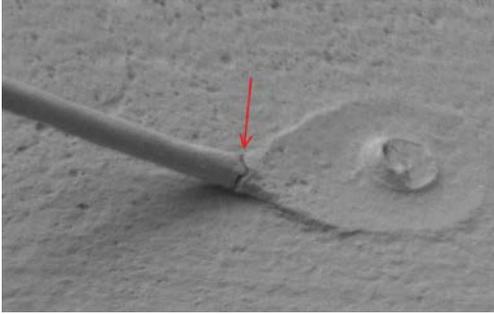
Stitch Bond Cracking

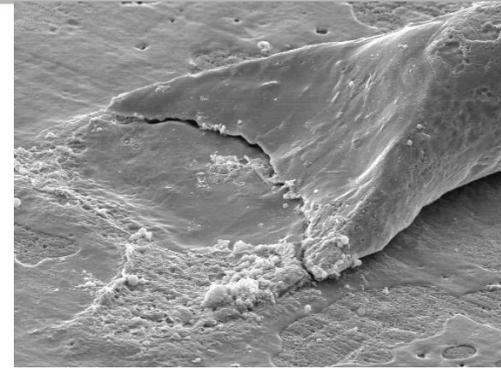
Break in wire at heel of stitch/wedge

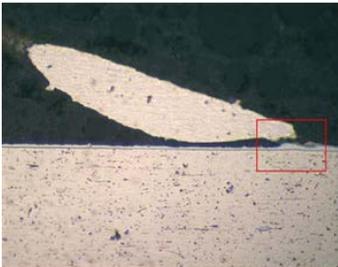
Delamination contributing to potential corrosion and stitch/wedge break

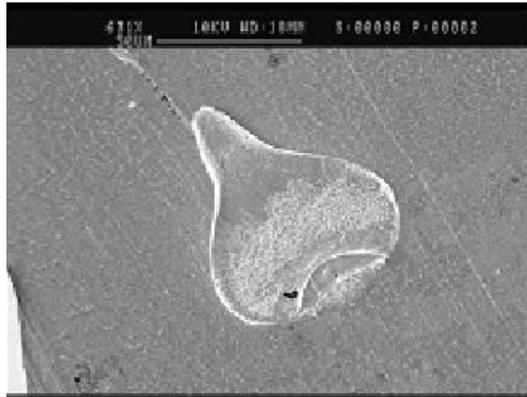
SEM image of the gold stitch bond in [redacted]
[redacted] No corrosion was noted.

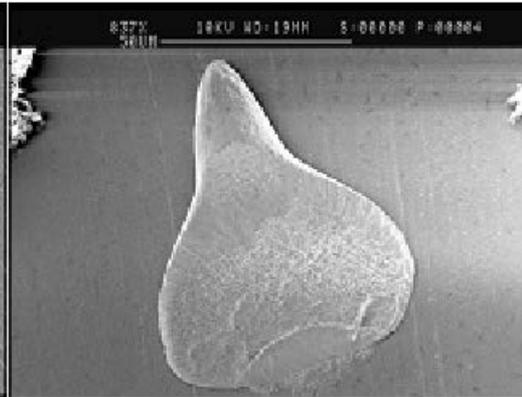
SEM image of the gold stitch bond in [redacted]
[redacted] No corrosion was noted.

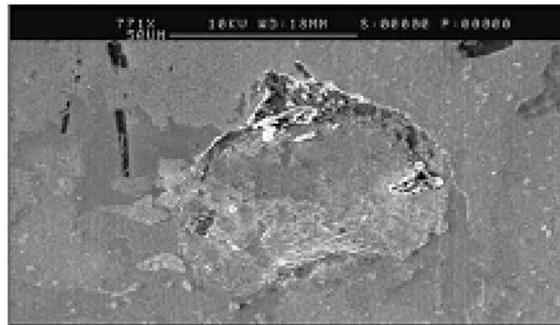
SEM image of the copper stitch bond in [redacted]
[redacted] Note the corroded copper.

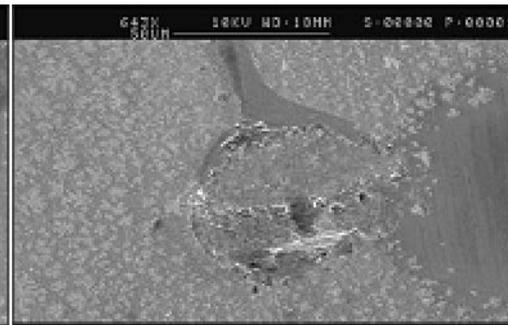
SEM image of the copper stitch bond in [redacted]
[redacted] Note the corroded copper.

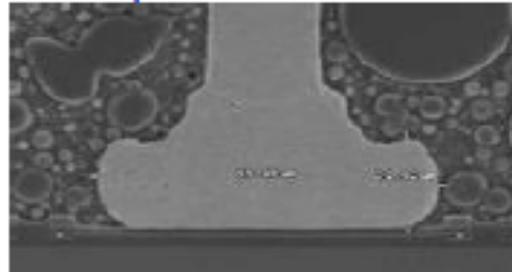
Optimized splash and effective ball bond area giving "typical" shapes. Still defining "non" conditions.

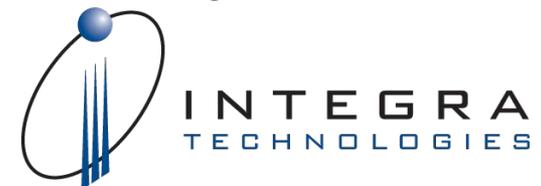
Cu Bond Wire Study at Integra and ASI – An Update

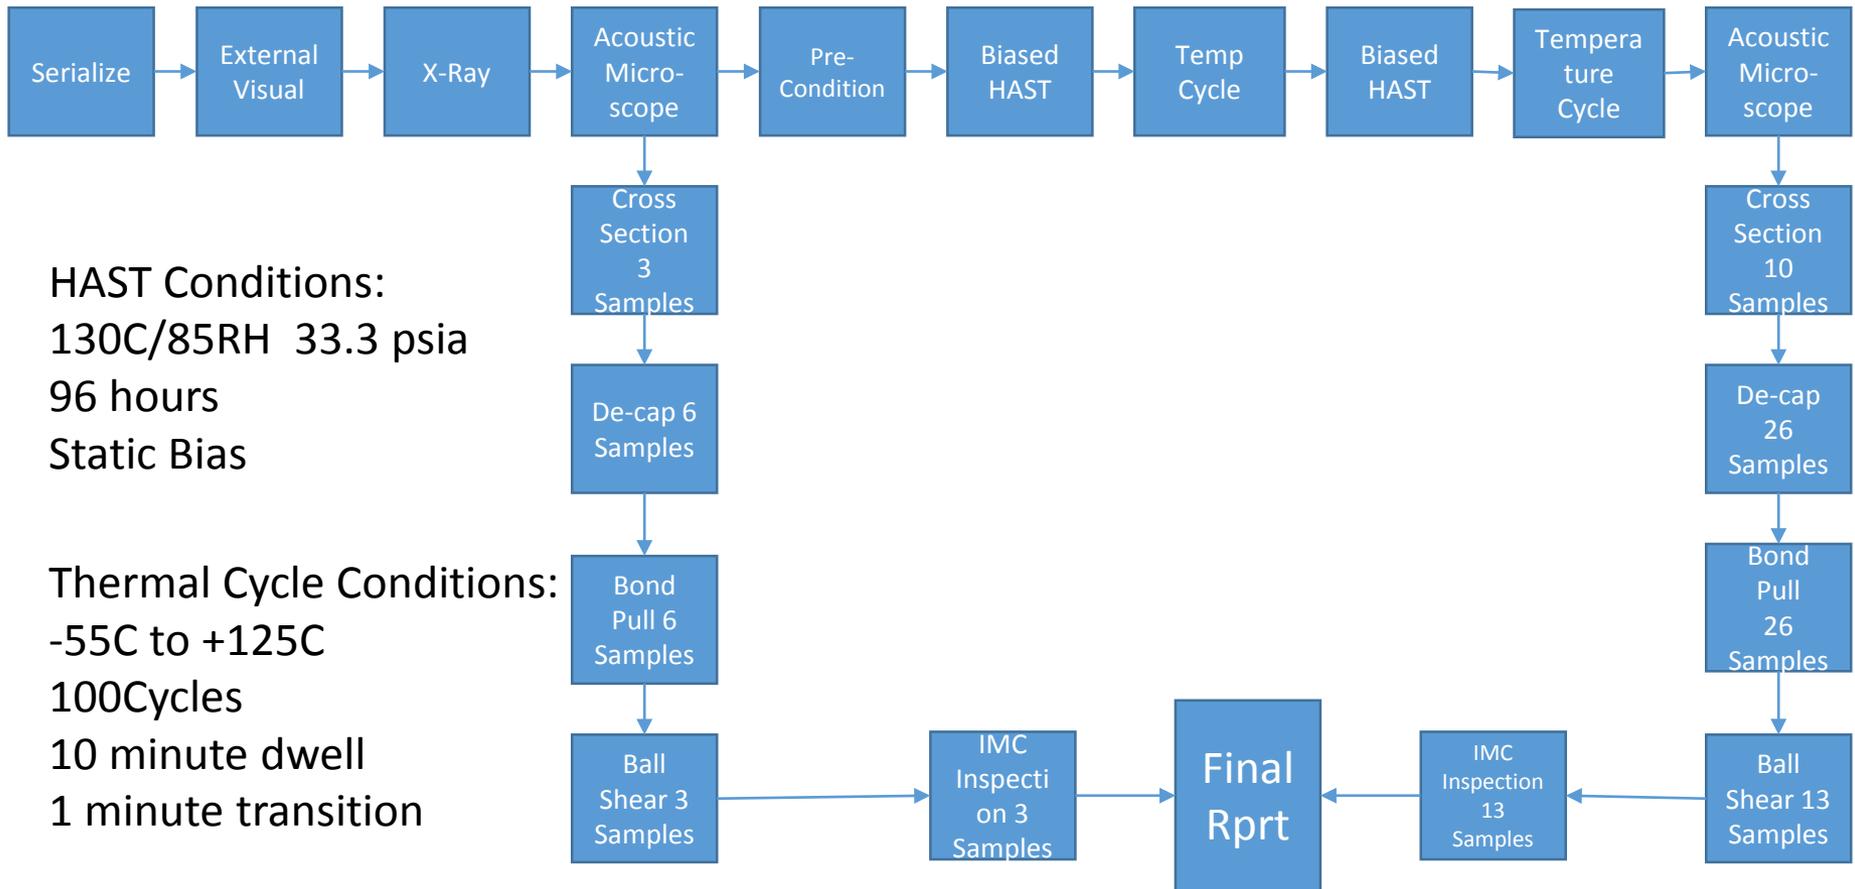
Process Flow for Phase 2

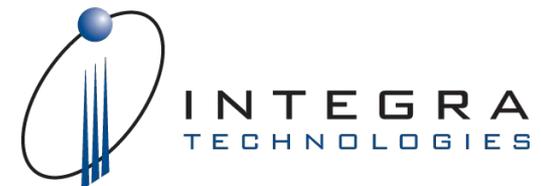
With limited data on sample sizes and stress level:

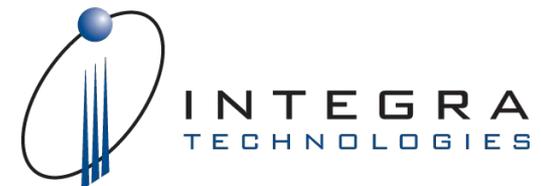
1. **IMC was found to be 6% greater pre to post stress**
2. **Aluminum Splash was observed**
3. **Bond lifting was observed with location dependency**
4. **IMC**
 - a. **Au/Pd IMC was much thinner than Au/Al – IMC was not measurable due to thickness and slow diffusion with this metal stack**
 - a. **IMC seen on all other devices**

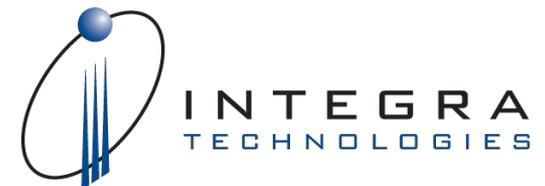
Phase 2 Qual Work Is Continuing

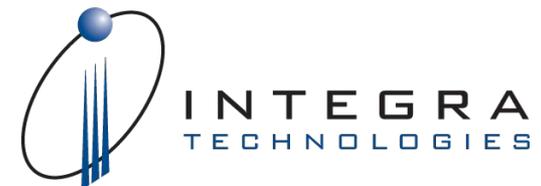
Copper Wire Bond De-Encapsulation

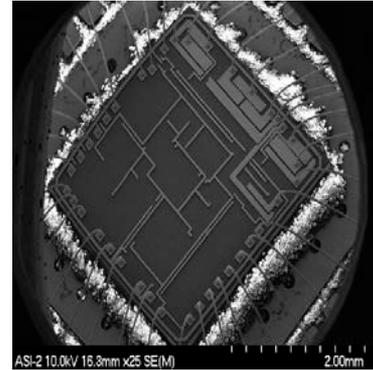
- Both methods yielded similar values for maximum and average bond pull
- Laser/Chemical process improved minimum bond pulls
- Both methods must be tightly controlled to avoid damage to the devices
- Laser/Chemical process is more automated reducing variability

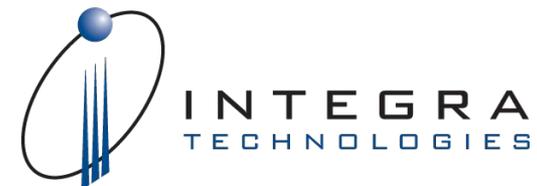
ASI's Full Chemical De-capsulation (continued)

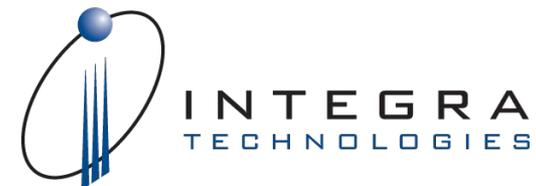
- **Laser/Chemical De-encapsulation is repeatable.**
 - Five devices for this analysis
 - Bond wire reduction reduced to .07 mils utilizing this method
 - Lead frame plating was noticeably better preserved.
 - Condition of bond pad and overall wire bonds were better preserved.
- **Bond pull data distribution**
 - No wire pulled below 2 X gold limit
 - Gold limit for 1 mil wire is 2.5 grams
 - 80 % of bond wires broke at the mid span.
 - All low pull strengths were mid span breaks
 - 20 % of bond wires broke at the neck down of the ball bond.
 - No stitch bond breaks observed.

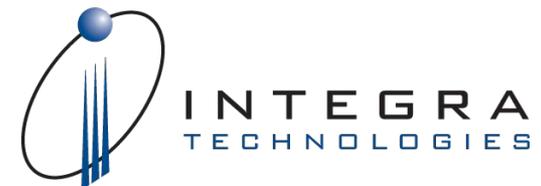
- Laser/chemical process resulted in tighter distribution.
- Average and maximum breaking force was similar for both methods but minimum breaking force was higher when laser/chemical process was used.
- Both methods resulted in bond pull strengths above the 2X limit of gold bond wires.
- Laser/chemical process resulted in cleaner opening with less damage to bond pads, lead frames and overall wire bonds.
- Either process needs setup parts to optimize de-encapsulation.
- Tight controls are needed for either process as both utilize Acid as part of the process which can and will attack the copper wire bonds.

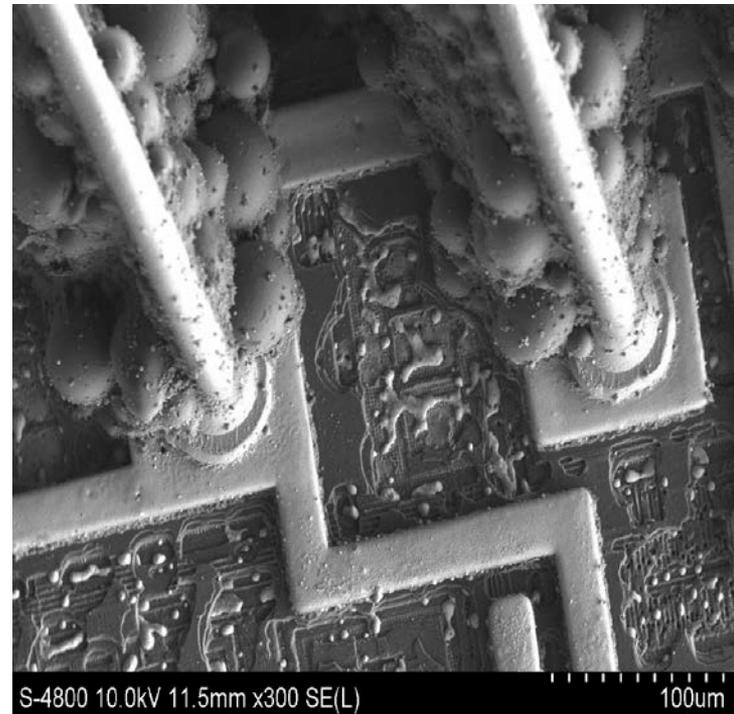
INTEGRA
TECHNOLOGIES

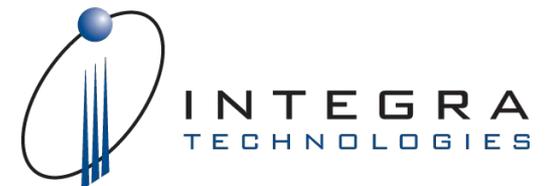
Phase 1 Inspection Criteria

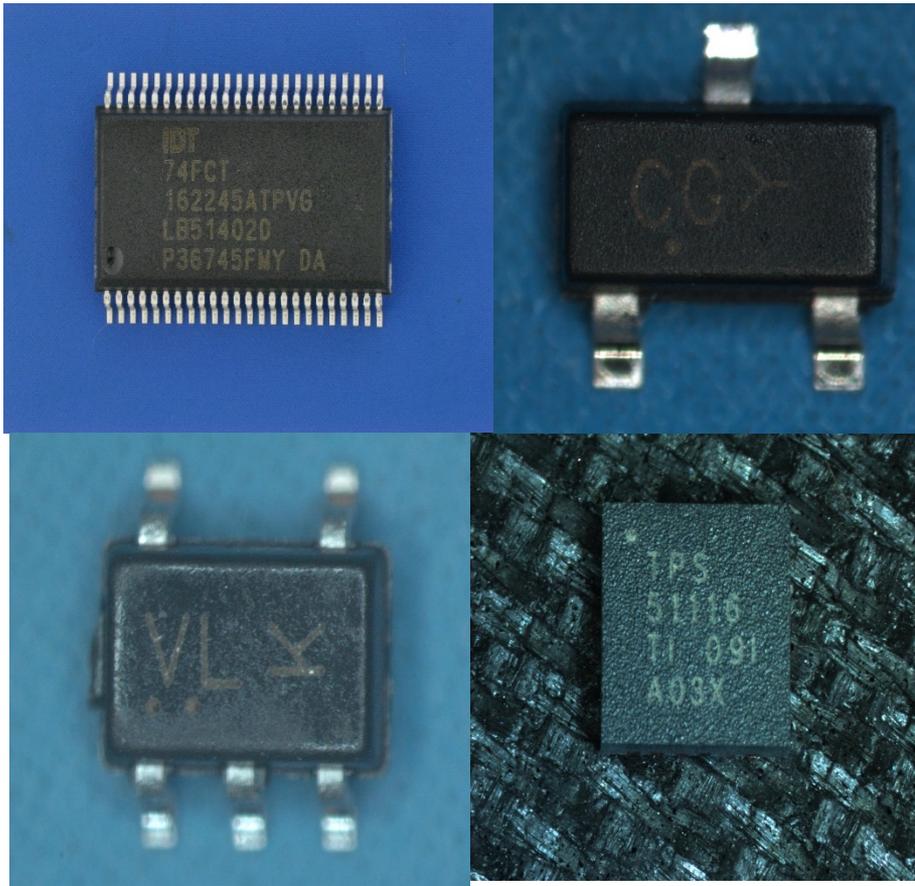
- Devices were purchased from Authorized distributor.
- All devices were inspected and found to be in good condition.
- No indication of improper storage that might effect reliability study.
- Minor oxidation was seen on the leads post stress.
- No cracks or package related defects were noted post stress.

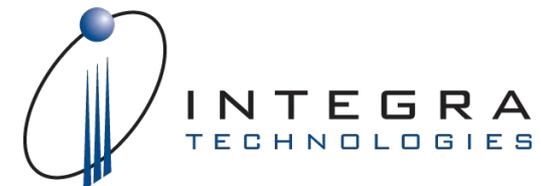
External Visual Inspection Results – Pre-Stress

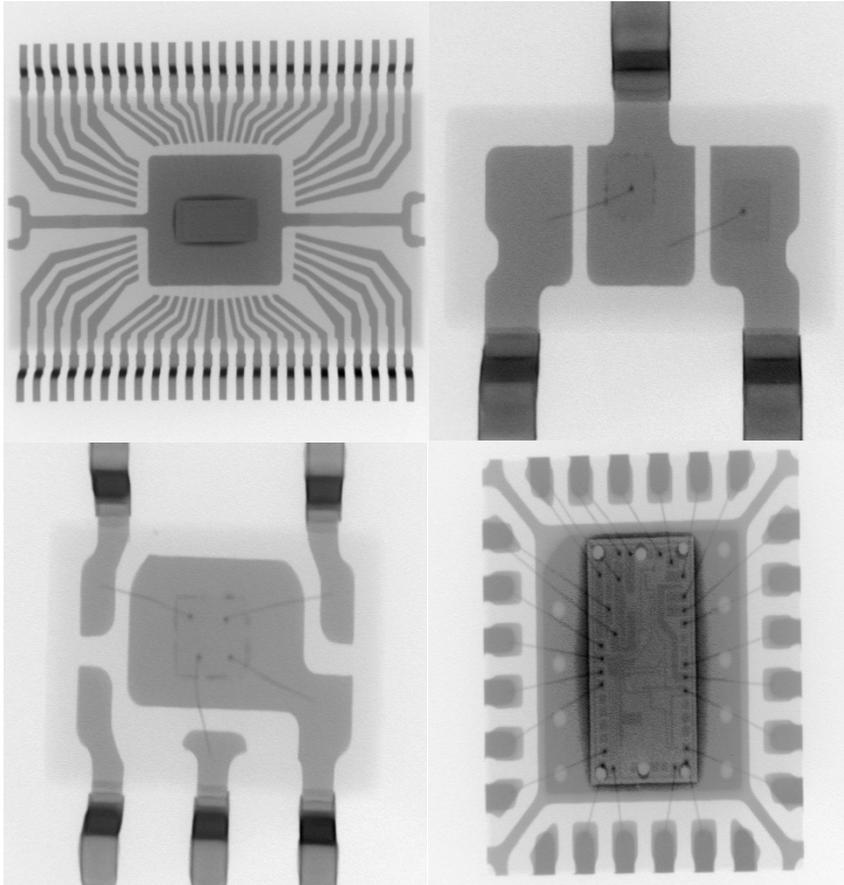
- All devices were inspected and found to be acceptable.
- Copper wire bonds were noted in X-Ray and confirmed in cross section

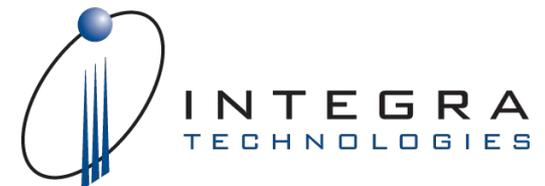
X-Ray (Gold Copper Comparison)

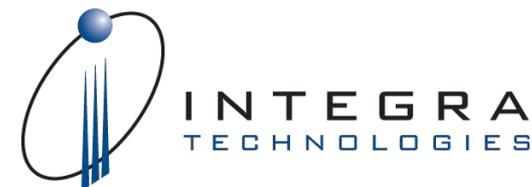
Pre/Post Stress	M74LVHC1GT5 0DFT1G		BAS70-04LT1G2		74FCT162245 ATPVG		TPS51116RG ET	
	QTY In	QTY Out	QTY In	QTY Out	QTY In	QTY Out	QTY In	QTY Out
Die Condition	2/2	2/2	2/2	2/2	2/2	2/2	2/2	2/2
Bond Condition	2/2	2/2	2/2	2/2	2/2	2/2	2/2	2/2
De-encapsulation Quality	2/2	2/2	2/2	2/2	2/2	2/2	2/2	2/2
Internal Wires	2/2	2/2	2/2	2/2	2/2	2/2	2/2	2/2
Lot Disposition	Pass		Pass		Pass		Pass

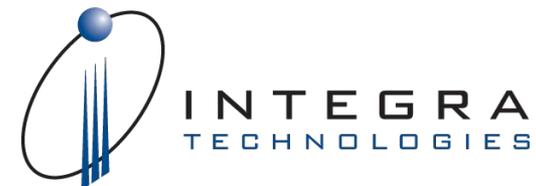
- While not every device showed a location dependency there does seem to be a dependency on this device type.
- With the larger sample size in phase 2 and the addition of ball shear these site dependencies can be better documented and explained.
- Pre data is from S/N 9 and Post data is from S/N 2
- No other bond lifts were noted.
