## **Recent Issues in Laser Diode Packaging for High Reliability Applications**

June 2022

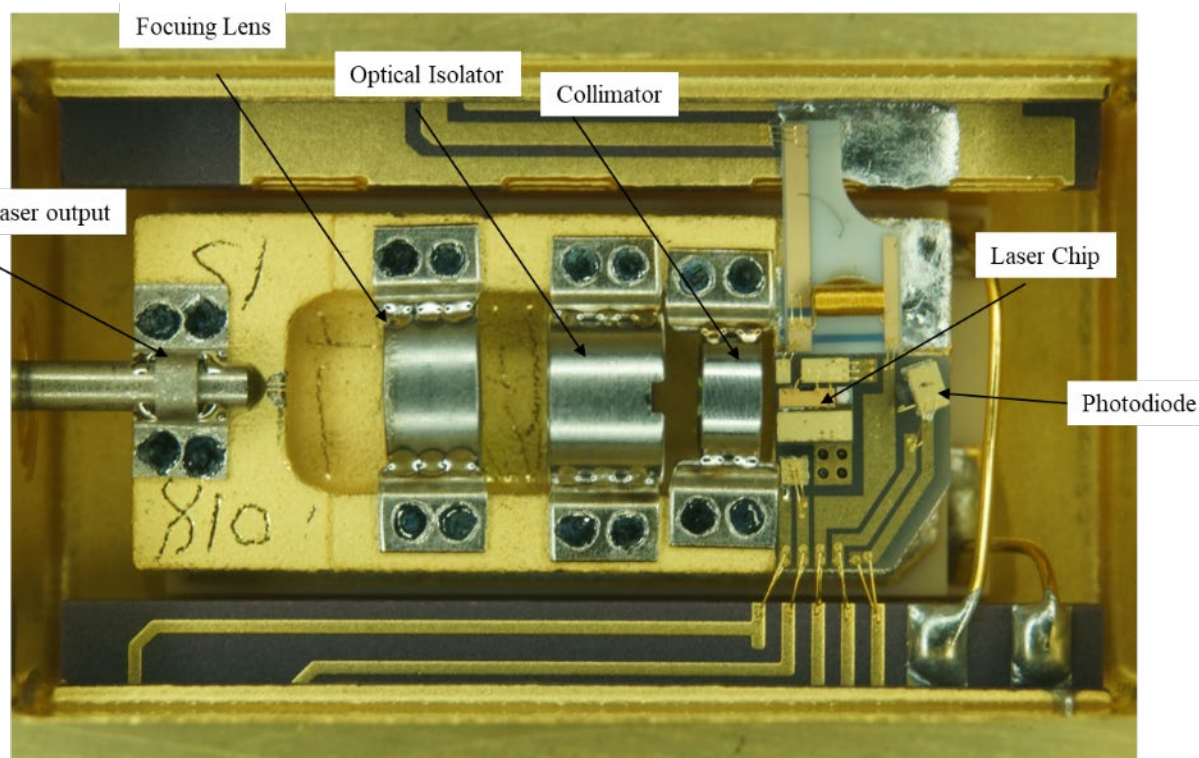
A **Distributed Feedback (DFB) laser** contains a periodically structured element or diffraction grating in the active region of the device to stabilize and lock the laser wavelength. It provides high wavelength stability and narrow linewidth.

Example of a DFB laser diode containing bulk optics inside laser diode package

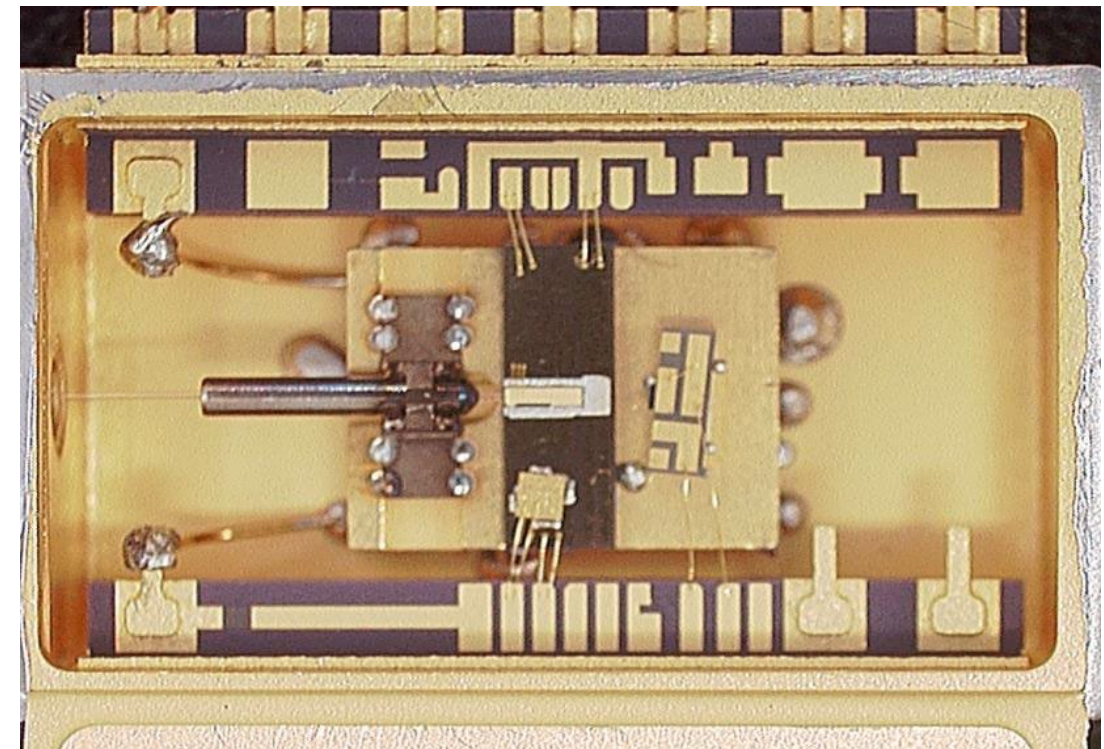
Example of a DFB laser diode with no bulk optics

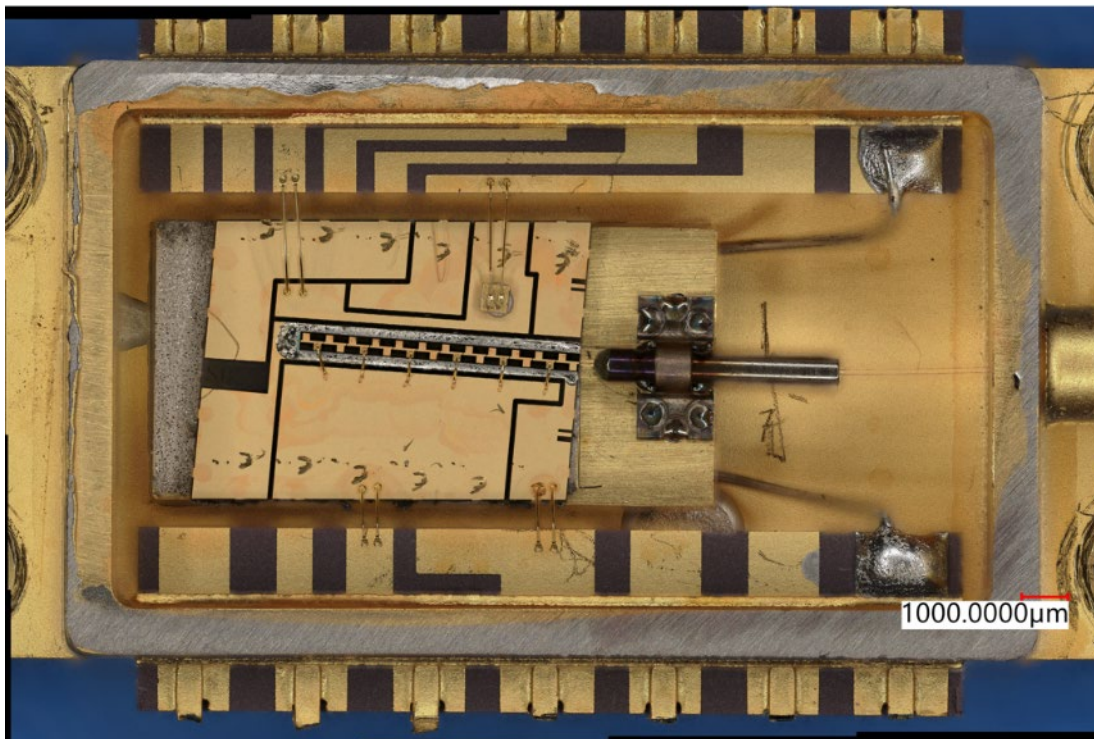
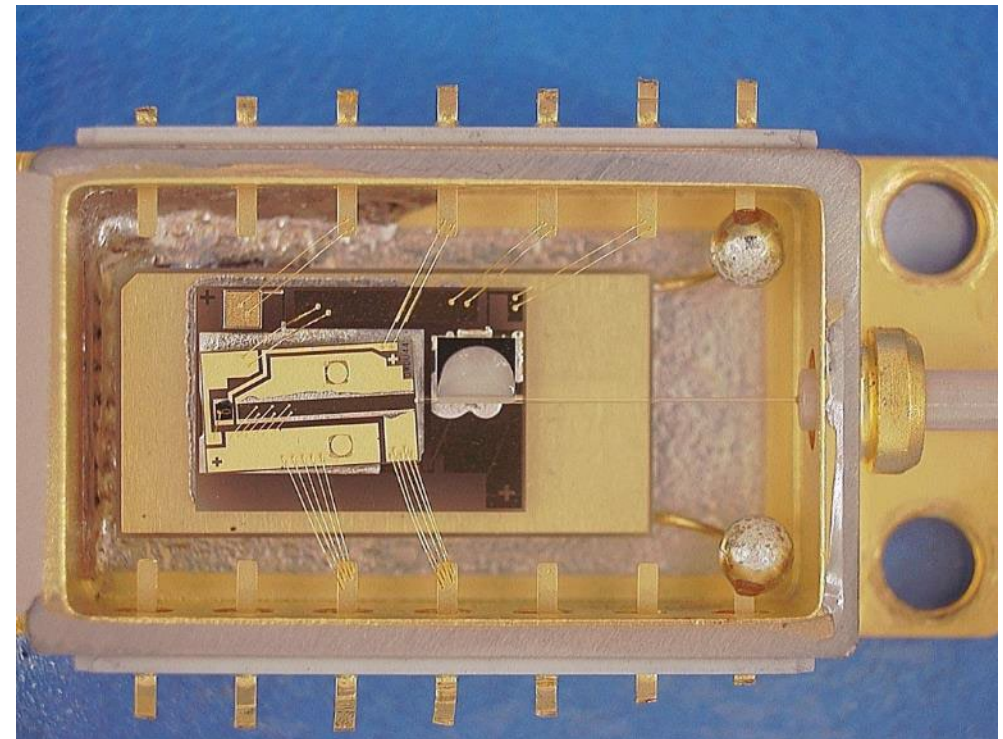
A **Fiber Bragg Grating (FBG) laser** achieves wavelength stabilization using a Fiber Bragg Grating in the fiber instead of the laser diode active material. Recent work with FBG lasers has shown reduced stimulated Brillouin scattering (SBS) when amplifying compared to the DFB laser.

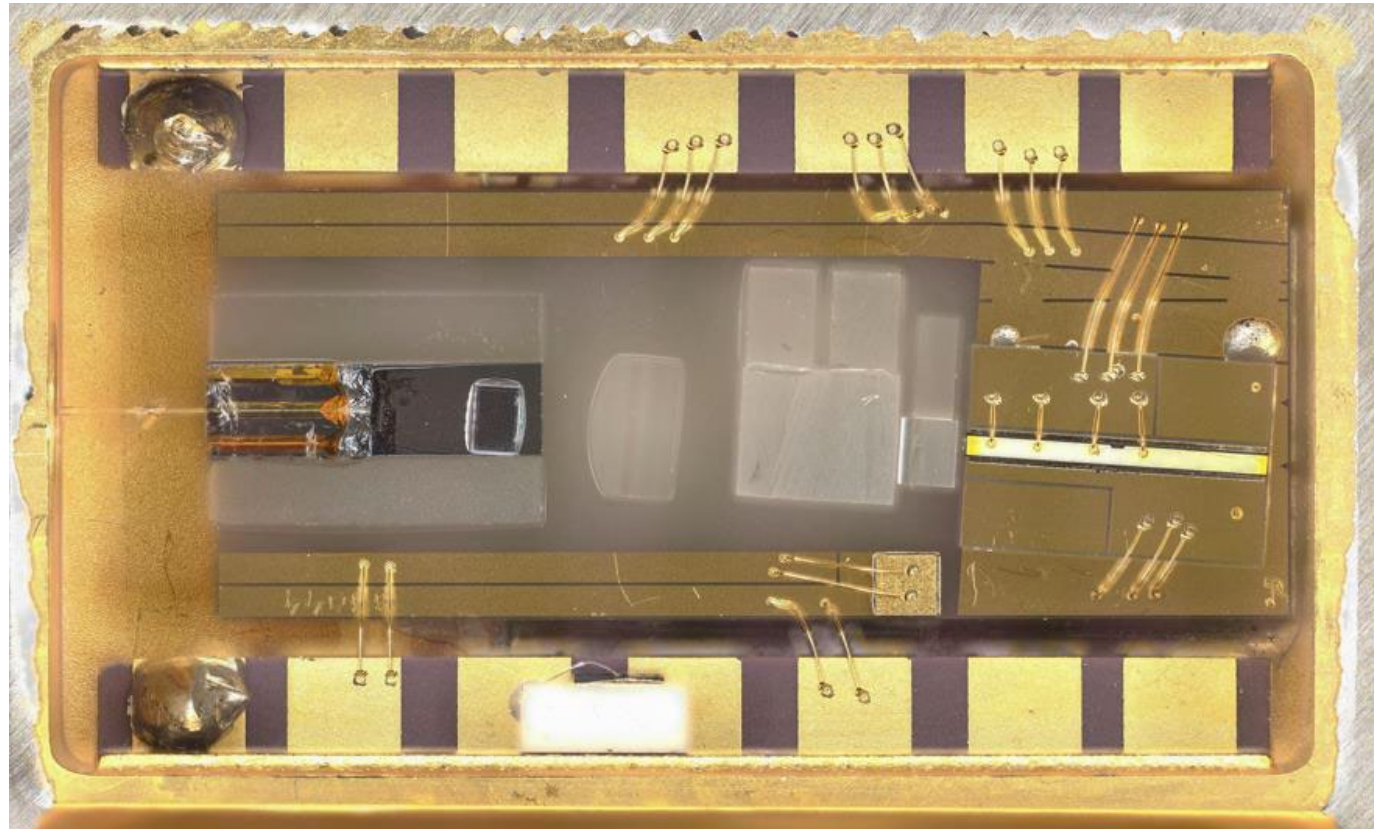
A **Spectrum Stabilized Single Frequency Laser** achieves wavelength stabilization using a transmission grating in front of the laser diode output. This allows for the optic to be thermally decoupled from the diode itself.

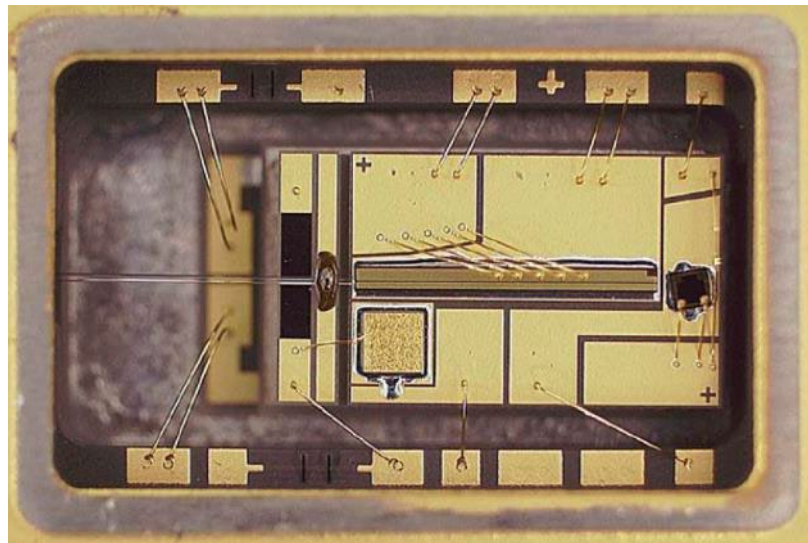
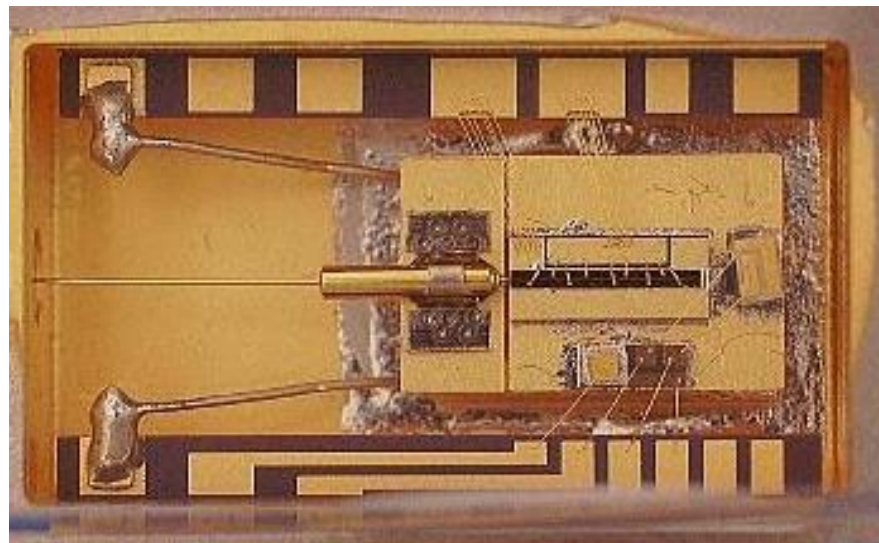
A **Multi Mode Pump Laser** is similar in construction to the single mode pump laser but note the much larger number of wire bonds to the laser bar for the higher current device.

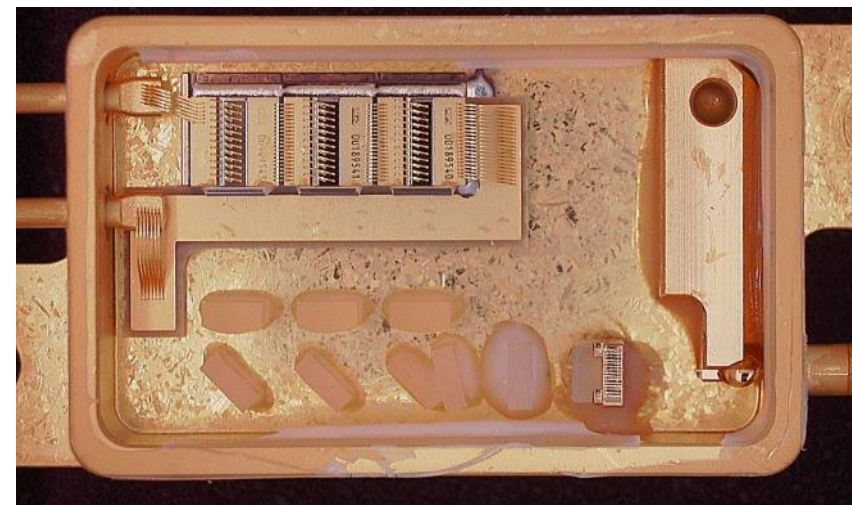
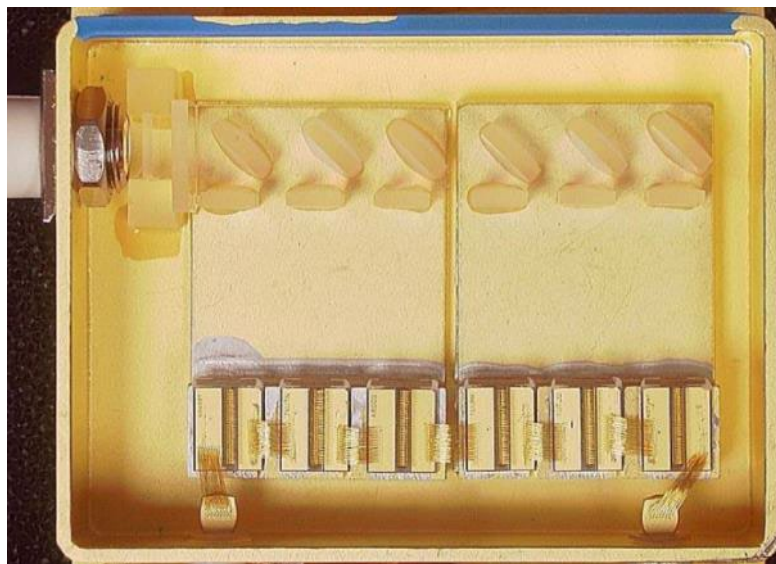
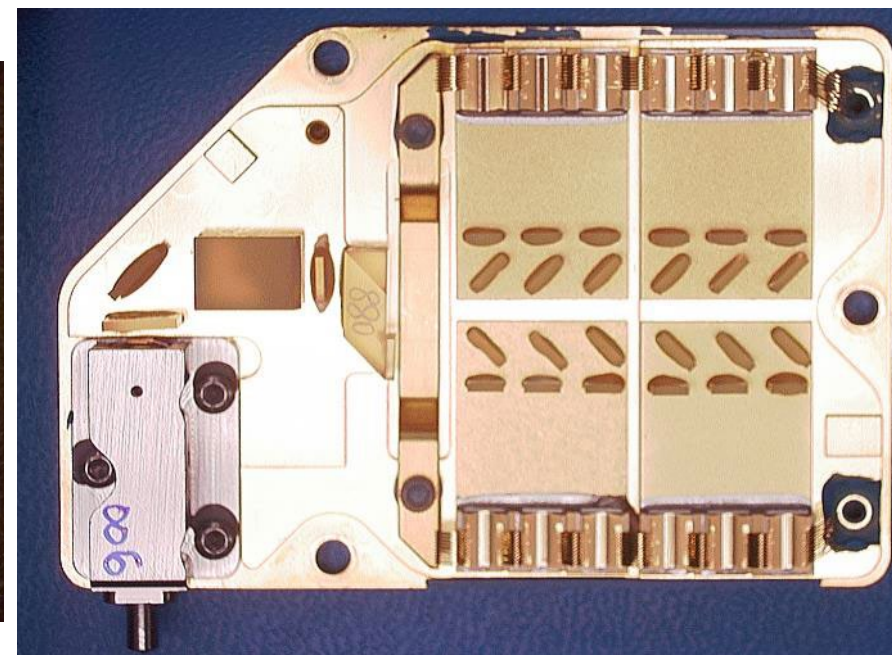
A **High Power Laser** utilizes bulk optics to collimate laser diode output in both axes, bulk grating for wavelength stabilization, and focusing lens for injecting light into fiber optic.

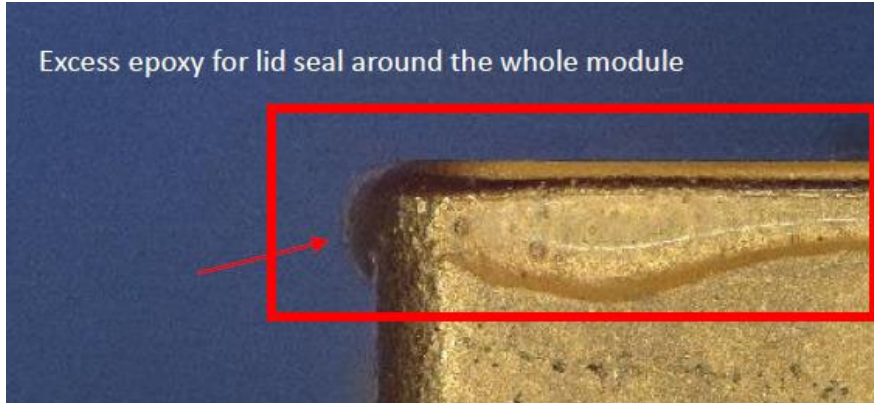
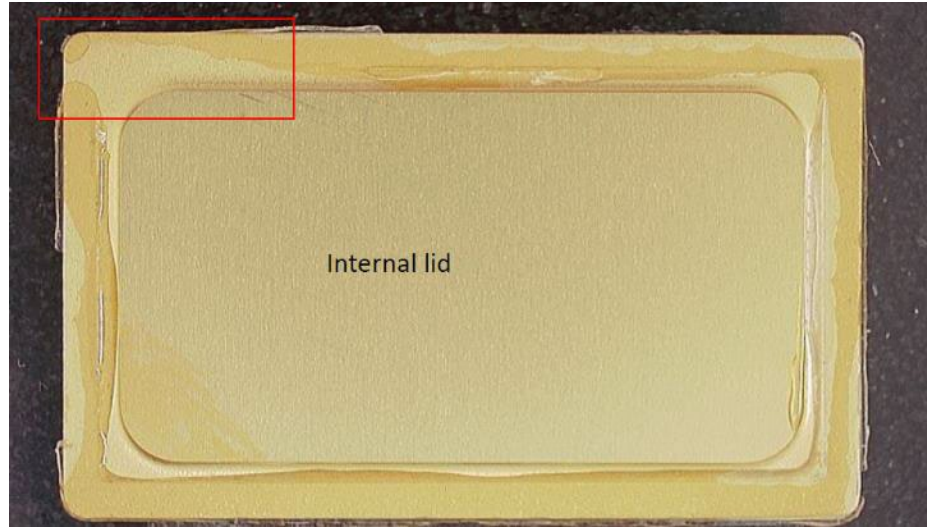
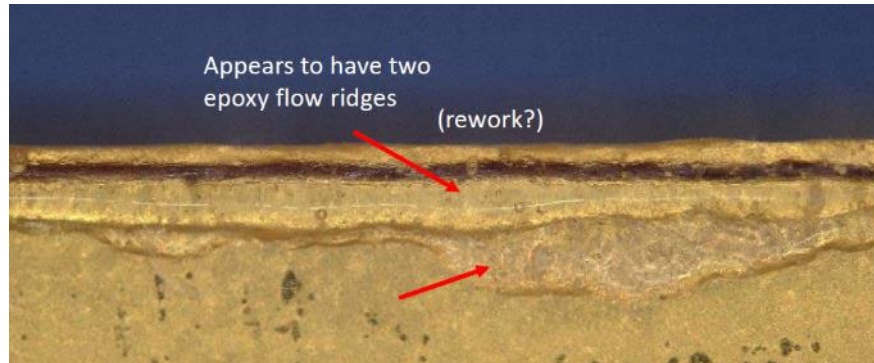
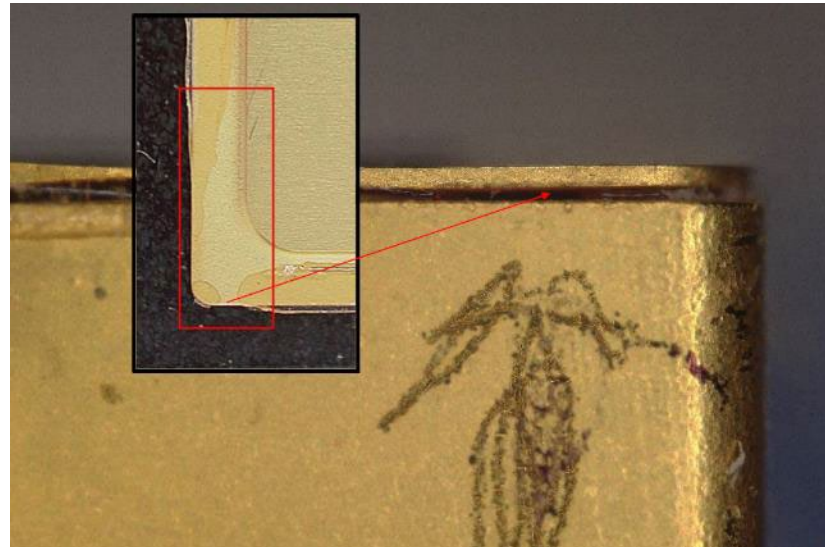
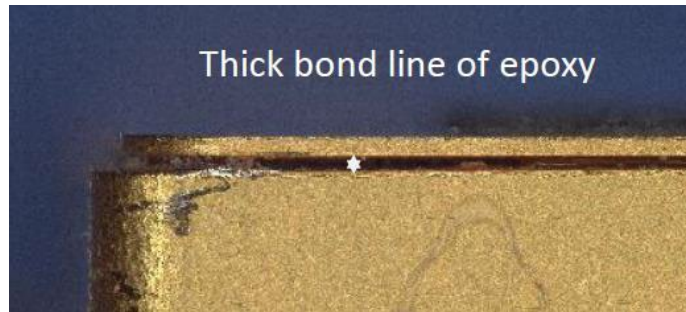
Lid sealing issues due to improper epoxy application are common in COTS parts. Close examination of the epoxy bond line should be made for high reliability functions.

Epoxy seals are not typically recommended for hermetic packages but can be used to reduce contamination risk.

In vacuum applications, epoxy used should be tested for outgassing.

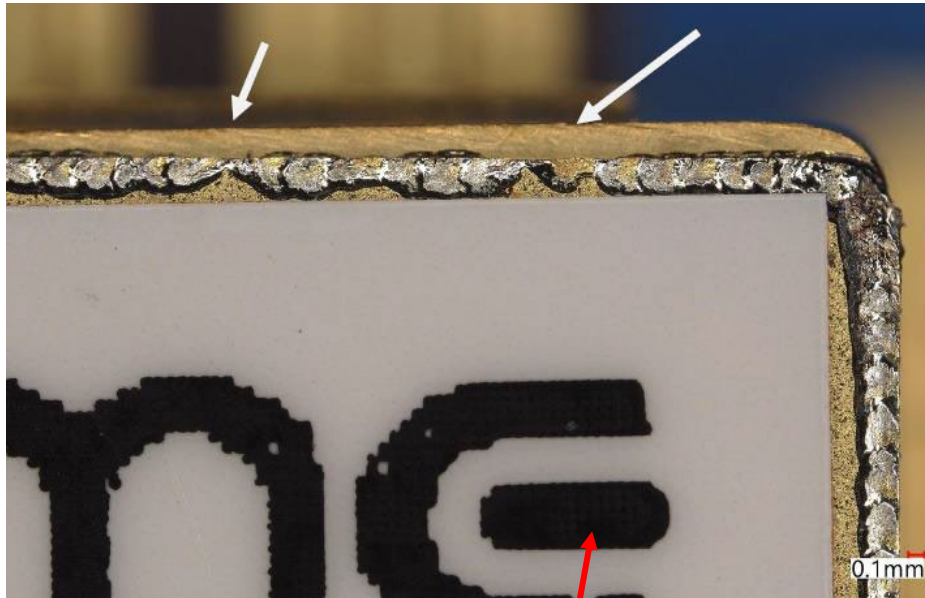
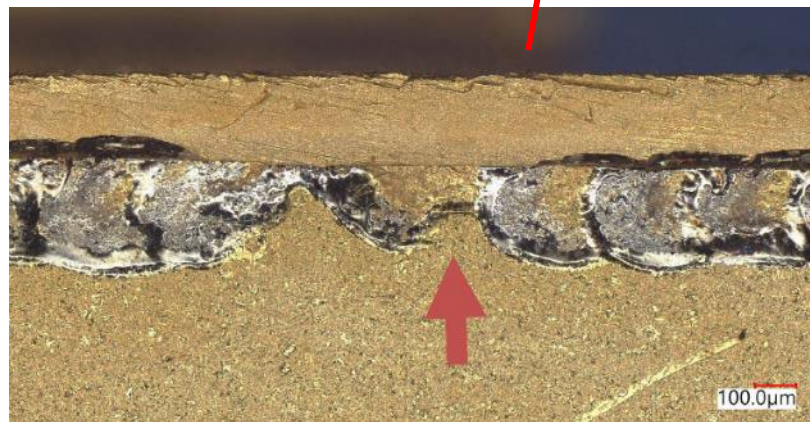
Inconsistent weld in lid seal

The package shown on the left was caught as having a suspected bad weld seal during incoming inspection of the part. The part failed hermeticity testing.

It is recommended that all parts with a hermetic requirement be tested individually.

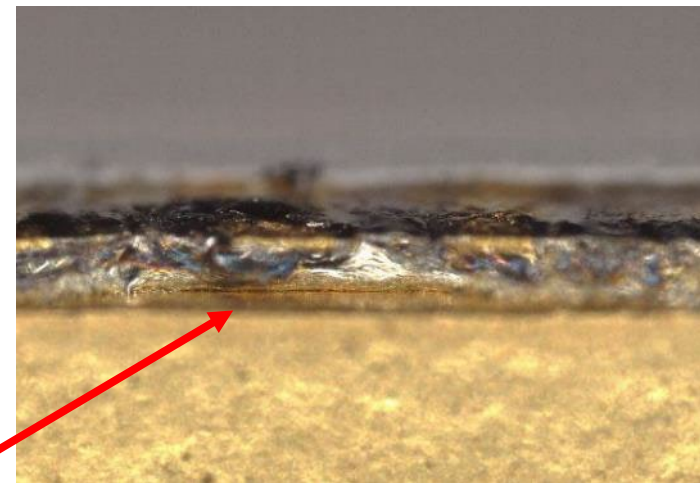
# Welded Joint Issues

In some applications welded joints are used to hold the housing for the optics and fiber ferrule in place.

Cracked or insufficient joints can cause the optics or fiber to shift during vibration and/or temperature cycling.

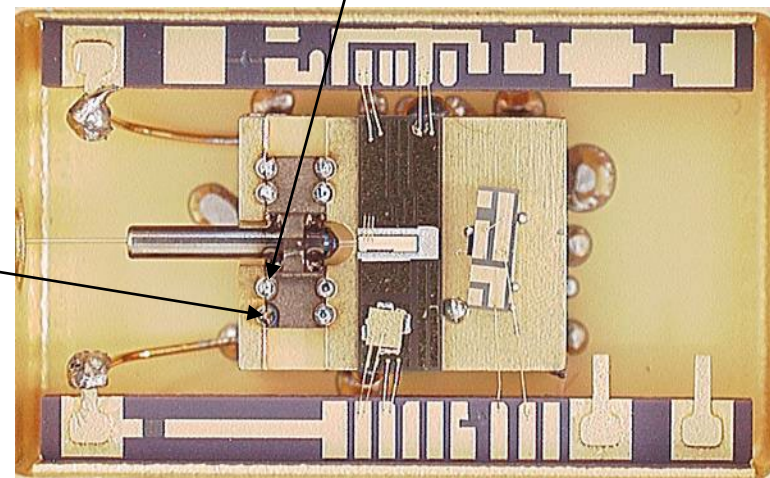
SEM image shows cracked welds at the fiber mounting structure.

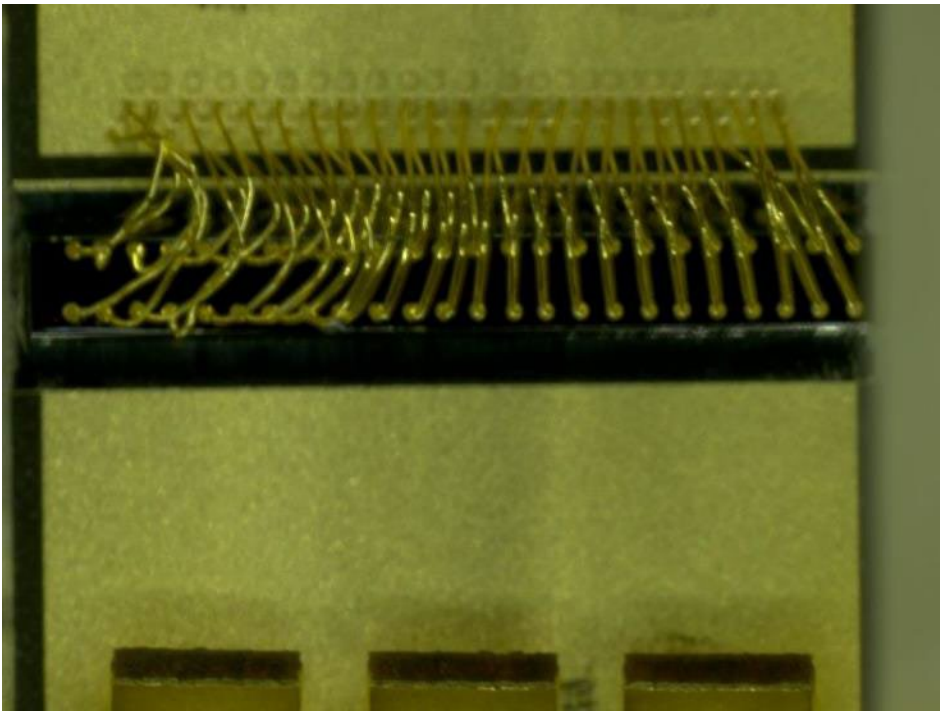
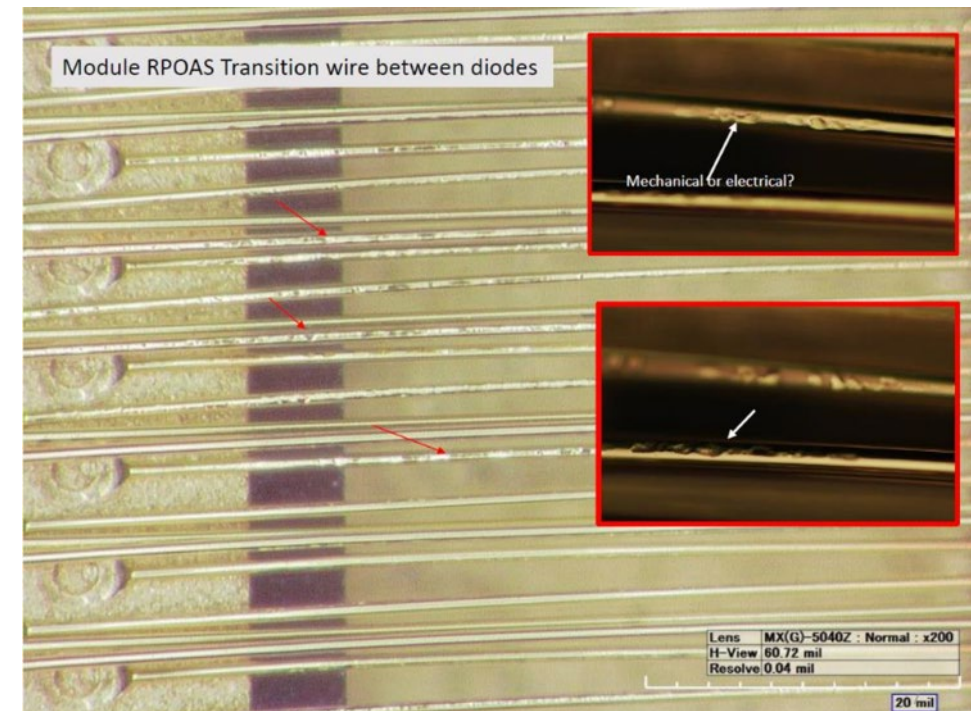
- Disturbed wire bonds, seen on the bottom left, are typically seen when part has been reworked or when the manufacturer performed an intermediate testing step that required probing the part during assembly.
- Damaged wire, seen on the bottom right, can either be an issue with the lot of wire, caused by mishandling of the wire during installation or a tooling issue, or overdriving the part.

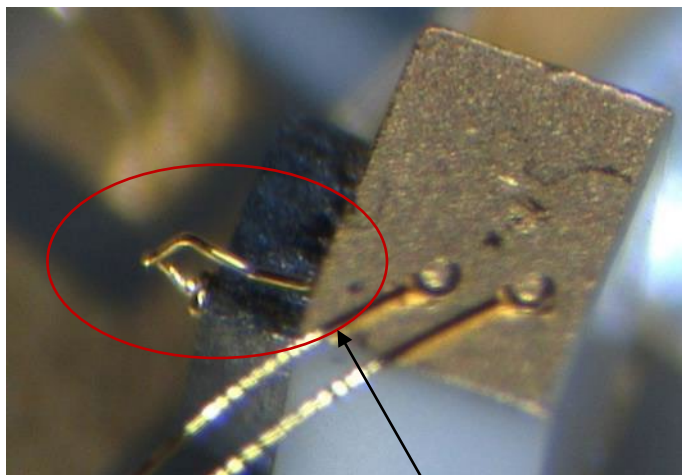
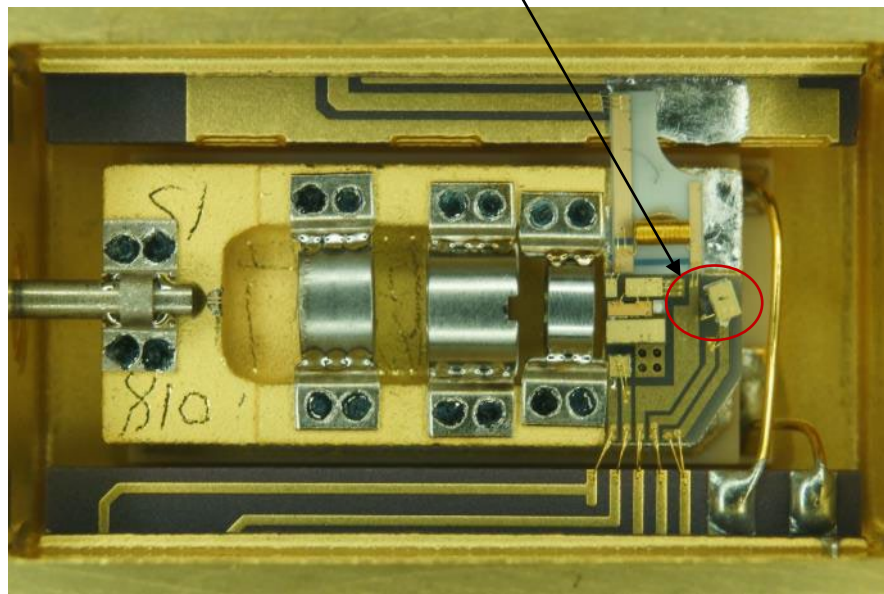
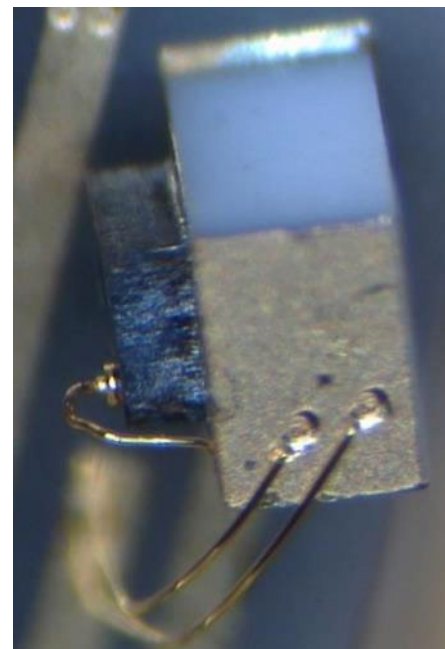
The images shown are from the same laser diode and show an abnormal bend on a wire bond on the photodiode of the part. The bend was noted but was not adjusted. This diode was removed from flight candidacy but was used for life test purposes.

A bend like the one shown could be an issue with workmanship or damage during manipulation or installation of the photodiode into the next higher assembly.

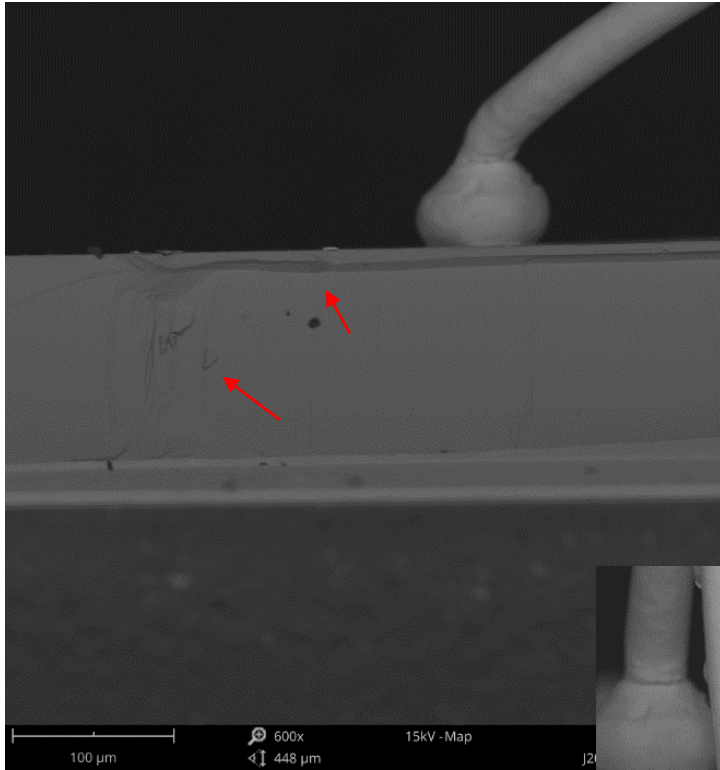
Compression damage to the GaAs due to bonding pressure

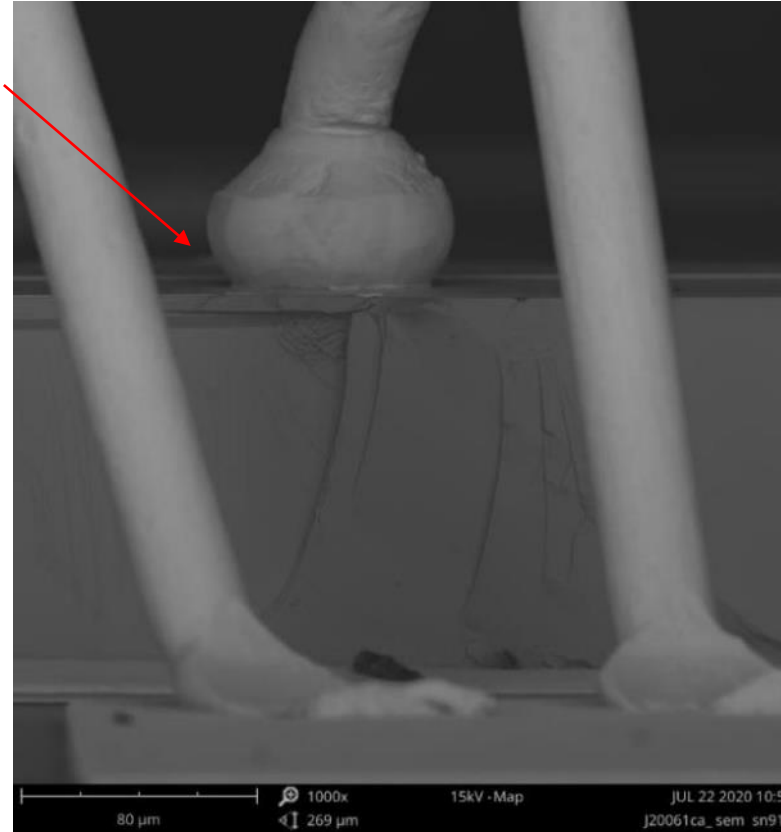
Images show damage to the laser bar of a high power laser diode due to excessive force of the bond.

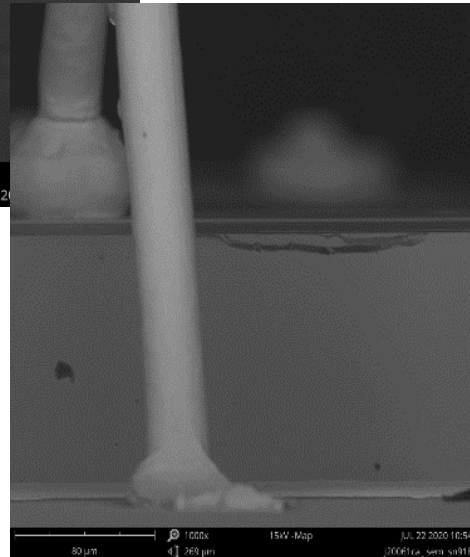
Chip damage due to excessive bond force.

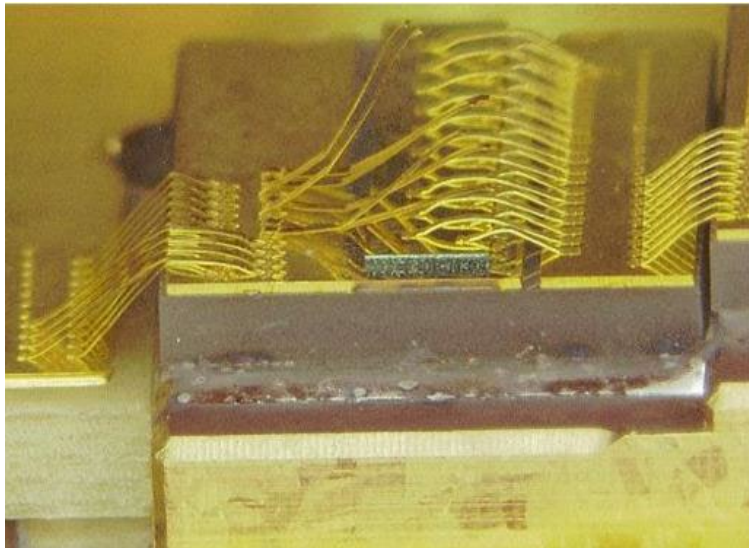
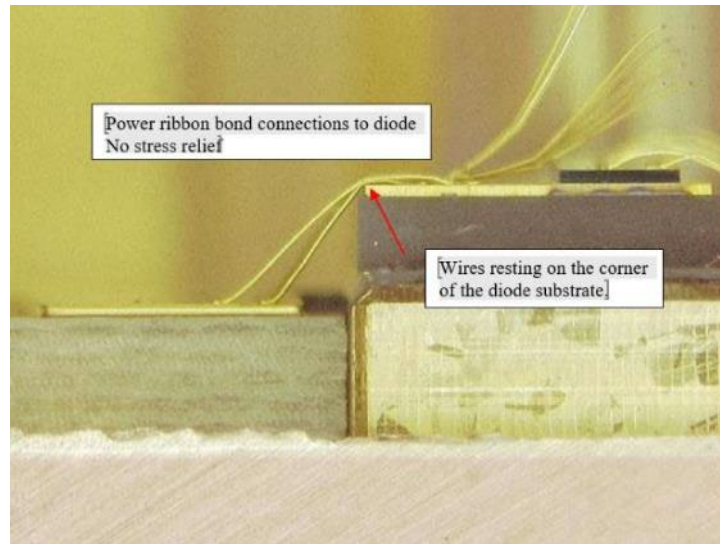
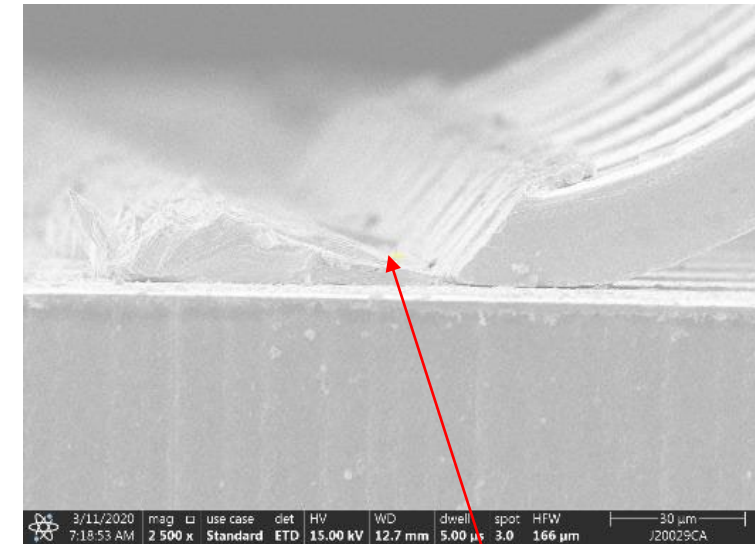
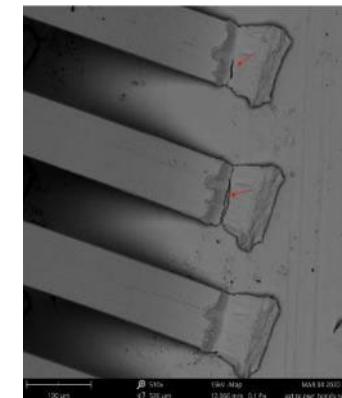
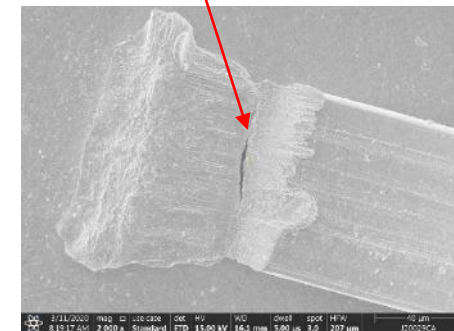
Close-up images of ribbon bonds of the part show anomalous bonds containing cracks and gaps in the ribbon weld. These were caused by the vendor's ribbon bonder putting too much force during the application.

Inspection also found improper strain relief on the ribbon bond during transition over the substrate corner (2<sup>nd</sup> image from left). Both issues were corrected with the vendor prior to the final flight lot.

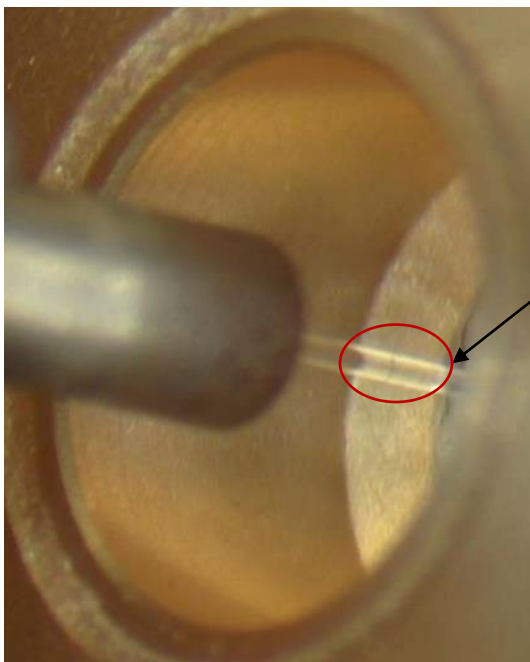
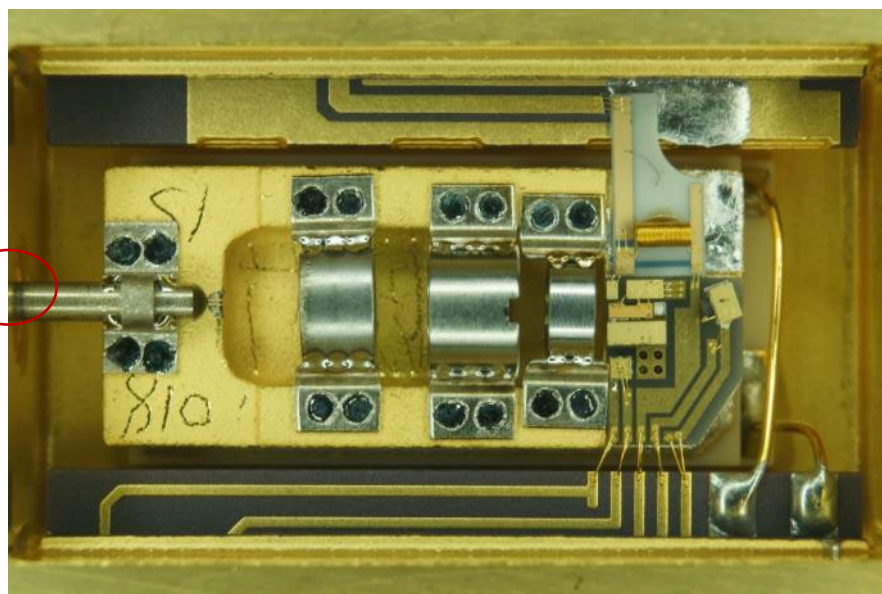
This part in the top two images had a line across the fiber in the “snout”. Fiber optics need to be carefully inspected during precap for any abnormalities.

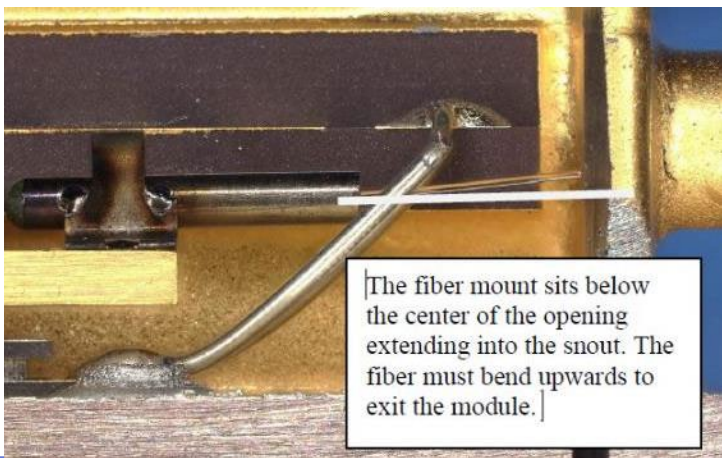
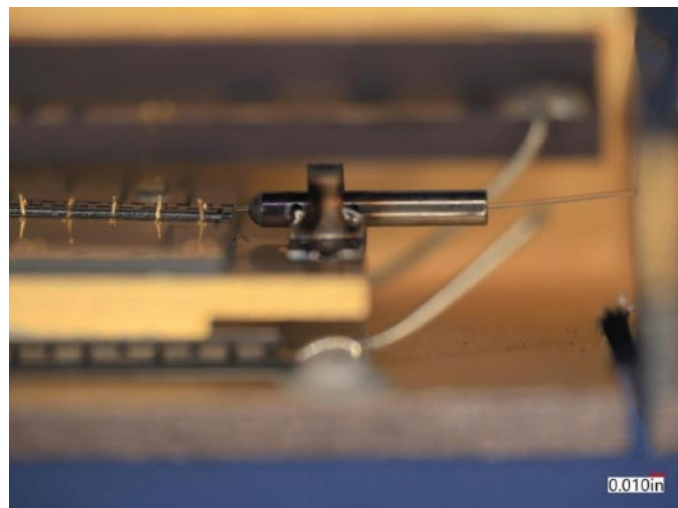
The bottom two images show potential strain on the fiber caused by the fibers not sitting in plane with the output. When the fiber mount sits below the opening in the package wall, it forces the fiber to bend upward to enter the snout.

Possible long term reliability concern depending on mission requirements (temperature ranges, number of temperature cycles, vibration, etc.)

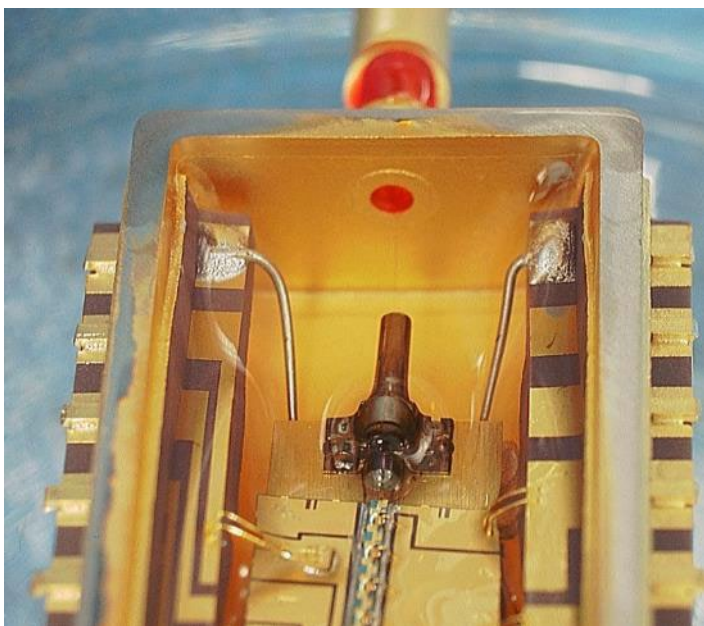
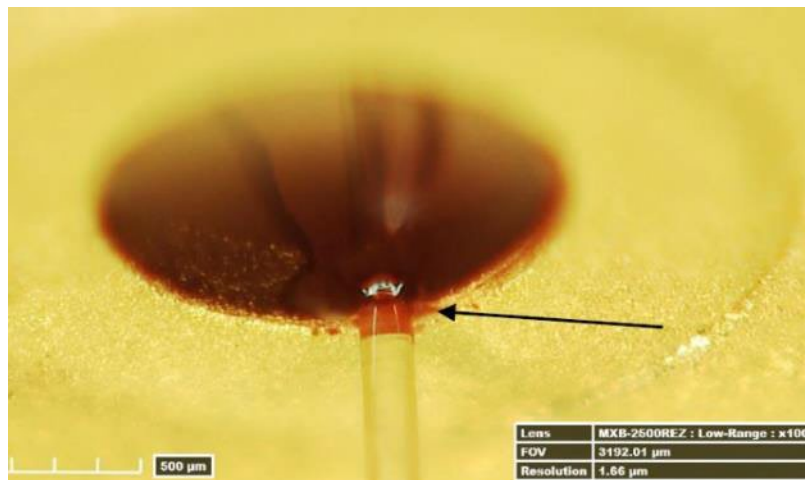
In hermetic packages, a glass seal is preferred over an epoxy seal. Epoxy seals can have shrinkage and cracking over time which could cause a failure in hermeticity or a strain on the fiber output.

Images below show some examples of a cracked epoxy seal within a laser diode package.

It is also recommended to keep the fiber optic centered within the snout opening of the laser diode for long term reliability and stability.

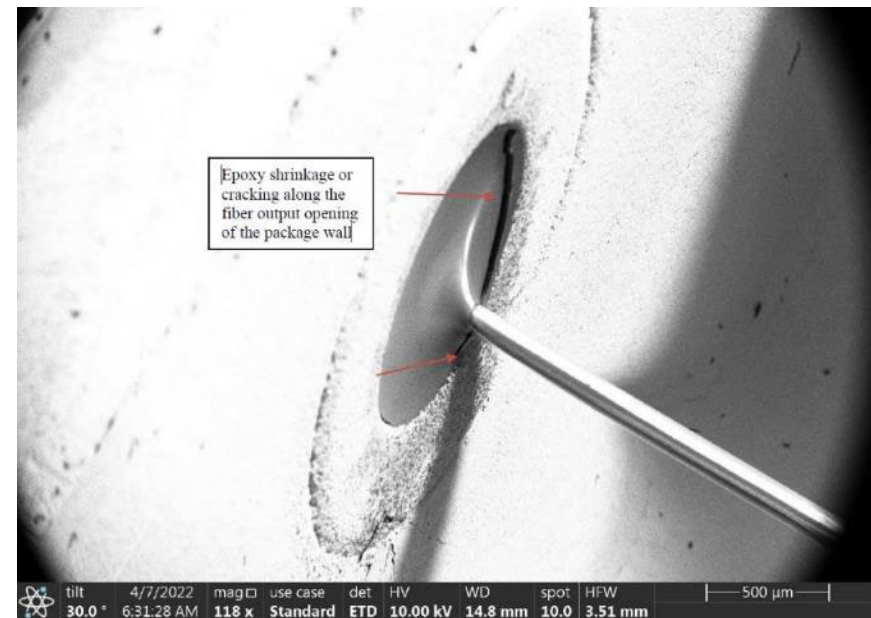
The fiber is positioned on the bottom of the snout opening in the package wall.

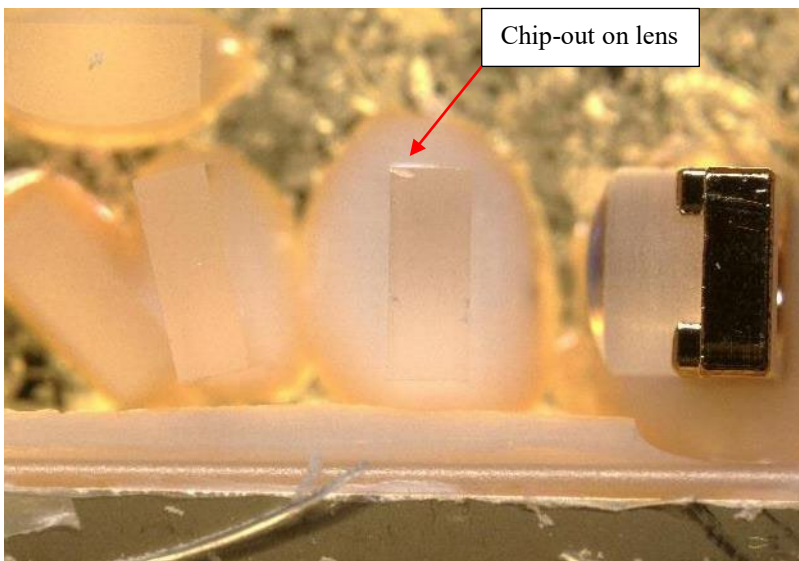
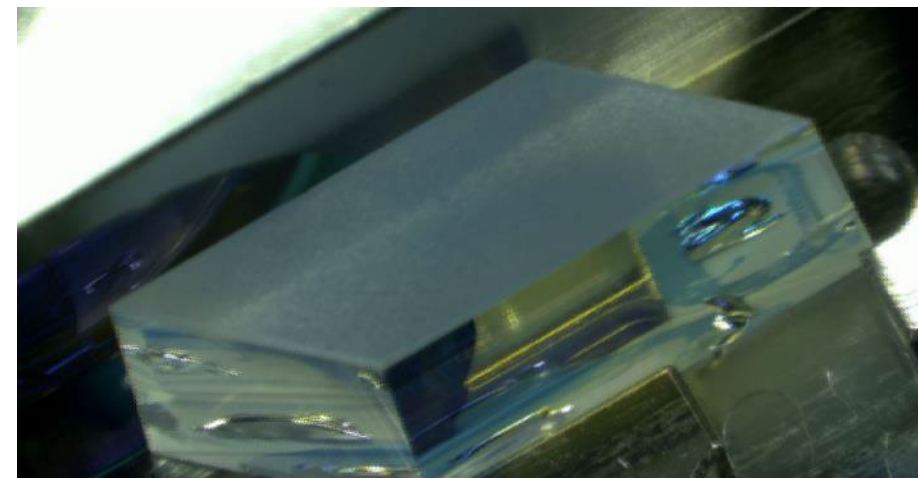
Chips and Cracks are commonly seen within the optical components of laser diodes.

Chips and cracks can lead to a loss of power of the laser. Cracks will propagate in thermal environments which could lead to a latent laser failure.

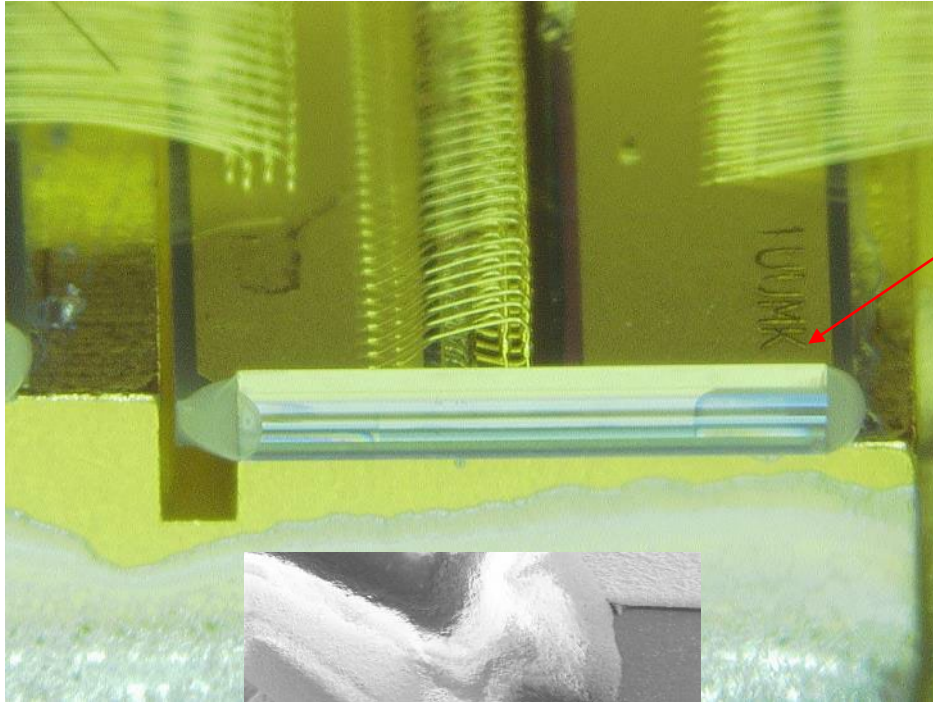
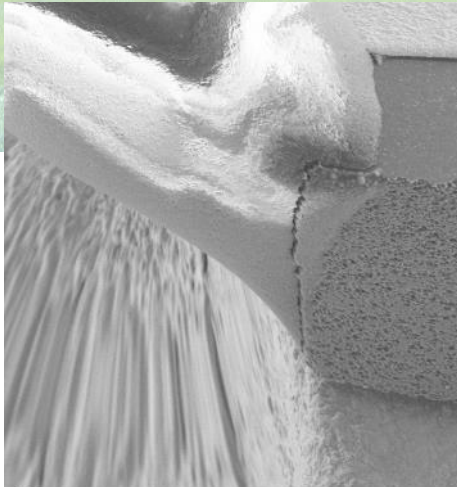
Images showing the small individual lenses on a 2 pin high power laser diode. The anomaly can be seen through the lens. The surface was not prepped properly which led to the adhesive not sticking to the lens or diode surface. The adhesive line was cracked, leaving the lens barely attached to the diode. The shear strength was in some cases less than 10gf (For reference a correctly attached optic here has a shear force >450gf).

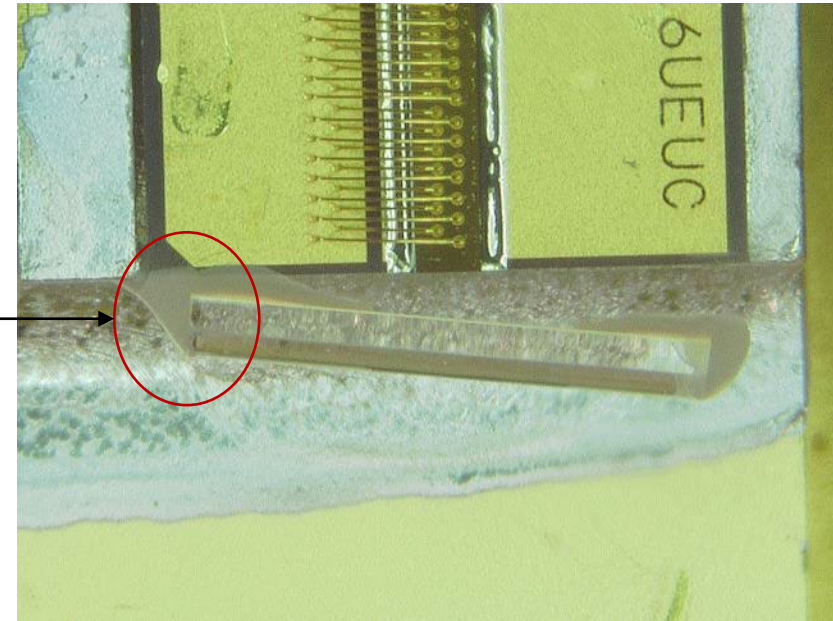
Chiplet lens epoxy failure
