## **Recent Issues in Laser Diode Packaging for High Reliability Applications**

June 2022

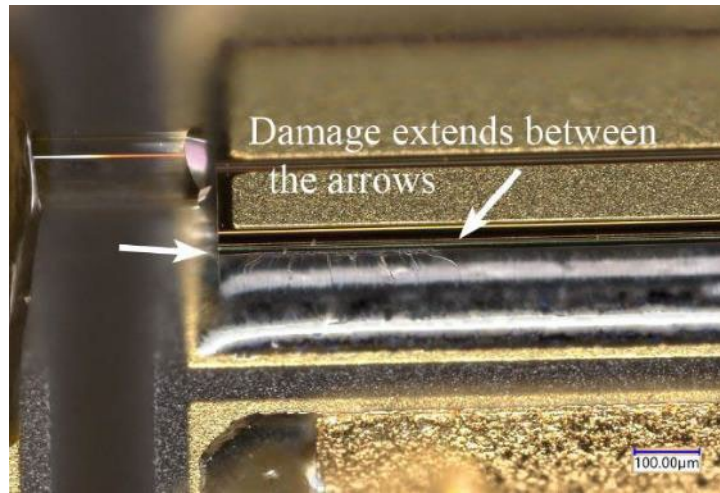
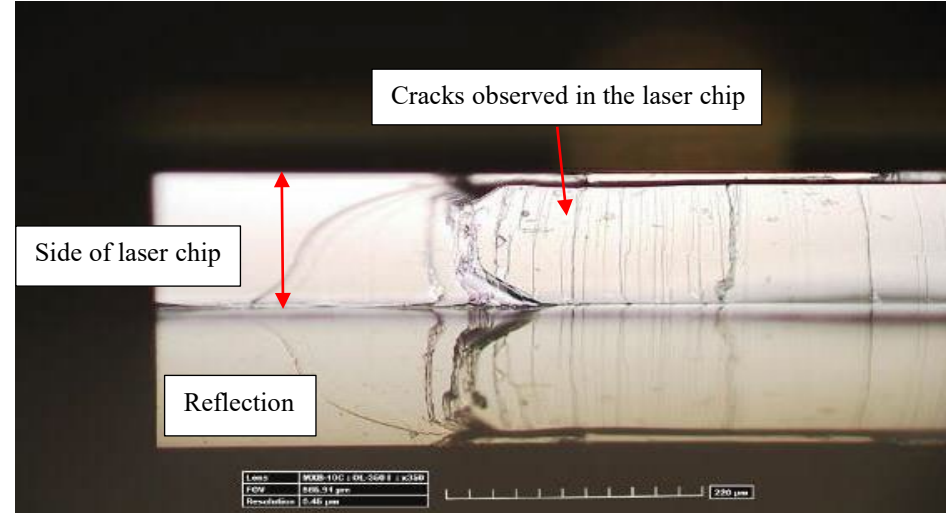
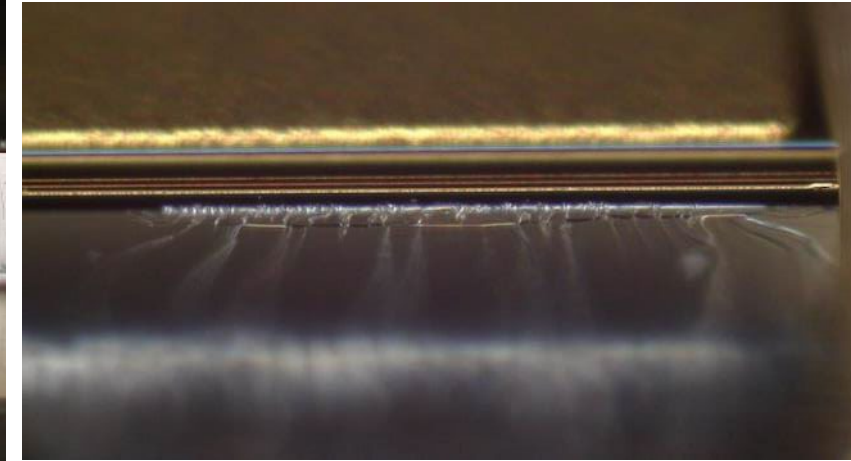
Damage to the laser bar is not acceptable in any high reliability laser diode application.

If found during pre-cap inspection, the part is immediately removed from the lot and high reliability use. Most examples of laser bar damage shown were after laser failure.

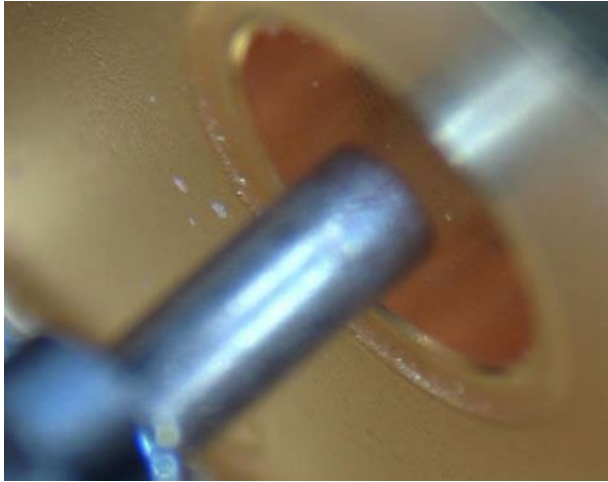
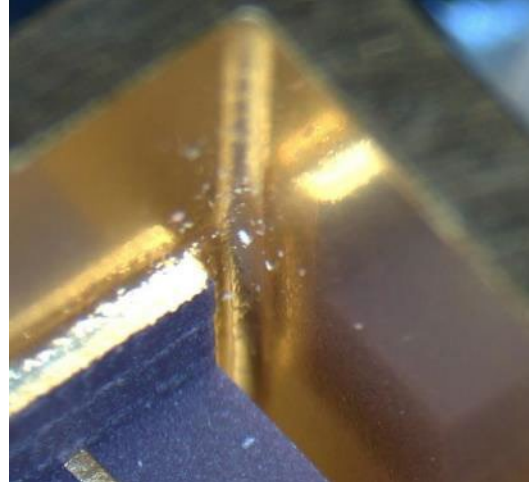
While other parts exhibited some of this white debris, this particular part had significantly larger amounts in various locations.

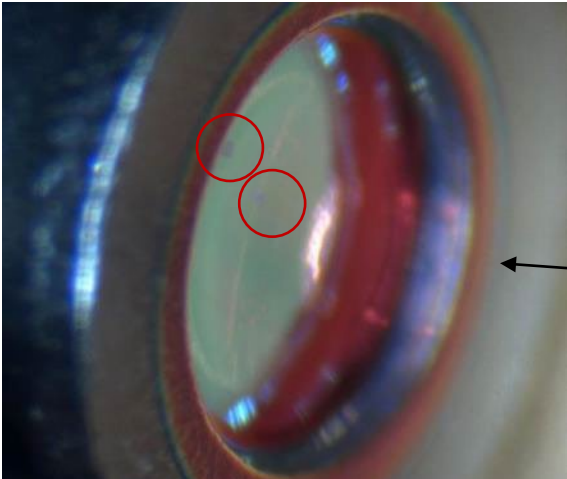
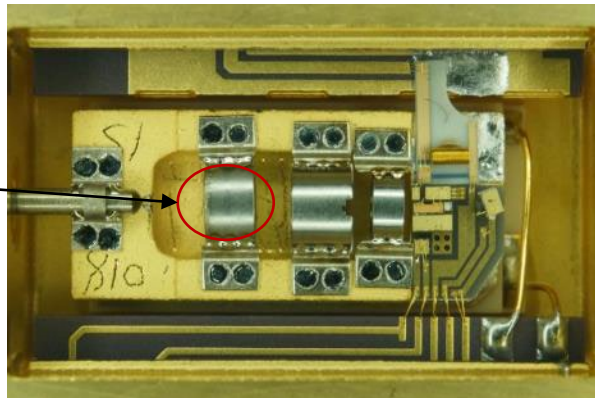
The fiber side of the focusing lens was found to have 2 small pieces of debris.

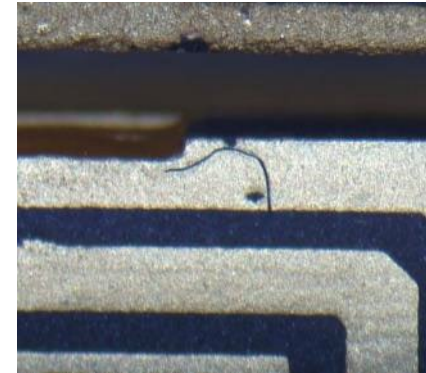
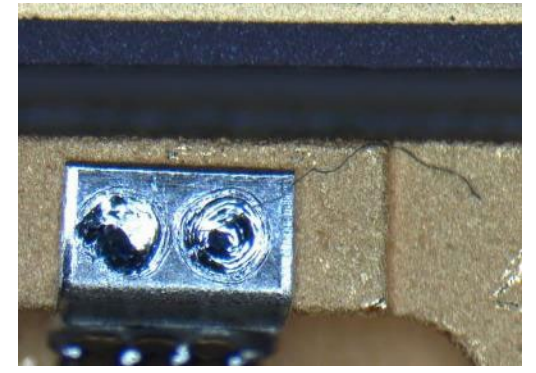
Some other examples of larger debris was observed in a handful of parts.

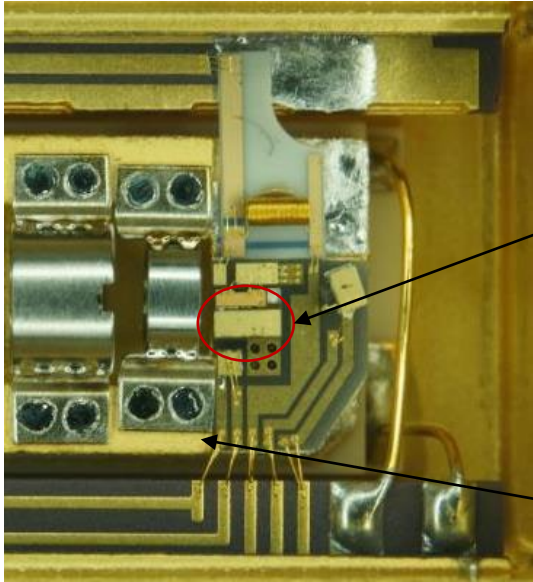
Solder balls found during precap inspection near the laser diode chip.

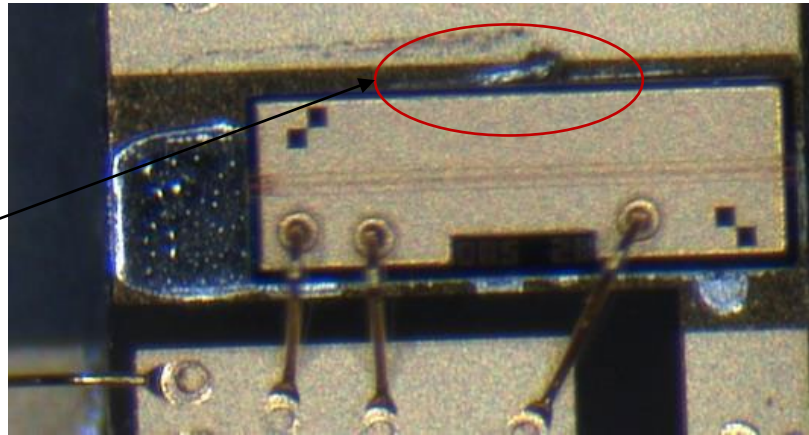
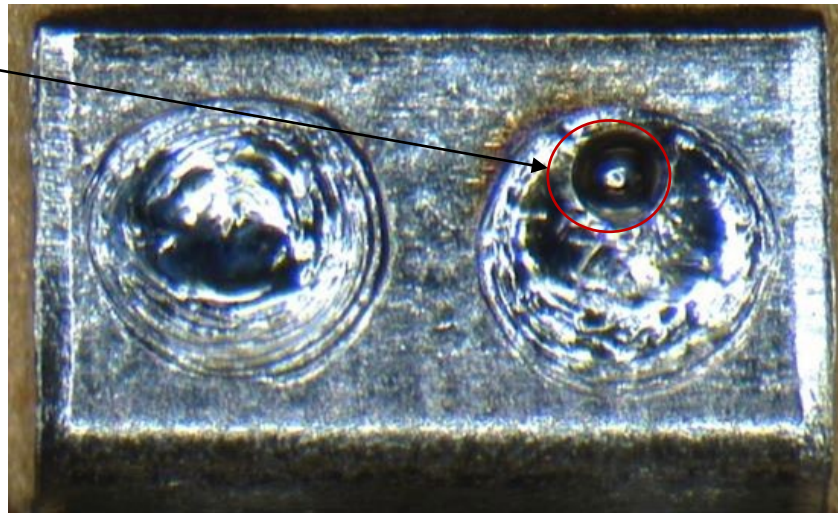
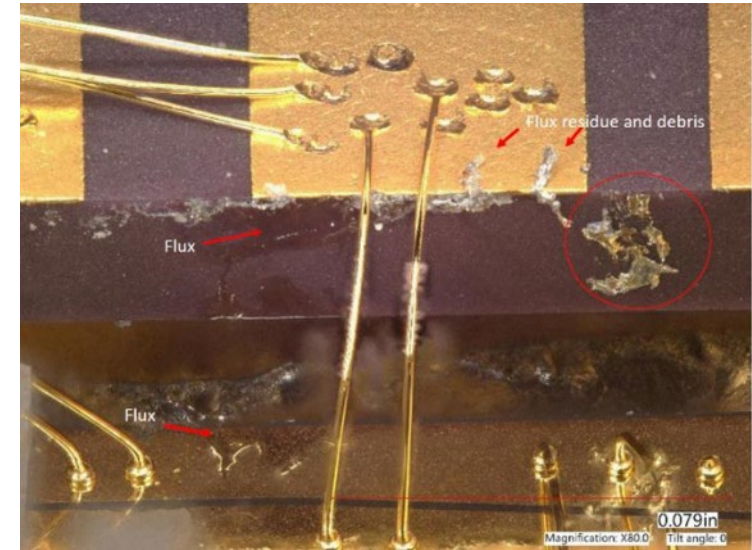
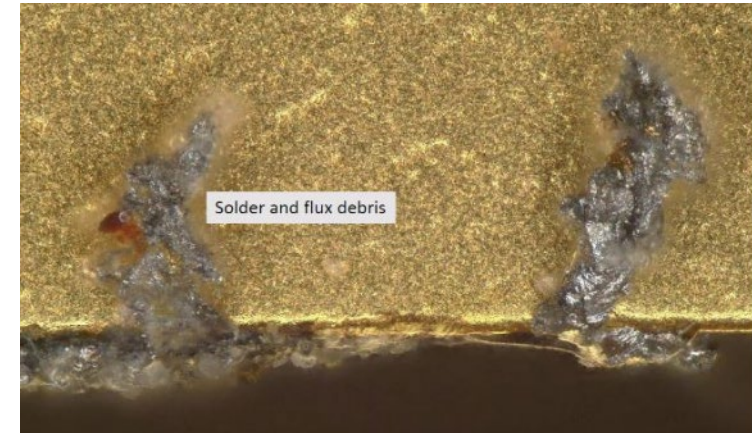
Solder and Flux Debris inside of laser diode package

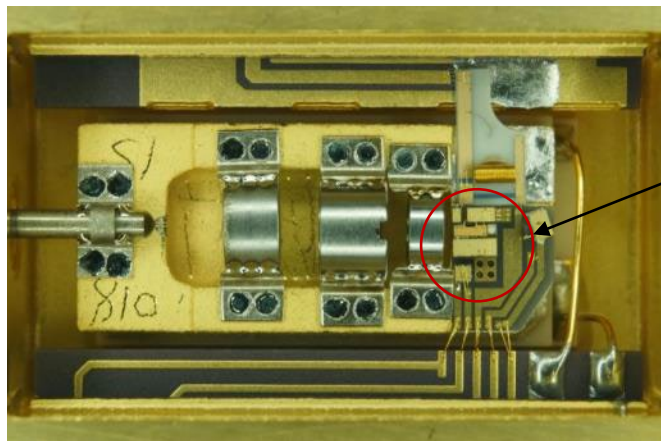
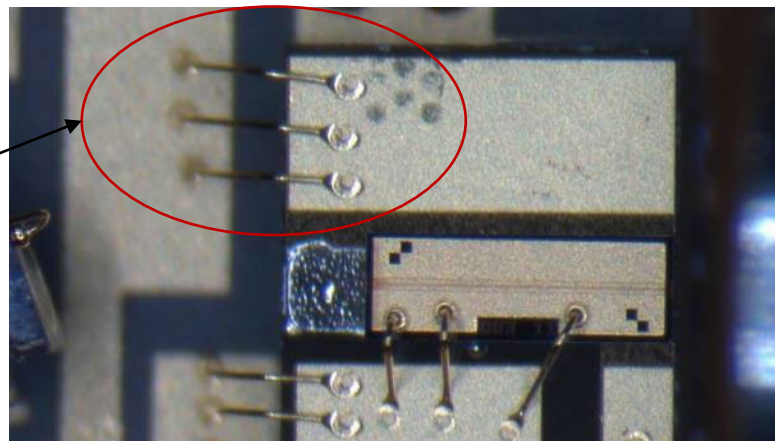
Three extra wire bonds were found on this device, which created a path to bypass the inductor.

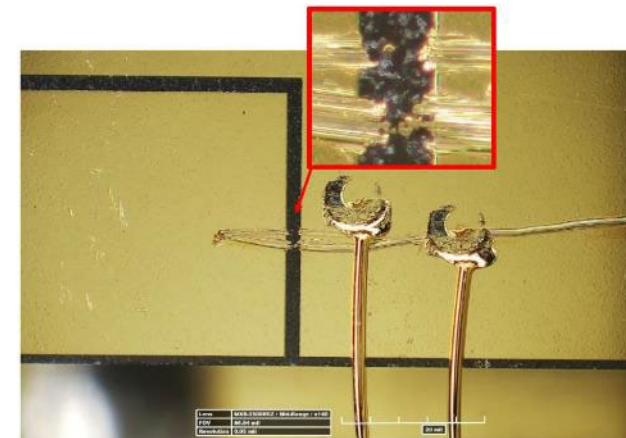
A short almost caused by a scratch

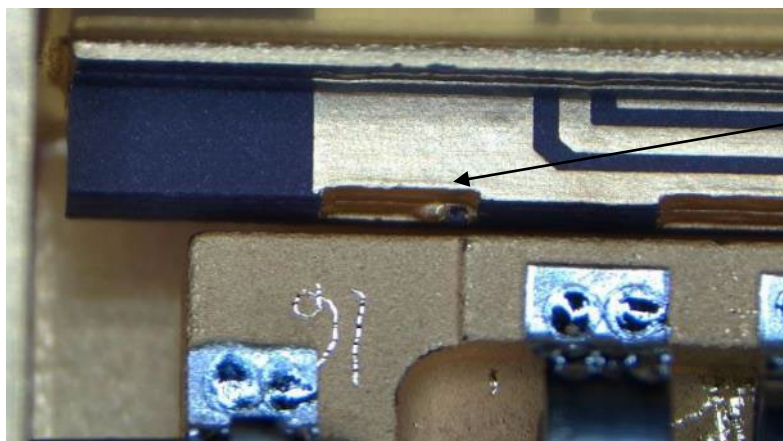
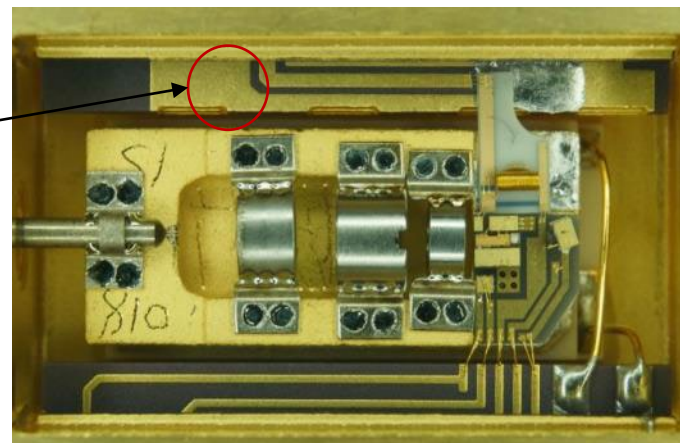
Images show a defect in the ceramic lead frame feed-through. This is a package level defect and not an assembly/workmanship defect.

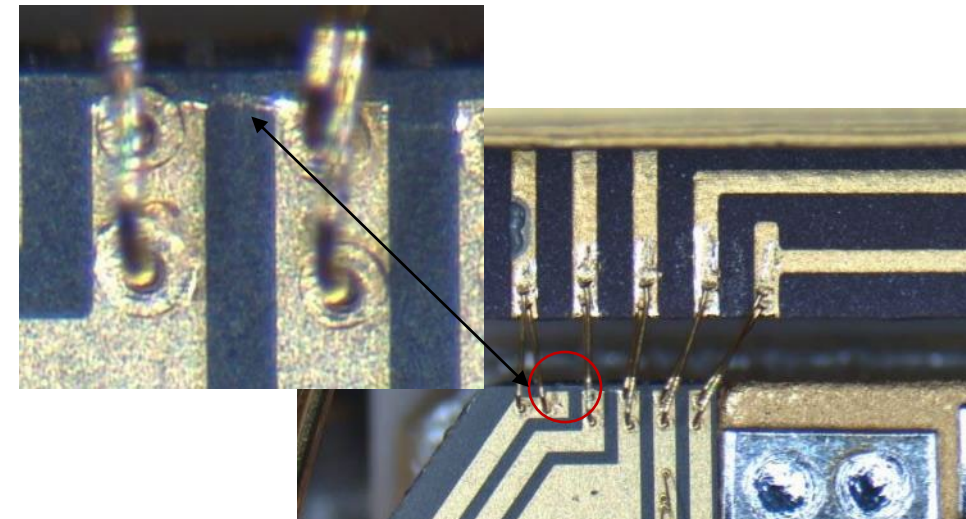
Mechanical smearing of material almost forming a short between non-common circuit elements.
