CSP ASSEMBLY RELIABILITY: COMMERCIAL AND HARSH ENVIRONMENTS

N. P. Kim, Boeing Information Space and Defense Systems
K. Selk, B. Bjorndahl, TRW Electronics and System Technology Division
R. Ghaffarian, J.K. Bonner, S. Barr, Jet Propulsion Laboratory- California Institute of Technology
Reza.Ghaffarian@JPL.NASA.Gov, (818) 354-2059

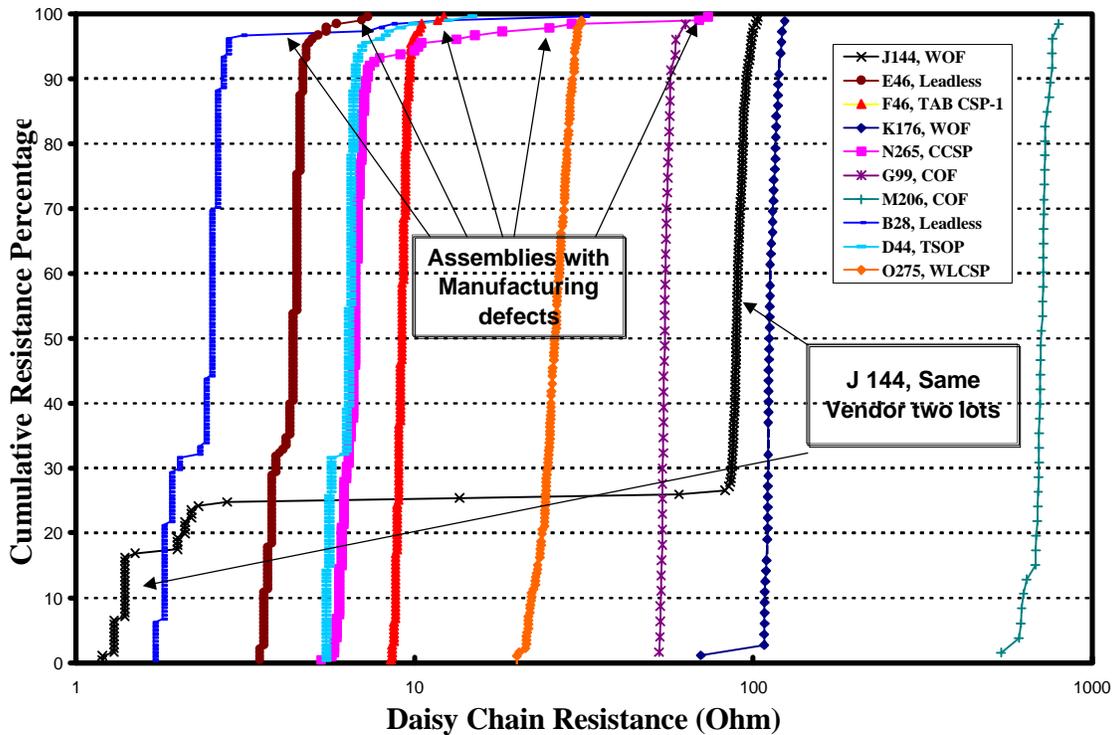
Figure 4 Cumulative Resistance for CSP Assemblies,

Effects of package lot source apparent from J144, wire-on-flex (WOF), plots of accumulative daisy-chain resistance. One sets had a resistance value of about 2 and the other about 87 , each with relatively a narrow distribution. The package lot was apparent from a marking on the package for each category; therefore, the possibility that such variations were due to board or assembly was rejected. Package K176, WOF, from the same vendor showed a more narrower resistance distribution. Resistance values were higher than J144, but their values were close to one of the lot source.

Resistance values for M206, chip-on-flex (COF), were unrealistically high, nearly 700 . Resistance measurement of two adjacent balls within the package were high, narrowing the cause of high value to package. These results may indicate that the trace fabrication process for this technology is the source of high resistance. Further comparison of results for the JPL CSP consortium will further shed light on these issues.

- Assembly daisy-chain values were from 2 to 700 and for a package from two production versions were significantly different.

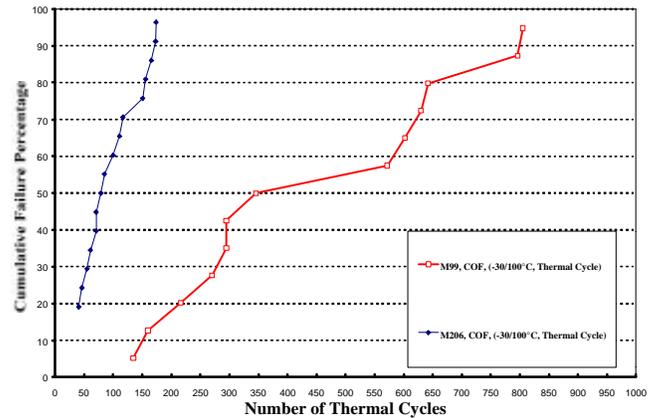
Figure 5 Cumulative Failure Distribution for Flex on Chip Assemblies with 99 and 206 I/Os

Figure 5 shows cycles to failure for the two chip on flex packages with two different I/Os under the same thermal cycling conditions. Test results are for 99 I/O and 206 I/O packages subjected to cycle A condition (-30°/100°C). The cycles to failure distribution for the higher I/O assembly is much narrower than its lower I/O package. One may even note two possibly distinct failure distribution for the G99 I/O assemblies. The reason for the two failure trends are yet to be identified.

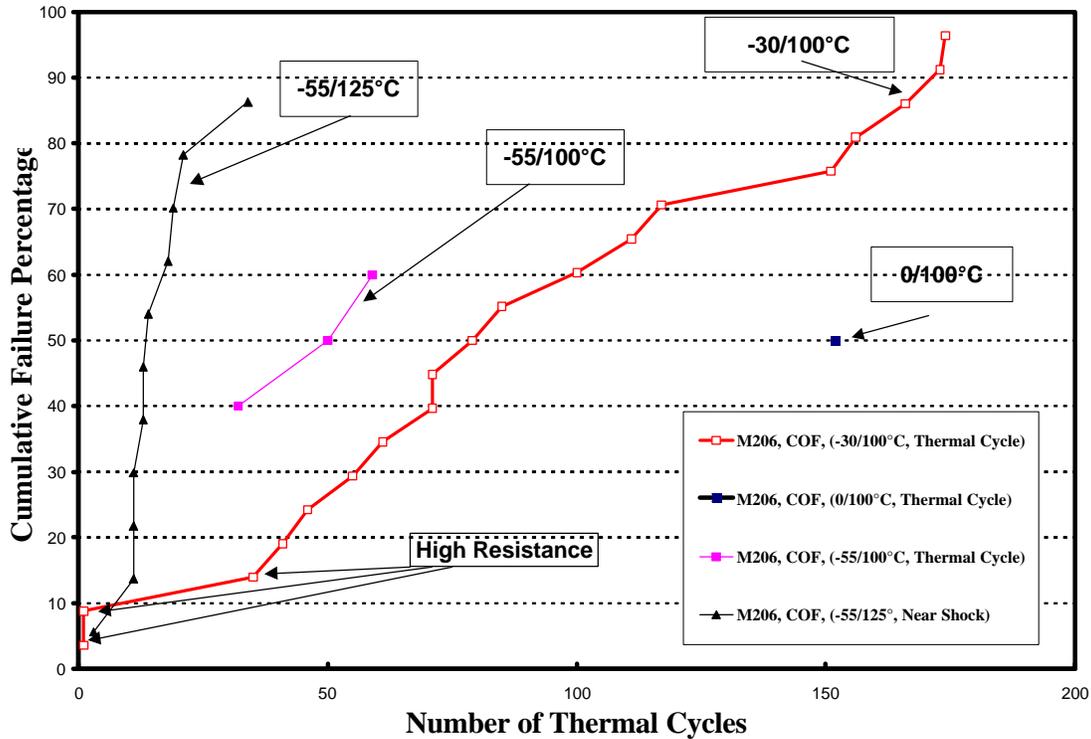
Figure 6 Cumulative Failure Distribution for Flex on Chip Assemblies with 206 I/Os Under Four Thermal Cycle Conditions

Figure 6 compares cycles to failure test results for the G package with 99 I/Os under four thermal cycling conditions. The trends are as expected, i.e., as the thermal cycling temperature ranges increase, the cycles-to-failure decrease. Note that assemblies failed between 3 to 34 cycles under a near thermal shock in the range of –55° to 125 °C (B condition). Cycles-to-failure was 152

cycles under a typical commercial thermal cycling conditions in the ranges of 0° to 100°C. Results for –55°/100°C and –30°/100°C were between the two extreme cycling conditions as expected.

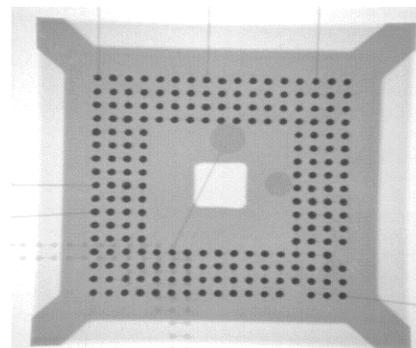
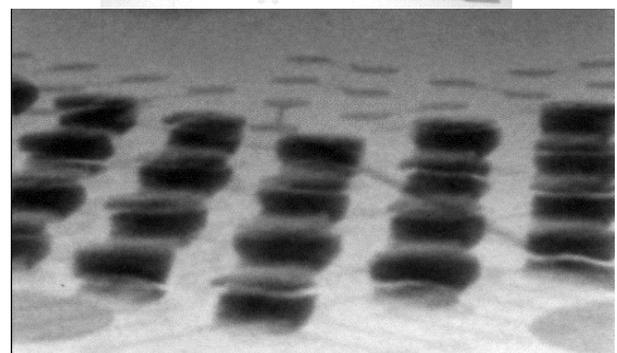
Figure 7 Exaggerated X-rays showing failure from either package or board sites

One M206 assembly, which failed at 35 cycles in the range of –30°/100 °C, was inspected after it was further cycled to 500. By further cycling, we were able to exaggerate the cracking and separation of solder balls/joint. This allowed the clear observation of solder joint openings that are generally impossible to detect when they have just failed. Figure 7 shows an X-ray photomicrograph of an exaggerated failure. It is apparent that separation occurred either from the package site or board site

- Failures for one assembly were either from board or package. This is similar to BGA failure reported by the JPL BGA consortium (2).

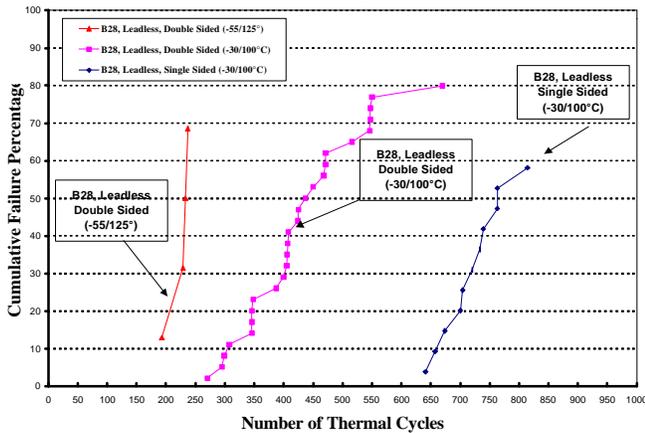
Figure 7 Single and Double Sided Assembly Failure Comparison

Figure 8 shows thermal cycling test results for package B, a leadless assembly with 28 I/Os, under two conditions for both single and double sided assemblies. The assembly location on the board was such that in a double sided assembly, it was a direct mirror image of itself with a 90° rotation (see Figure 4).

The single-sided assemblies failed at much higher cycles that double-sided assemblies. The N50 (cycles to 50% failure) were 437 for double- and 763 for single-sided assemblies under cycle A condition (-30°/100 °C). The double sided assemblies also failed much earlier than single sided assemblies under other thermal cycling conditions. As an example, results for double sided assemblies under –55°/125°C is also included in this Figure.

- Single-sided assemblies showed about 40 percentage higher cycles-to-failure than double-sided mirror imaged leadless packages.
