MANUFACTURING ROBUSTNESS OF CSP ON AN SMT LINE

Alex Chen, Karen Chang, Nancy Romas, Jason Bragg, Calvin Quan, Melanie Smith, Irene Sterian
Celestica, Toronto, Canada

Reza Ghaffarian, Ph.D.
Jet Propulsion Laboratory, California Institute of Technology , Pasadena, USA

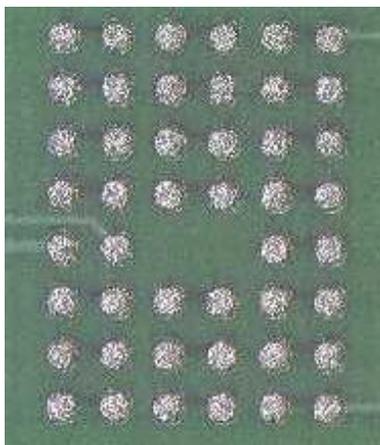
Figure 4. Solder paste on pads

Solder Paste Printing
Due to progress made from previous builds, the optimum 6 mil stencil was designed and used during the experiment. It was found that the print quality and consistency also depended on the quality of the solder paste and screen printer used. Originally, a commonly used no-clean paste was applied. Although satisfactory, the print quality was greatly improved upon changing the paste to a newer type of no-clean paste. Switching from a conventional printer to a later model printer also improved the consistency and quality of the screening process. The later model printer is equipped with a pressurized solder paste dispensing head. And it has an alignment repeatability of 6σ at 25 μm, and a print accuracy of 3σ at 25 μm. Figure 4 shows the paste screened onto a component site.

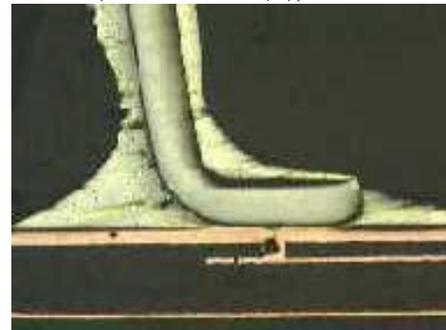
Solder Paste Reflow
With the use of different thermal reflow profiles, the number of voids present in the joints changed. Solder joint integrity could be undermined by the location and size of those voids. Excessive voiding reduces the amount of solder

at the joint and can affect reliability. However, entirely eliminating voiding is not necessary since if they are in the benign location, they could increase the package standoff, thus improving solder joint reliability.

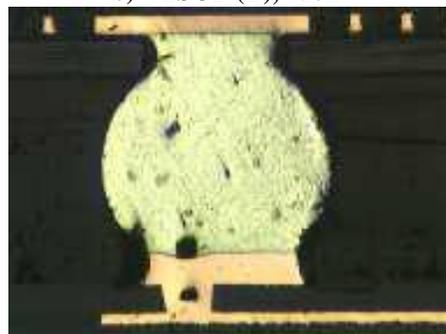
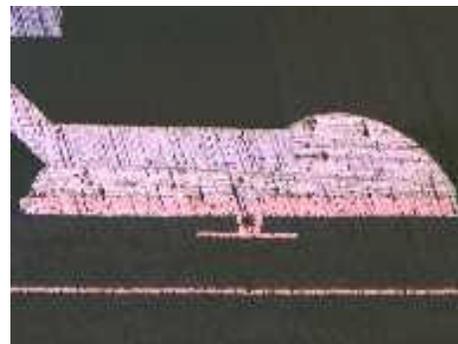
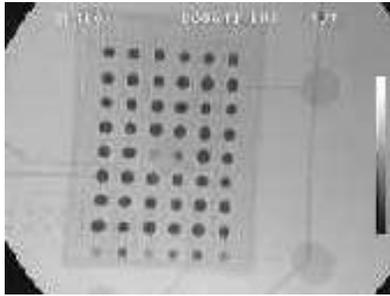
Figure 5. Cross section photomicrographs of assembled CSPs

Post-assembly Inspection
a)   Cross-sectioning
Cross sectioning was performed on a board that passed the daisy-chain electrical continuity test. Solder voiding was observed, as expected from flux outgassing during reflow. Some of these voids were directly associated with the microvias. Most of the voids were found not to exceed one quarter of the solder joint's diameter. Figure 5 shows the joints for each of the package styles.

Note the voids in Figure 5c. The standoff height was also determined by examining the cross-section under a high magnification light microscope.

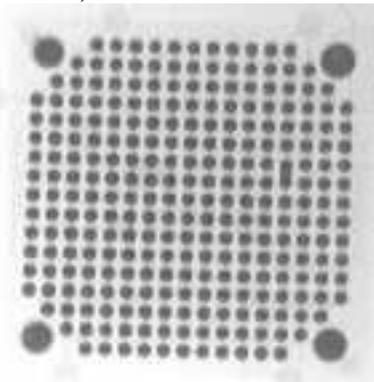
d)   Missing ball w/solder balls

X-ray inspection was performed on assemblies that did not pass electrical probing. Major causes of failures that were detected include: CSP misregistration, solder bridging, and insufficient solder. Figures 6 show some of these fails.

Figure 6d shows a CSP with a missing solder ball. As effective as X-ray was found to be, it also has its limitations. Figure 6e shows a CSP which failed electrical probing, yet no defect can be found. It is possible that the defect exists in the z-direction, and therefore cannot be detected with 2-D x-ray. However, the possibility of a faulty CSP cannot be ruled out.

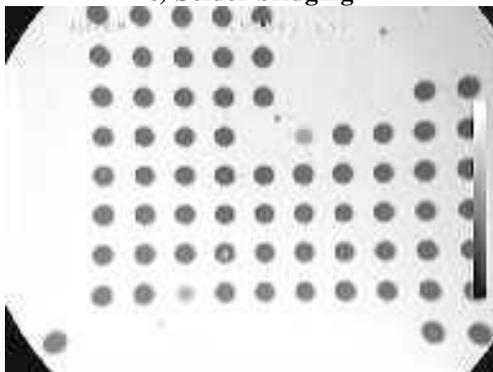
a) Misregistration

b) Insufficient solder

c) Solder bridging

All these defects were considered to be due to the assembly process. Voiding, though observable through x-ray, was not considered to be caused by a process deficiency as the amount of voiding can be controlled by altering the reflow profile with respect to the solder paste type. There were some occurrences of missing balls causing failure, though this was relatively rare. As stray solder balls were often found in the immediate vicinity, one possible explanation for the missing balls was that excessive outgassing through the microvia caused the solder ball to explode.

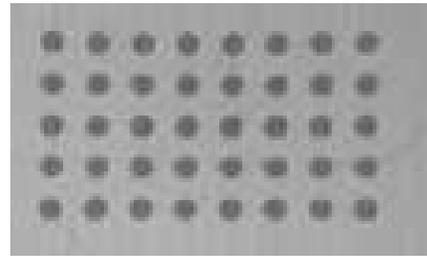
e) Electrical fail

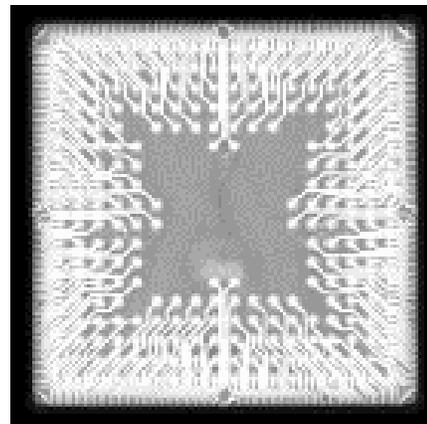
Figure 7 SAM image of Package O

SAM is a system that was designed primarily for the inspection of microelectronic devices. The system uses a pulse echo and through-transmission techniques of ultrasonic inspection; it operates over a frequency range of 5 to 150 MHz. Using SAM, it was found that some of the assemblies had voids and some had delamination. Delamination occurred on both surfaces of underfill material. Figure 7 is a SAM image taken of Package O (wafer level CSP) exhibiting delamination.

- Proprietary flip chip underfill material gives less voiding and delamination.
