A Description of the IMAGE FEA Work

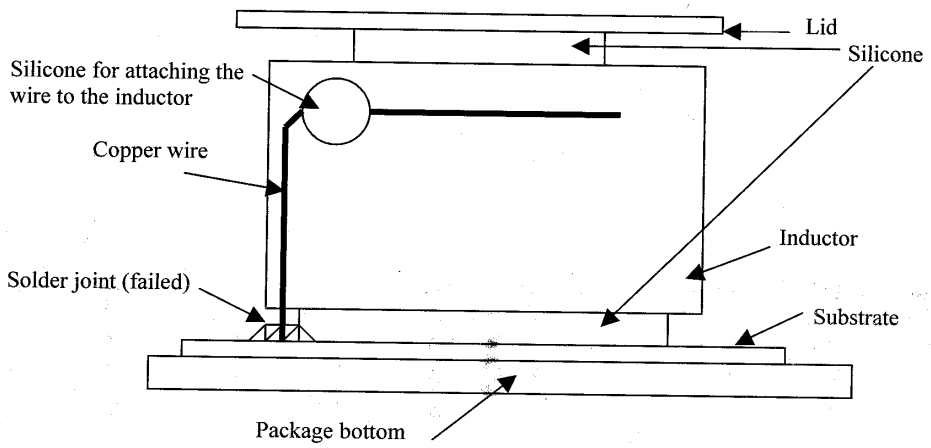
Fig. 1

An Interpoint DC/DC converter failed during the vacuum test. Failure analysis revealed that the failure was due to a lifted solder joint that connects a current-carrying copper wire to the substrate. It was obvious that the pressure variation during the vacuum test put the thin metallic lid in up-and-down motion. Since the whole internal structure of the converter is all physically attached (see Fig. 1), the cyclic motion of the lid fatigued the solder joint.

Based on the FEA analyses, we suggest that IMAGE Project needs to inspect each and every Interpoint converter to be used as flight hardware. Such inspection may be performed using 3-D X-ray to ensure a sufficient gap between the wire and the wall of the inductor, as well as the bent curvature of the wire in its vertical path to the solder joint.

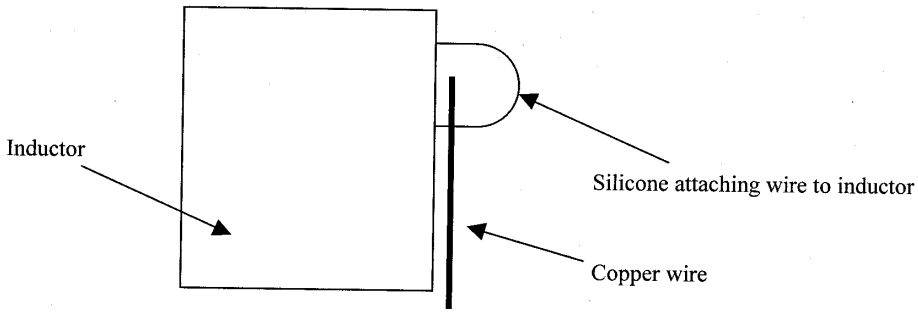
Fig. 2

-- very close to the inductor (Fig. 2)
-- not so close to the inductor (Fig. 3)
-- nearly straight-line down to the solder joint (Fig. 4)
-- curved line down to the solder joint (Fig. 5)

The first two FEA models are both for straight-line wire geometry with the first model being close to the inductor and second being not so close to the inductor (Figs. 6 and 7). Given a nominal deflection of the lid, the Von Mises stress of the solder material was way beyond the 63:37 solder's yield strength, indicating that fatigue is likely to occur. For the same lid deflection, the second case showed that the Von Mises stress on the solder was right at the level of the yield strength and leaves no safety margin for the solder joint. Thus we conclude that, for this very converter, a straight-line wire vertically interconnected to the substrate is not acceptable for the consideration of solder joint integrity.

From the above two modeling results, we know that the copper wire needs to be placed not so close to the inductor. The guideline from the FEA results demonstrated that the gap between the wire and the wall of the inductor needs practically to be at least 30 mil. Since we want to determine which wire geometry is the best in terms of producing the minimum stress to the solder material, there is no need to model the close-to-inductor scenario for curved wire case. Thus modeling the scenario of curved wire that is apart from the inductor wall is sufficient to identify the desirable geometry of the wire.
