Tin Whiskers Growing Inside ~45 Year Old AF114 Germanium Transistors

Parts Analysis by: Chris Greenwell/QSS Group, Inc.

Summary Prepared by: Jay Brusse/QSS Group, Inc.

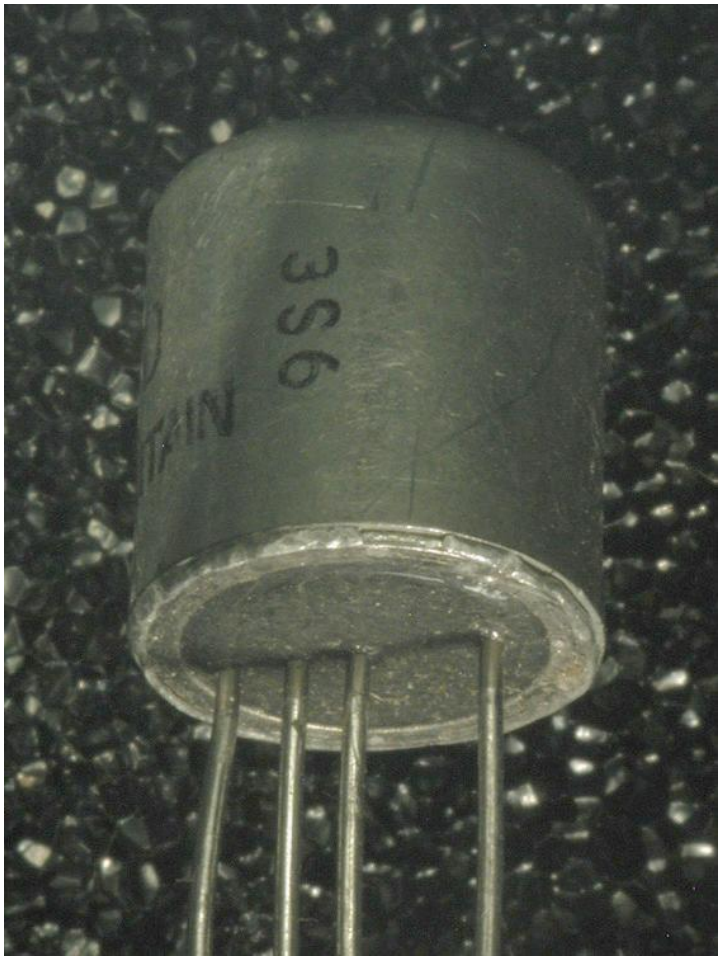
External Photographs – AF114

No Lot Date Code Information Marked on Devices
Based on Input from Source Assume parts made circa 1960

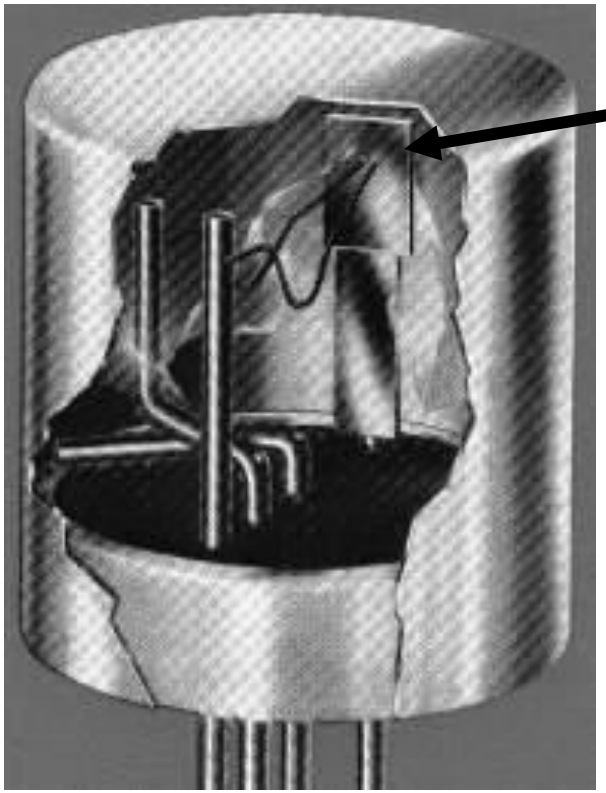
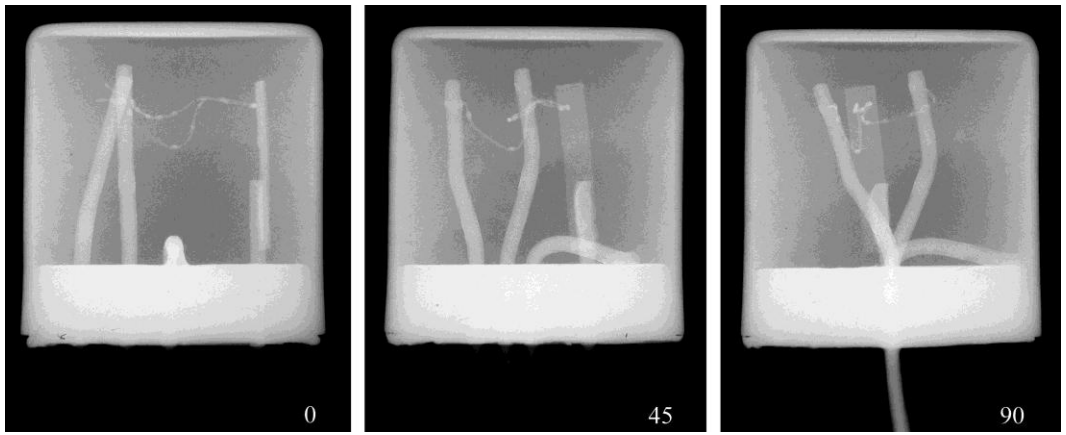
Internal Diagram & X-Ray of AF114

Note that Pin 3 is connected to the case,
but is not connected to the transistor (pins 1, 2 and 4)
Pin 1 = Emitter, 2 = Base, 3 = Case, 4 = Collector

NASA GSFC X-Ray of AF114 Device Received
(3-Views at 0°, 45°, 90°)

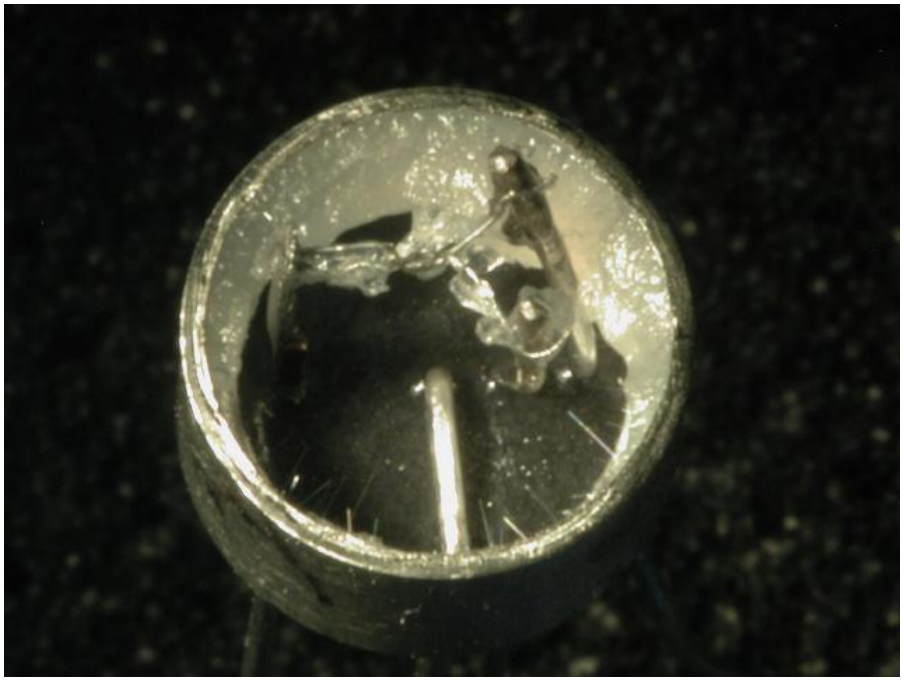
Internal Optical Microscopy of AF114 after Opening TO Package

Inside of Transistor with Top Removed
Whiskers are already evident

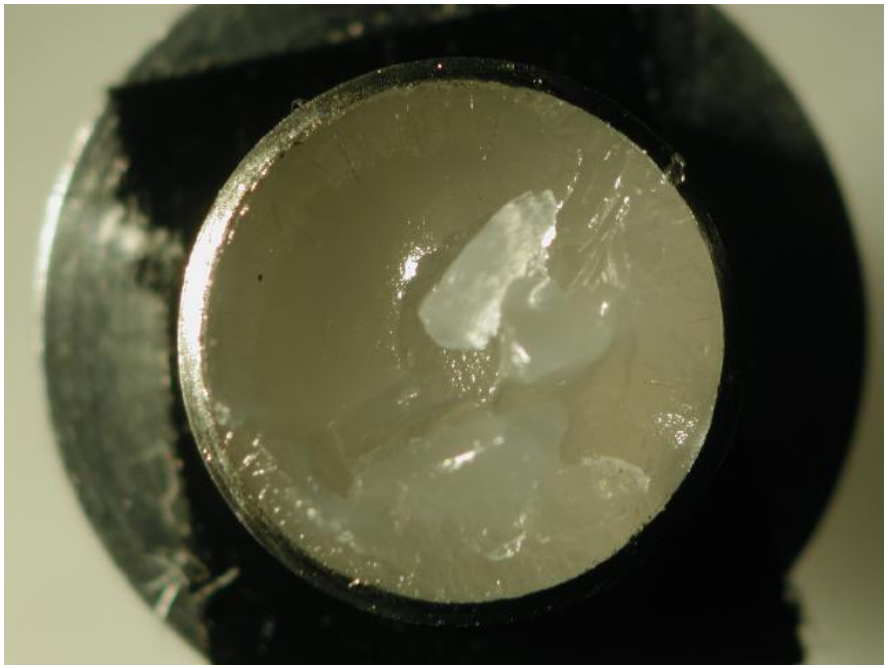
Top of Case contains
Jelly-Like Substance
(Somewhat lower viscosity than petroleum jelly,
Suspected to be some type of Silicone)

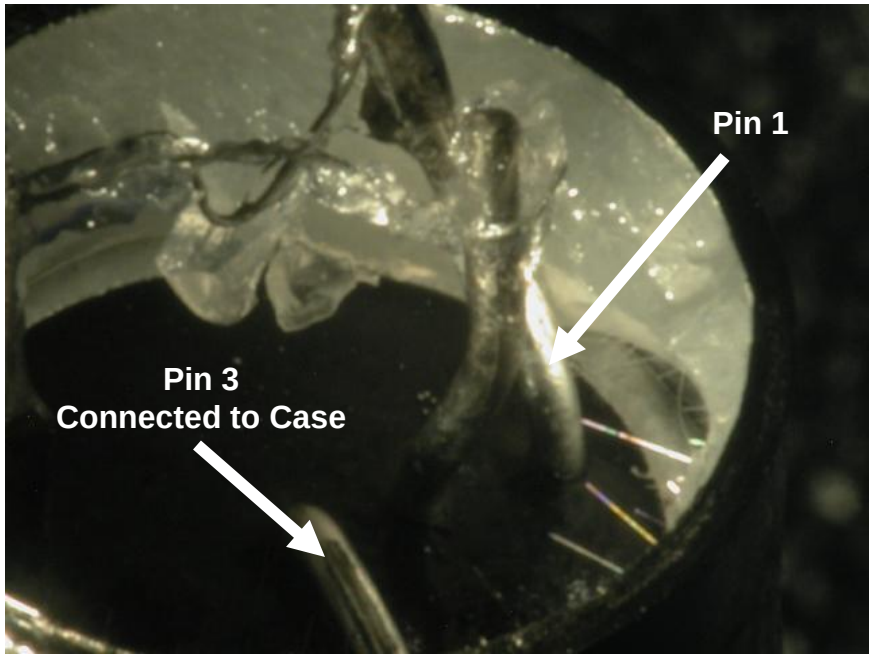
Internal Optical Microscopy

Whiskers Shorting from Case to Pin 1

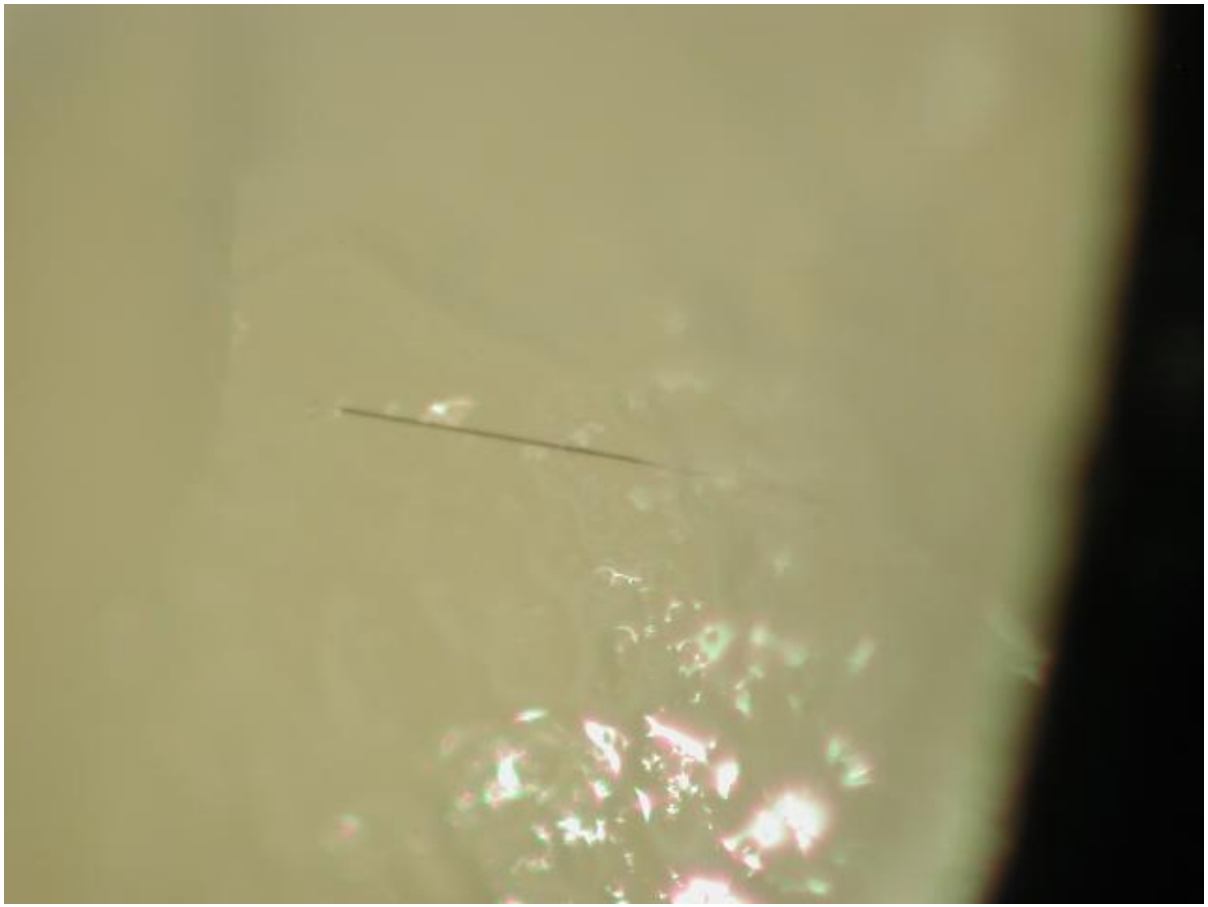
Internal Optical Microscopy

Whiskers Grow Readily Within and Through the Jelly-Like Substance.

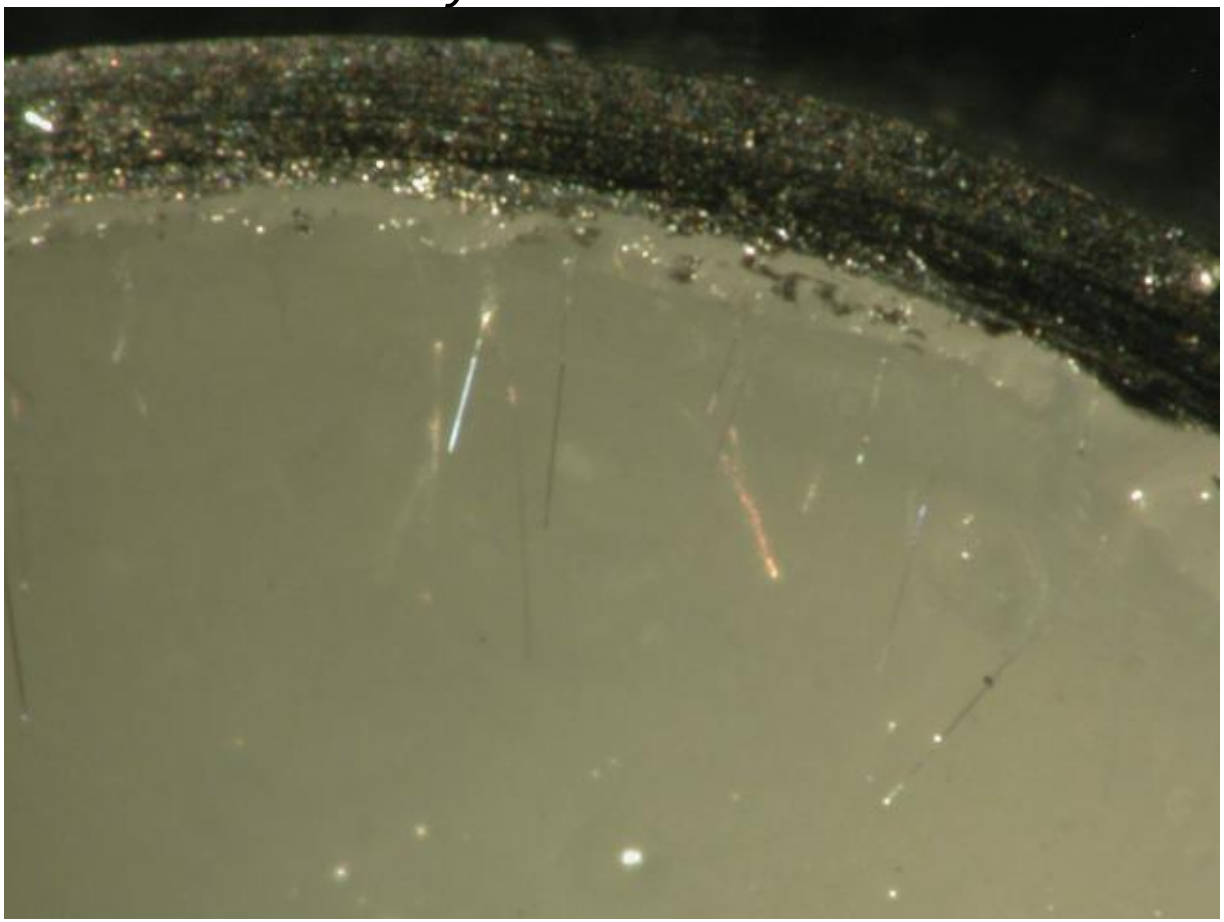
Internal Optical Microscopy

Whiskers Grow Readily Within and Through the Jelly-Like Substance.

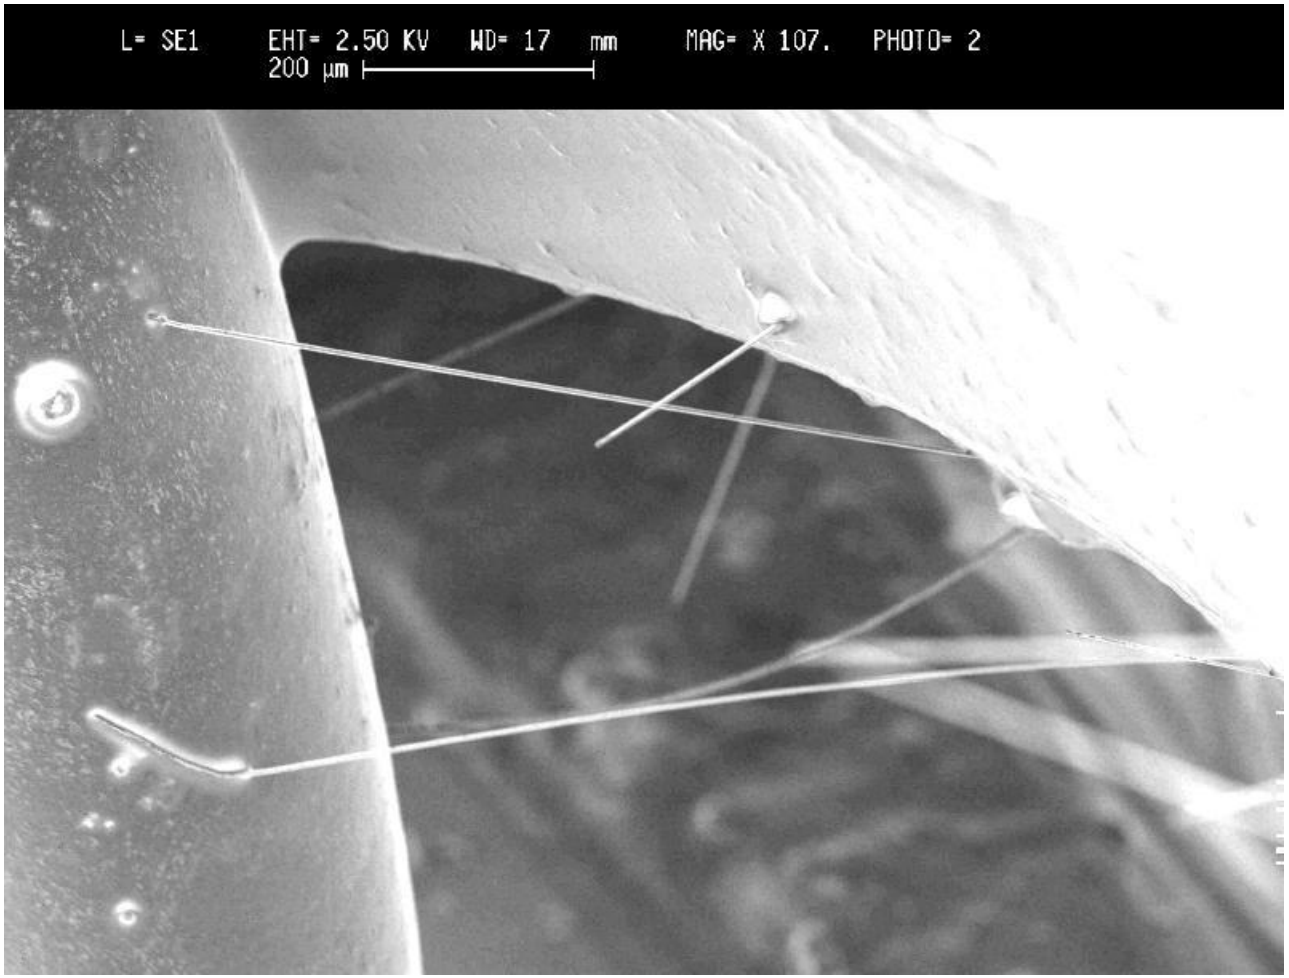
Scanning Electron Microscopy

Whiskers Shorting Case to Pin 1

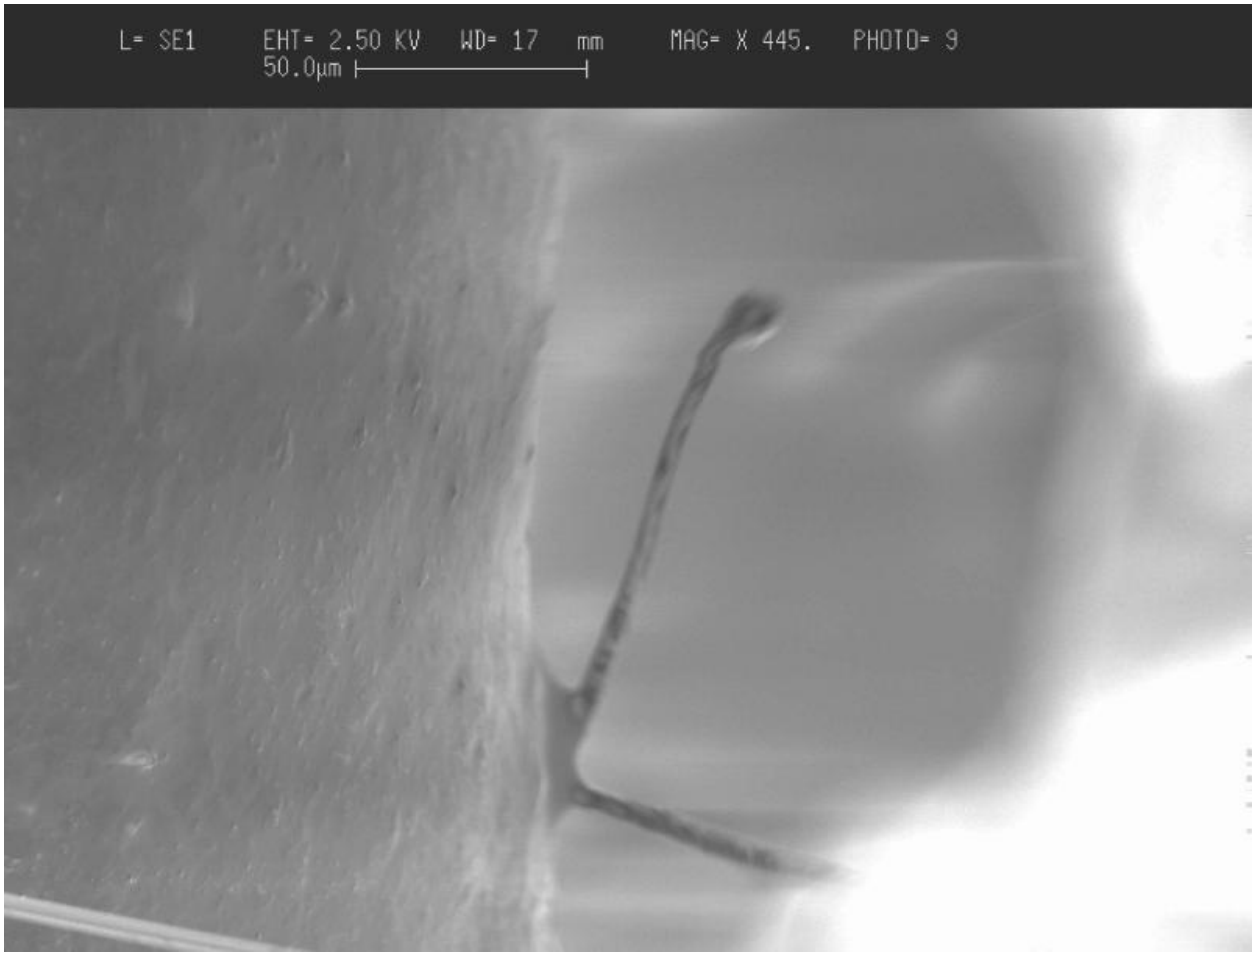
Scanning Electron Microscopy

Whisker Shorting to Pin 1

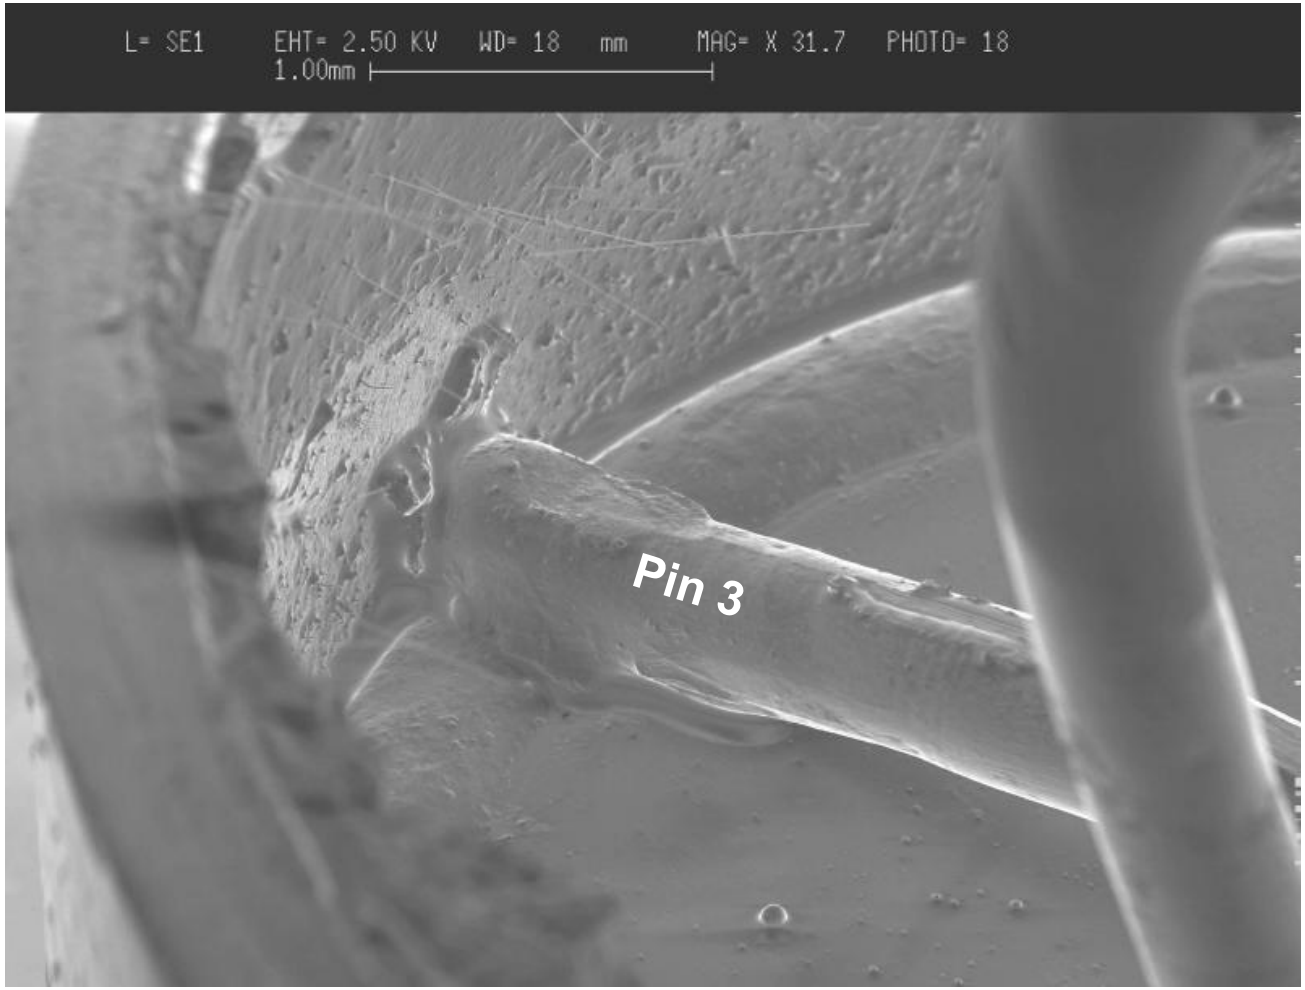
Scanning Electron Microscopy

Whiskers Growing from Case Wall

Whiskers Growing from Case Wall Towards Internal Pins

Pin 3 Connected Internally to Case

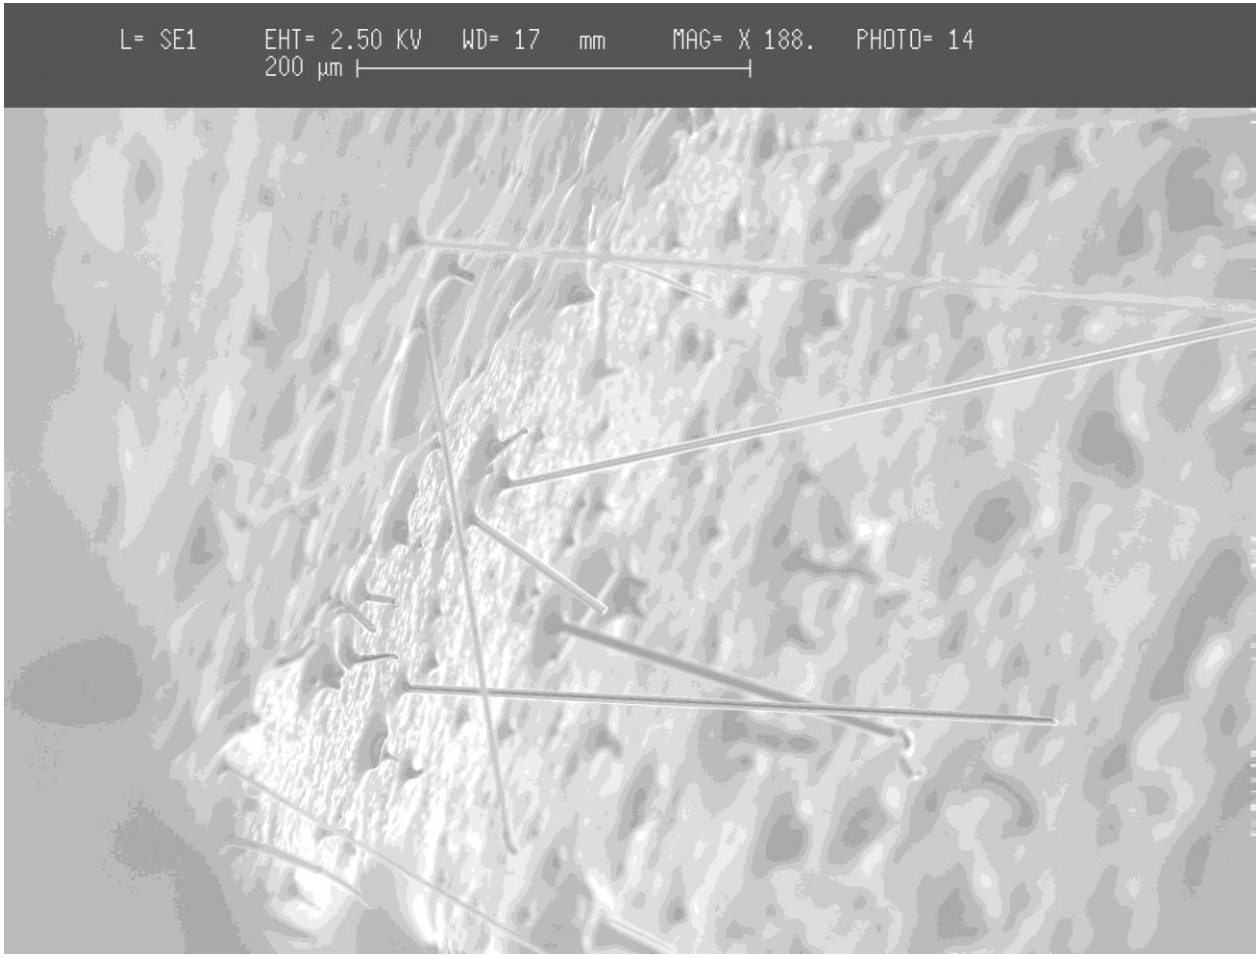
Scanning Electron Microscopy

Filament Type Whiskers + Nodules

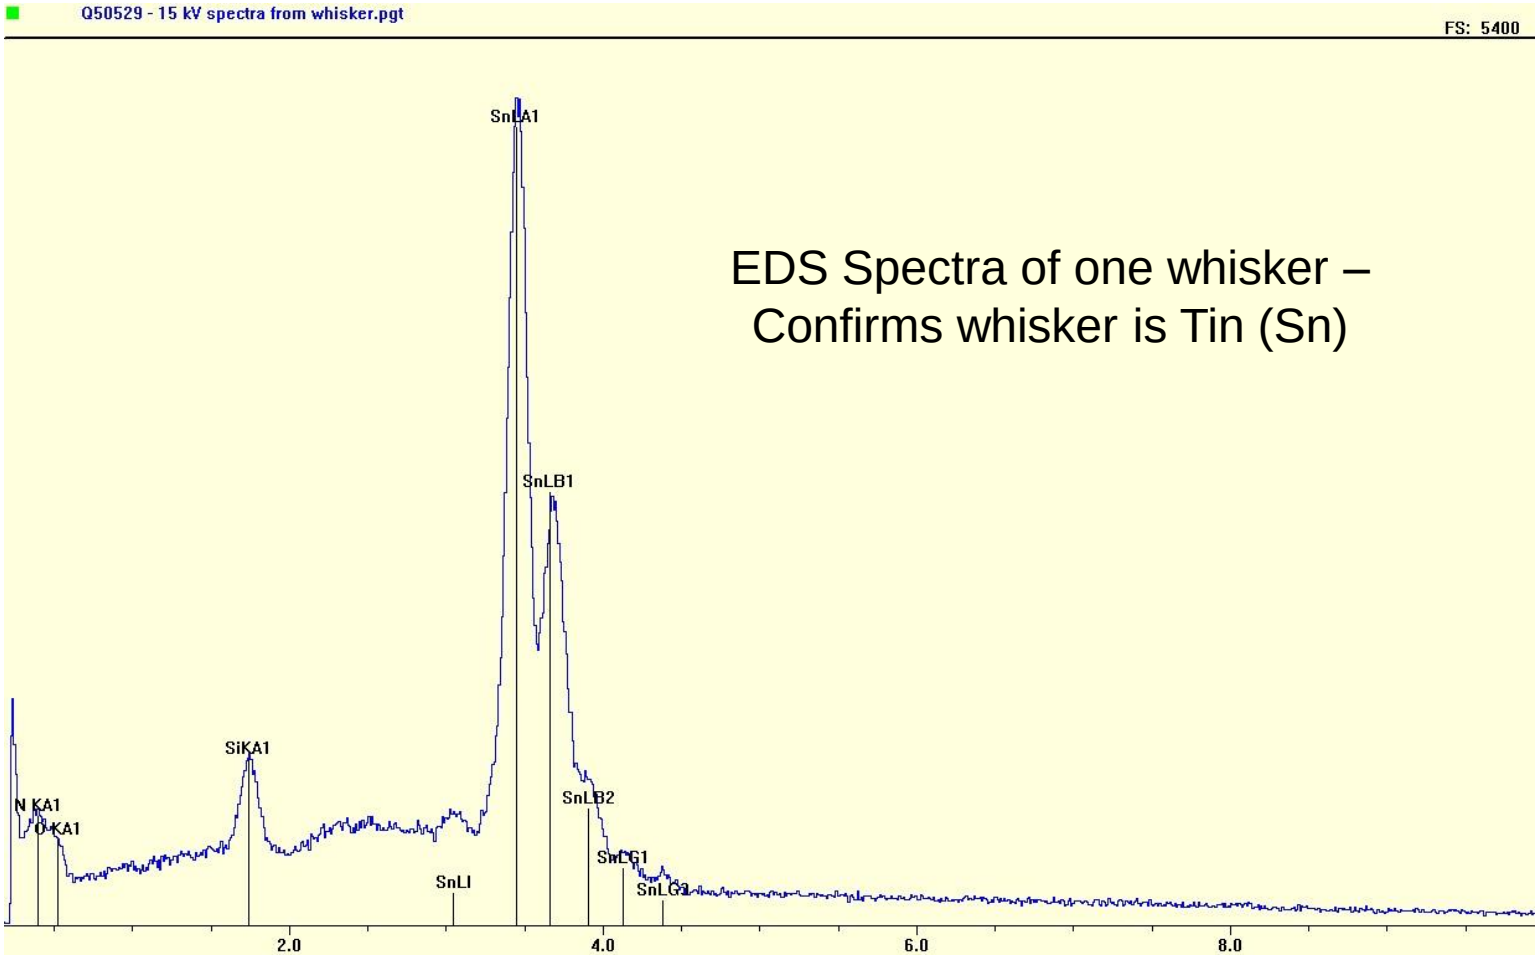
Scanning Electron Microscopy

EDS Spectra of one whisker – Confirms whisker is Tin (Sn)

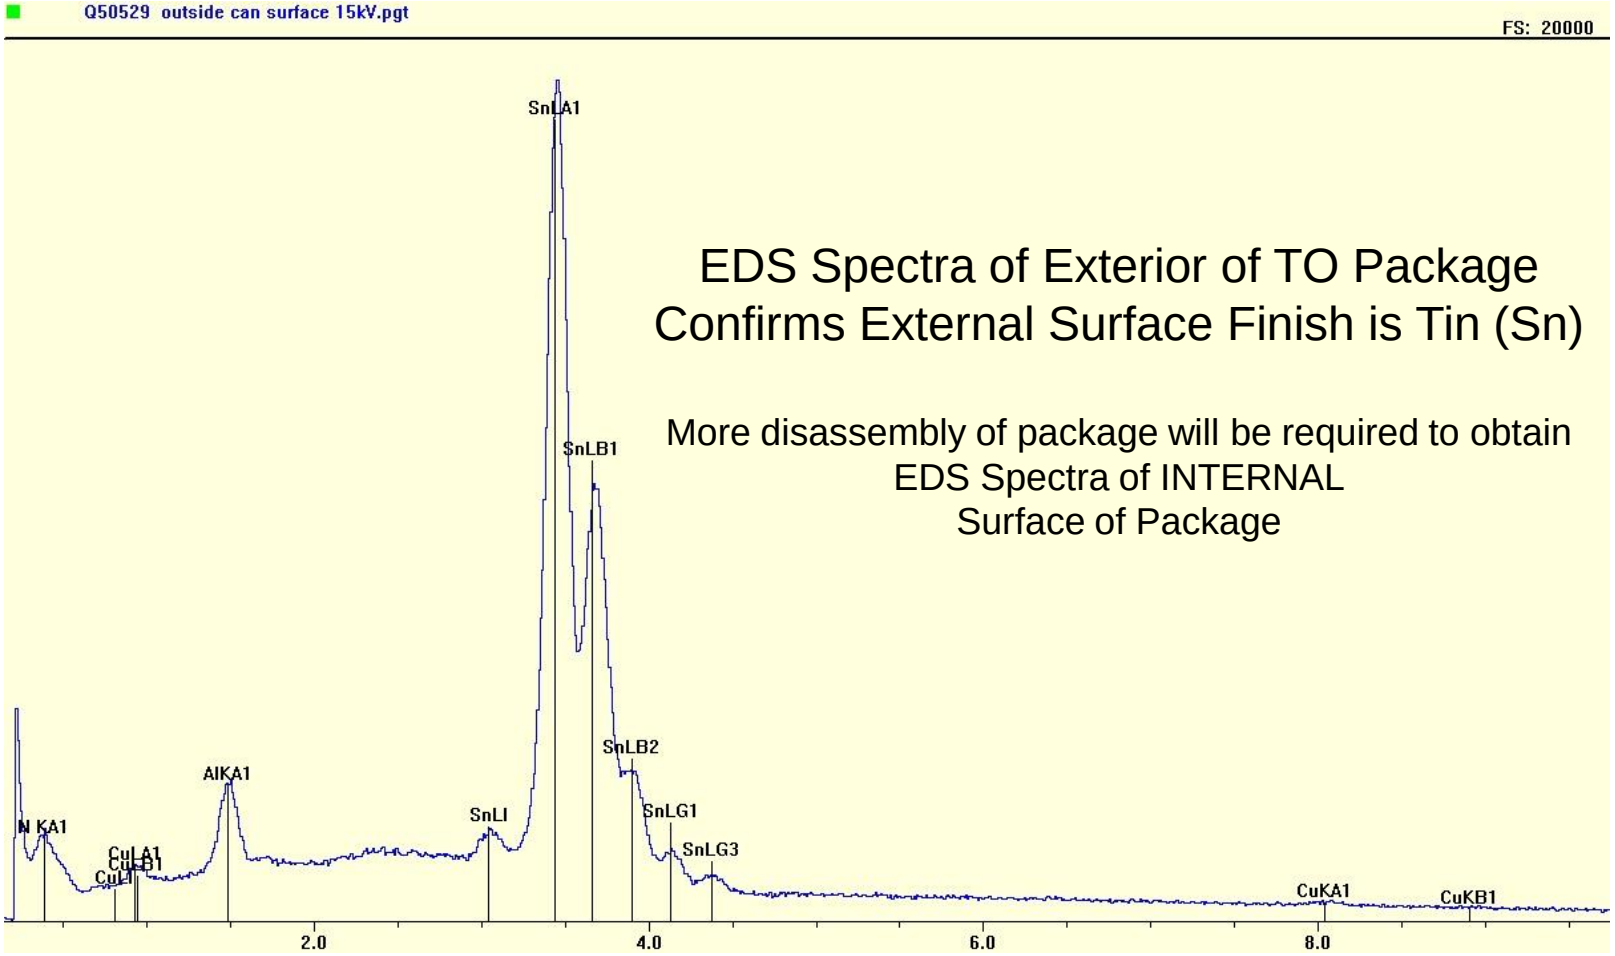
Scanning Electron Microscopy

EDS Spectra of Exterior of TO Package
Confirms External Surface Finish is Tin (Sn)

More disassembly of package will be required to obtain
EDS Spectra of INTERNAL
Surface of Package

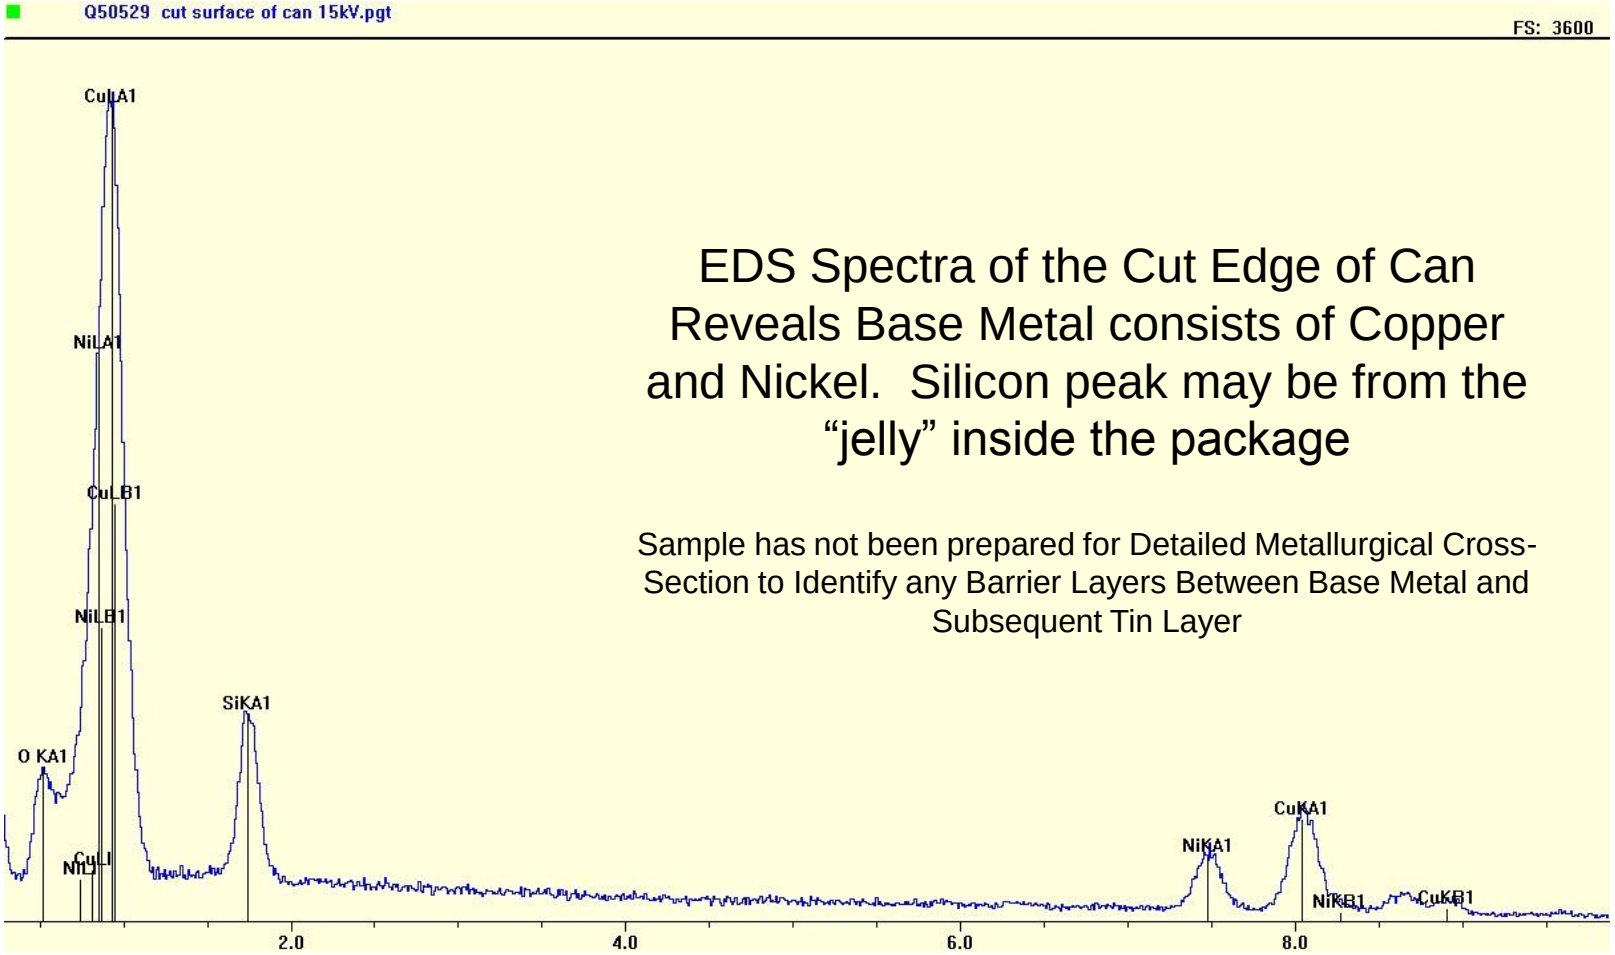
Scanning Electron Microscopy

EDS Spectra of the Cut Edge of Can Reveals Base Metal consists of Copper and Nickel. Silicon peak may be from the "jelly" inside the package

Sample has not been prepared for Detailed Metallurgical Cross-Section to Identify any Barrier Layers Between Base Metal and Subsequent Tin Layer
