3D X-ray CT for BGA/CGA Workmanship Defect Detection

JPL Publication 12-21 12/12

NASA Electronic Parts and Packaging (NEPP) Program
Office of Safety and Mission Assurance

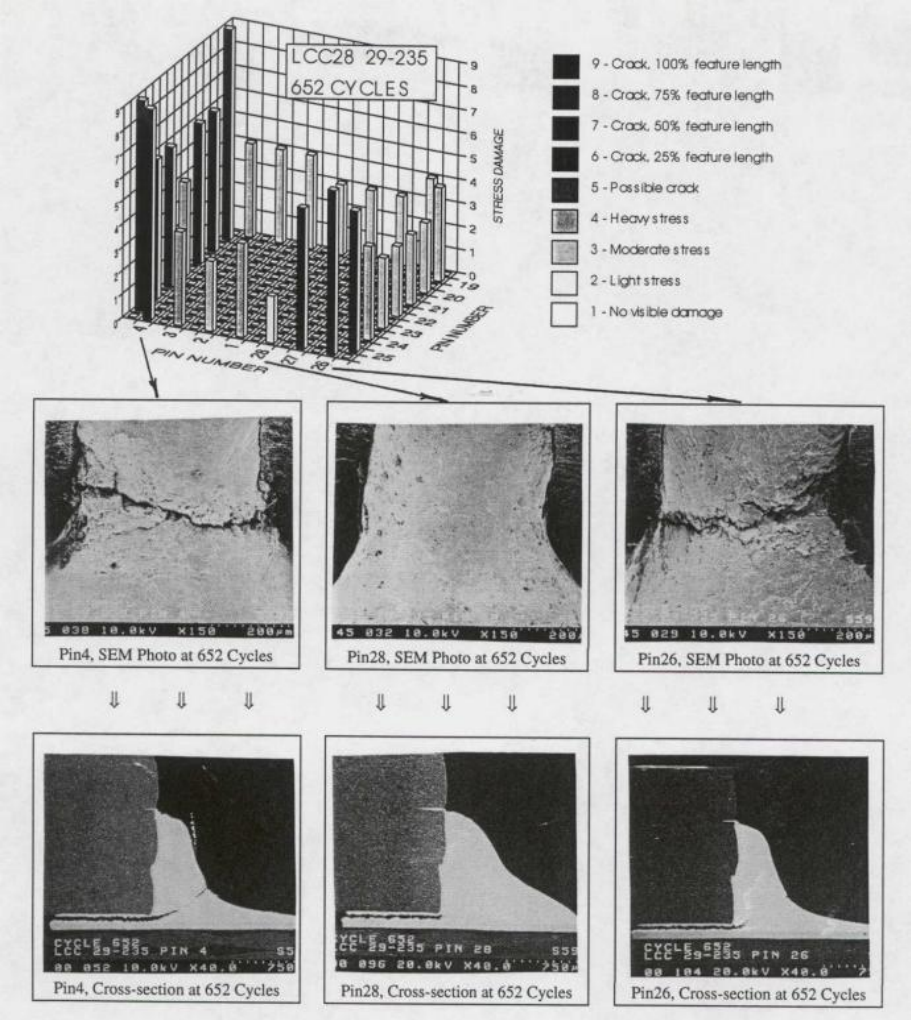
For both leaded and leadless package solder joints, the author has performed visual inspections at different magnifications to correlate damage rankings due to thermal cycling exposures to those revealed by cross-sectioning [7, 8]. An example of such correlation is shown in Figure 2.3-1. Numerous leaded and leadless package assemblies were subjected to thermal cycling, removed at intervals, inspected visually and by scanning electron microscopy (SEM). Results were then correlated to cross-sectioning images. Generally, good correlations were found between ranking the levels of crack formation by visual inspection projection and subsequently by cross-sectional evaluation.

Figure 2.3-1. Comparison of qualitative projection by visual inspection and verification by X-sectioning for ceramic leadless package assembly [7,8].

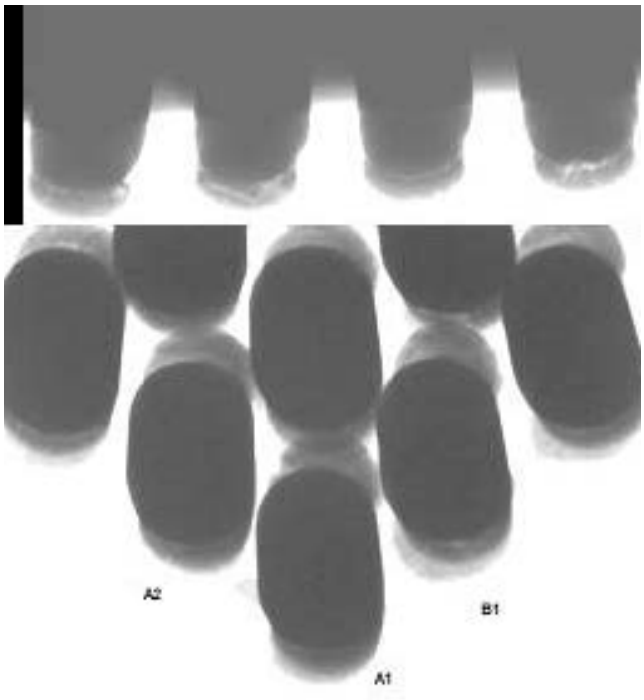
Figure 3.1-1 shows X-ray photomicrographs of an assembled ceramic column grid array with 560 columns after thermal cycling, using a 2D X-ray system with an oblique view capability. X-ray images from two views are included. CGA columns having high lead composition (10Sn/90Pb) are much darker than the eutectic solder (63Sn/37Pb) used for attachment to the board. Within lighter solder joints, at lower sections of columns, other lines, possibly caused by cracking, are apparent. Lack of smoothness of patterns may be an indication of solder graininess. This generally occurs due to solder grain growth as thermal cycling progresses.

Figure 3.1-1. X-ray photomicrographs of CGA using a 2D X-ray system with a rotational detector at two angles. Signs of cracking/damage are somewhat apparent.

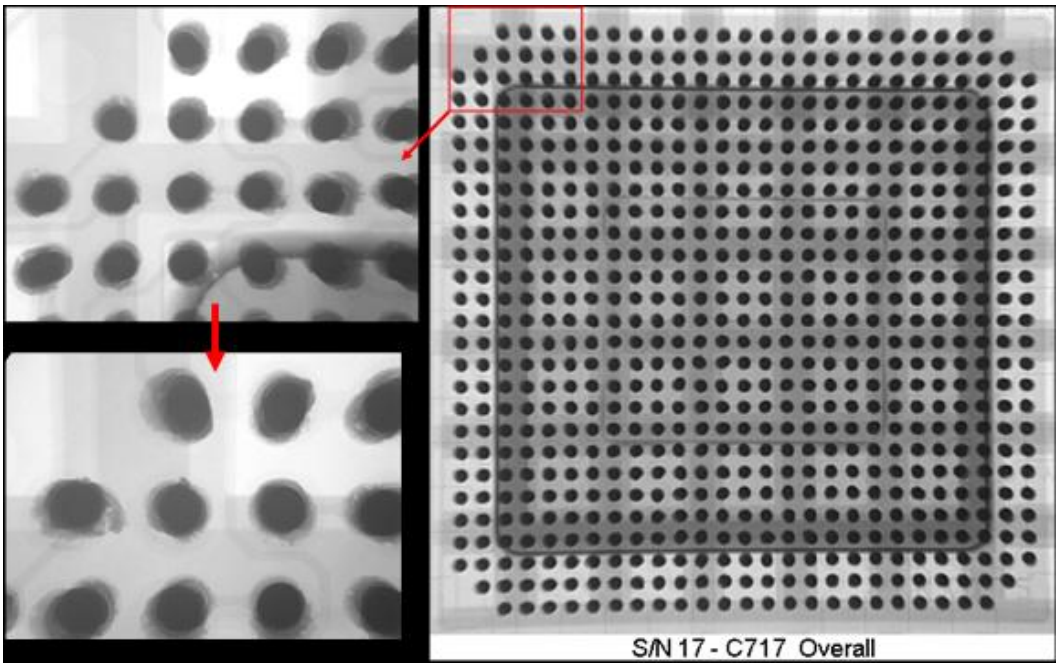
Figures 3.1-2 and 3.1-3 show X-ray features of two CGA 717 I/O assemblies after thermal cycling, one with a non-solder mask defined (NSMD) and the other with a solder mask defined (SMD) pad configuration. To better compare the two pad configurations, the corner solder columns are magnified by bringing the X-ray source close to the top of the packages. No apparent significant differences between the two pad designs are discernible from the 2D X-ray images. The level of damage cannot be discerned by the 2D X-ray system.

Figure 3.1-2. X-ray photographs of CGA 717 I/O assembly with NSMD pad design after thermal cycling.

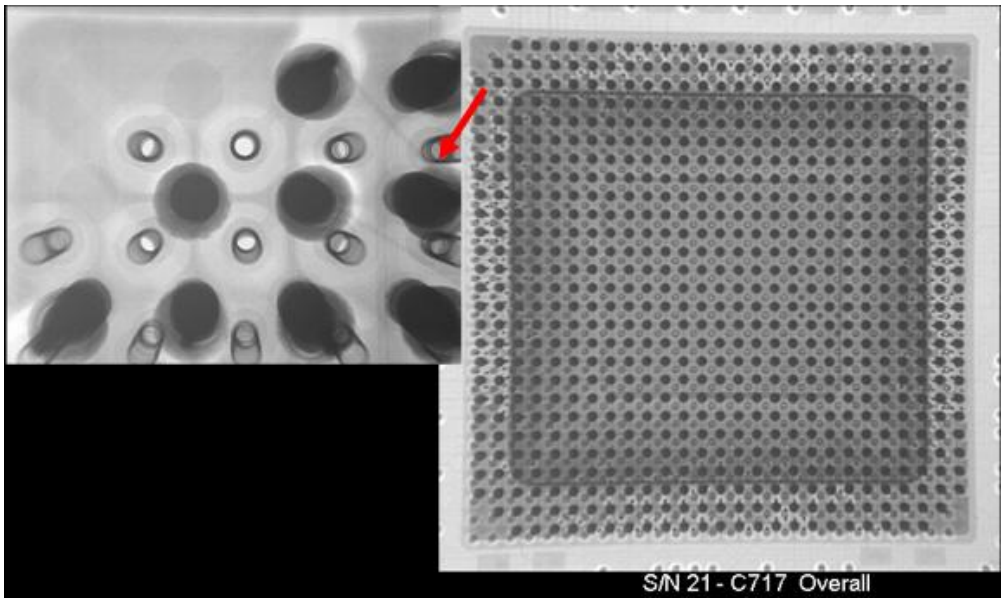
Figure 3.1-3. X-ray photographs of CGA 717 I/O assembly with SMD pad design after thermal cycling.

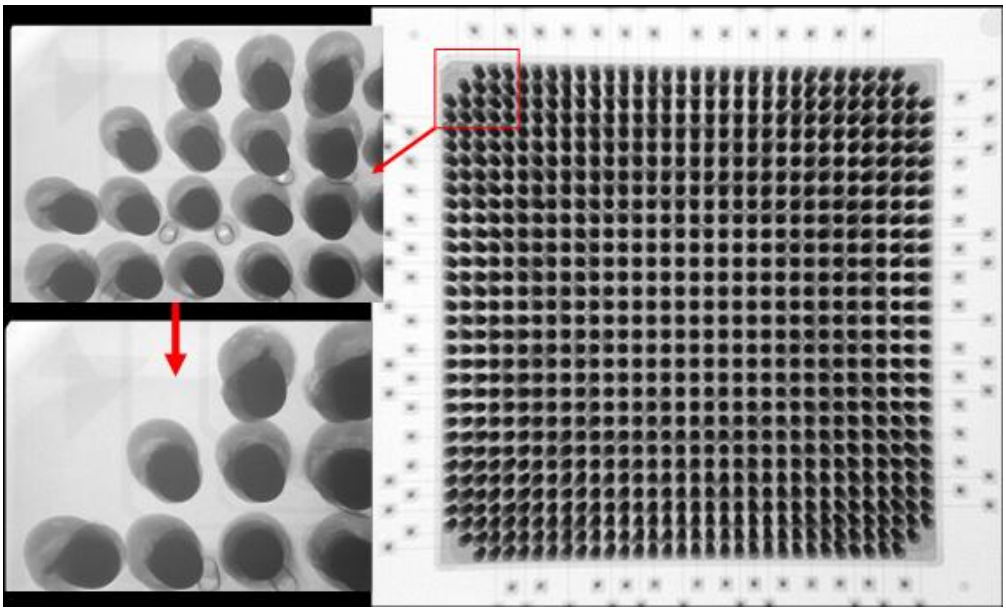
Figure 3.1-4 shows 2D X-ray images of an assembly CGA with 1144 columns after exposure to thermal cycling. Images of corner solder columns at much higher magnifications are also included in the figure. Figure 3.1-5 compares X-ray images of corner columns for the standard condition when the board is sitting flat (top left) or tilted at an angle (top right). No further improvement was observed in better detecting damage caused by interference of other columns, even with the detector tilting.

Figure 3.1-4. X-ray photographs of a high I/O CGA assembly after thermal cycling.

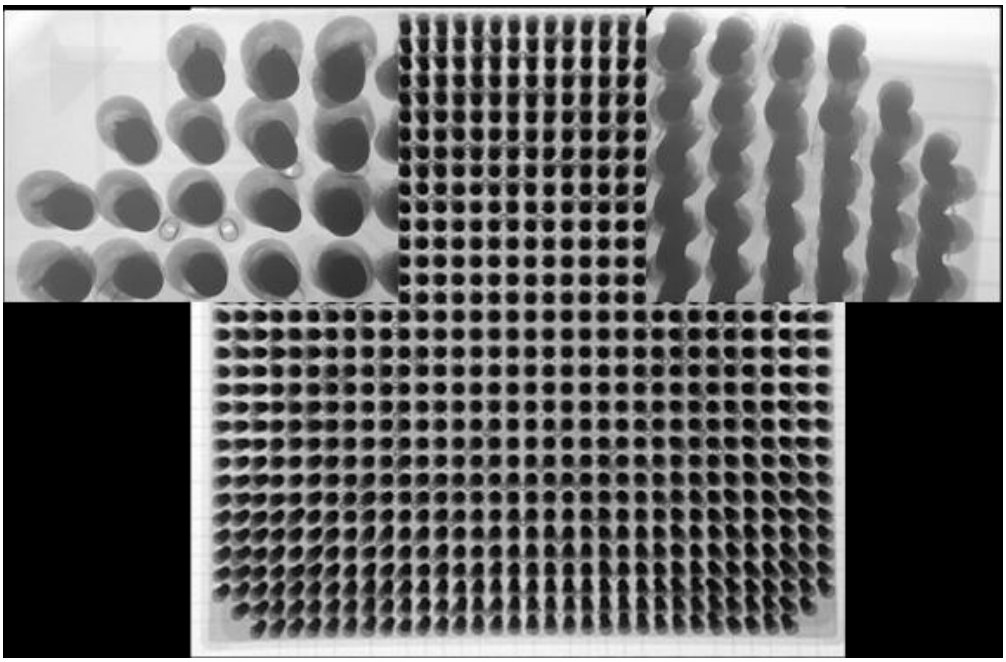
Figure 3.1-5. X-ray photographs of a high I/O CGA assembly showing higher magnification images when the board is sitting flat (top left photo) or tilted at an angle (top right) during X-ray evaluation.

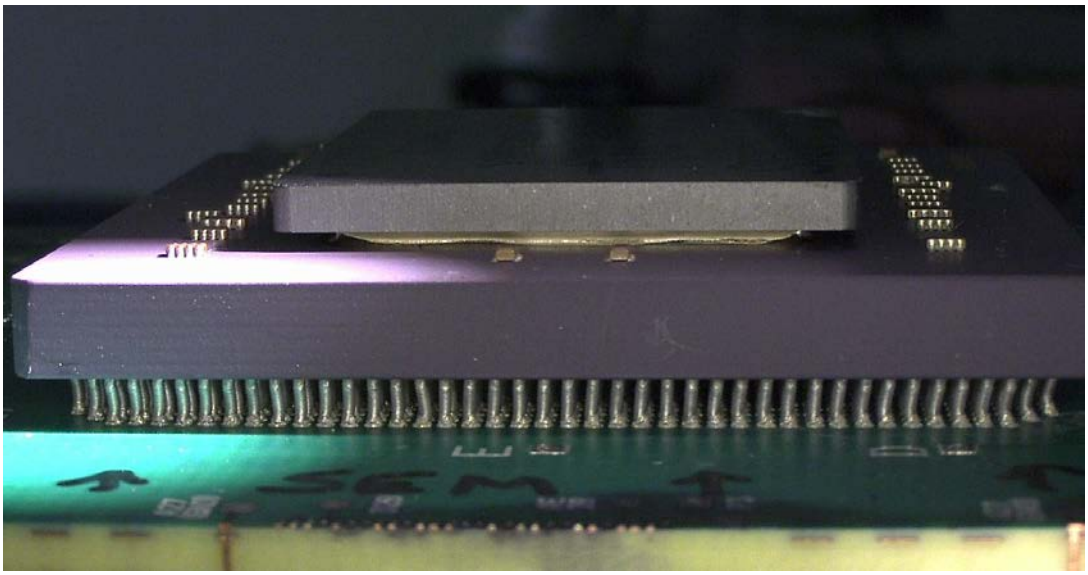
For comparison purposes, both optical and 2D/3D X-ray images were taken of an assembly CGA with 1752 columns after exposure to thermal cycling. An optical image of this package assembly after a number of thermal cycles is shown in Figure 3.2-1. It clearly shows deformation of solder joints; therefore slight to severe tilt of columns due to thermal cycling and coefficient of thermal expansion (CTE) mismatches of package and printed circuit board. The solder microstructural changes and tilting of columns are more severe for the corner than for center columns, as expected.

Figure 3.2-1. Optical photograph of a CGA1752 package assembly after thermal cycling.

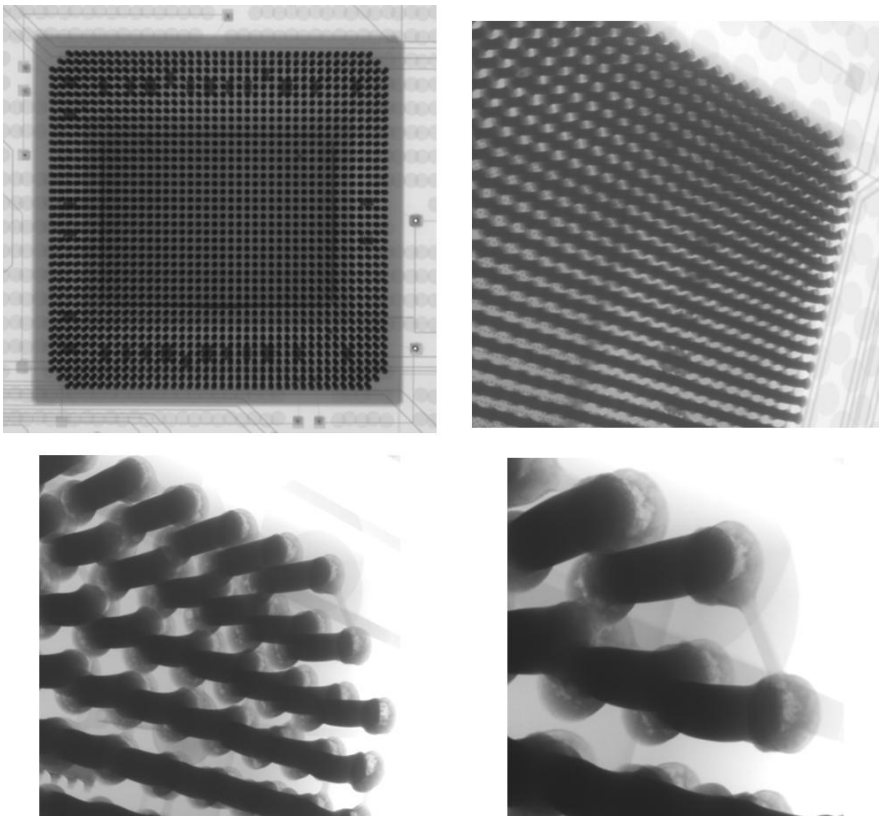
A few representative 2D X-ray images for this package assembly are shown in Figure 3.2-2. On the top left X-ray image, die and slightly larger heat sink than die are clearly apparent at the center of the package. Around the perimeter, spotted darker areas represent chip capacitors mounted on the package ceramic substrate that are also visually apparent, a specific feature of this high I/O non-hermetic CGA package. The two bottom photos were taken at an angle and higher magnification. Dark cylindrical features are columns and lighter areas at the ends are solder joints. Two shades of lightness are apparent, the lightest areas showing possible separation, while less light areas show solder joint materials with some shift, and this is the case based on visual inspection and optical photomicrographs.

Therefore, the change in X-ray intensity also shows potential damages, especially the shift at the interface between column and solder. Microcracks observed by optical microscopy are not as apparent and it is extremely difficult to determine if indeed lighter appearance is due to microcracks or not (i.e., if there was no prior knowledge of the condition of the CGA assembly). Attempts to better define column damage toward the internal section of the package was impossible because of interference with the X-rays due to heat sink, die, and the ceramic substrate. The low detectability of CGA internal columns is one of the drawbacks of X-ray for CGA packages. Heavy ceramic packaging materials reduce X-ray intensity and interfere with resolution of columns and solder joints under X-ray inspection.

Figure 3.2-2. 2D X-ray photographs of a CGA1752 assembly after thermal cycling.

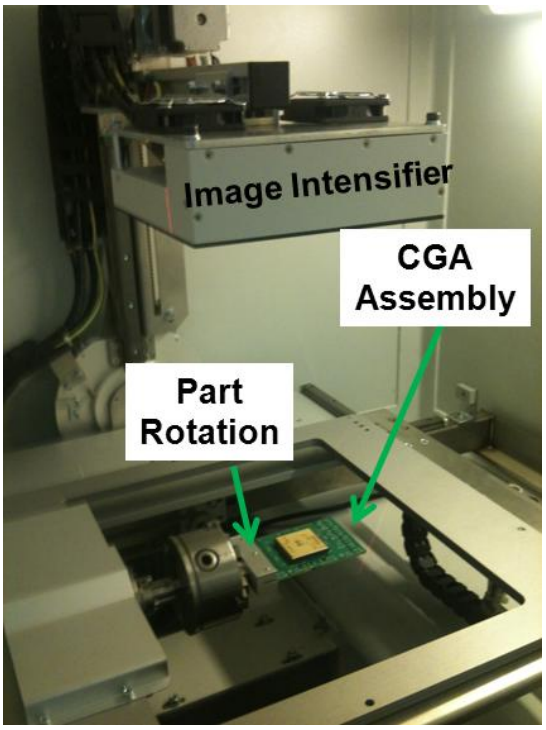
Figure 3.2-3. Photograph of CGA assembly in position and ready for rotation to generate 3D X-ray images.

Figure 3.2-3 shows a representative setup to prepare for generating 3D X-ray images. Rotation of the sample allows a series of X-ray images with relative positional coordinates of each image to be captured. These data are stored while the object is rotated within the X-ray beam. When all digital data have been captured, the data bank is processed to reconstruct the cross-sectional 2D or 3D images. Figure 3.2-4 shows a number of X-ray X-sectional images, both horizontal and vertical, taken from the 3D volumetric images. It clearly identifies a few feature of this specific package—decoupling capacitors are apparent when the horizontal image is constructed. Oversize heat sink, die, and overall column features are also apparent.

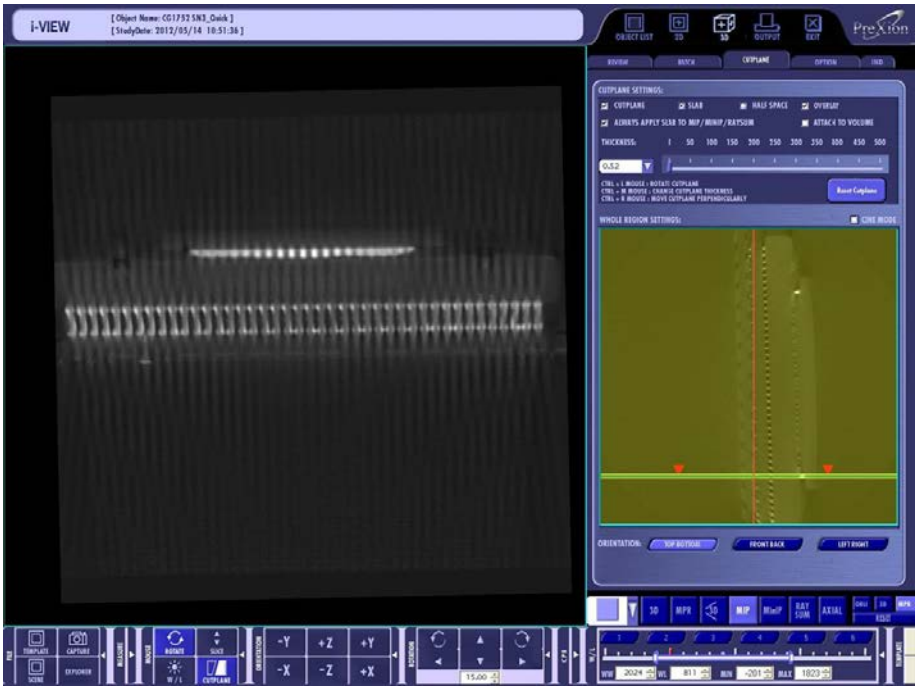
Figure 3.2-5 shows a representative X-ray X-section of a CGA1752 photograph (left side) and the location where such X-sectioning was performed (right side). Column tilting and some signs of damage are apparent, but because of the much lower magnification than with the 2D X-ray images, the exact level of damage could not be clearly identified. Figure 3.2-6 shows an attempt to increase magnification and possibly better delineate damage features. Lower magnification of the 3D images did not allow better identification of damage due to thermal cycling. Improvement was seen when the board was cut close to the package.

Figure 3.2-5. 3D X-ray photographs of a CGA1752 assembly after thermal cycling.

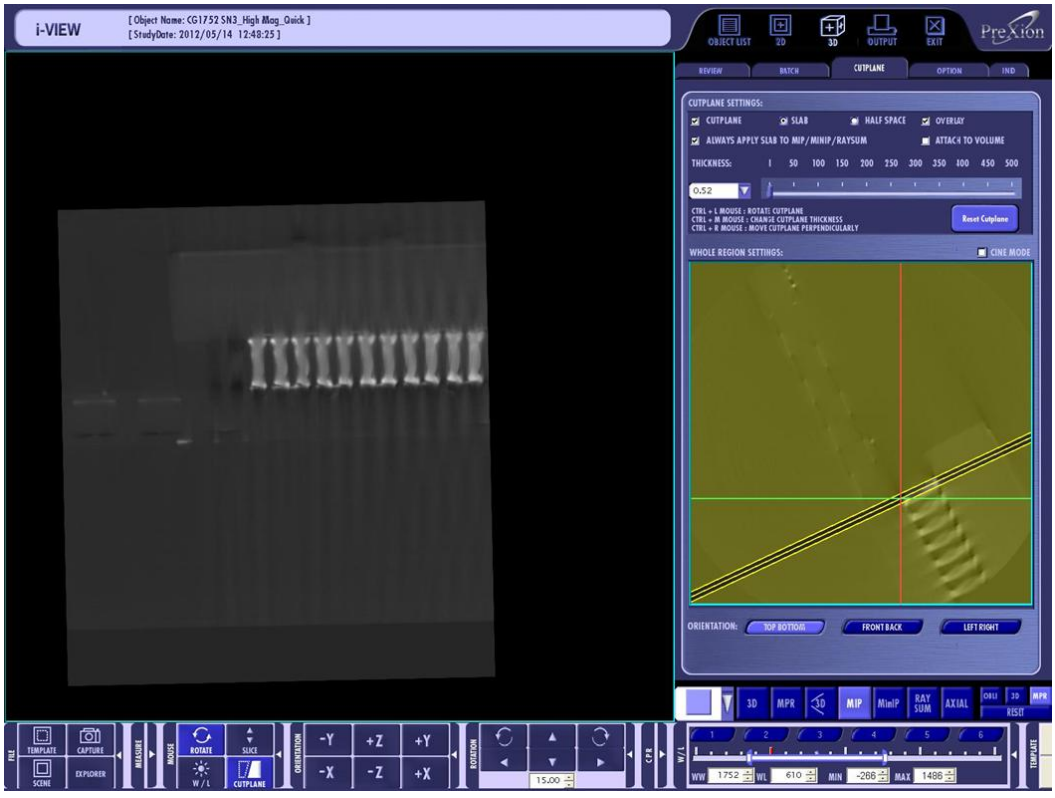
Figure 3.2-6. Higher magnification of 3D X-ray photographs of a CGA1752 assembly.

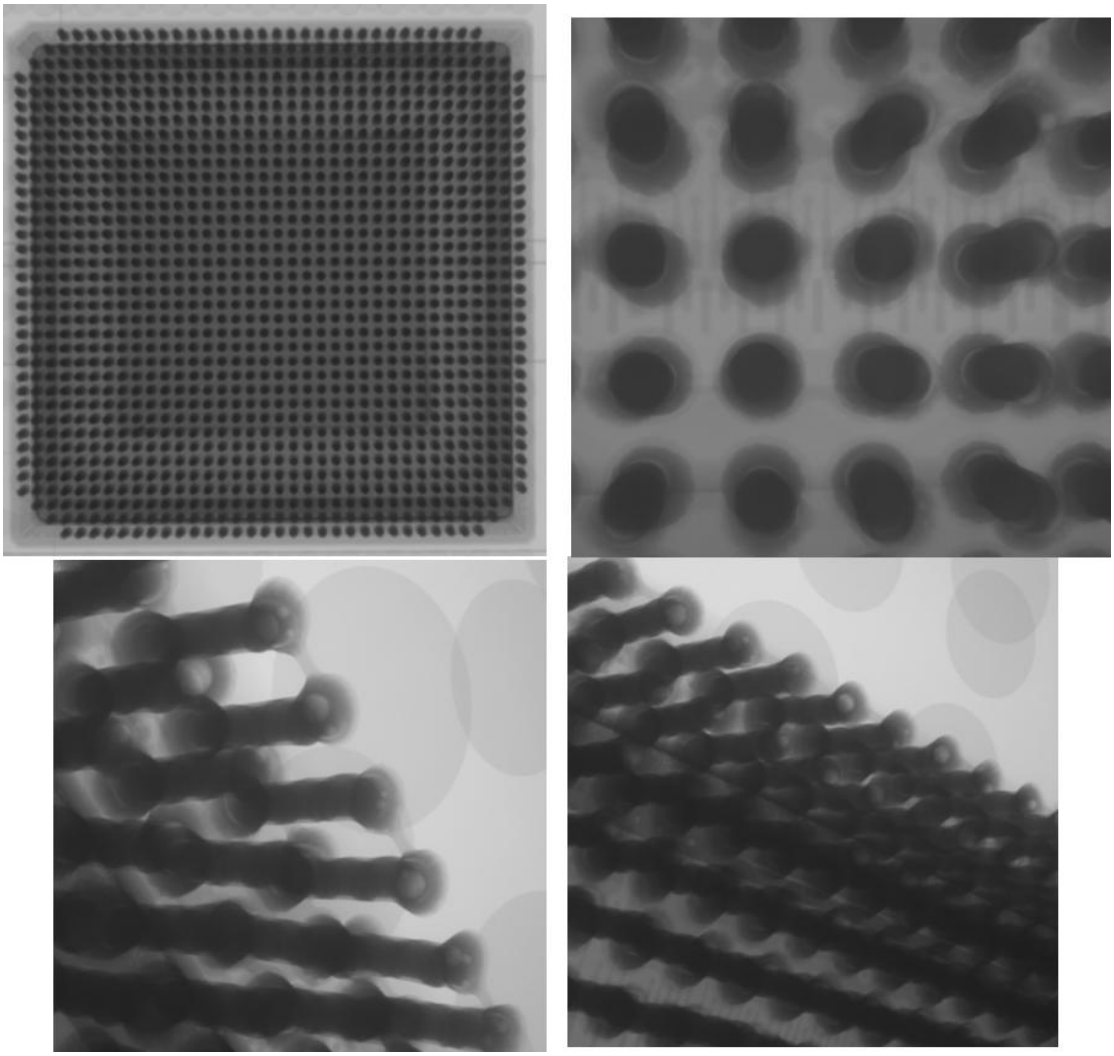
Figure 3.2-7 shows a few representative 2D X-ray images for another CGA package assembly with 1272 spiral columns that differ from the high-lead columns in CGA1752. On the top left X-ray image, die is clearly apparent at the center of the package. The corner columns are missing and clearly apparent. The two bottom images were taken at an angle and at higher magnification. Less column tilt is apparent compared to the CGA1752 assembly. Dark cylindrical features are columns, and even darker spotted areas represents the copper spiral surrounding the tin-lead solder column. The lighter images at the ends of columns are solder joints engulfing even brighter spherical images. These bright volumes are possibly voids formed at the interface of column and PCB. This needs to be verified through optical microsectioning.

Figure 3.2-7. 2D X-ray photographs of a CGA1272 assembly after thermal cycling.

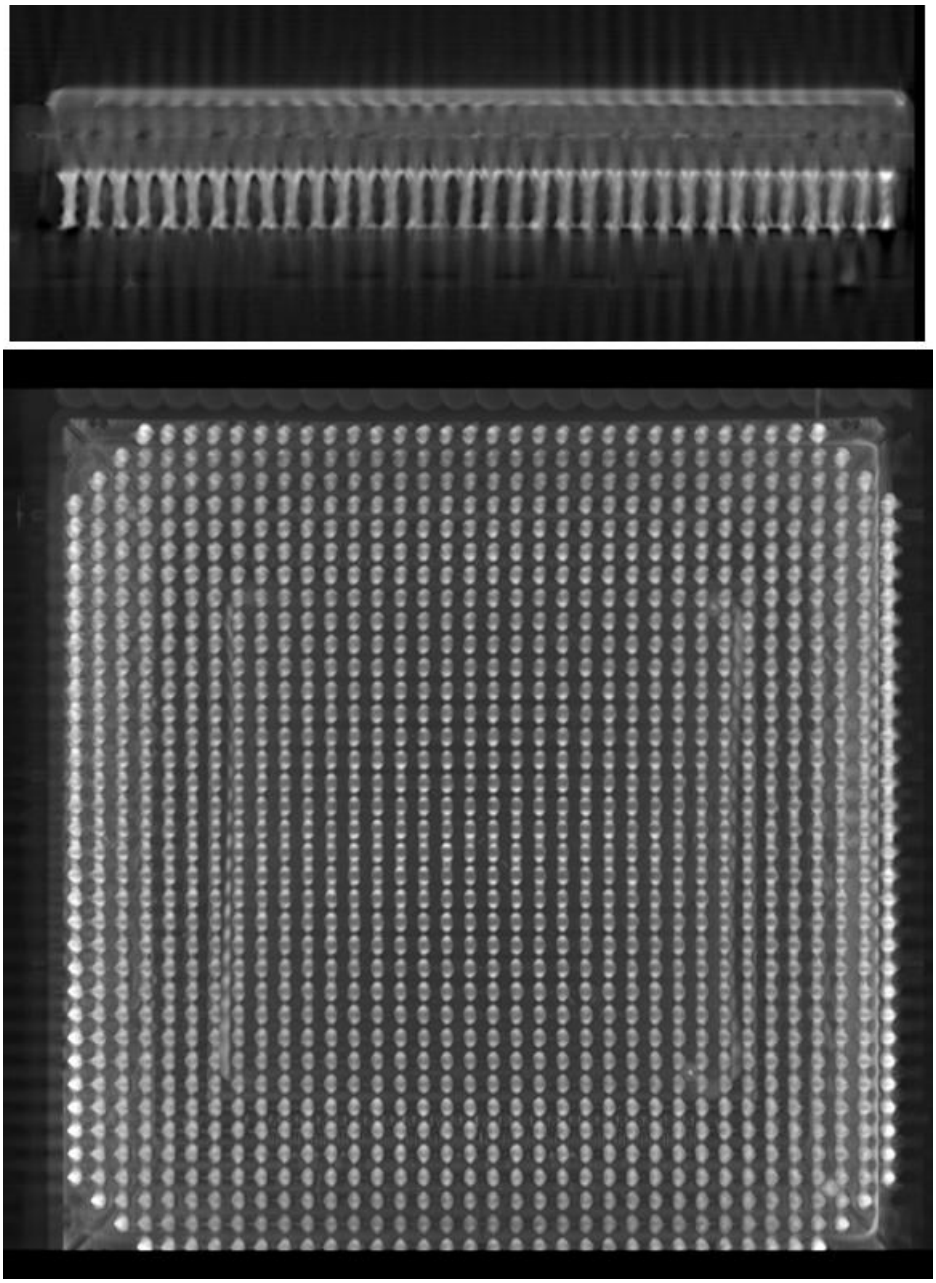
Figure 3.2-8 shows two representative X-sectional views, vertical and horizontal, from the 3D X-ray tomography of a CGA1272 package assembly after thermal cycling. These columns appear to have tilted and shifted less compared to those for the CGA1752 assembly.

Figure 3.2-8. Slices from 3D X-ray digital data generated by X-section, either vertical or horizontal.

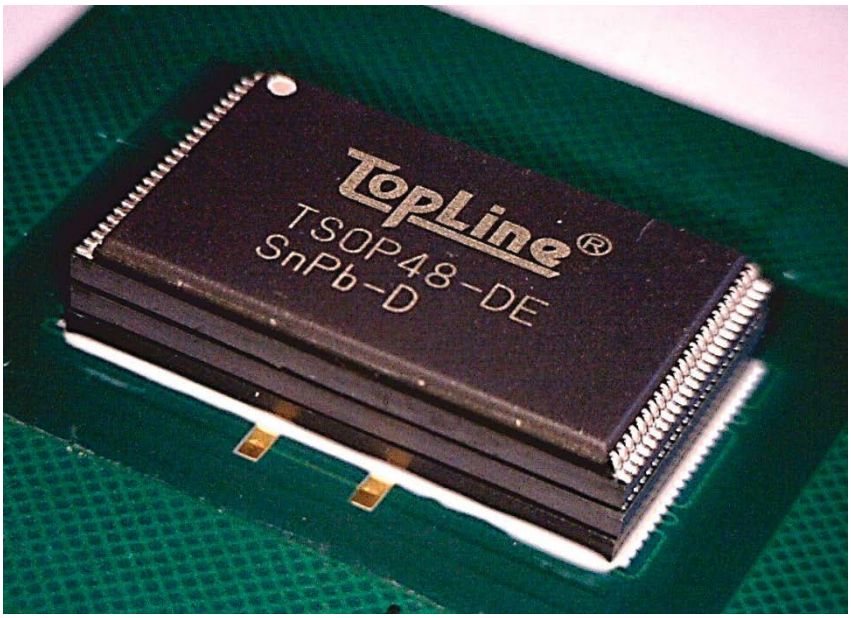
Figure 4.1-1. Photograph of 4-high stacked package surface-mounted assembly with underfill.

A 3D stack package assembly after thermal cycling and failure was selected for both 2D and 3D computed tomography X-ray evaluation to determine if either of the two X-ray systems can detect failures. The 3D package consists of 48 lead TSOPs solder stacked (4-high) and integrated into a single dual-flat no-lead (DFN) packages. Dummy packages were used in a daisy chain configuration for interconnect testing. Pb-free solder was used in the stacking assembly process and 63Sn-37Pb solder was used to mount the package to the test board. An example of the completed assembly is shown in Figure 4.1-1. A number of these assemblies were subject to thermal cycle testing in the range of –55 to +125°C. One failed test sample was selected for failure characterization and comparison by optical microscopy and 2D/3D X-ray systems. The comparison provided key advantages and disadvantage of each inspection system for use in advanced stack electronic packaging.

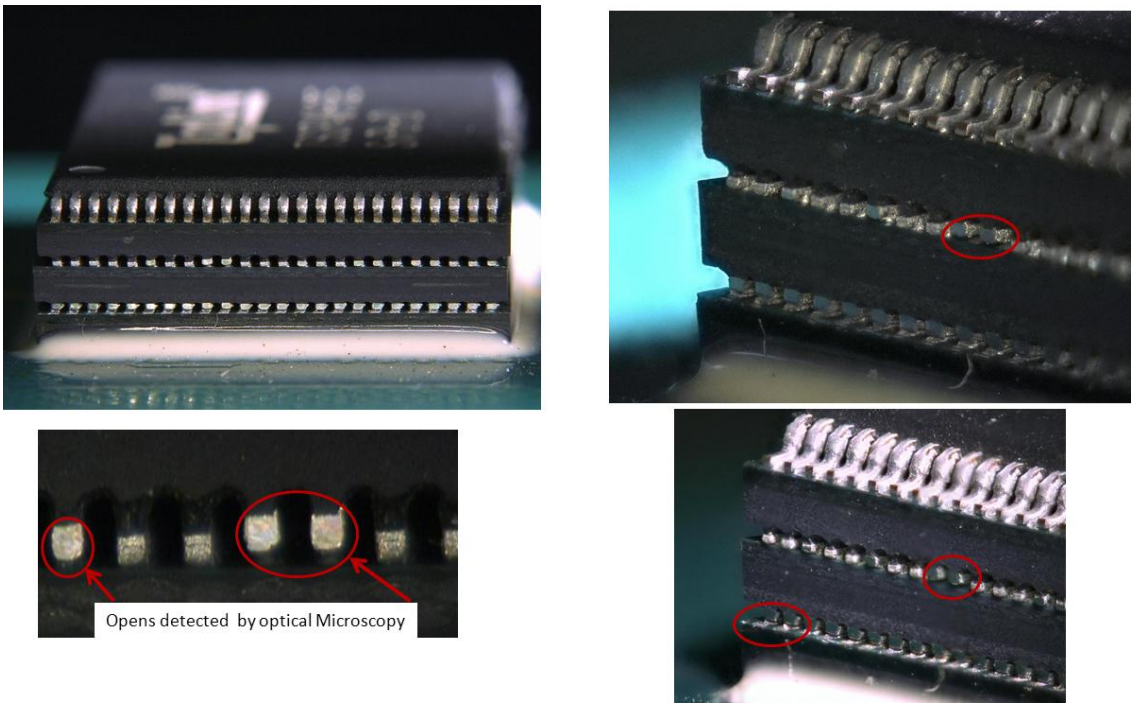
Representative optical photographs of a 4-high stack after thermal cycling are shown in Figure 4.1-2. The top photos show an overall feature of the 3D stack package assembly, with some signs of separation of no-lead packages at the center and at the edge. Higher magnification images shown at the bottom clearly show separation and failure due to thermal cycling exposure. The apparent failures are marked with red circles for better identification.

Figure 4.1-2. Photograph of a 4-high stacked package after thermal cycling showing failures of no-leads.

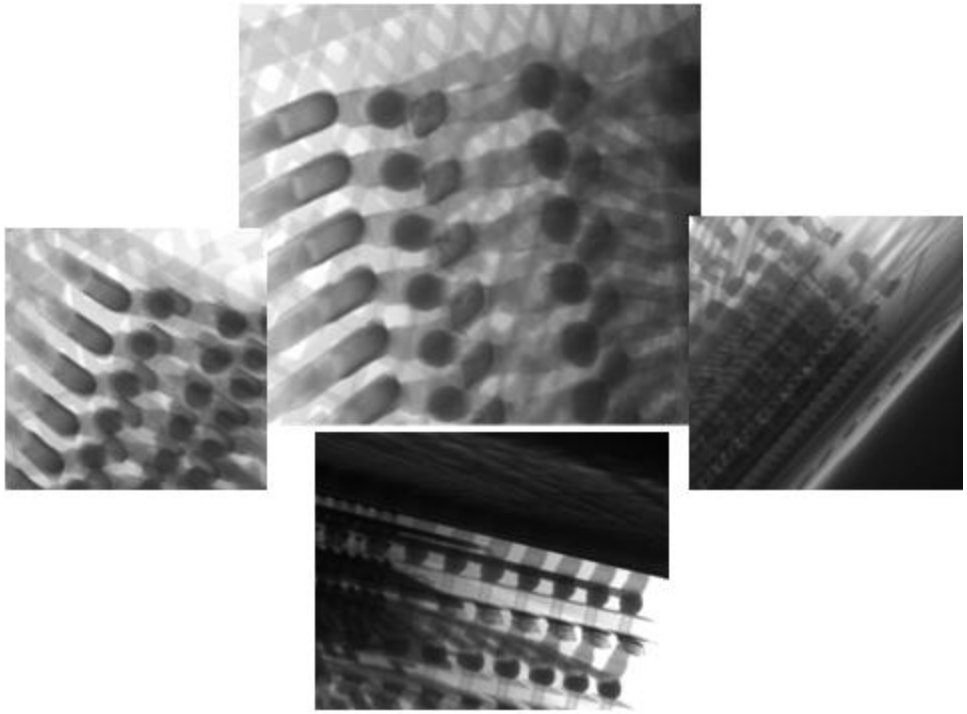
Figure 4.2-1 shows a few representative 2D X-ray images for the 4-high TSOP stacked-surface mounted package assembly. These 2D X-ray images were taken at various angles, and other attempts were made to delineate the no-lead failure separations that were clearly apparent from both optical microscopy inspection and images. The result was no clear identification of separation. As apparent from the X-ray images, combining stack leads and copper mesh used in the board made it difficult to distinguish the failure separation, which was easily noticeable via optical microscopy. This is one of the drawbacks of X-ray system; it exposes everything between source and detector.

Figure 4.2-1. 2D X-ray images of a 4-high stacked package after thermal cycling in an attempt to delineate failure observed by optical microscopy.

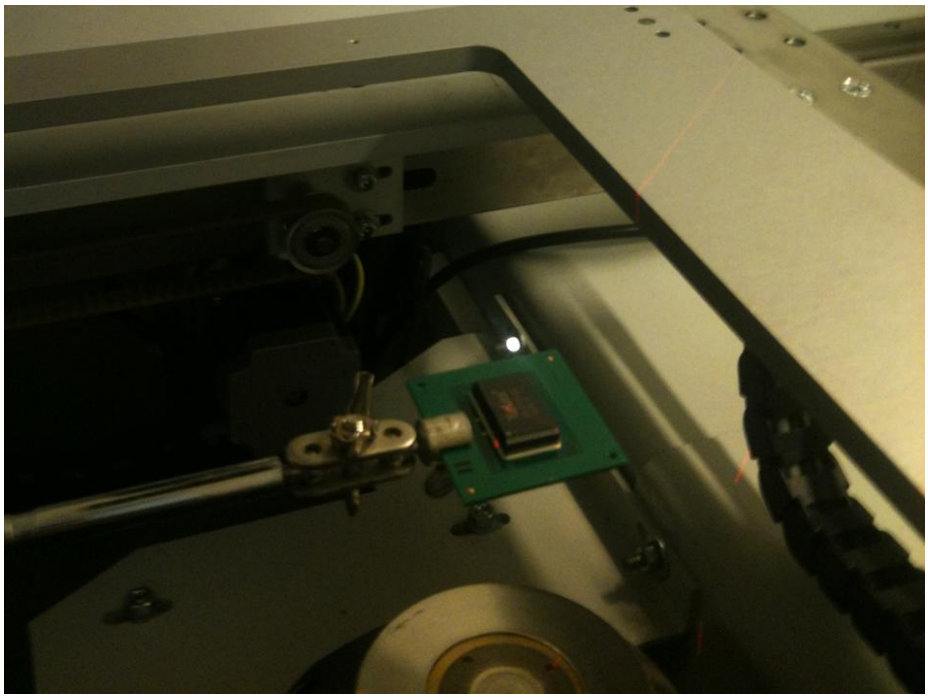
Figure 4.3-1. Photograph of 4-high stack assembly in position and ready for rotation, to generate 3D X-ray images.

The X-ray system with the 2D into 3D image transformation was used to characterize thermal cycling damage to a 4-high stacked package assembly. The CT images are automatically created by designing a sample holder for insertion in the rotational motor tool installed in the 2D X-ray. The board assembly was slightly higher than the 3D stack package; therefore, maximum ideal magnification could not be achieved. Figure 4.3-1 shows a representative setup in preparation for generating 3D X-ray images of 3D stack assembly. Rotating the sample allows capturing a series of X-ray images with relative positional coordinates of each image that is captured. These data are stored while the object is rotated within the X-ray beam. When all digital data have been captured, the data bank is processed to reconstruct the cross-sectional 2D or 3D images.

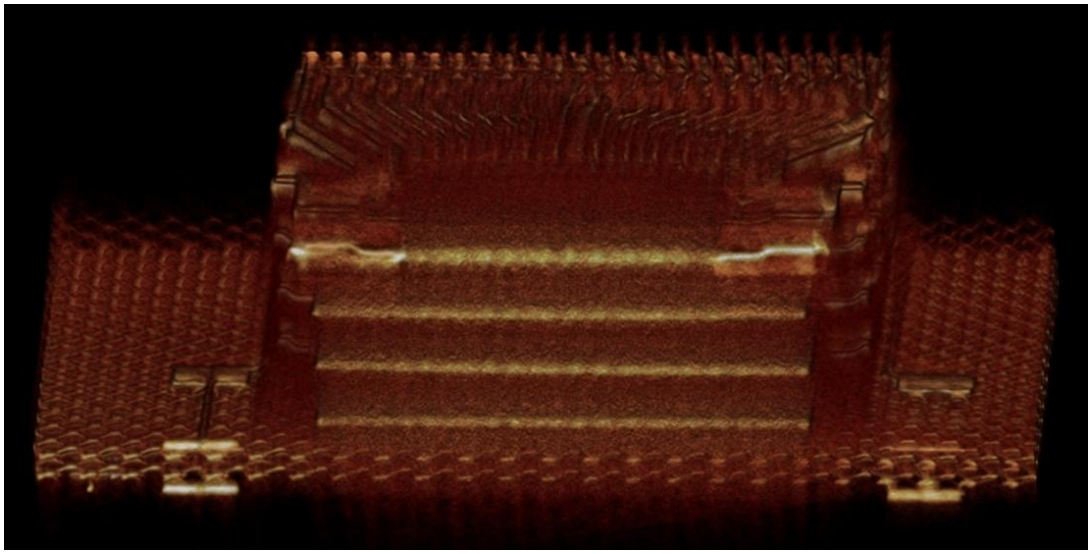
Figure 4.3-2 shows an overall 3D X-ray image constructed from the 2D layers. Figure 4.3-3 shows a number of representative x-sectional X-ray images of the same package. Many geometrical features of the 3D stack package are apparent, but resolution is not high enough to distinguish the separation of no-lead solder attachment observed during microscopic evaluation. Even additional attempts to change coloring and better separate various stack layers (see Figure 4.3-4) did not reveal failures that were apparent optically. Low magnification did not allow better identification of damage due to thermal cycling.

Figure 4.3-2. 3D X-ray images of a 4-high stacked package after thermal cycling showing overall assembly configuration.

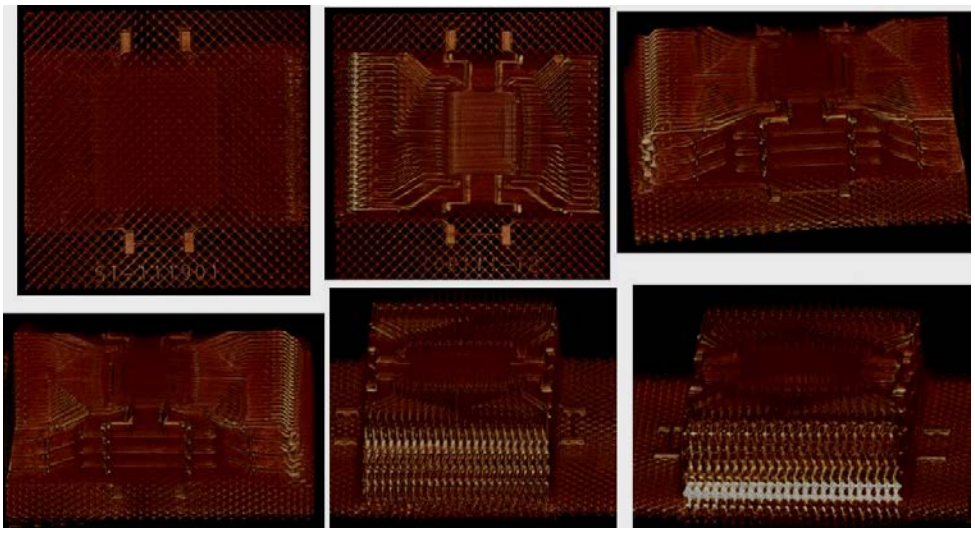
Figure 4.3-3. 3D X-ray slice images of a 4-high stacked package after thermal cycling showing diversity of images that can be generated from the image data set.

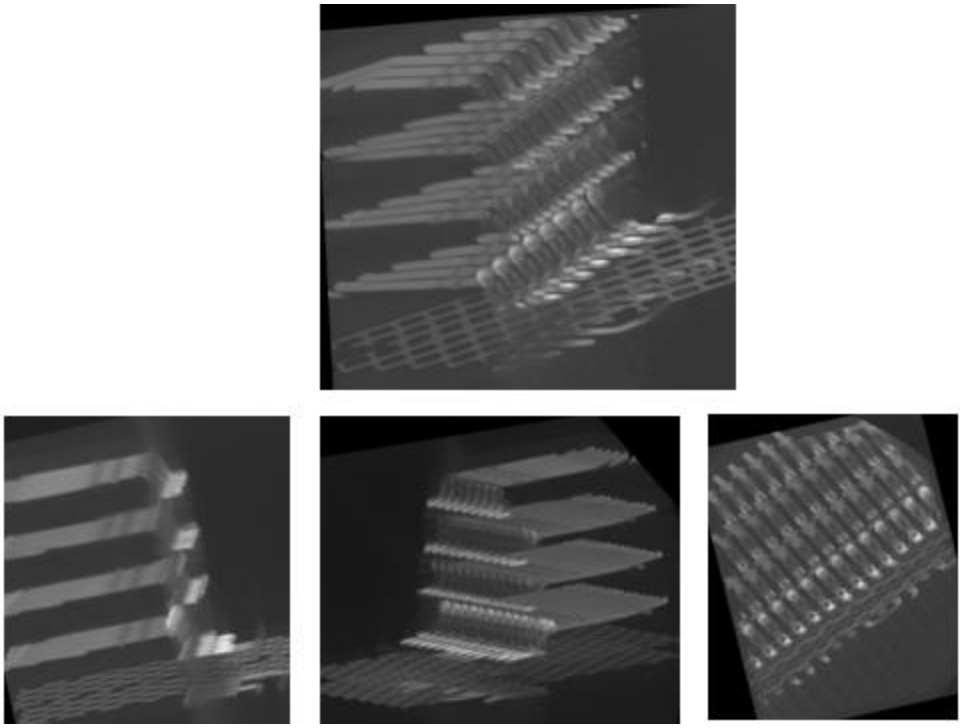
Figure 4.3-4. 3D X-ray slice images of a 4-high stacked package after thermal cycling showing diversity of images, but apparent separation observed by optical microscopy.
