# Solder Reflow Failures in Electronic Components during Manual Soldering

Alexander Teverovsky, Chris Greenwell,  
Frederick Felt

Perot Systems/NASA GSFC, code 562,  
Parts, Packaging, and Assembly Technologies Office

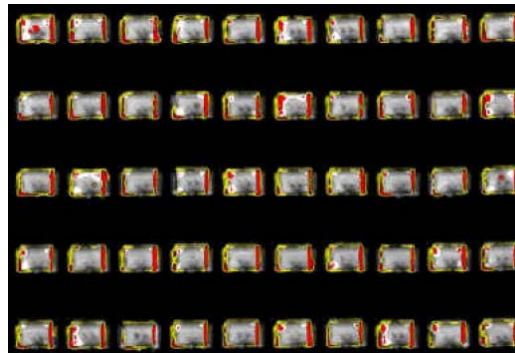
Typical CSAM images

- ❑ Three power FETs in plastic surface mount packages (D2Pak) failed short circuit after manual soldering onto a board.
- ❑ The parts passed screening including 100% C-SAM inspection.
- ❑ Failed parts had top-of-die delaminations.

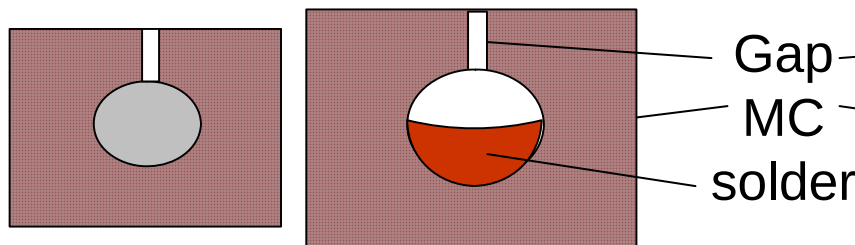
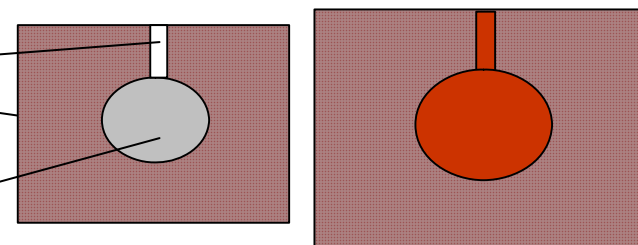
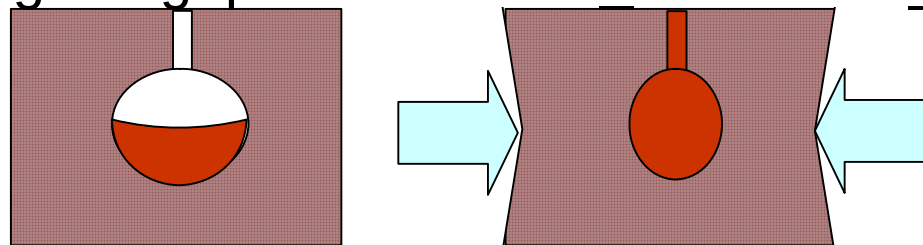
Molten solder does not wet glass/ceramic/plastic and should be pressed to flow in a gap by internal or external forces.

- ❑ Internal force: compressive stresses develop if expansion of solder > expansion of MC.

- ❑ An external force during soldering might result in molten solder filling the gap even at  $CTE_{MC} > CTE_{solder}$ .

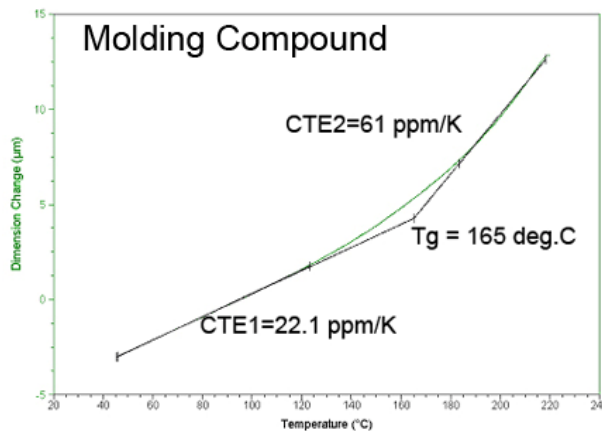
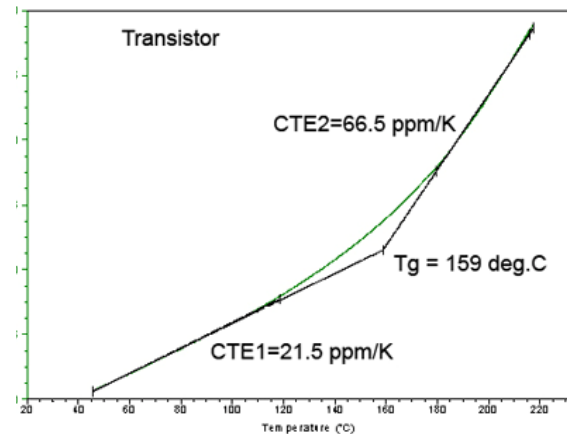
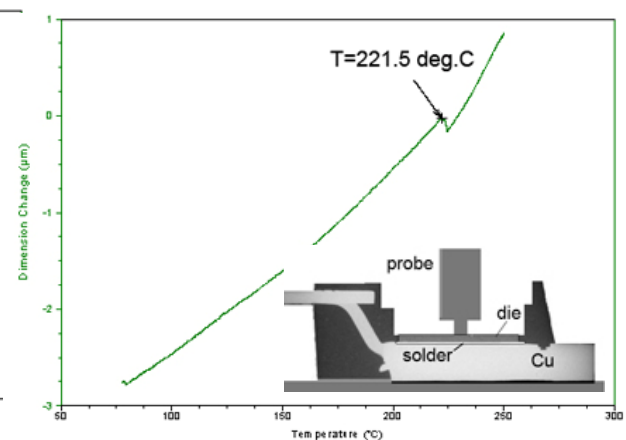
Deformation vs. temperature was measured on MC, transistors, and with a probe installed on a die (after decapsulation).

Probe-on-a-die measurements confirmed that a high-temperature tin-silver solder with a melting point of 221°C was used.

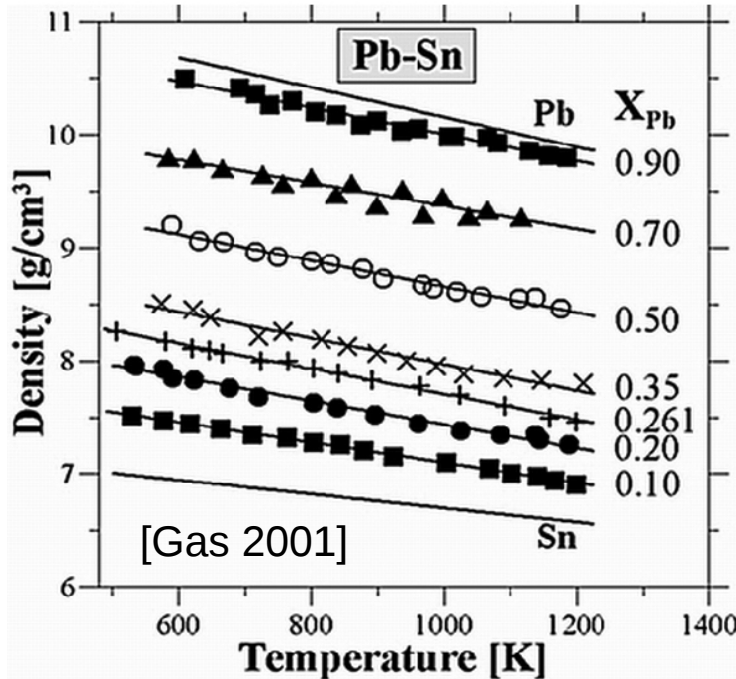
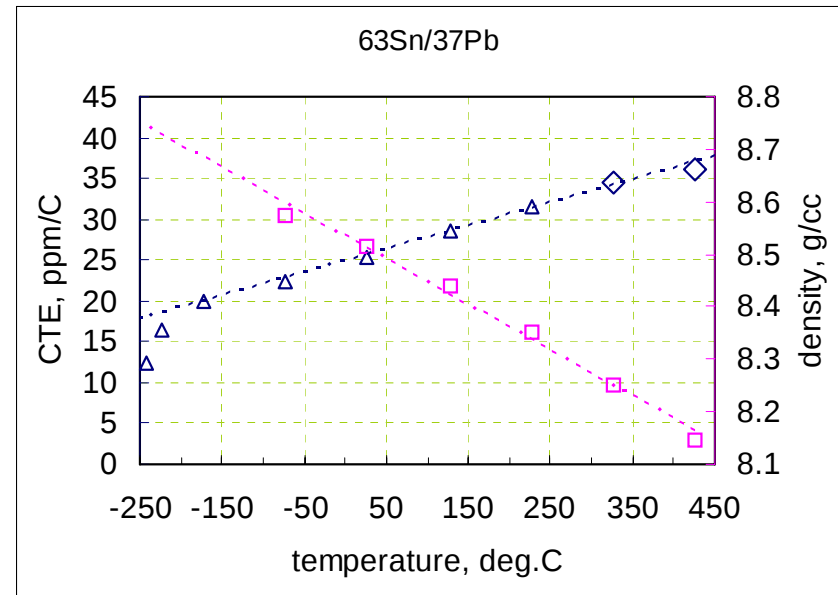
Available literature data on solder expansion were used for best-fit estimations of CTE and density at  $-65 < T < 450$  °C.

Molten near-eutectic solder has  
CTE = 34.5 ppm/K.

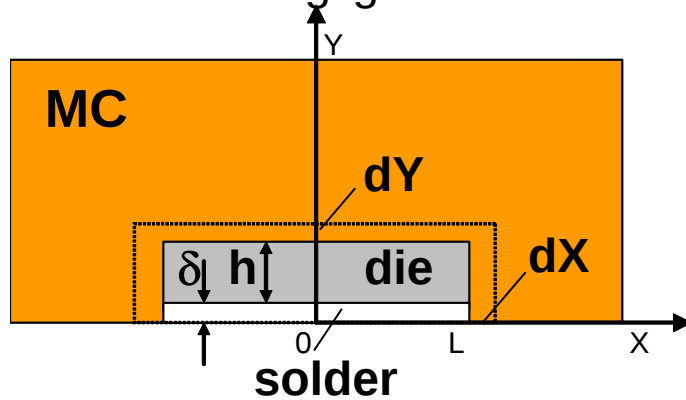
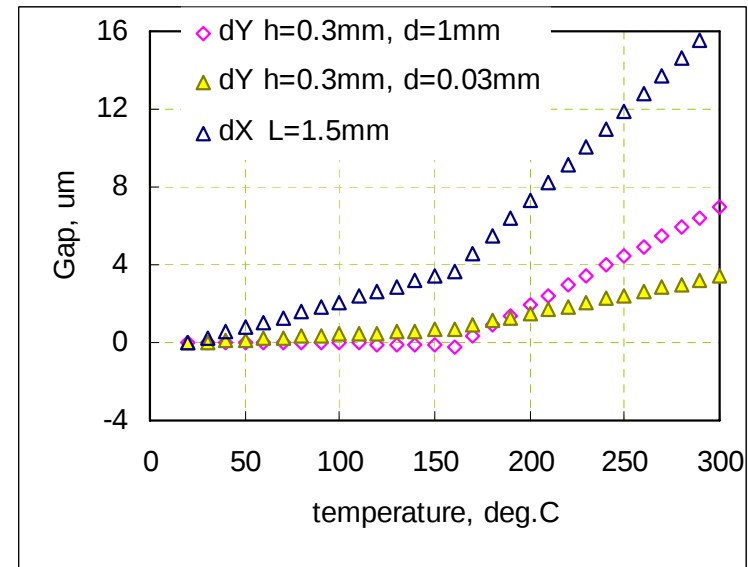
A size of MC/die gap,  $\Delta Y$ , was calculated assuming that at RT  $\Delta Y=0$  and adhesion is negligible.

Compressive stresses ( $\Delta Y < 0$ ) might occur at very thick layers of solder ( $\delta \sim 1\text{mm}$ ) only.

- ❑ Heating of the package uniformly creates enough room for solder expansion and no reflow failures should occur.
- ❑ Power FETs are designed for SMT for oven reflow soldering at  $T \sim 250\text{ }^{\circ}\text{C}$  (up to 30 sec.), which exceeds  $T_m = 221\text{ }^{\circ}\text{C}$ .
- ❑ Heating to melting temperature is a necessary by not a sufficient condition for reflow failures.

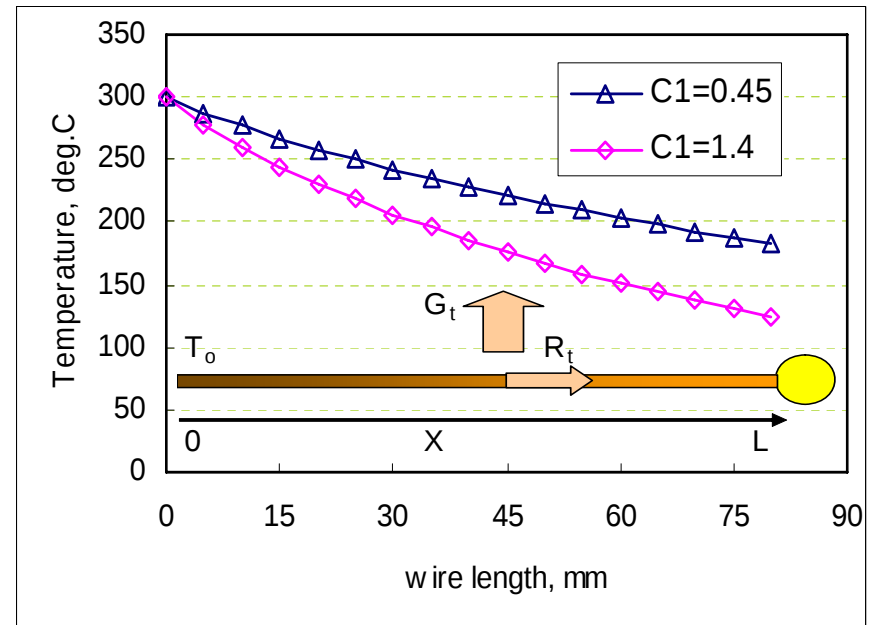
Temperature distribution along a wire of diameter  $d$  and length  $l$

- ❑ At a specified conditions a soldering iron is set to  $T_o = 300$  °C and at  $L = 76$  mm  $T_{\text{sensor}} < 180$  °C (no melting).
- ❑ Cutting leads to ~1" will increase  $T_{\text{sensor}}$  to 220 to 250 °C and might cause solder reflow failures.

- ❑ Reducing the length of wires increases die temperature. Special care (thermal shunts) should be taken to avoid solder reflow failures.
- ❑ Avoid holding or touching plastic packages during soldering.

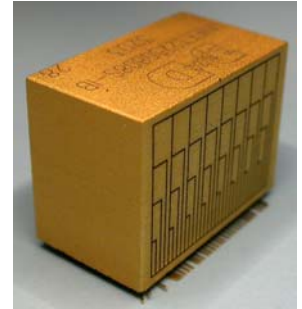
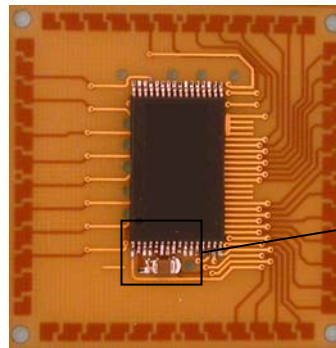
- ❑ The part passed all screening and qualification testing but failed with a short circuit in internal power supply lines after manual soldering onto a board with a soldering iron set to 700 F (371 °C).
- ❑ The part is comprised of 8 micro-boards with a TSOP memory microcircuit and ceramic capacitor in the power supply line. Interconnections are made on the boards and externally, via package metallization (8  $\mu\text{m}$  Au/Cu/Ni).
- ❑ How to pinpoint location of the defect?

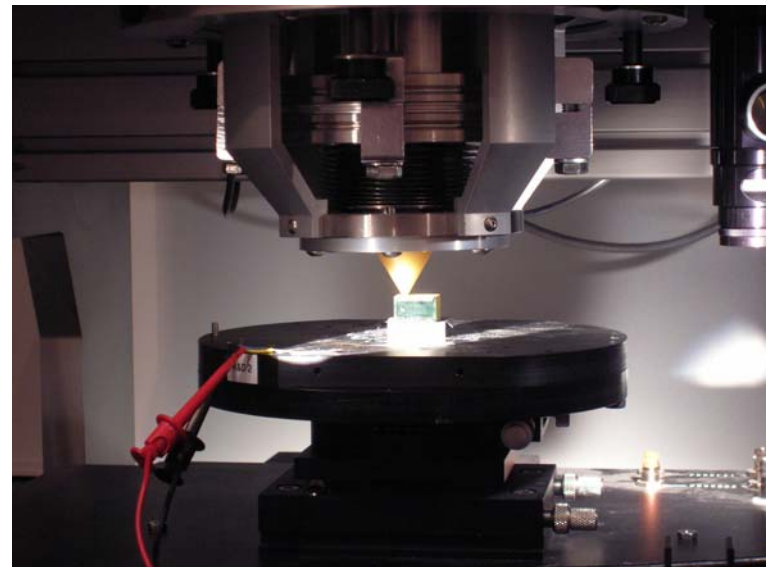
- ❑ MCI with a superconducting quantum interference device (SQUID) probe (NEOCERA) was used to locate the defect.
- ❑ Maximum current of 2.7 mA, 533 Hz, was applied to the sample.
- ❑ The technique allows for current density mapping by scanning magnetic field at a distance from the surface  $\sim 100\ \mu\text{m}$ .
- ❑ SQUID is effective to depth of several millimeters.

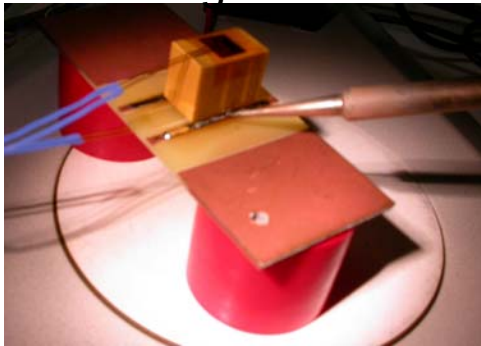
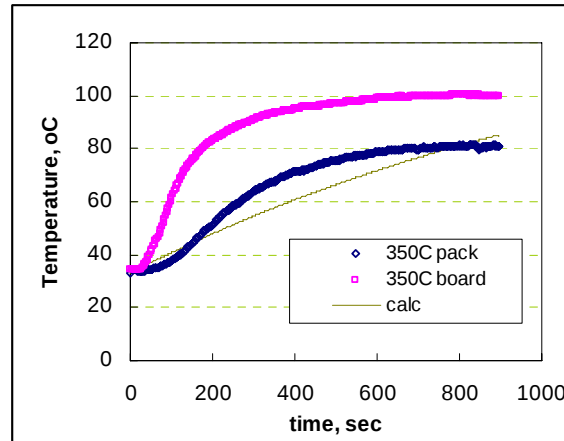
Soldering simulation.

- ❑ *Overheating during soldering (soldering iron was set to 371 °C). Experiment showed that possible T rise do not exceed 80 °C.*

Experimental (marks) and calculated (line) temperature variations. The soldering iron was fixed at the middle of contact pads.

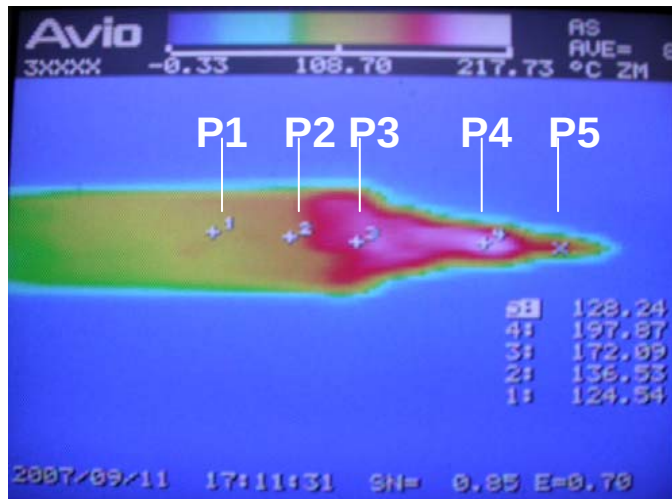
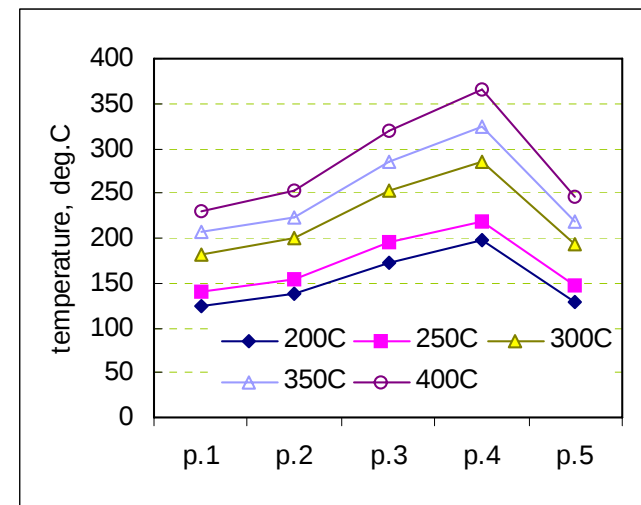
- ❑ Temperatures of a soldering iron were set to 200, 250, 300, 350, and 400 °C.

- ❑ IR measurements in 5 points were used to get temperature distributions.

Temperature of the holder near the tip (P3) is only 10% to 13% lower than  $T_{\max}$ .

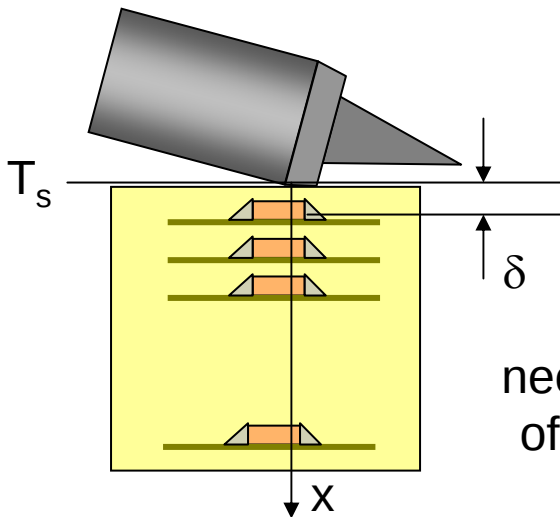
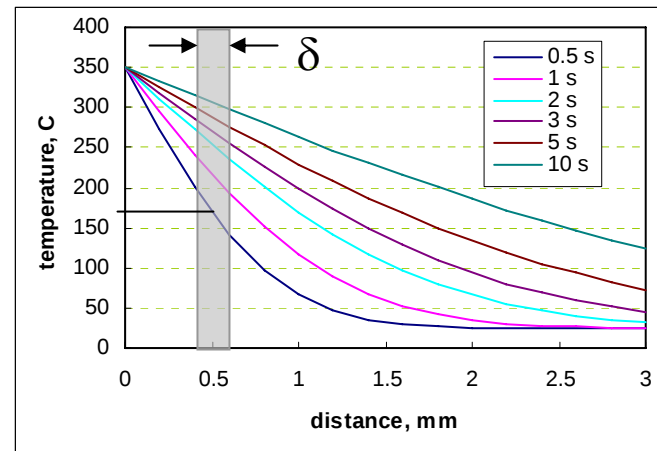
T distributions across 3D-plus package

- ❑ Temperature distributions were calculated at  $T_s = 350\text{ }^\circ\text{C}$  and thermal diffusivity,  $\alpha = 4.3\text{E-}7\text{ m/s}^2$ .

Only ~0.5 sec is necessary to reach  $T_m$  of solder (~183 °C) at the top board

The most probable cause of failure is inadvertent touch by a soldering iron.

- ❑ Preheating and equalizing temperature across the package might reduce the probability of failures.
- ❑ Temperature of soldering iron holder near the tip might be much higher than melting temperature of solder. Occasional touch to the surface of the package might cause failures.
