# GODDARD SPACE FLIGHT CENTER

## Test Lab Report Summary

<i>Report Number:</i>	Q20102DPA	<i>Project:</i>	SORCE
<i>Part Type:</i>	Microcircuit	<i>System:</i>	
<i>Part Number:</i>	RT54SX16-1CQ208BX3	<i>Initiated Date:</i>	03/15/02
<i>Date Code:</i>	0101 (1), 0113 (1)	<i>Report Date:</i>	03/29/02
<i>Manufacturer:</i>	Actel	<i>Investigator:</i>	C. Greenwell (562)
<i>Generic Number:</i>	RT54SX16	<i>Requester:</i>	T. Perry (562)
<i>Purchase Spec:</i>	Mfg. 883 Flow	<i>Approval / Date:</i>

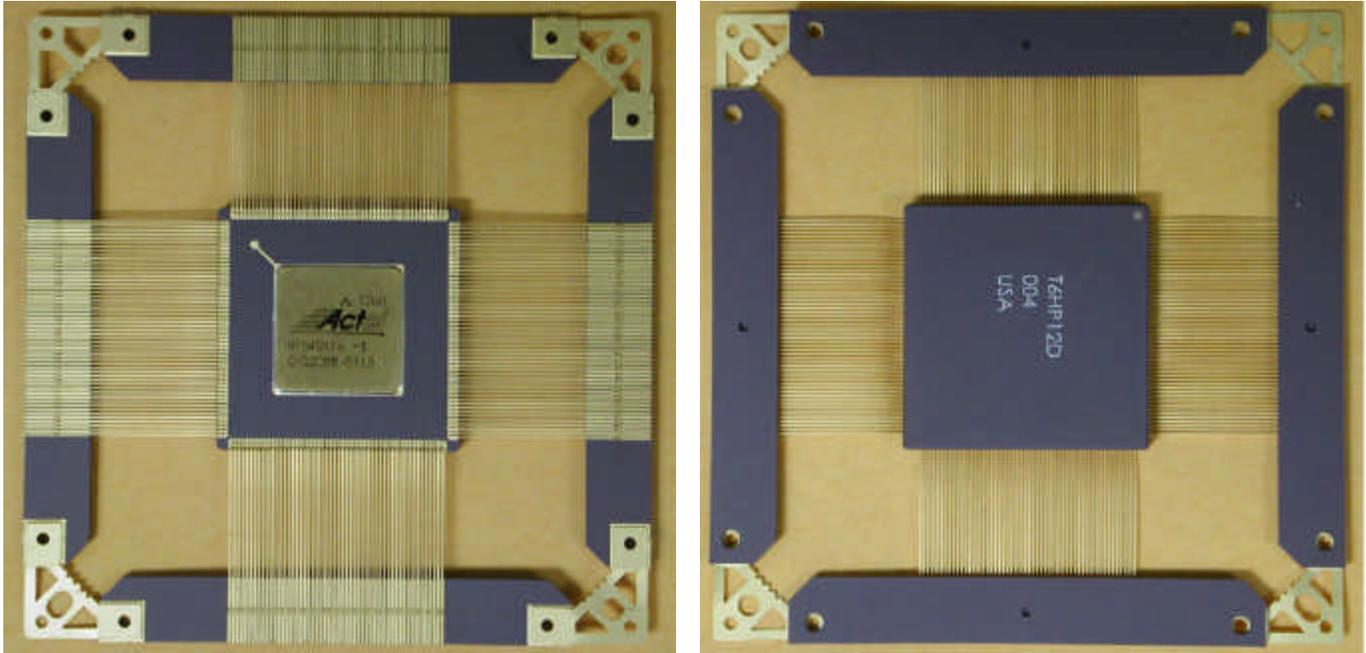
Figure 1. External top and bottom views of the RT54SX16-1CQ208BX3 dc 0113 device. Part markings on the dc 0101 devices were identical except for the date code and '003' in place of '004' on the bottom side.

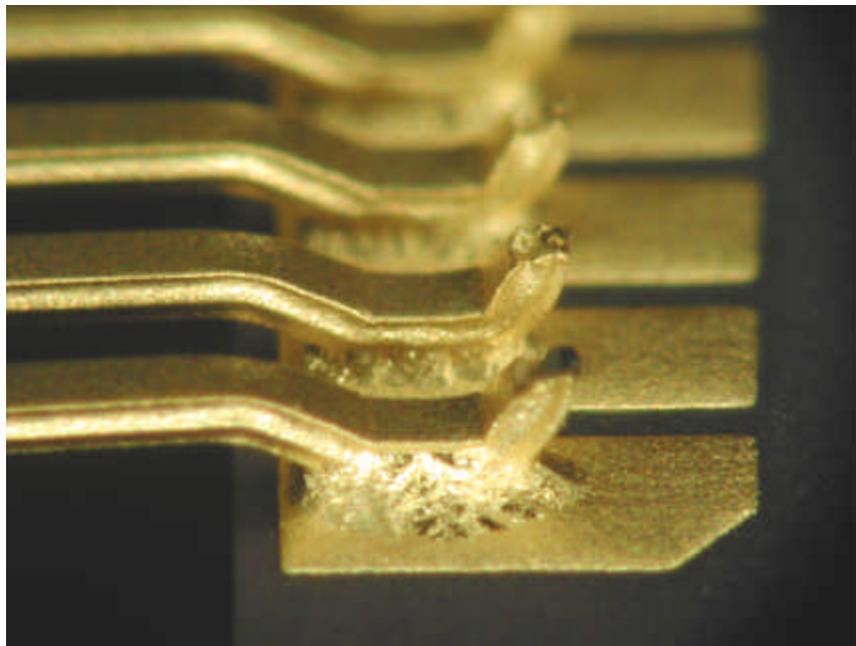
Figure 2. Close-up view shows details of the external lead attach.

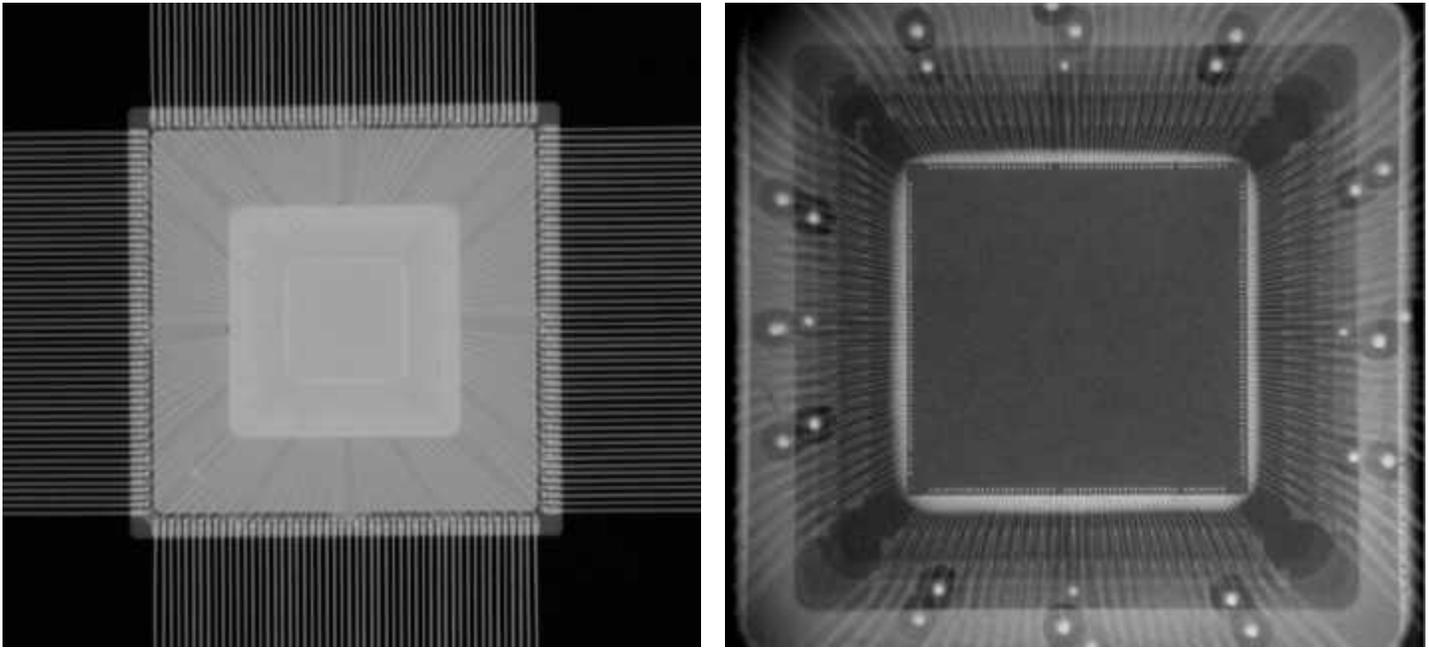
Figure 3. Radiographic images of the RT54SX16 devices. Right image is a close-up of the cavity area. Both devices appeared basically identical.

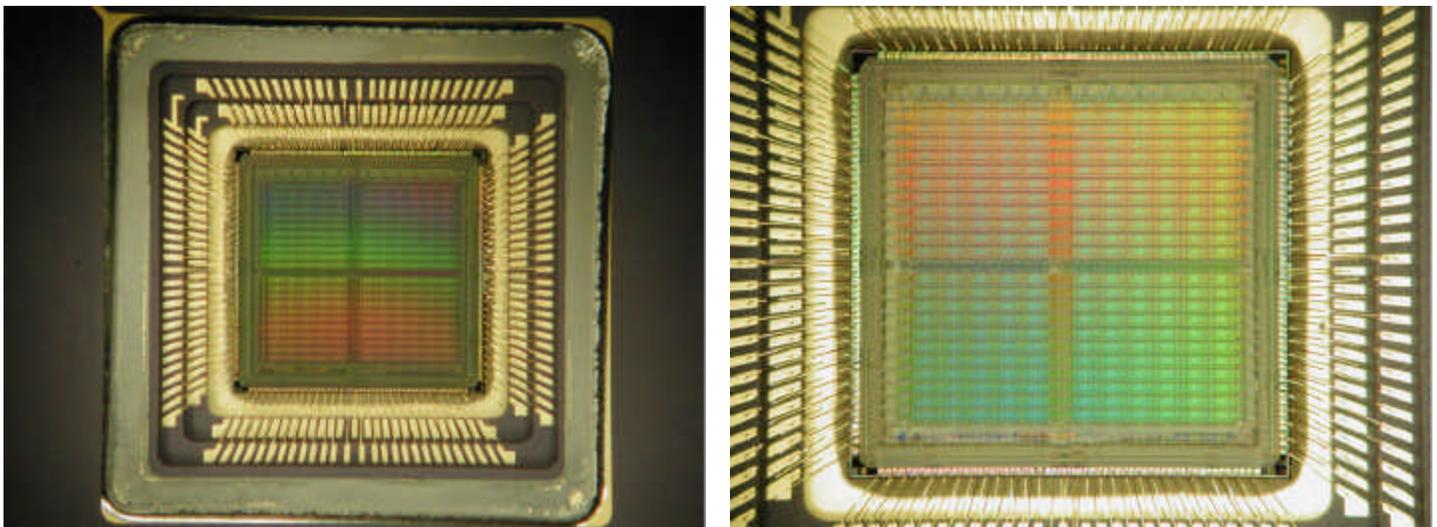
Figure 4. Internal views of SN 003 (dc 0101) device.

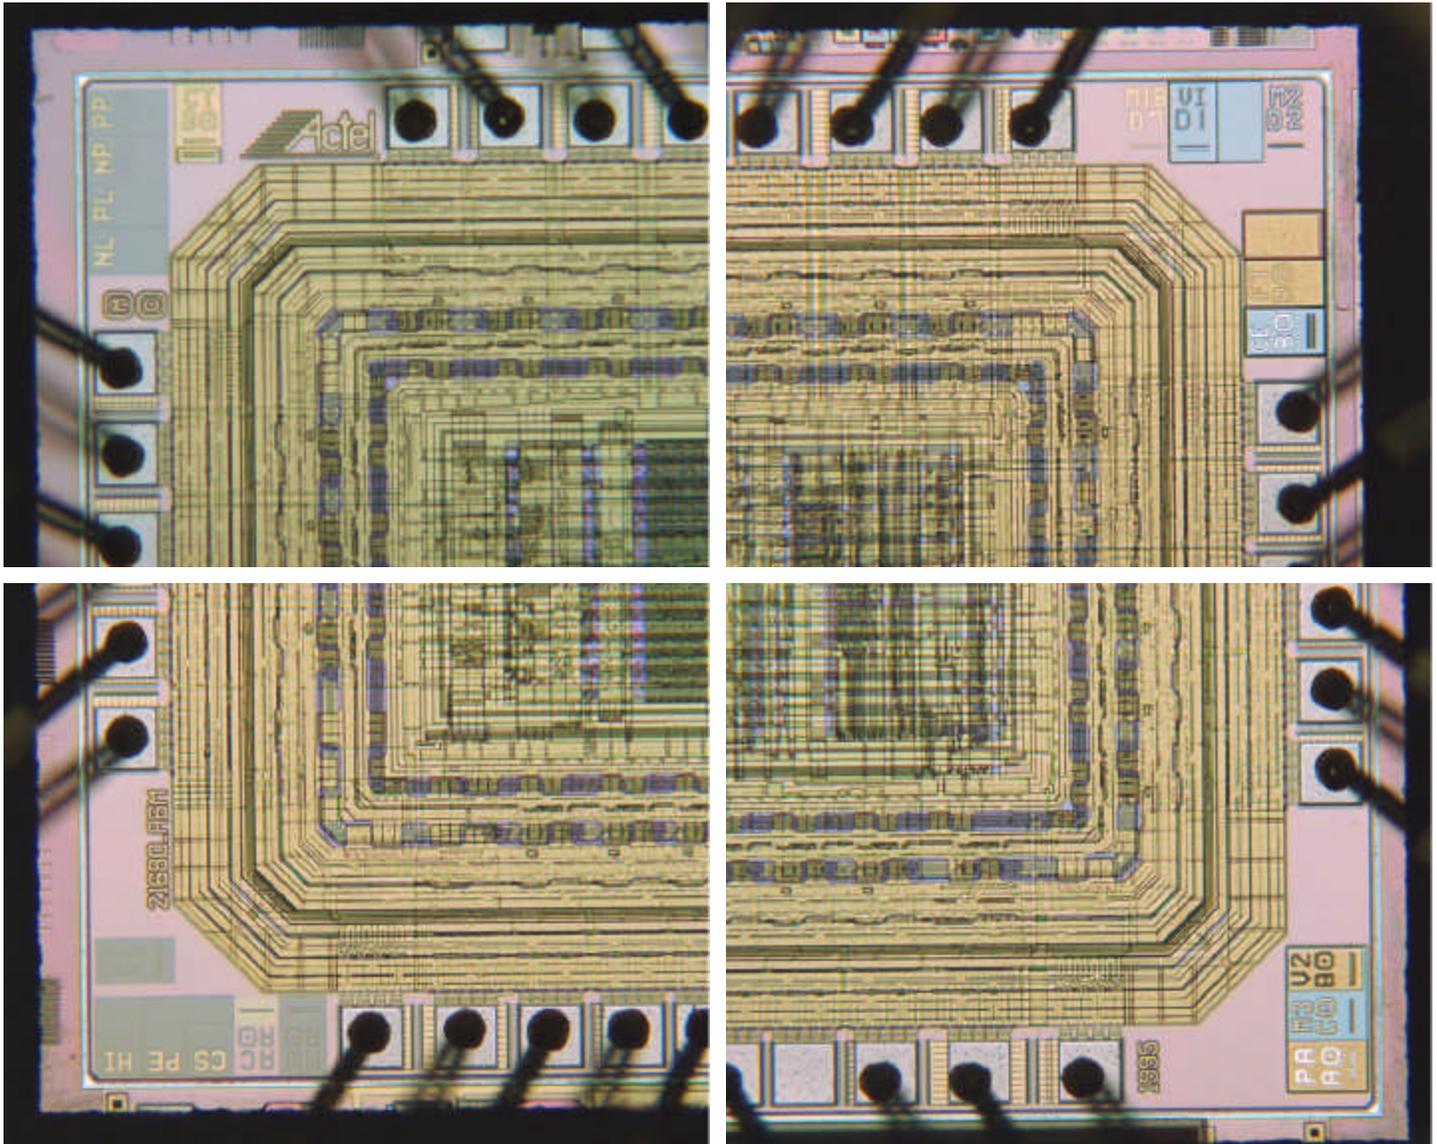
Figure 5. Relatively high magnification images show all four corners of the SN 003 (dc 0101) die. An entire die view at this magnification would be six pages wide.

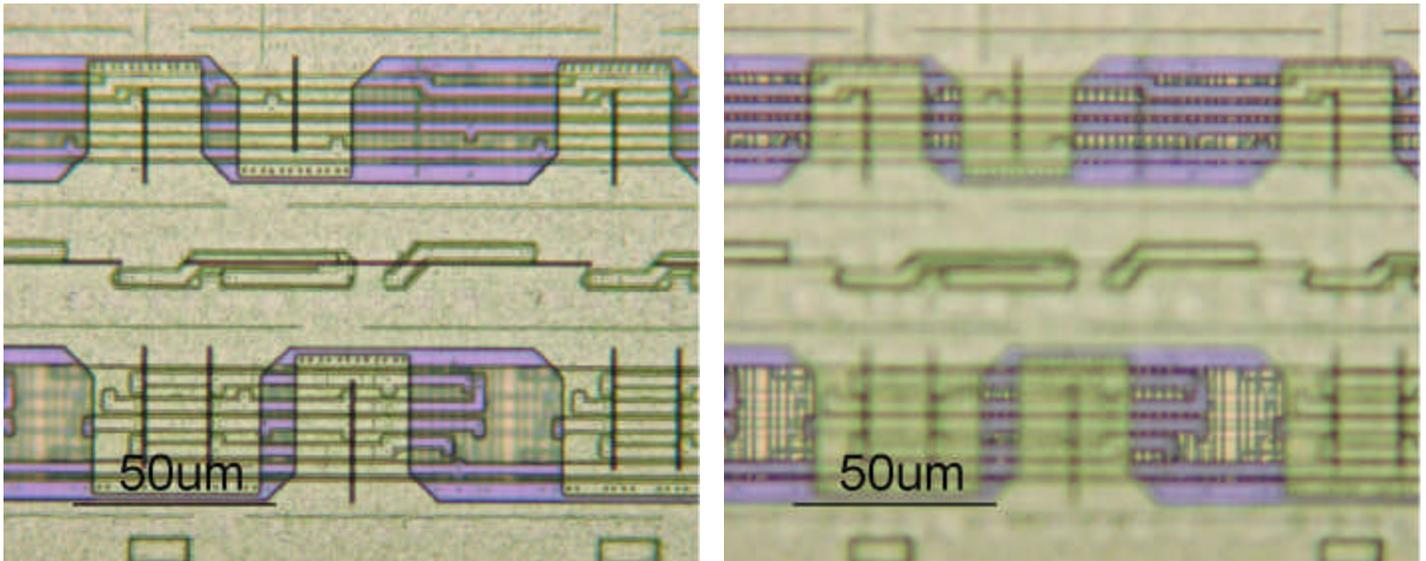
Figure 6. High magnification images of SN 0003 show typical die features. These images or of the same area focused at different planes. The die has a relatively high vertical structure; three metal layers.

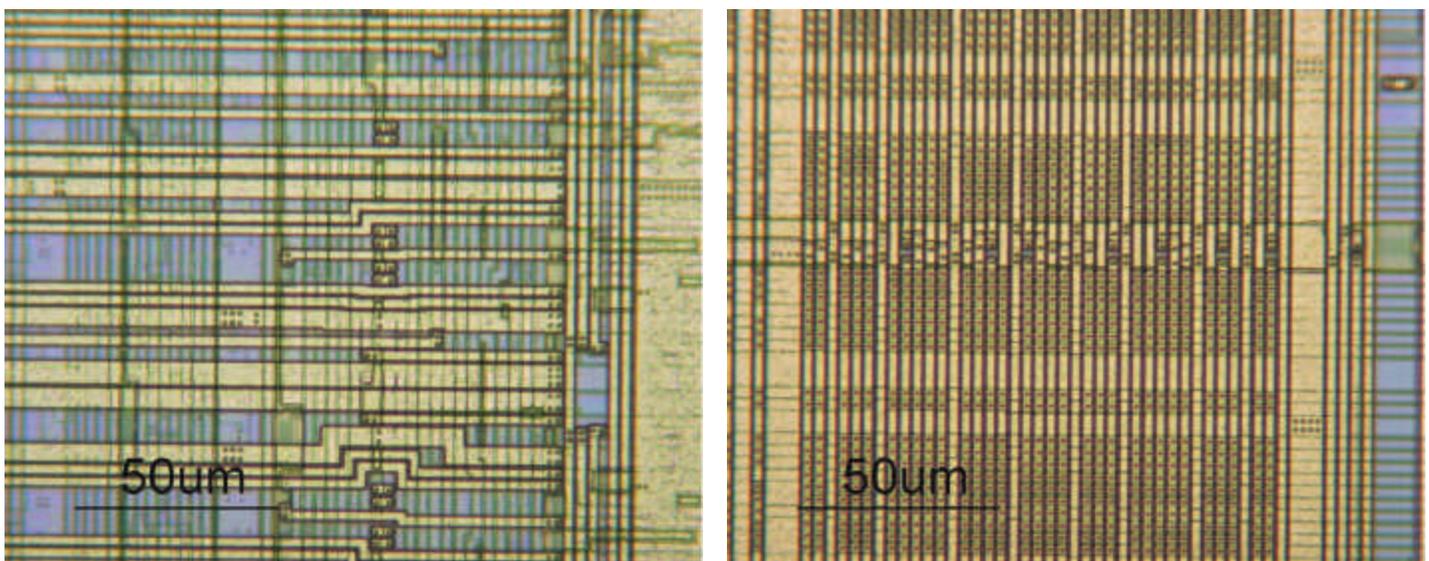
Figure 7. High-mag optical images show typical die features on SN 004 (dc 0113).

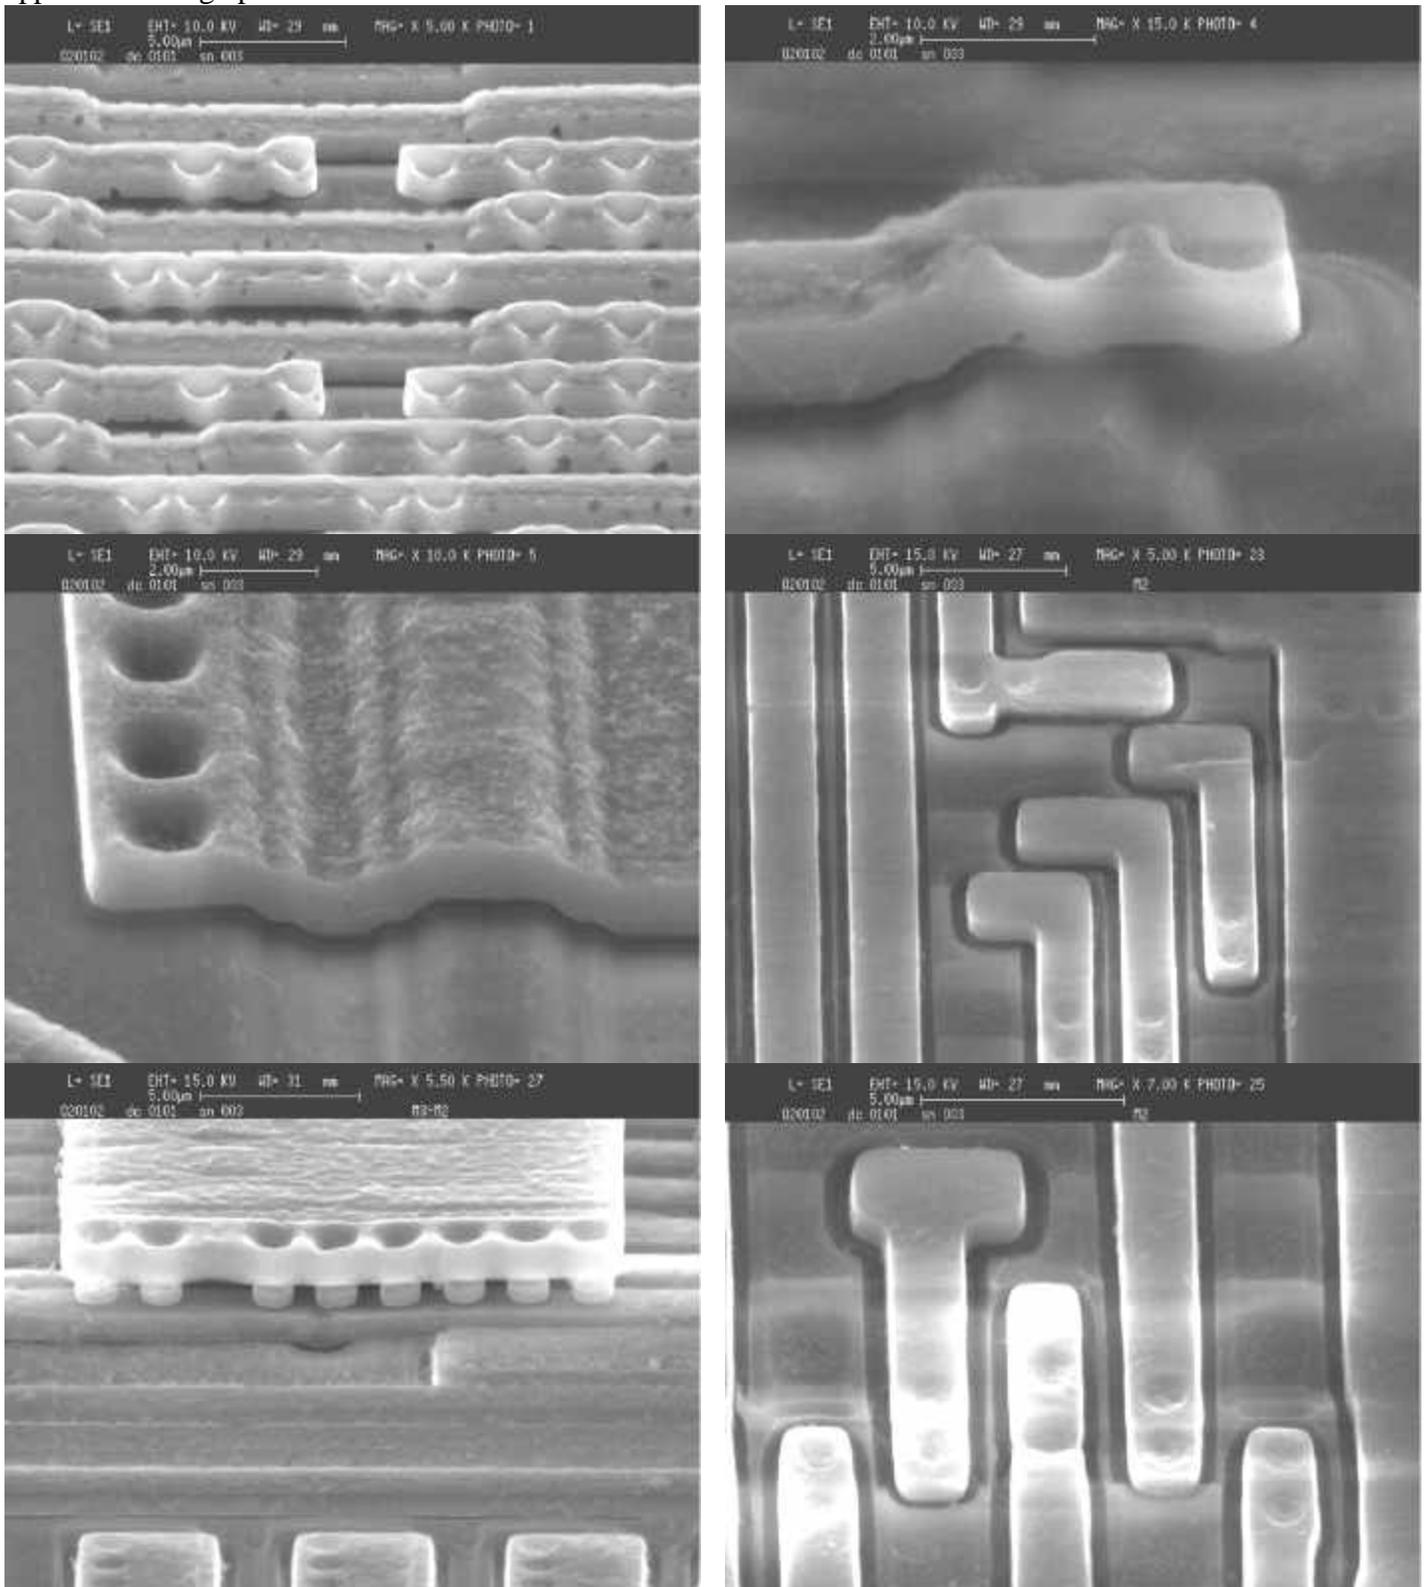
Figure 21. SEM images of die metallization on SN 003.
