# Destructive Single-Event Effects in Diodes

Megan C. Casey<sup>1</sup>, Jean-Marie Lauenstein<sup>1</sup>,  
Michael J. Campola<sup>1</sup>, Edward P. Wilcox<sup>2</sup>, Anthony M. Phan<sup>2</sup>,  
and Kenneth A. LaBel<sup>1</sup>

<sup>1</sup>NASA Goddard Space Flight Center

To be presented by Megan C. Casey at the NASA Electronics Parts and Packaging (NEPP) Electronics Technology Workshop (ETW), Greenbelt, MD, June 26-29, 2017.

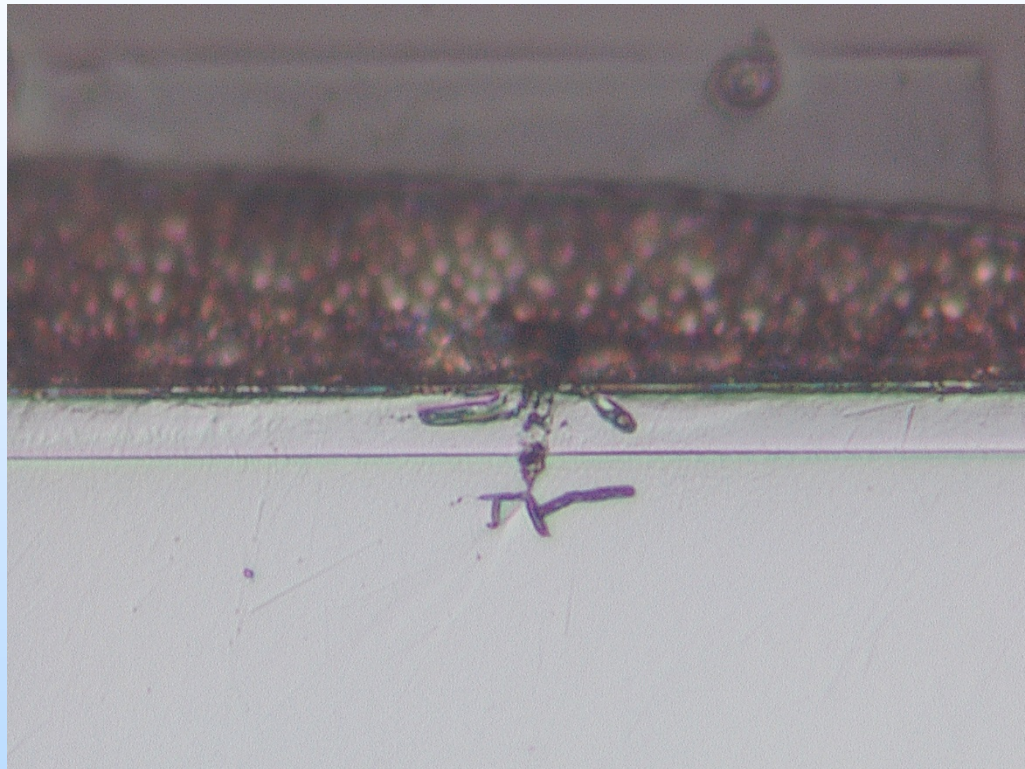
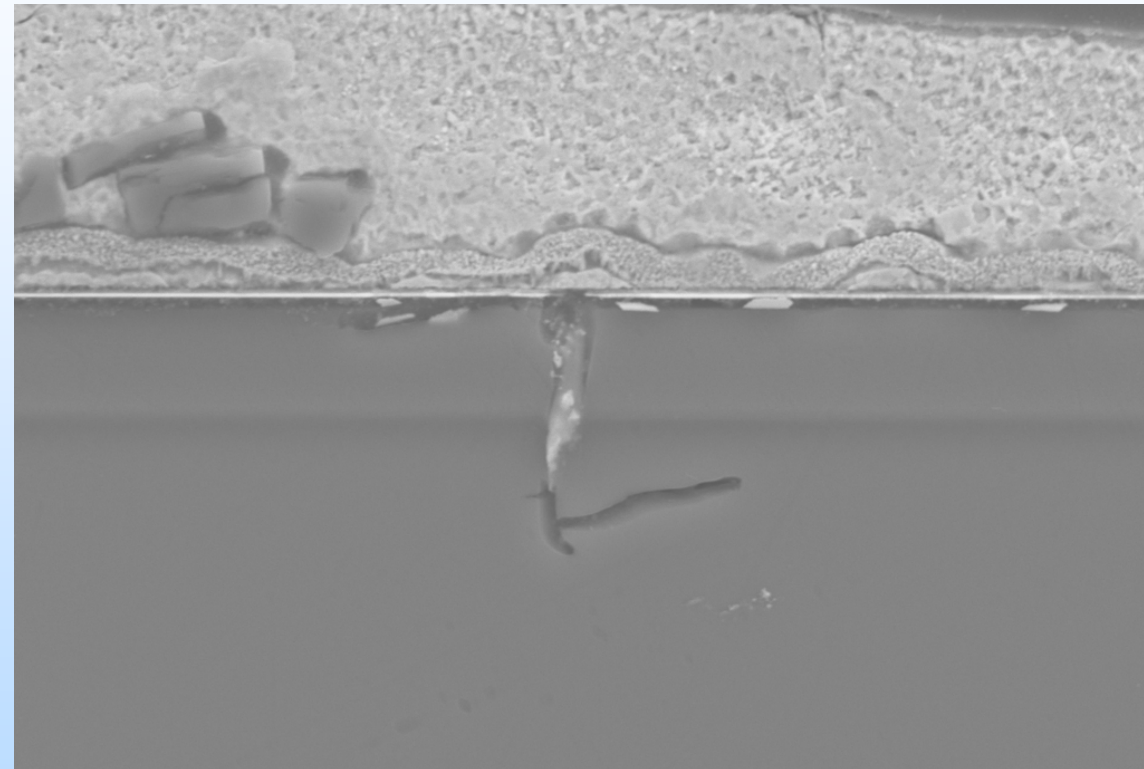
Cross-Section at Failure Location

Metal has clearly displaced from Schottky junction into void  
formed from high current

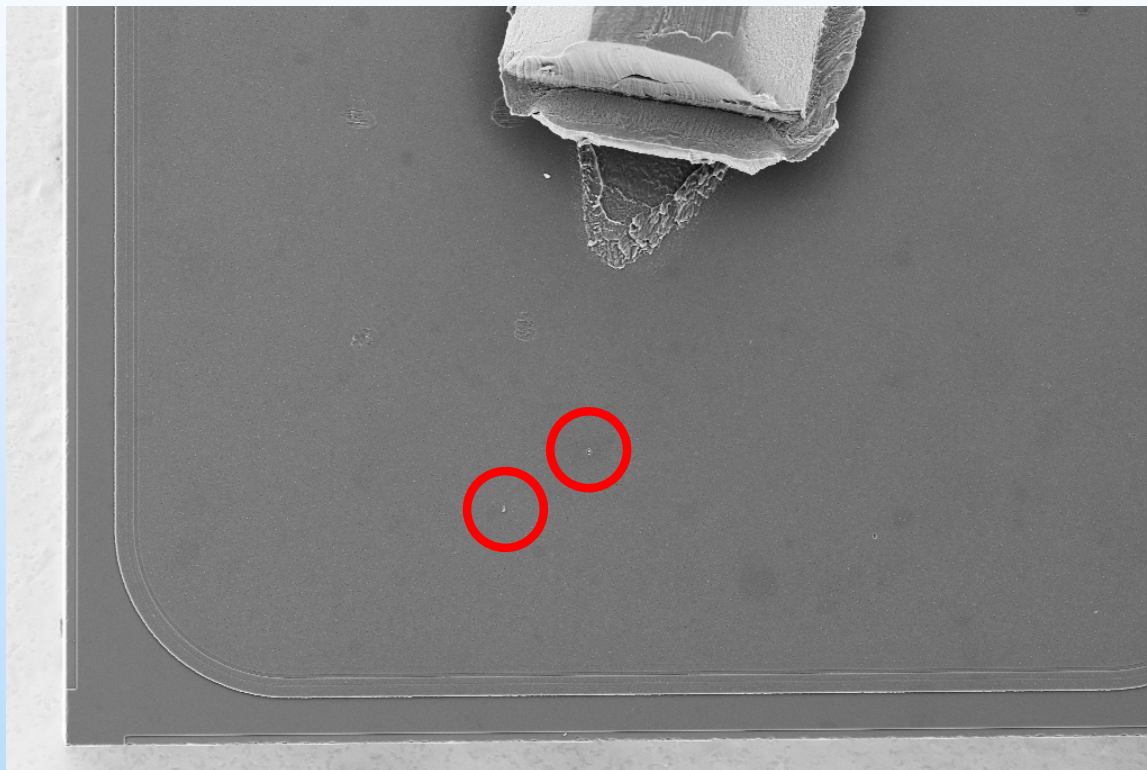
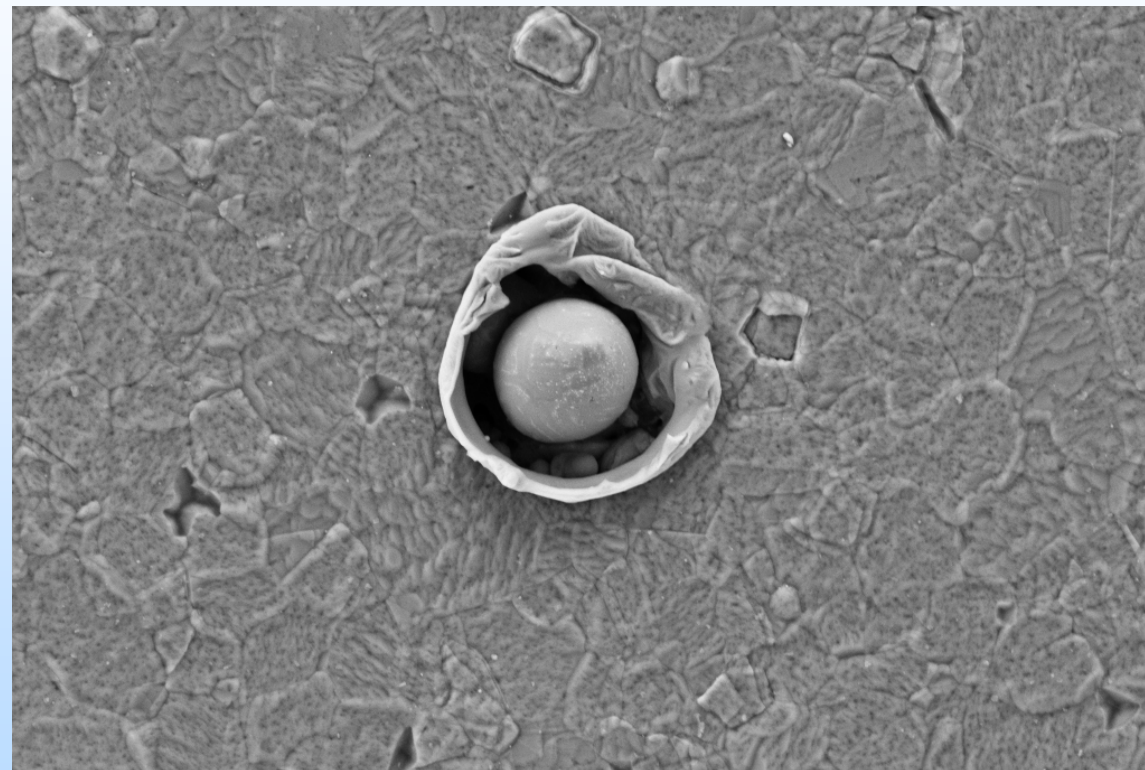
Surface SEMs of Failure Location

Unlike other part that experienced catastrophic failure, location is visible in high-magnification optical images

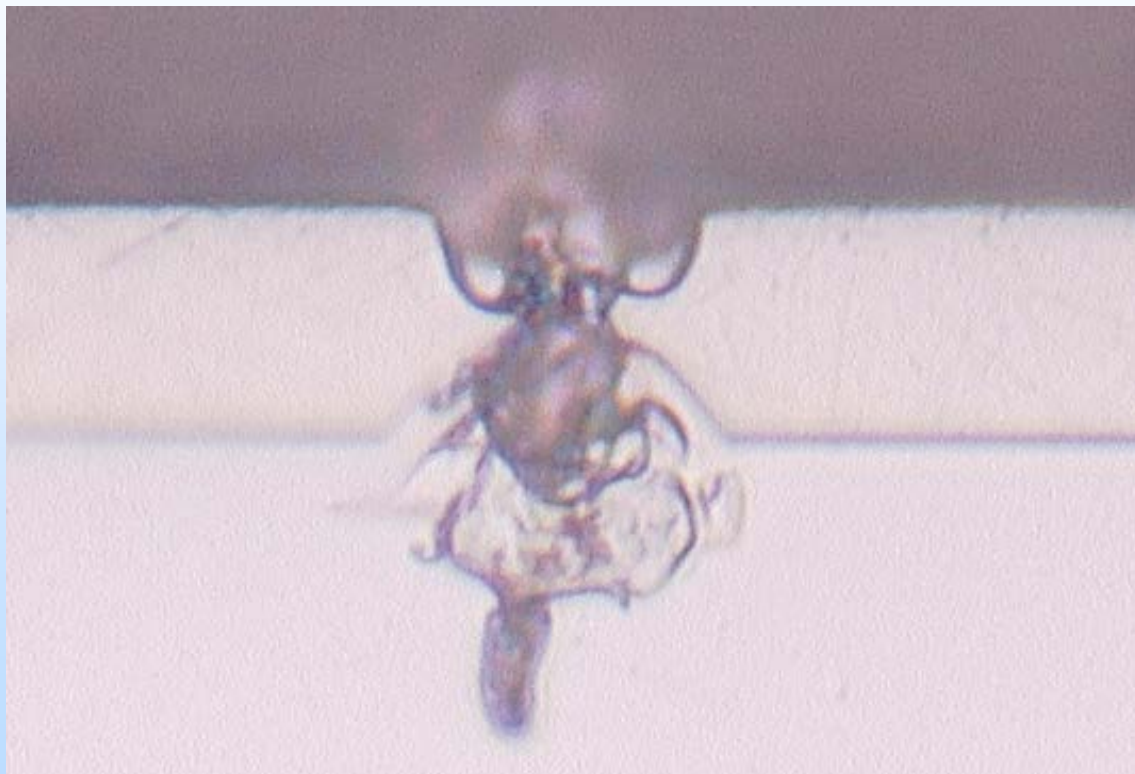
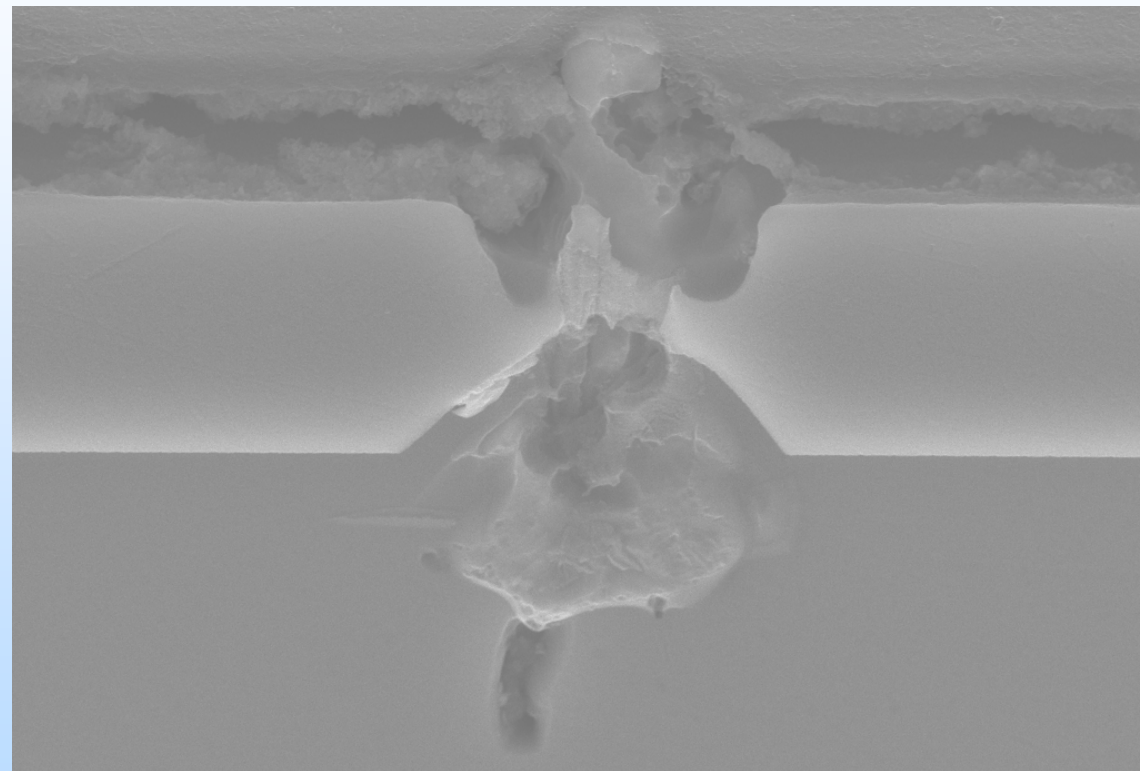
Cross-Section at Failure Location

Metal has clearly displaced from Schottky junction into void  
formed from high current
