## Corrosion of Silver-Plated Copper Conductors

**Abstract** Silver-plated conductors, insulated, with fluorocarbon plastics or aromatic polyimide resin and used in aerospace applications, in both Europe and the United States, have been examined for evidence of red-plague corrosion. Extensive metallurgical investigations have shown that, in the worst cases, 3% of the strands making up the braid cross-section can have some degree of corrosion. Metallography revealed that it had initiated at isolated defects in the silver-plating.

The purpose of this paper is to detail the findings of the metallurgical examinations performed by ESA on cables discovered to have degraded by red plague corrosion. In addition, an extensive laboratory test programme was undertaken in an attempt to gain a more comprehensive understanding of the red plague phenomenon. The aims of this programme will be discussed, as will the results achieved to date. A test method based on the laboratory procedures of Anthony & Brown<sup>1</sup> has been developed into a draft ESA specification, which is thought suitable for the acceptance-testing of fabricated wires and cables.

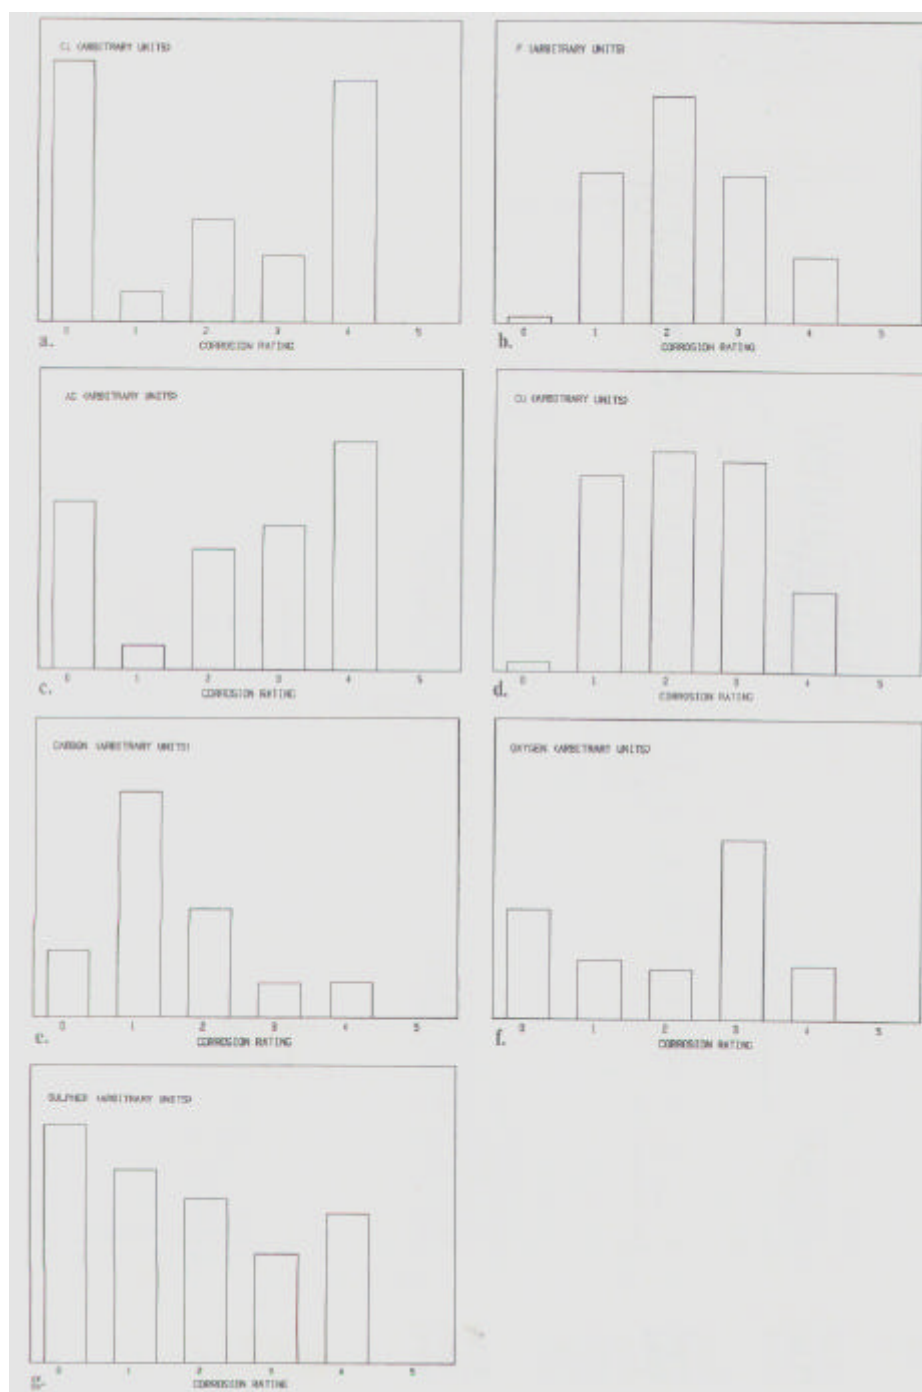
Figure 12a g. Influence of individual contaminants on the corrosion rating

The influences Of Surface elements on the corrosion ratings of wires and cables are shown in Figures 12a-g. This graphical presentation highlights two unexpected findings:

- High amounts of C1<sup>+</sup> are present with corrosion ratings of 0 and 4, whereas the intermediate ratings are connected to low amounts of C1<sup>+</sup>
- F<sup>-</sup> apparently does not contribute to strong corrosion.

A possible explanation is thought to be that chlorine and fluorine have different influences on the metals present.

programme (Fig. 12). When the graphs for chlorides and fluorides are considered, it is tempting to assume that the chlorides have protected the silver-plated copper strands against corrosion, but once a defect in the plating is present they increase the apparent amount of corrosion. The fluoride graph shows the reverse effect of corrosion behaviour.

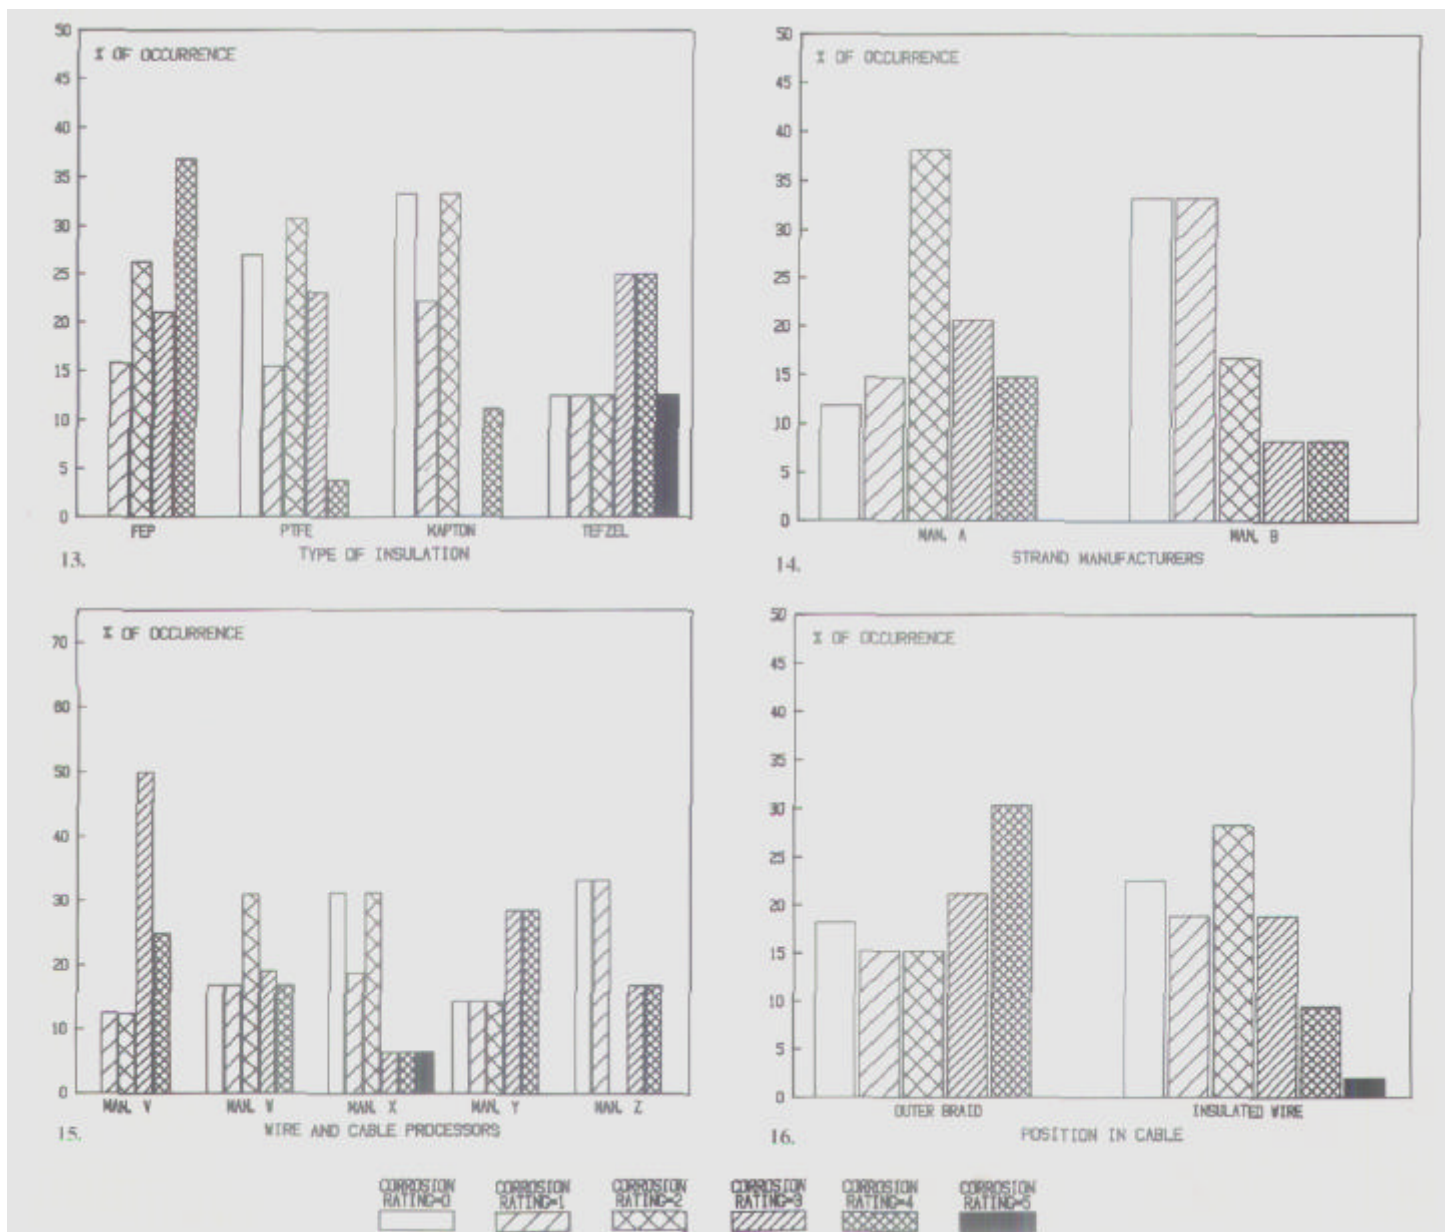
**Figure 16. Positions of strand in cable and corrosion rating (for silver-plated strands). 'Insulated wire' includes inner conductor of cables and hook-up wires**

The influence of strand position - whether braid or stranded wire - is illustrated in Figure 16. It seems that the accelerated test is likely to produce slightly more corrosion on the braided strands than on the inner conductor. The amount of air trapped within the insulations depends on both the construction of the cable and the method by which the insulation is applied. The braids are surrounded by a far greater volume of air than the inner conductors, thus permitting the ingress of greater quantities of oxygen and moisture during the test exposure.

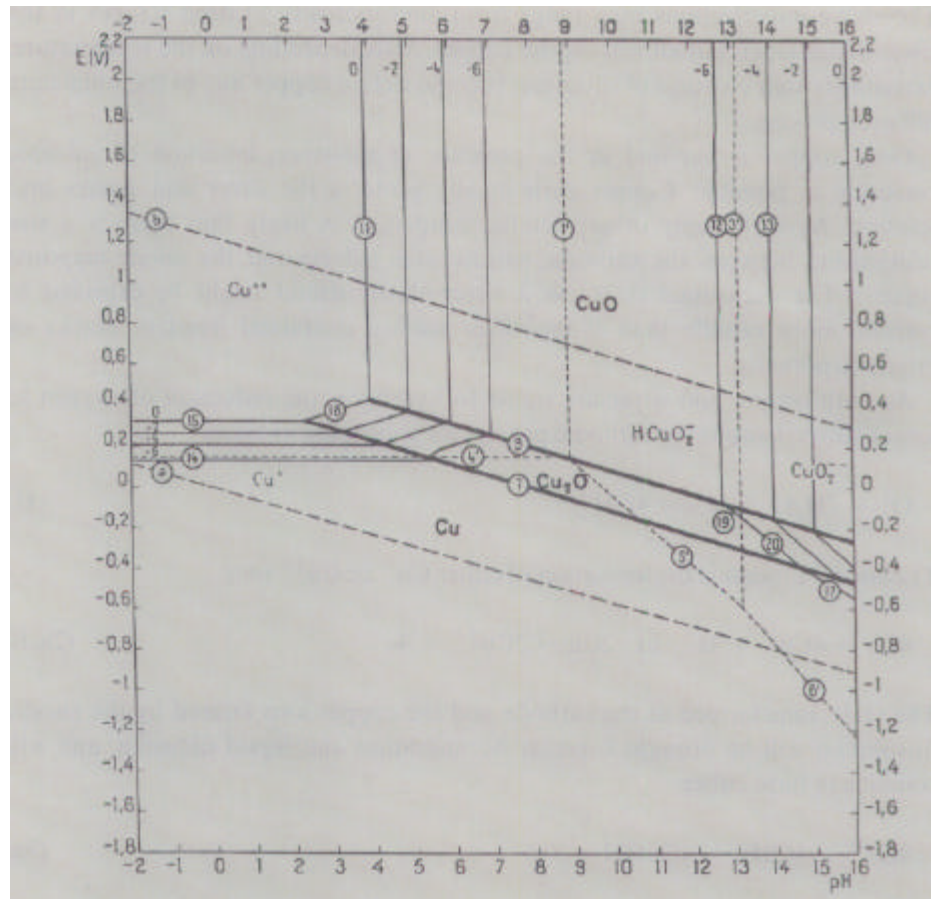
Figure 23. Pourbaix diagram for copper-water system

At high partial oxygen pressures, the corrosion potential in the copper-water system is close to the open-circuit potential of the cathode and hence the potential is shifted to more positive values, and according to the Pourbaix diagram (Fig. 23) the black cupric oxide ( $\text{CuO}$ ) is the stable phase. At low partial oxygen pressures, the corrosion potential is near the open-circuit potential of the anode. This value is more negative and according to the Pourbaix diagram the red cuprous oxide ( $\text{Cu}_2\text{O}$ ) is more stable. These factors will account for the observations made during the accelerated Anthony & Brown corrosion test, that when corrosion does occur

- the end exposed within the flask has a black (self-sealing?) oxide, and
- the centre part (exposed to a lower partial oxygen pressure) corrodes more extensively due to the formation of red cuprous oxide.
