GODDARD SPACE FLIGHT CENTER

Evaluation Report

Microcircuit (24)
Mfr.: Hitachi
P/N: 58V1001T25
D/C: 9538

Project
PEM
System

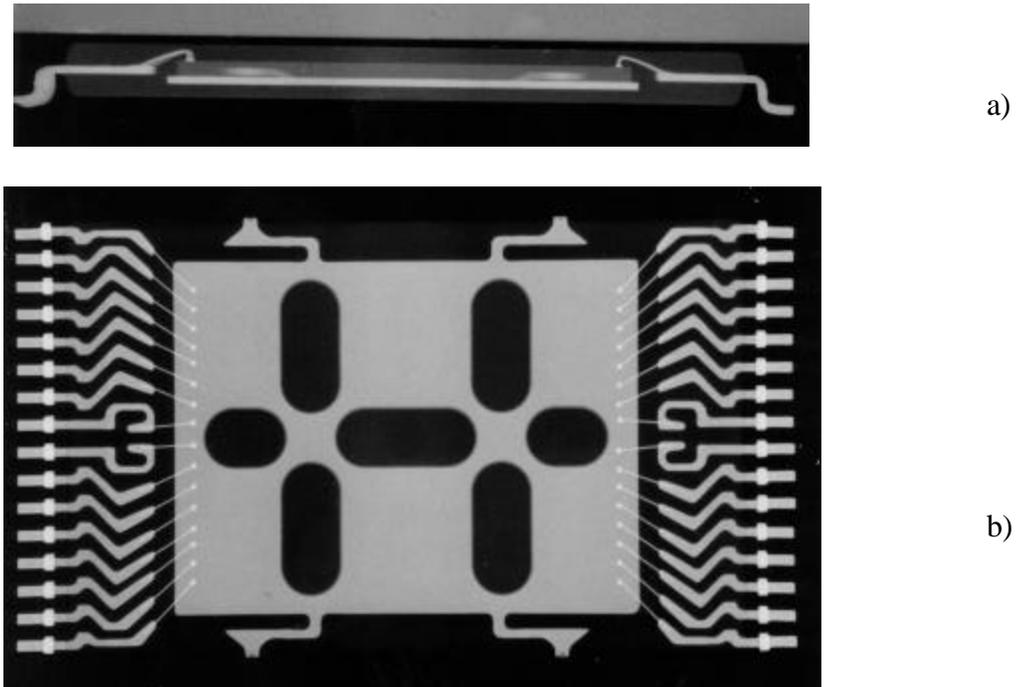
Figure 2. Side view of the package. (50X)

All samples were subjected to external microscopic examinations (e.g. see Figure 1). No package warping, cracks, voids, or foreign inclusions in the plastic encapsulant were found. Practically all parts had gaps between the lead frame support bar and the molding compound on the side of the package (see Figure 2). Cross sectional examinations showed that these gaps were shallow and did not extend into packages more than 150-250 μ . Radiographic examination showed adequate wire bond dressing. Typical top and side X-ray views are shown in Figure 3. The die-paddle had holes which were probably designed to reduce voiding in die attach material, to enhance adhesion between the molding compound and lead frame, and to provide stress relief for the large die.

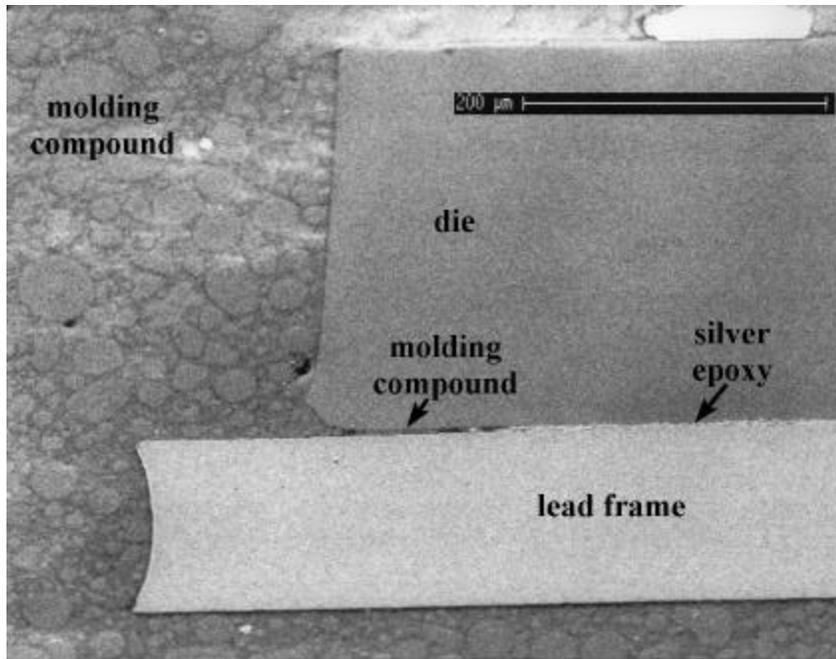
Figure 11. General SEM view of the cross section, SN 34, plane 6. (199X)

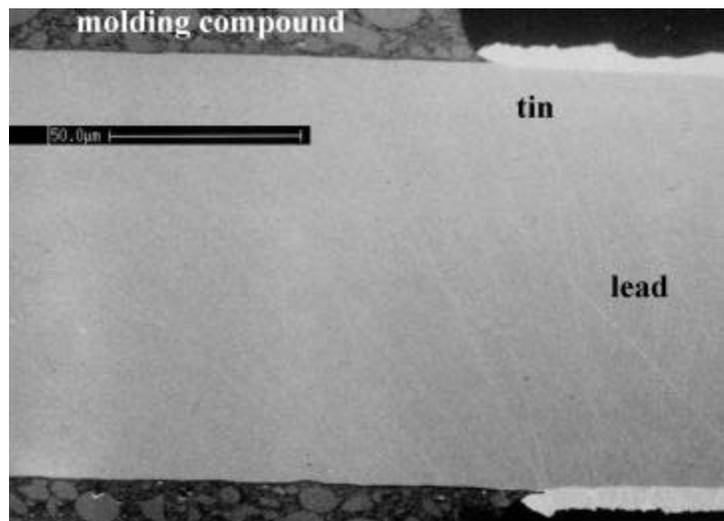
The molding compound was filled with a mixture of a spherical and ground fused silica. Bromine was detected in the EDX spectrum of the molding compound indicating a brominated epoxy resin. Particles of several micrometers in size were found embedded into the polymer matrix. EDX analysis revealed antimony (Sb) and oxygen (O) in their composition indicating most likely antimony trioxide, which is used as a flame retardant. The molding compound had no cracks or big voids and formed intimate contact to all internal surfaces (die, wires, and lead frame). No gaps and/or delaminations were observed along the molding compound-lead frame interfaces (see Figures 11 and 12). Iron (Fe) and nickel (Ni) were detected in the lead frame composition indicating an Alloy-42 lead frame. External parts of the lead frame were tinned.

Figure 12. SEM view of the molding compound-to-lead frame cross section, SN 34, plane 4. (580X)
