# Reliability Evaluation of PEMs Rejected During C-SAM Examination

**Alexander Teverovsky**

Parts, Packaging, and Assembly Technologies  
Office, Code 562, GSFC/ QSS Group, Inc.

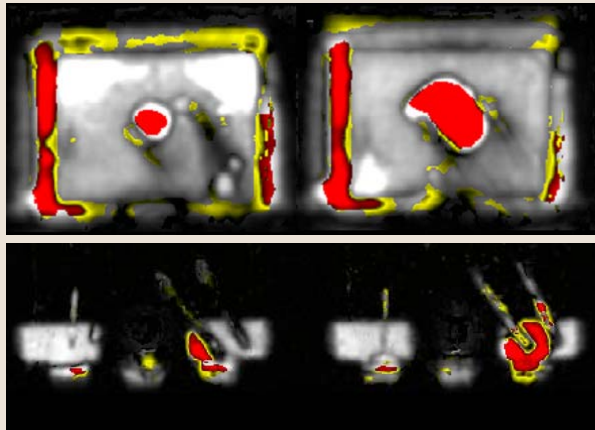
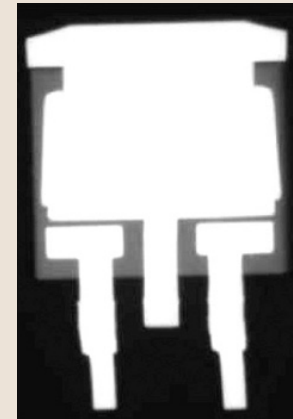
FETs 1 and 2 have  
Al wire bonds.  
Characteristics of  
molding compound:  
 $T_g = 165\text{ }^\circ\text{C}$   
 $\text{CTE1} = 21.5\text{ ppm}/^\circ\text{C}$

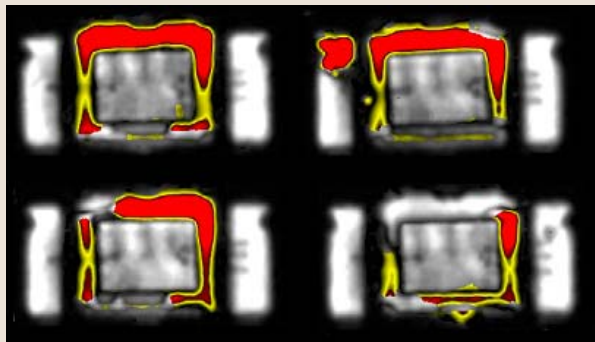
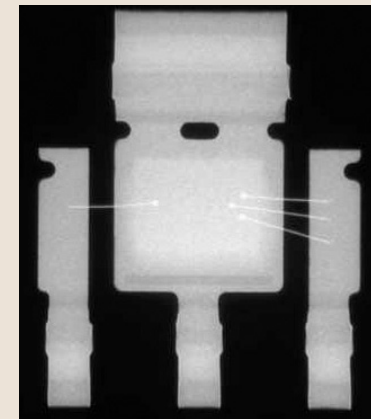
FET3 has  
Au wire bonds.  
Characteristics of  
molding compound:  
 $T_g = 155\text{ }^\circ\text{C}$   
 $\text{CTE1} = 16.4\text{ ppm}/^\circ\text{C}$
