ISS Fiber Optic Failure Investigation

Root Cause Report

August 1, 2000

**ISS Fiber Root Cause Investigation Team
Lead organization NASA GSFC
Sponsored by: NASA JSC and the Boeing Company**

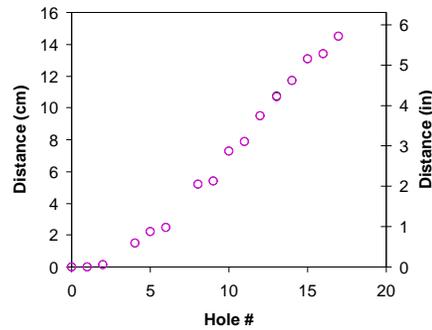
Figure 14 Distribution of Features Along a 6” Sample of CD0588XD Fiber

The arrangement of the bubbles and depressions were found to be in a fairly straight line and parallel with the longitudinal axis of the fiber. Figure 14 is a plot of the distribution of the features along the length of one of the “588” samples.

Aeolian motion may be occurring with the fiber in the draw tower. Using equations (4) and (5), one can predict the periodicity of defects which may be coincident with the resonant frequencies of the fiber in tension. The draw speed being known, we can determine that the defects spaced as shown in Figure 14 move past a fixed point at a frequency of 33 to 83 Hz.

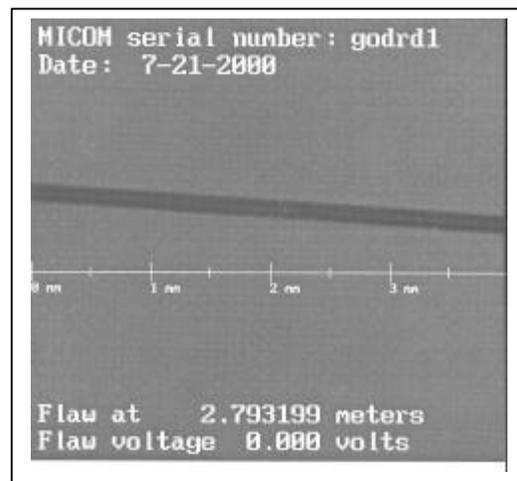
Figure 18 Cleaned Fiber

A fiber inspection system, built by the US Army Aviation & Missile Command for their own internal use, was used to try to inspect for 10 μm sized features in the polyimide surface that might indicate the presence of the bubble feature that has been consistently associated with "rocket engine" defects and low strength breaks. The system uses an infrared detector and looks for signal scatter off of the surface at feature locations. The feature is described with respect to the voltage of the returned scattered signal. When a feature is found that corresponds to a minimum signal voltage, the system takes a picture of the corresponding location. The inspection system is very sensitive to any surface feature, especially contamination such as lint and dust (Figure 17). A lint free dust capture stage was arranged around the fiber and the inspection was continued. Figure 18 shows the image of a debris-free fiber with polyimide surface features.

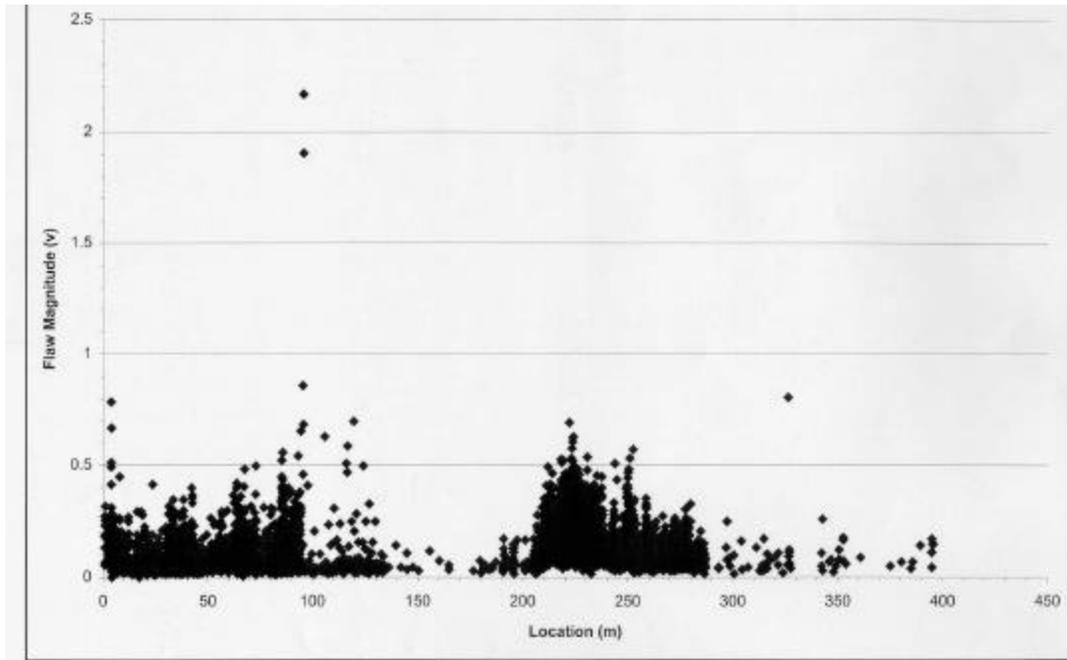
Figure 19 Feature Statistics for CD0588XD

To see if, using a more typical inspections speed, 0.5 m/sec, the machine could provide useful statistics which would differentiate the two reels. Figure 19 and Figure 20 show the results of running approximately 400 m through the machine, looking for a 0.1V feature size or greater. Additional work is required to understand the usefulness of a system such as this to identify defects in the polyimide coating.

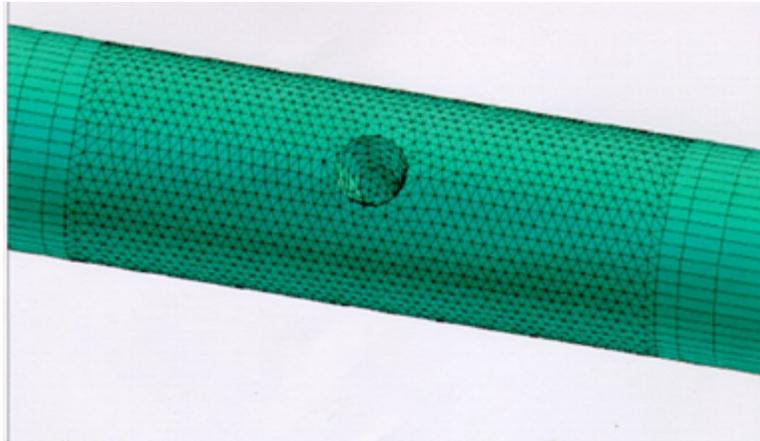
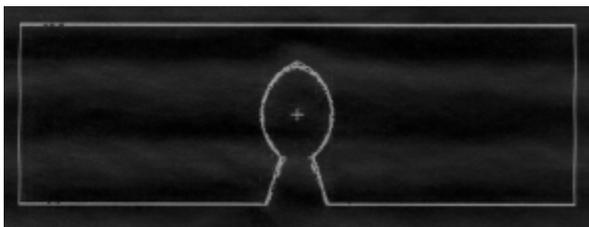
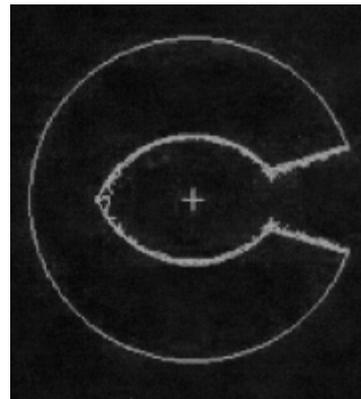
Figure 24 Model of “Rocket Engine” Defect

The shape of the cup in the cladding area reflects the speed at which the reaction occurs in the pure silica material and its increasing speed in the Ge rich material. A FEA model was constructed for the BF04515 fiber to understand the internal stresses in the glass with a “rocket engine” defect when the fiber is under a 25% strain (Figure 24a through c). Figure 25a through c shows that the internal stress in the fiber in this case rises by a factor of three over a section, which is experiencing the same amount of strain with no “rocket-engine” defect.

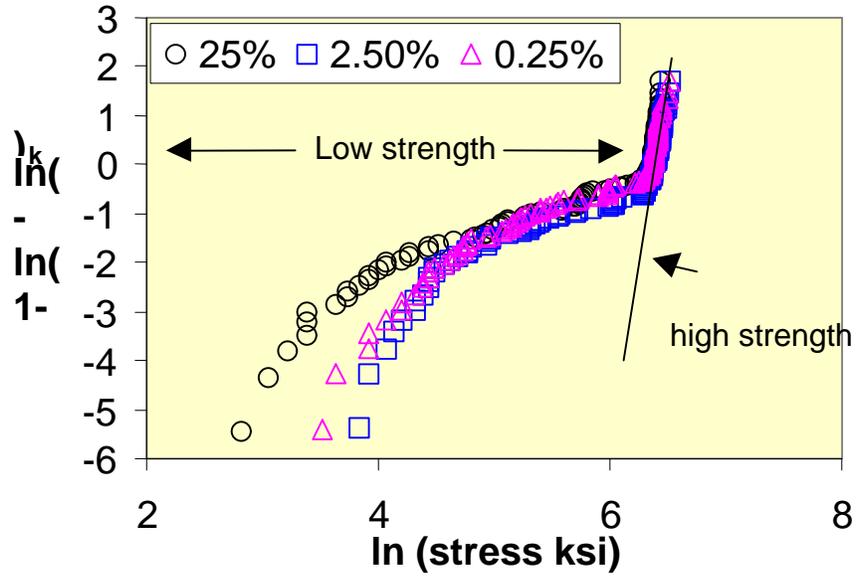
Figure 30 Weibull Plot for Strength of 1996 Vintage Cable from Several Cable Reels

The results of the initial strength tests are shown in the Weibull plots in Figures 30 and 31. Prior analysis showed that the fiber shipped by Lucent-SFT was proof tested to 141 kpsi (@ 3.36 lbs). The cable specification requirement is for a fiber strength of 200 kpsi (@ 4.76 lbs). Lindholm, et. al., report strengths of 500 kpsi (11.90 lbs) and higher for four carbon coated fibers they have manufactured. The plots showed the high strength of the cabled fiber to be around 252 kpsi (6 lbs) and the low strength to go as low as 126 kpsi (3 lbs).

The inspections found that defects were present in large numbers that were either small etch pits at the surface of the cladding or corrosion sites in the same location. The knees in the Weibull plots, an associated slopes, show that there is more than one dominant failure mode. According to the physics of glass, the order of the curves should show the black circles (highest strain rate) located to the right of the other curves, not to the left. Figure 31 shows that the distribution of low strength breaks among the reels was significantly different even for reels with the same date of manufacture. These distributions could not be used to quantify the expected life of the cable using classical methods.

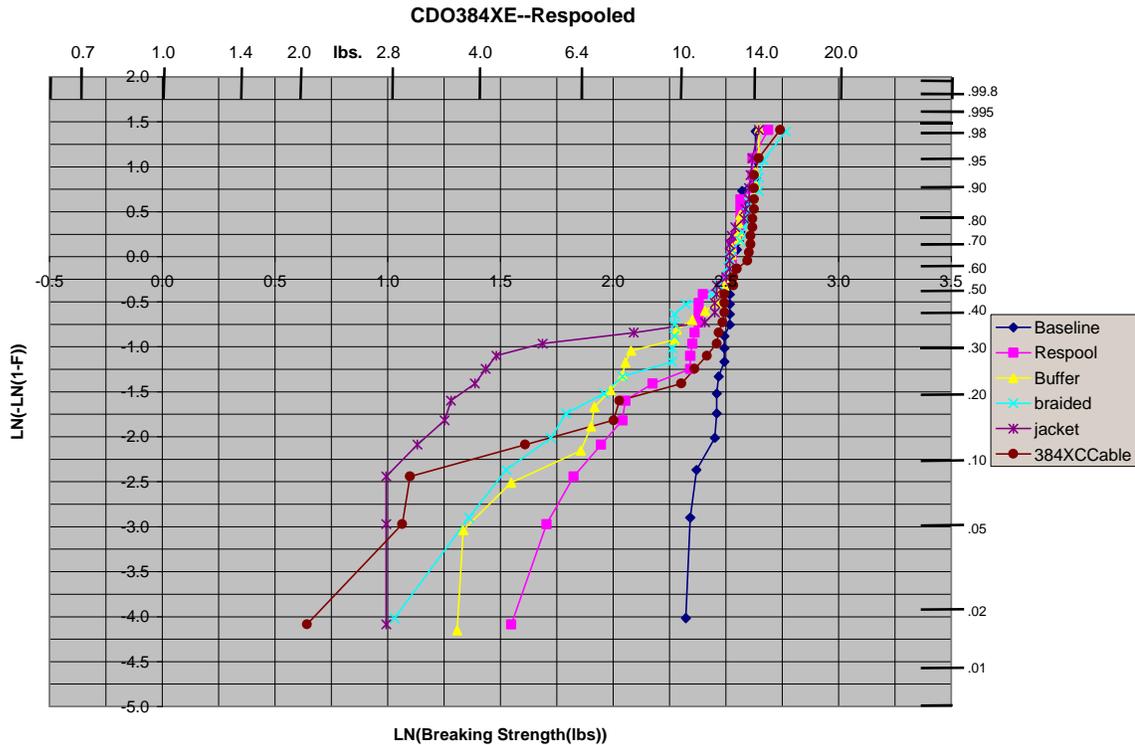
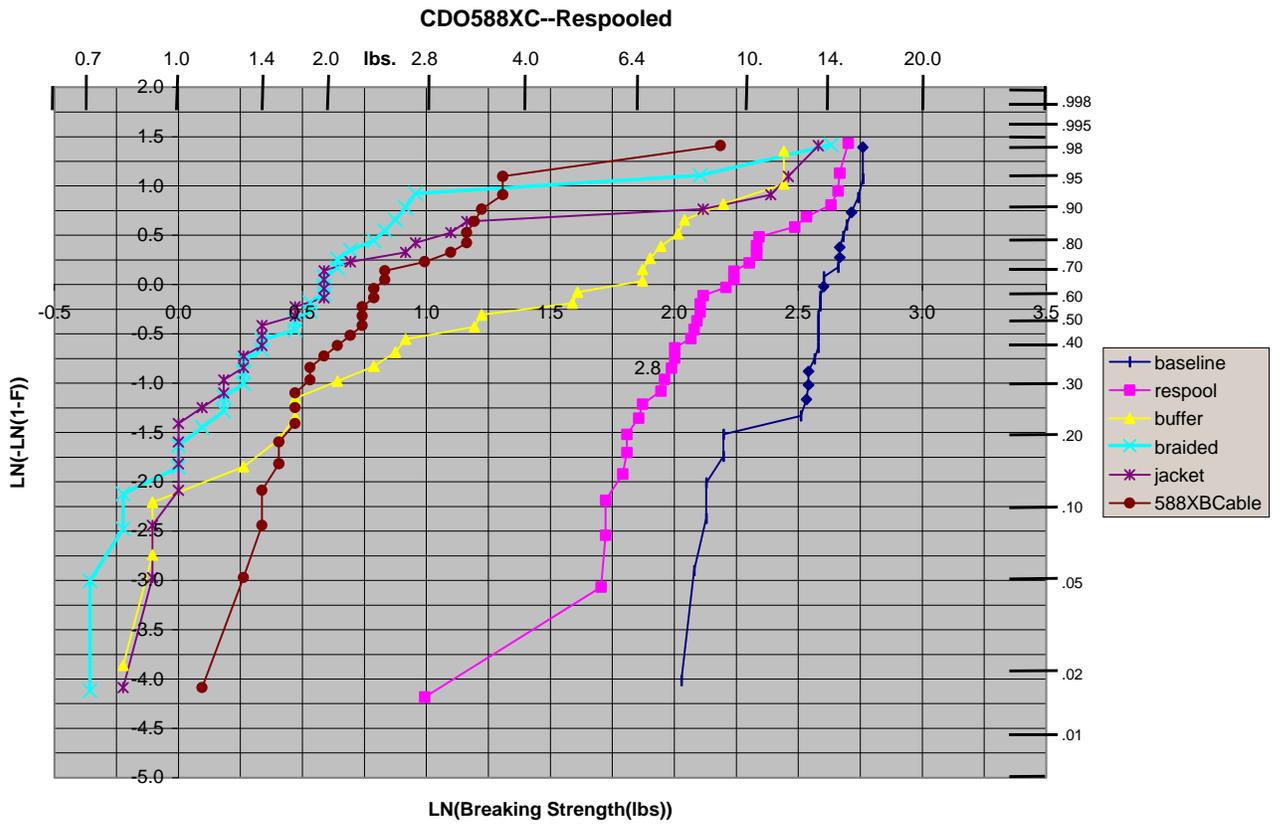
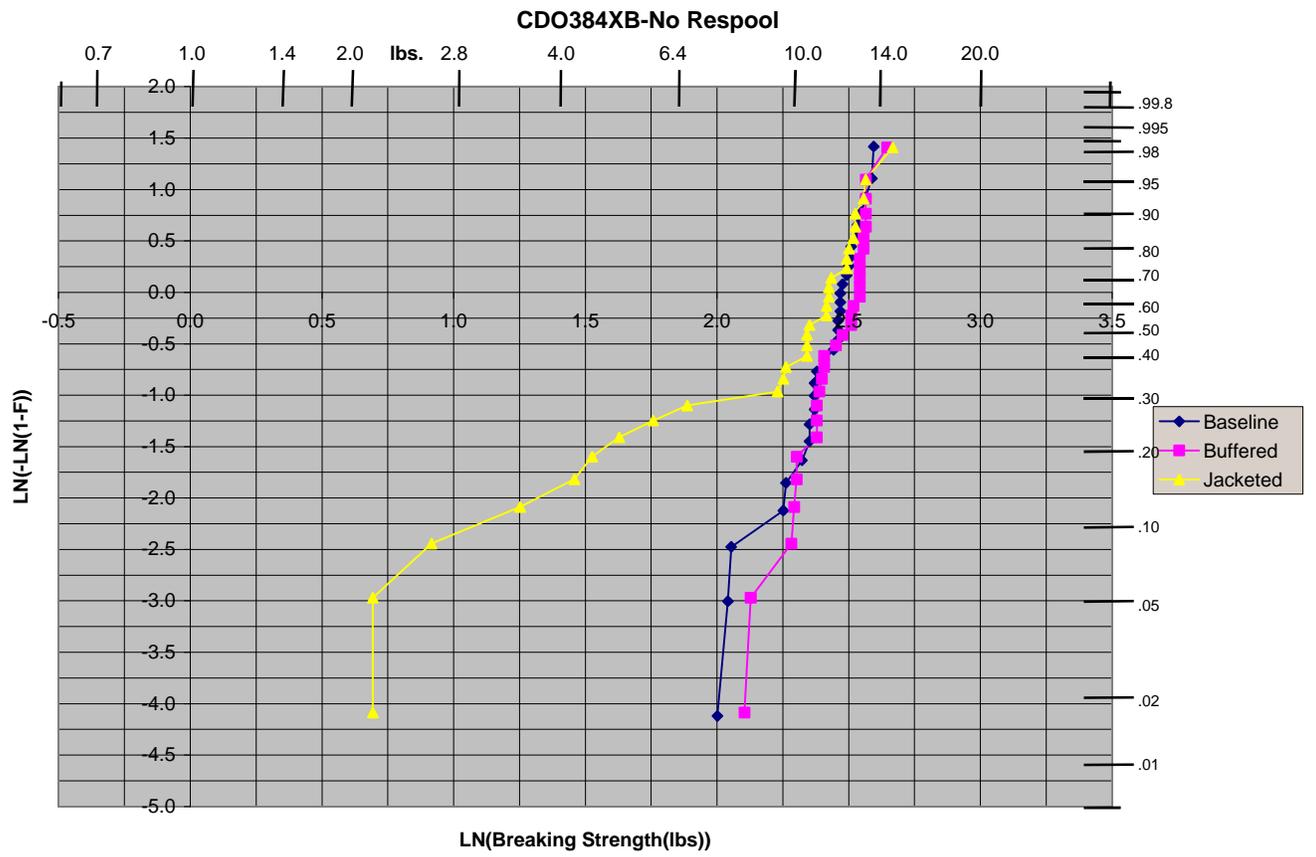
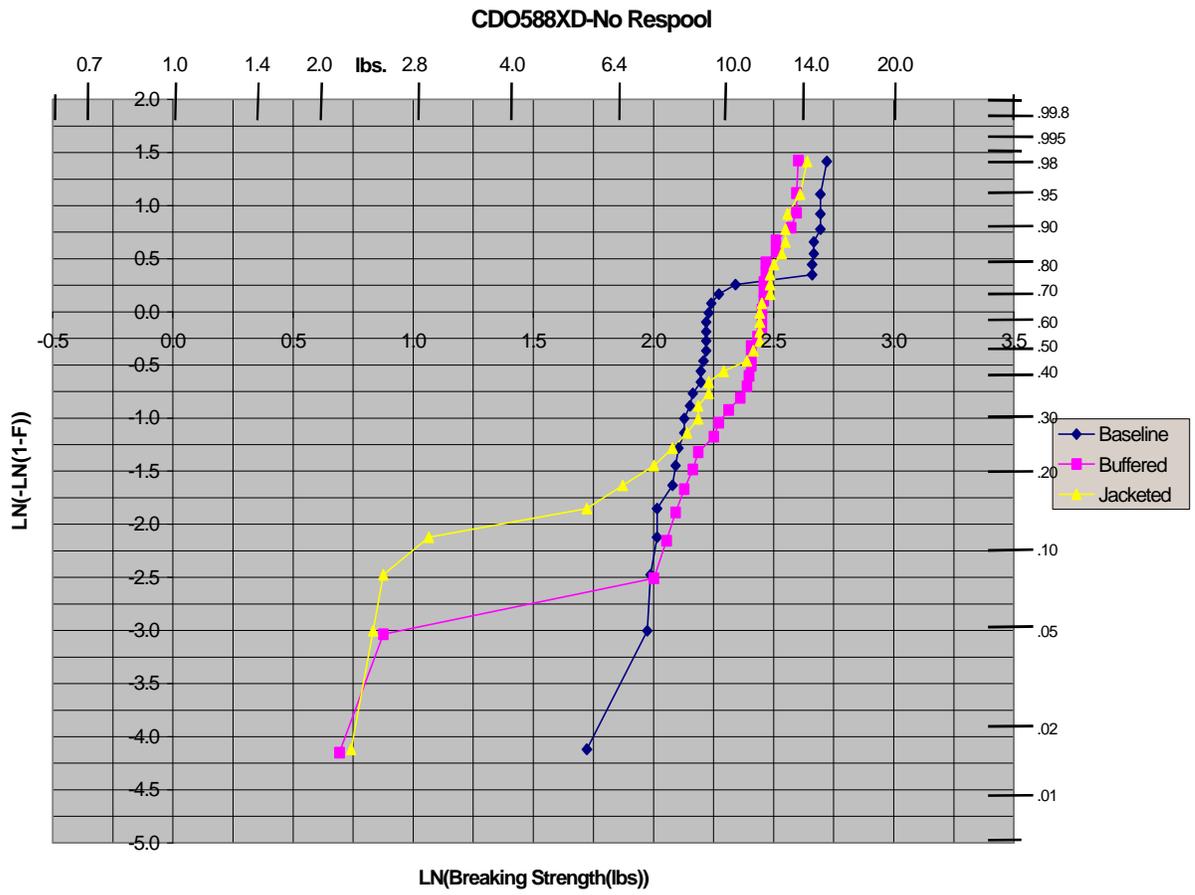
Figure 32 Strengths of DC0384 and DC0588 Fiber During Cabling

The results of the second round of strength testing are shown in Figures 32a through 32d. [ref-22, 23, 24] Figures 33a through 33d show the endfaces of the fibers at the low strength breaks.

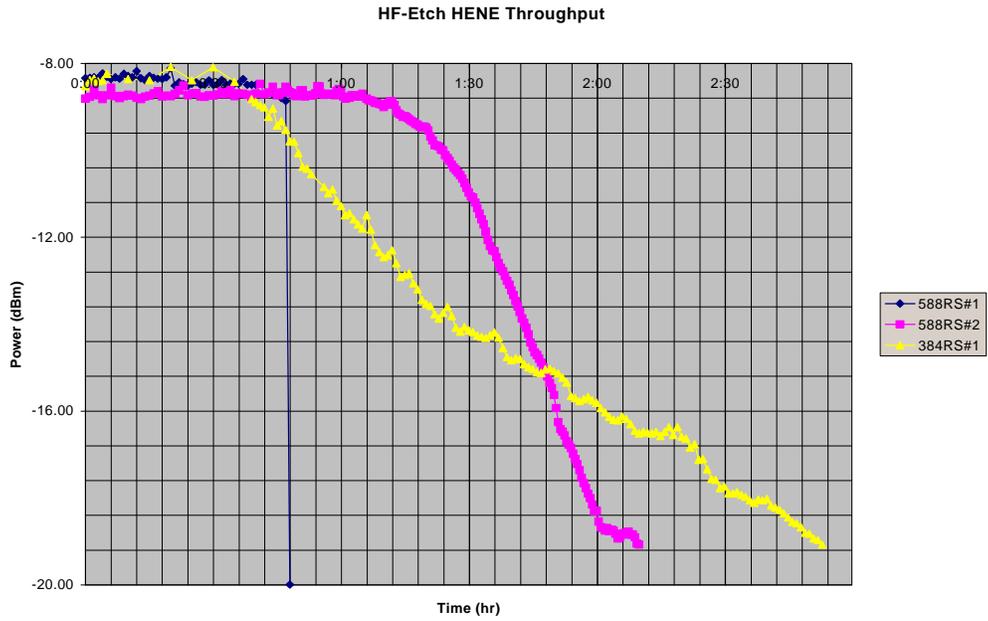
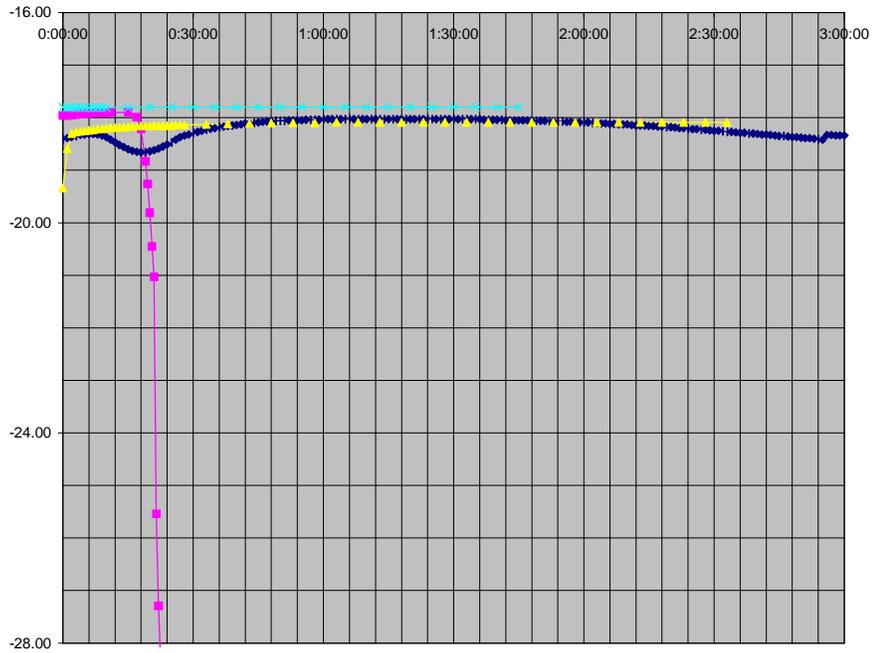
Figure 34 Optical Throughput During HF Etch Test

Exposure to HF was used to try to measure the increase in etch related defects due to the respool and buffering cabling processes. Table 10 shows the results of this testing. The results point again to the propensity of the 588 lot to allow etch related defects versus the 384 lot. The 384 lot in this test, appears to be more robust with respect to defect creation or exacerbation associated with the respooling process. Figures 34a and 34b show the optical throughput during the etching period. [ref-25]

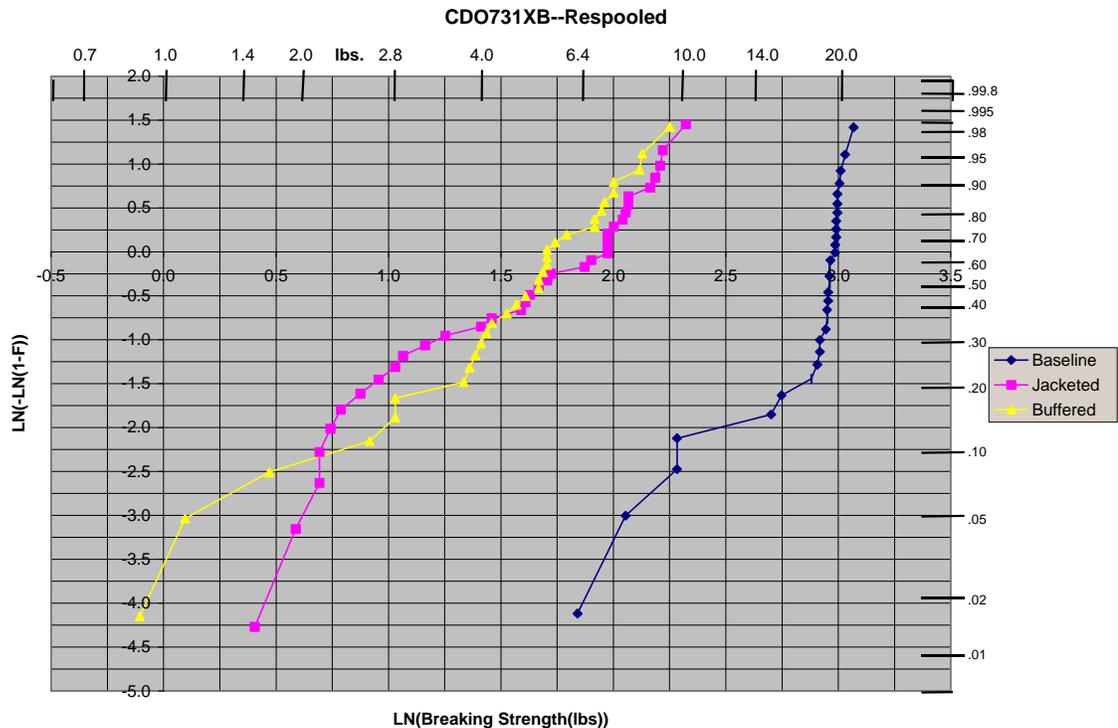
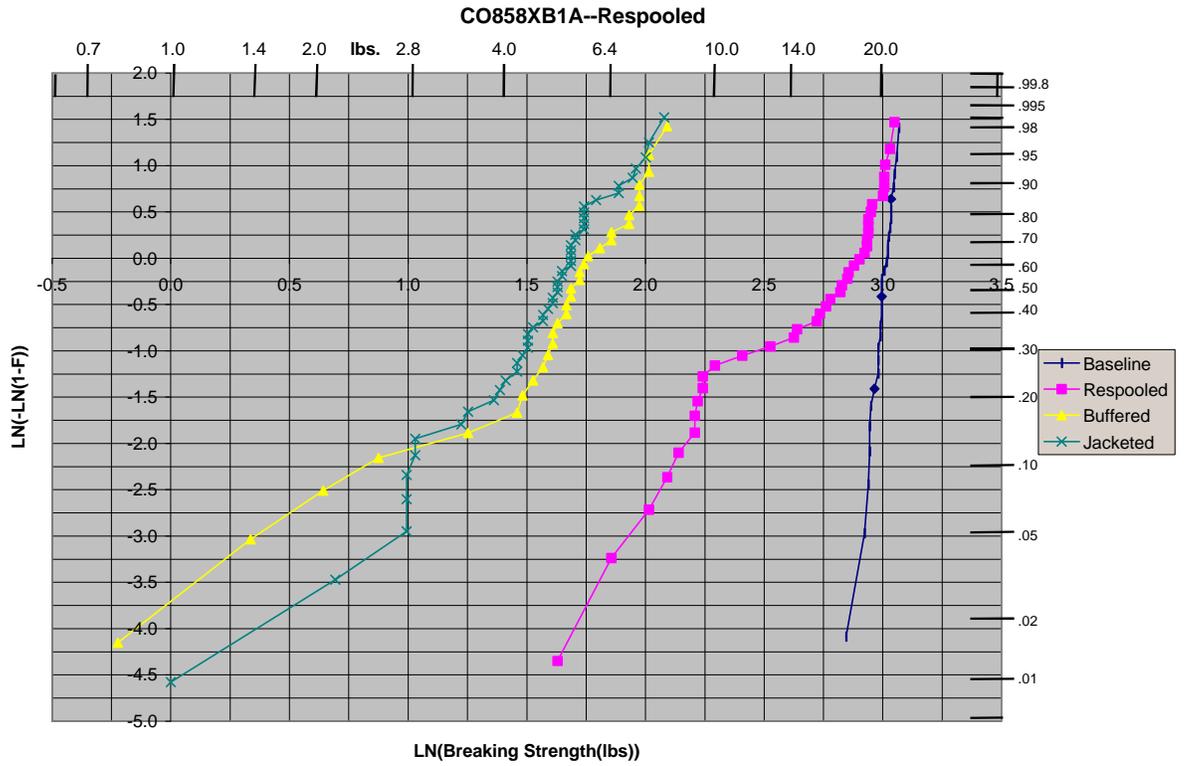
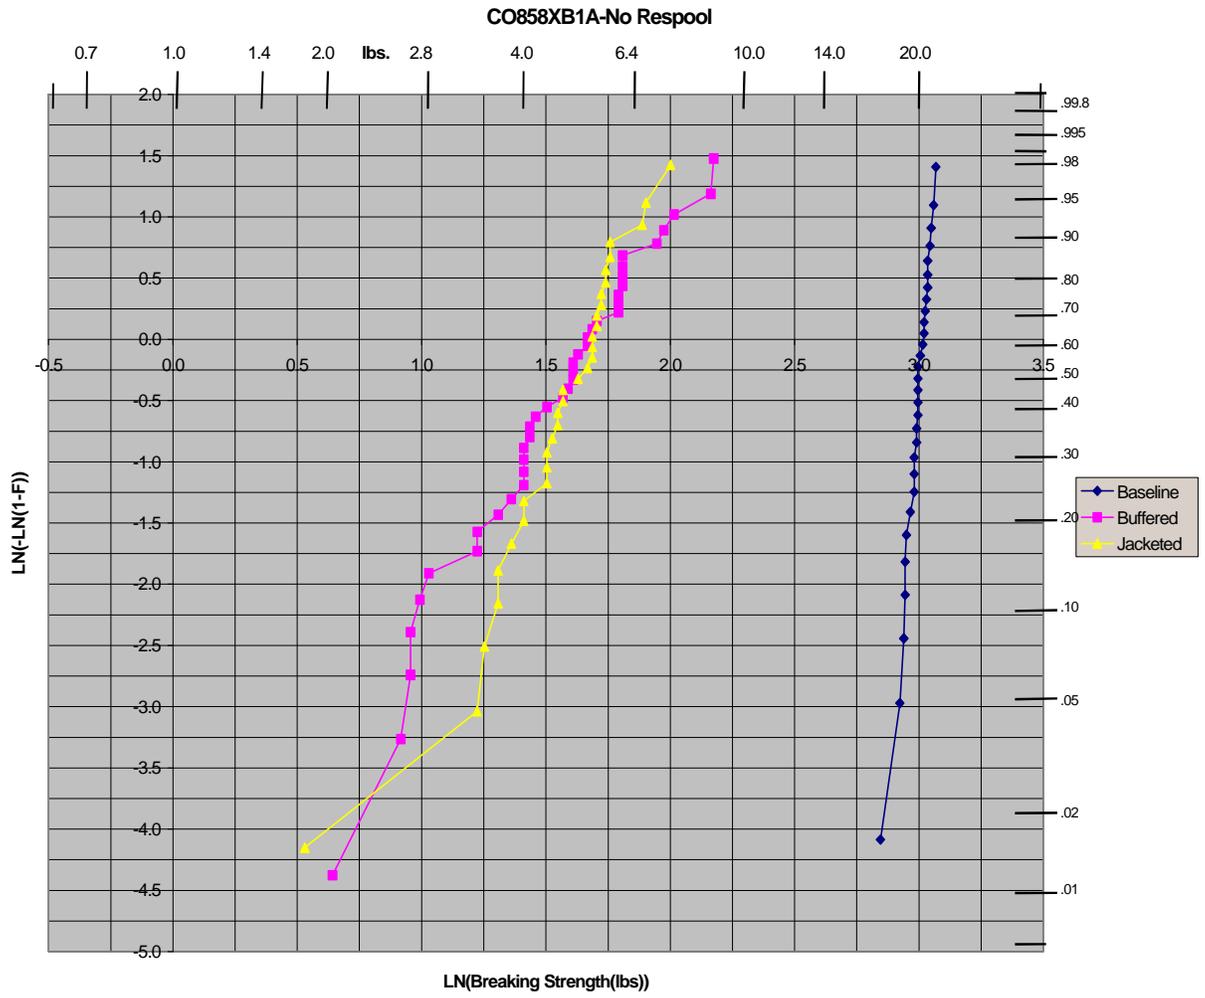
Figures 35 Strength for the Non-carbon Coated Fibers

Figure 35a through 35c show the affect of the various cabling processes on the fiber strength for the non-carbon-coated fibers. The unprocessed fiber has high strength, however as it goes through cabling, its strength is again increasingly reduced. The difference in the behavior between the two non-carbon coated fiber lots is still under study. [ref-26]

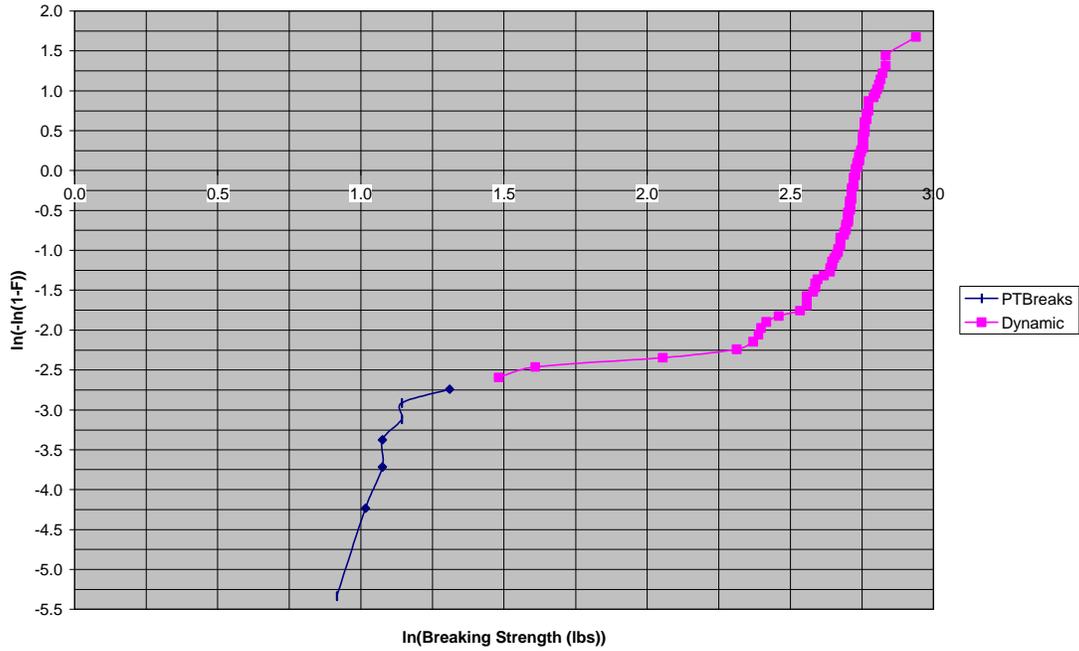
Figure 37 Hypothetical Break Strengths During Screen Compared to Actual Break Strengths on Proof Test Screened Sample

The fracture surfaces of the breaks found in the 04250 sample were analyzed and breaking strengths in lbs were calculated for them. These have been superimposed on the curve of breaking strengths found for the surviving sample, which was strength tested after the mandrel wrap screen. The lower (blue) section of Figure 37 represents the calculated values. The blue portion of the curve in Figure 38 are extrapolated values for the breaks, which occurred during the mandrel wrap screen in the 04245 sample. Figure 39 shows the dynamic strength data alone.
