Jay Brusse and Michael Sampson

Zinc Whiskers: Hidden Cause of Equipment Failure

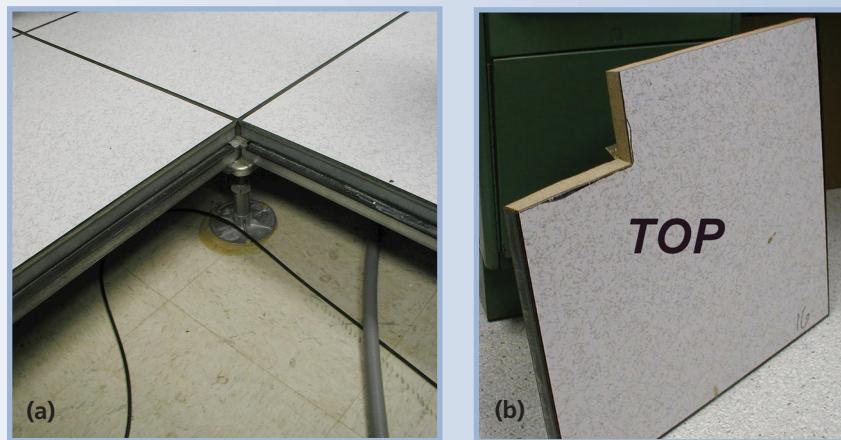
Figure 2. Typical raised-access floor system.

Raised-floor tiles, pedestals, and stringers are often constructed from steel to provide adequate strength. A thin zinc coating—from electroplating or hot dip galvanization (HDG)—is commonly applied to protect the steel from corrosion. This thin zinc film is at risk for forming zinc whiskers over time. Figure 2b shows one type of access floor tile known to form zinc whiskers. Figure 3 shows the tile's underside; a high-intensity light held parallel to the surface reveals what appear to be fuzzy dust-like formations. Closer examination reveals that the dust-like appearance is actually millions of zinc whiskers shown magnified in Figure 1.

A data center floor system with one tile up, permitting a view of the supporting pedestals and stringers; such a raised-floor arrangement facilitates under-floor cable routing. The subfloor space also serves as an air plenum (a). In this top and side view of one type of floor tile (b), cutting a tile reveals a vinyl top surface attached to a 1 inch thick wood fiber core. The core has a thin sheet of zinc-electroplated steel attached to its bottom and sides.
