Solder Reflow Failures in Electronic Components during Manual Soldering

Perot Systems/NASA GSFC, code 562,
Parts, Packaging, and Assembly Technologies Office

Purpose and Outline

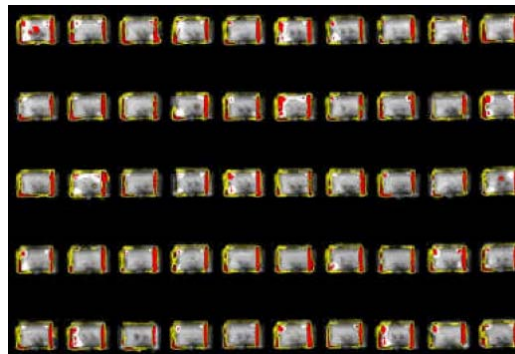
Typical CSAM images

- ❑ Three power FETs in plastic surface mount packages (D2Pak) failed short circuit after manual soldering onto a board.
- ❑ The parts passed screening including 100% C-SAM inspection.
- ❑ Failed parts had top-of-die delaminations.

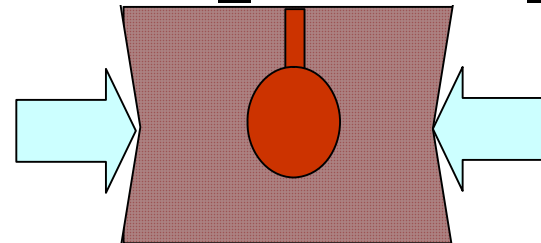
Molten solder does not wet glass/ceramic/plastic and should be pressed to flow in a gap by internal or external forces.

- ❑ Internal force: compressive stresses develop if expansion of solder > expansion of MC.

- ❑ An external force during soldering might result in molten solder filling the gap even at CTE_{MC} > CTE_{solder}.

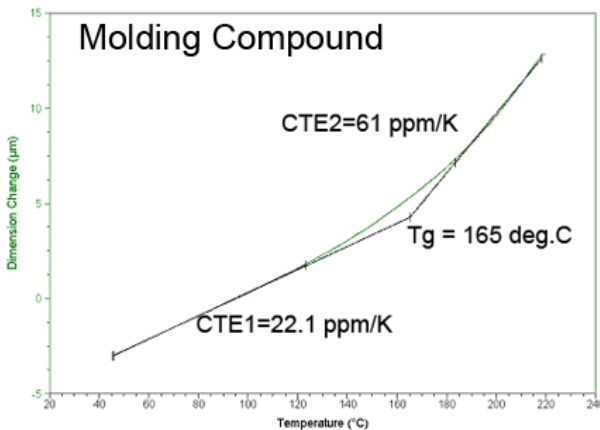
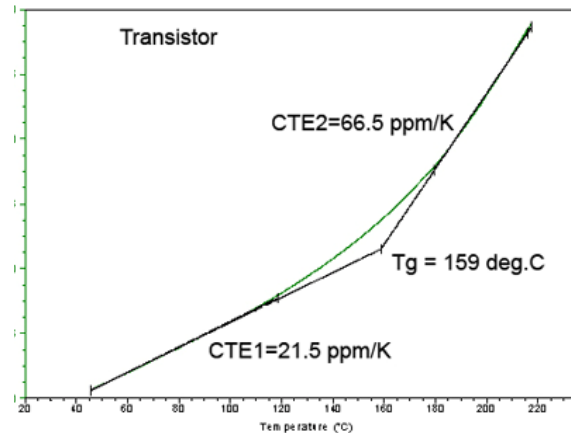
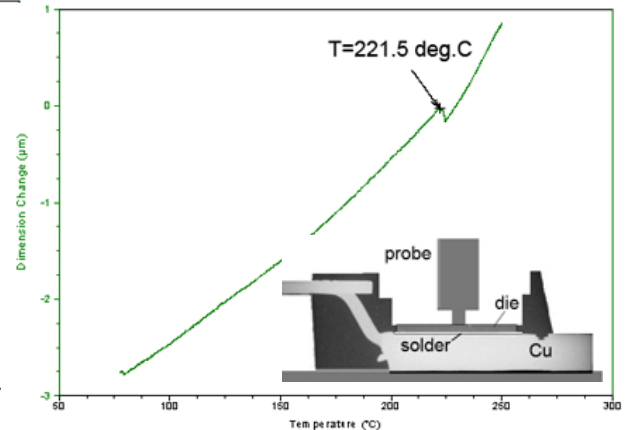
Average TMA characteristics

Deformation vs. temperature was measured on MC, transistors, and with a probe installed on a die (after decapsulation).

Probe-on-a-die measurements confirmed that a high-temperature tin-silver solder with a melting point of 221°C was used.

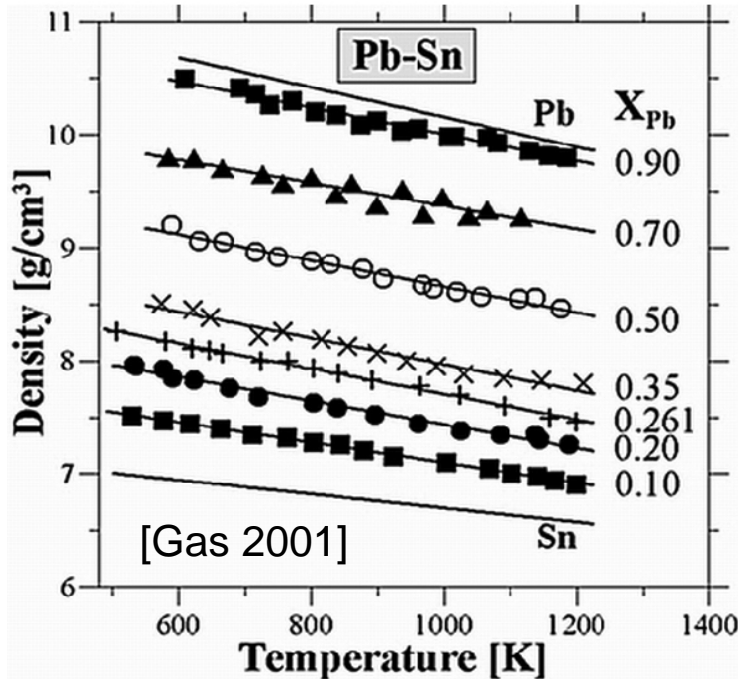
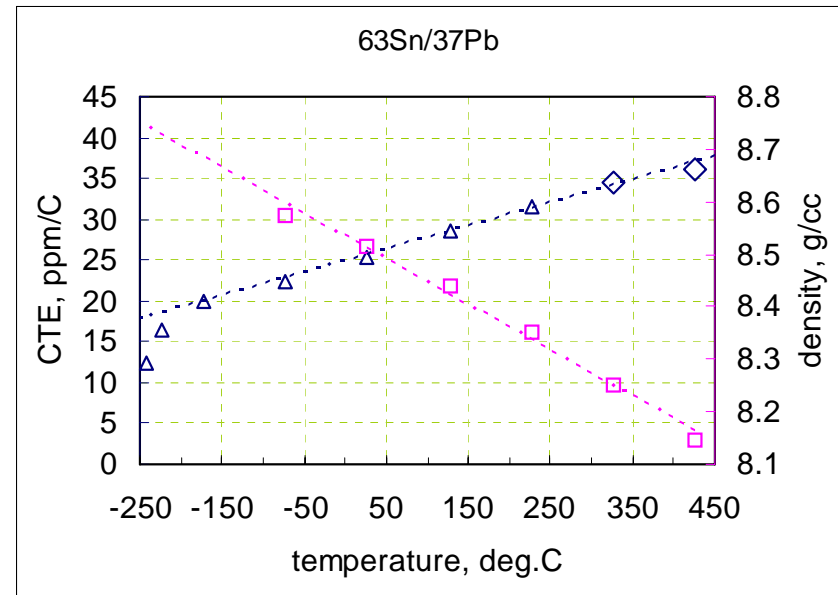
Temperature Deformations in Solder

Available literature data on solder expansion were used for best-fit estimations of CTE and density at $-65 < T < 450$ °C.

Molten near-eutectic solder has
CTE = 34.5 ppm/K.

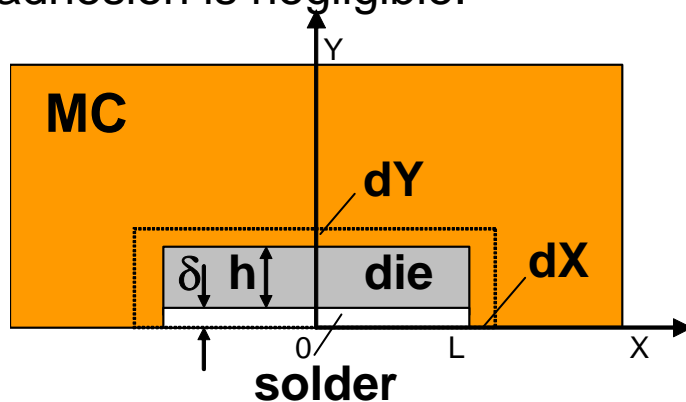
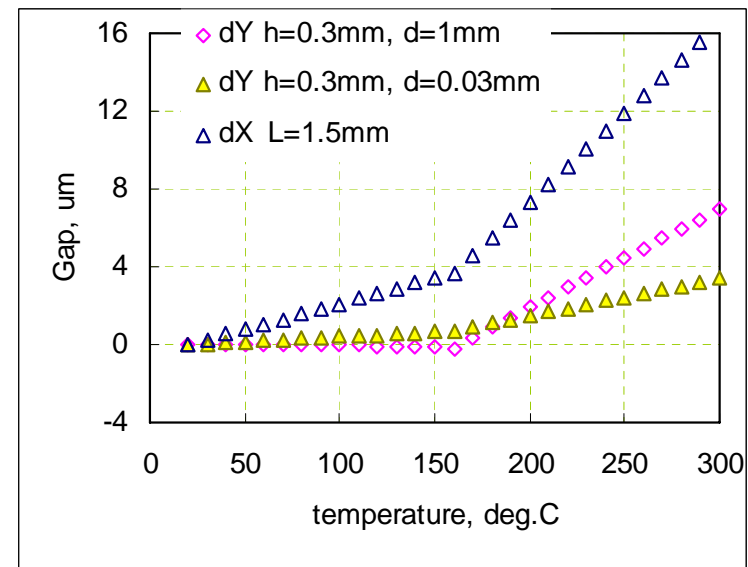
Delamination During Soldering

A size of MC/die gap, ΔY , was calculated assuming that at RT $\Delta Y=0$ and adhesion is negligible.

Compressive stresses ($\Delta Y < 0$) might occur at very thick layers of solder ($\delta \sim 1\text{mm}$) only.

- Heating of the package uniformly creates enough room for solder expansion and no reflow failures should occur.
- Power FETs are designed for SMT for oven reflow soldering at $T \sim 250\text{ }^\circ\text{C}$ (up to 30 sec.), which exceeds $T_m = 221\text{ }^\circ\text{C}$.
- Heating to melting temperature is a necessary by not a sufficient condition for reflow failures.

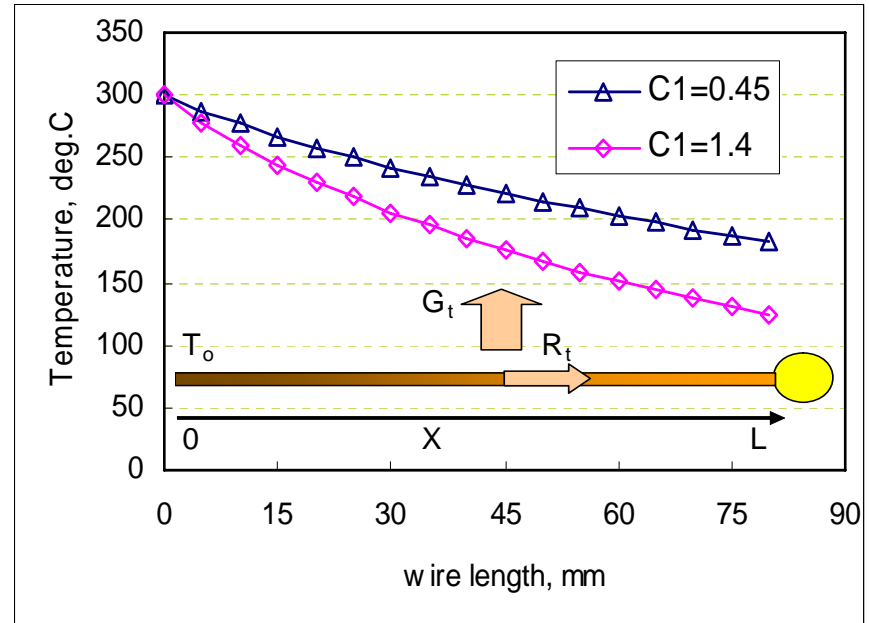
Effect of Wire Length

- ❑ At a specified conditions a soldering iron is set to $T_o = 300$ °C and at $L = 76$ mm $T_{\text{sensor}} < 180$ °C (no melting).
- ❑ Cutting leads to ~1" will increase T_{sensor} to 220 to 250 °C and might cause solder reflow failures.

- ❑ Reducing the length of wires increases die temperature. Special care (thermal shunts) should be taken to avoid solder reflow failures.
- ❑ Avoid holding or touching plastic packages during soldering.

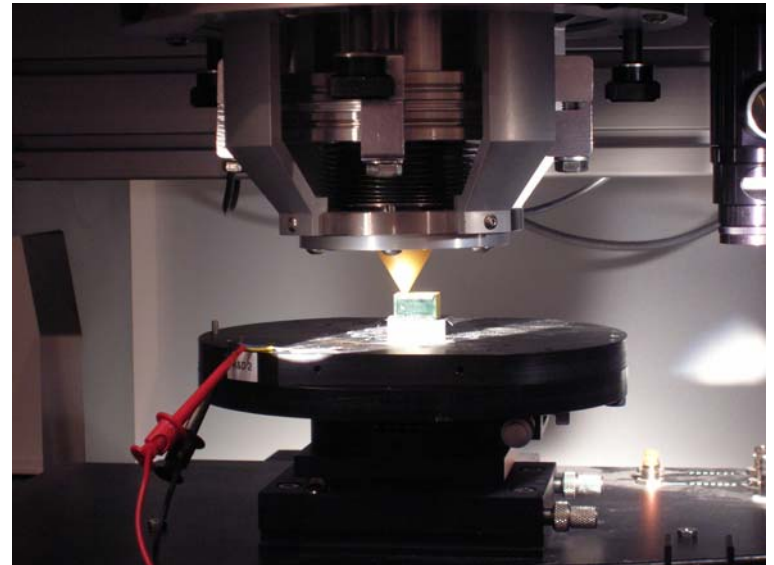
Magnetic Current Imaging with SQUID

- ❑ MCI with a superconducting quantum interference device (SQUID) probe (NEOCERA) was used to locate the defect.
- ❑ Maximum current of 2.7 mA, 533 Hz, was applied to the sample.
- ❑ The technique allows for current density mapping by scanning magnetic field at a distance from the surface $\sim 100 \mu\text{m}$.
- ❑ SQUID is effective to depth of several millimeters.

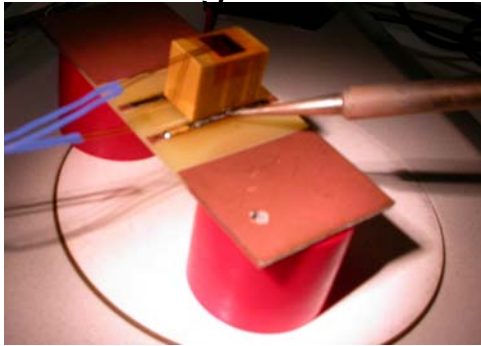
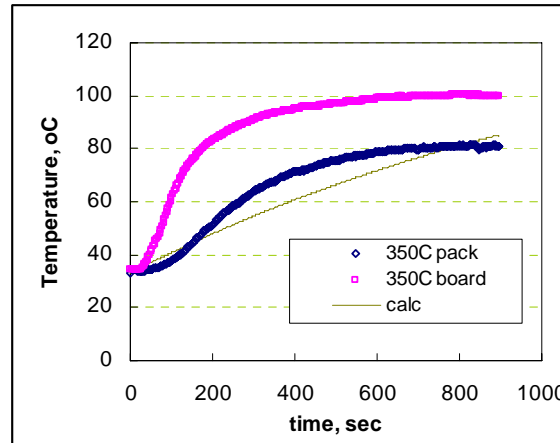
Soldering simulation.

- ❑ *Overheating during soldering (soldering iron was set to 371 °C).*
Experiment showed that possible T rise do not exceed 80 °C.

Experimental (marks) and calculated (line) temperature variations. The soldering iron was fixed at the middle of contact pads.

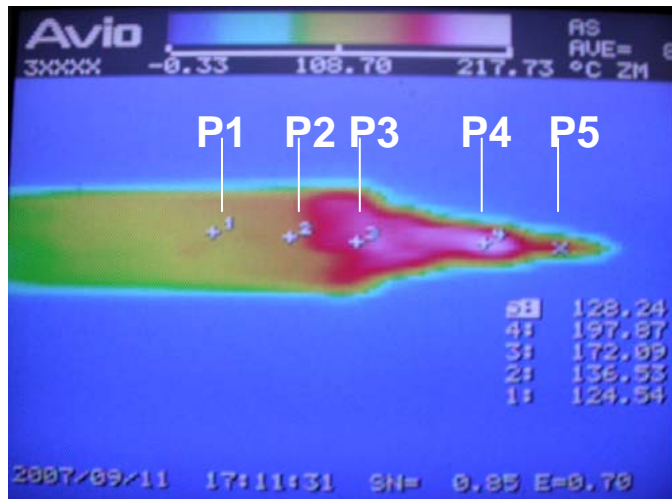
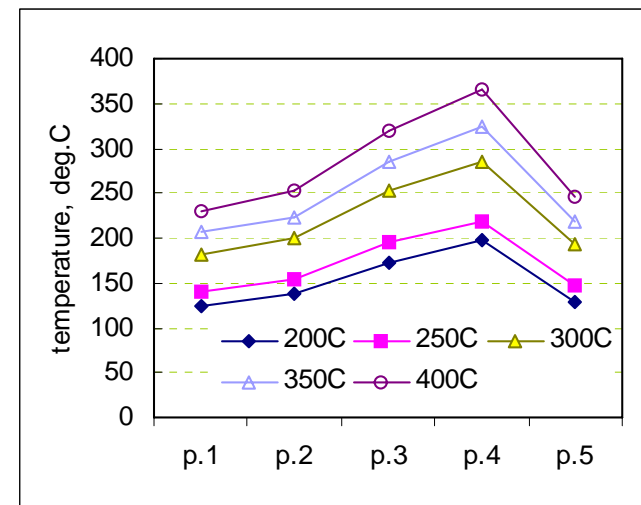
How Hot is a Soldering Iron?

- ❑ Temperatures of a soldering iron were set to 200, 250, 300, 350, and 400 °C.

- ❑ IR measurements in 5 points were used to get temperature distributions.

Temperature of the holder near the tip (P3) is only 10% to 13% lower than T_{max} .

- ❑ Preheating and equalizing temperature across the package might reduce the probability of failures.
- ❑ Temperature of soldering iron holder near the tip might be much higher than melting temperature of solder. Occasional touch to the surface of the package might cause failures.

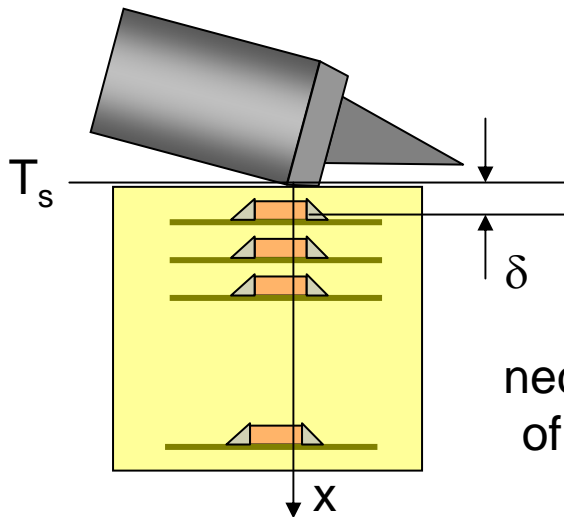
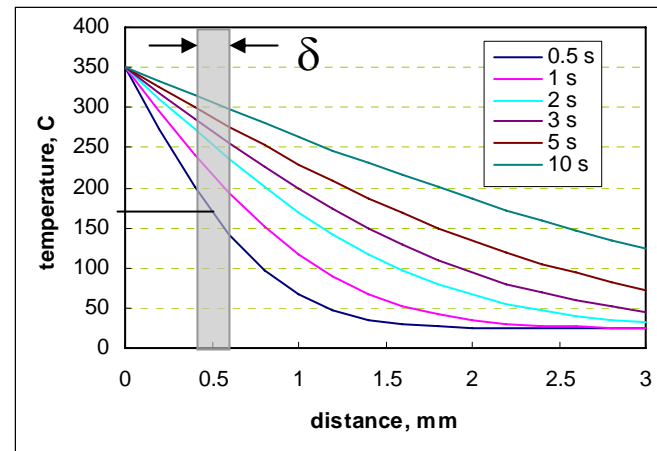
T distributions across 3D-plus package

- ❑ Temperature distributions were calculated at $T_s = 350\text{ }^\circ\text{C}$ and thermal diffusivity, $\alpha = 4.3\text{E-}7\text{ m/s}^2$.

Only ~0.5 sec is necessary to reach T_m of solder (~183 °C) at the top board

The most probable cause of failure is inadvertent touch by a soldering iron.
