Solder Reflow Failures in Electronic Components during Manual Soldering

Perot Systems/NASA GSFC, code 562,
Parts, Packaging, and Assembly Technologies Office

Purpose and Outline

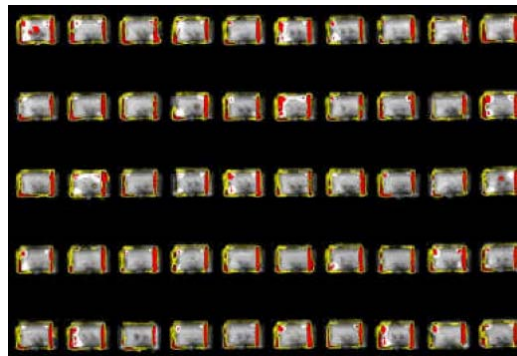
Typical CSAM images

- ❑ Three power FETs in plastic surface mount packages (D2Pak) failed short circuit after manual soldering onto a board.
- ❑ The parts passed screening including 100% C-SAM inspection.
- ❑ Failed parts had top-of-die delaminations.

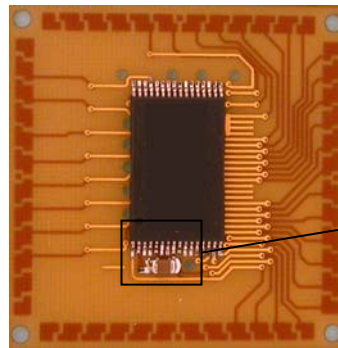
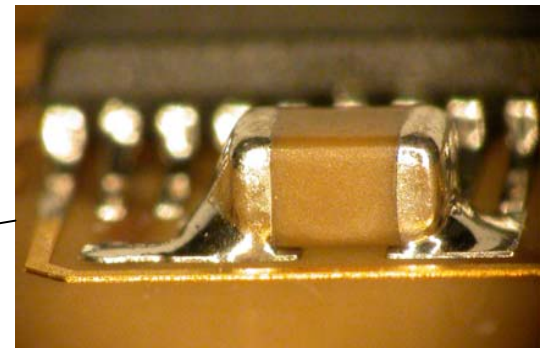
3D-plus Memory Failure

- ❑ The part passed all screening and qualification testing but failed with a short circuit in internal power supply lines after manual soldering onto a board with a soldering iron set to 700 F (371 °C).
- ❑ The part is comprised of 8 micro-boards with a TSOP memory microcircuit and ceramic capacitor in the power supply line. Interconnections are made on the boards and externally, via package metallization (8 μm Au/Cu/Ni).
- ❑ How to pinpoint location of the defect?
