NASA Electronic Parts and Packaging (NEPP) Program

Effect of Preconditioning and Soldering on Failures of Chip Tantalum Capacitors

NEPP task 2014

Alexander Teverovsky
Parts, Packaging, and Assembly Technologies
Office, Code 562, GSFC/ ASRC S&D
Alexander.A.Teverovsky@nasa.gov

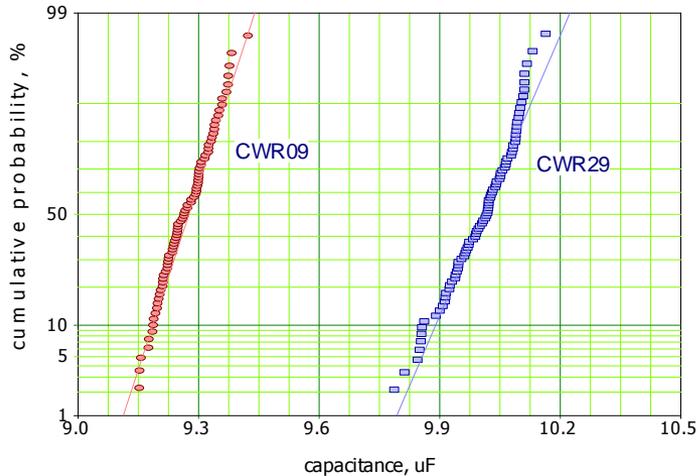
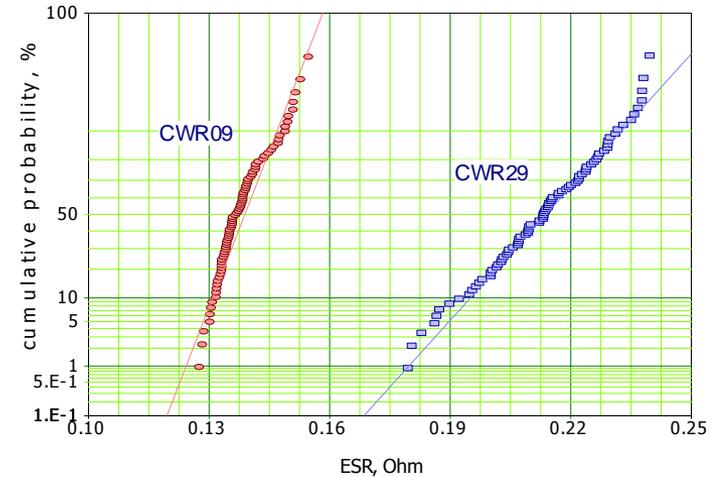
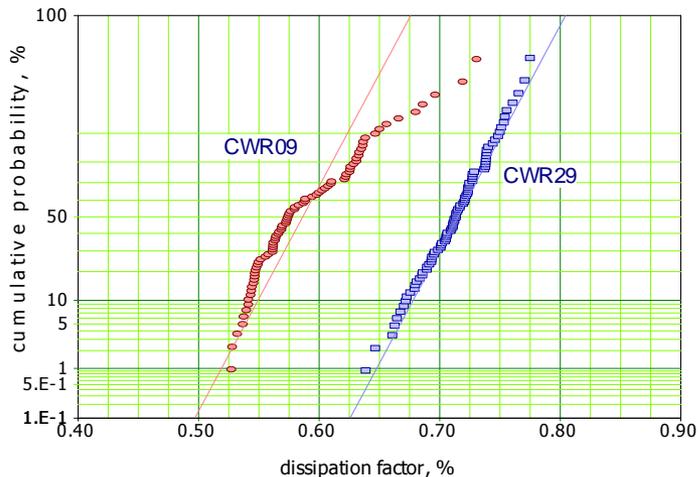
Initial AC Characteristics

- ✓ All characteristics are well within the specification limits ($DF_{\max} = 8\%$, $ESR_{\max} = 0.5 \text{ Ohm}$).
- ✓ DF values are ~ 10 times less than the specified limit.
- ✓ Although CWR29 suppose to be a low-ESR version of CWR09, ESR values in CWR09 capacitors are ~ 50% less than in CWR29.

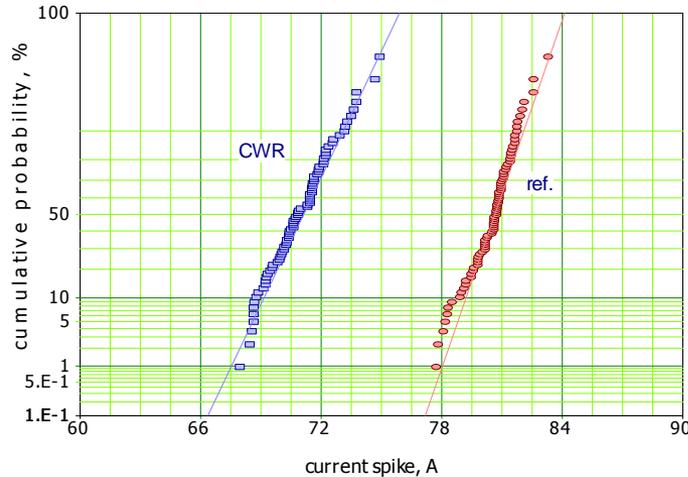
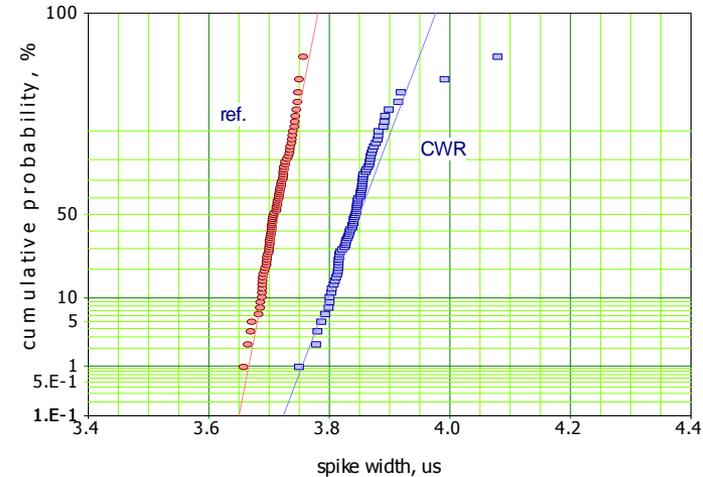
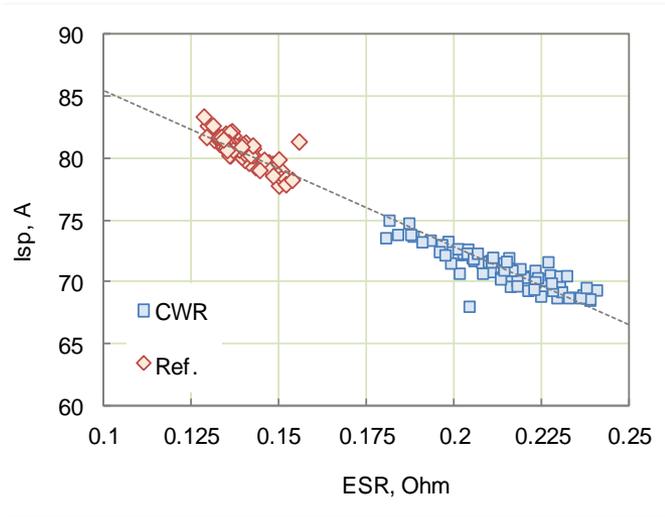
Initial Surge Current Testing

- ✓ All 160 parts passed SCT at 35V that resulted in current spikes ~ 75 A.
- ✓ A good correlation between I_{sp} and ESR indicates low circuit resistance, $R_{eff} \sim 0.29 \Omega$.
- ✓ The difference in I_{sp} for CWR29 and the reference lots corresponds to ESR values.
- ✓ Difference in the pulse widths corresponds to the characteristic time of the short circuit discharge: $\tau \approx C \times ESR$.

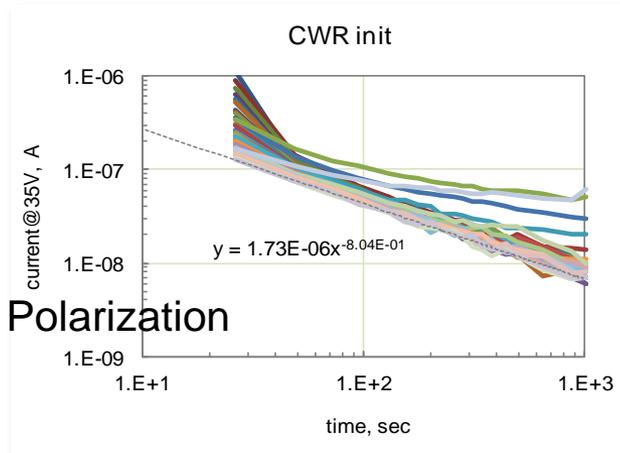
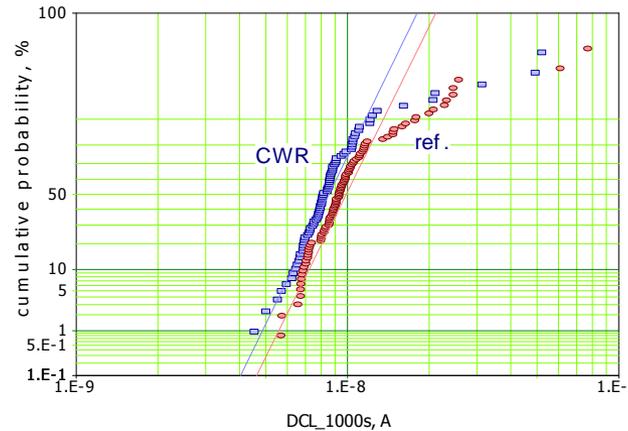
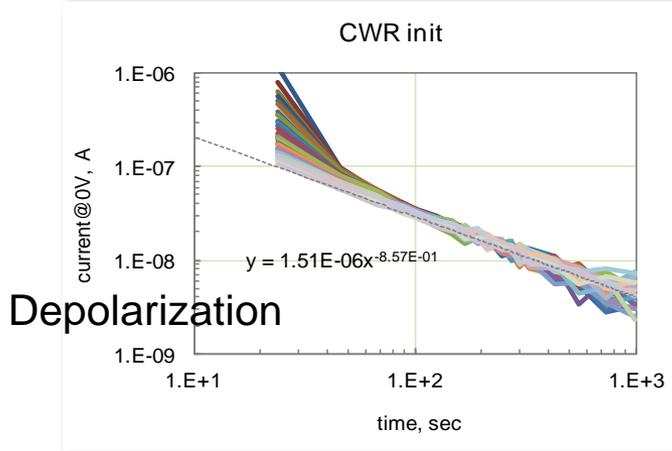
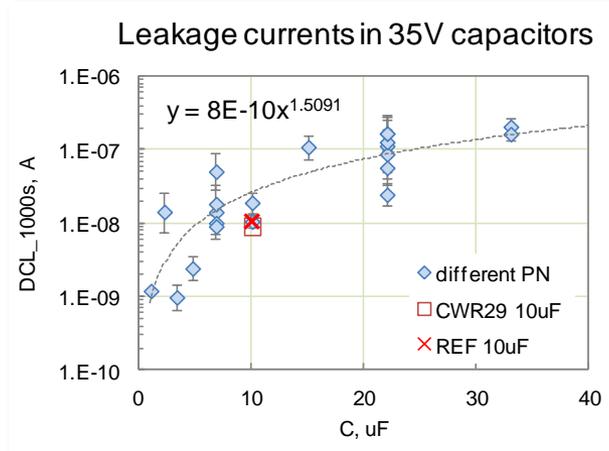
Initial DCL Characteristics

Analysis of initial characteristics showed that both lots had tight distributions of AC and DC characteristics indicative to high-quality products. No anomalies were observed during surge current testing, which rules out the possibility of screening escapees.

- ✓ DCL was measured after 1000 sec to increase the sensitivity to defects.
- ✓ Majority of parts (~80%) had leakage currents caused by absorption.
- ✓ All parts were well (more than 100X) within the specification, $DCL_{max} = 4 \mu A$.
- ✓ Both lots had similar DCL that were below median values for 35V capacitors.

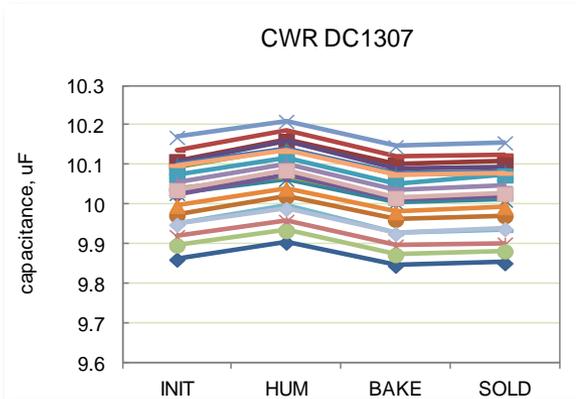
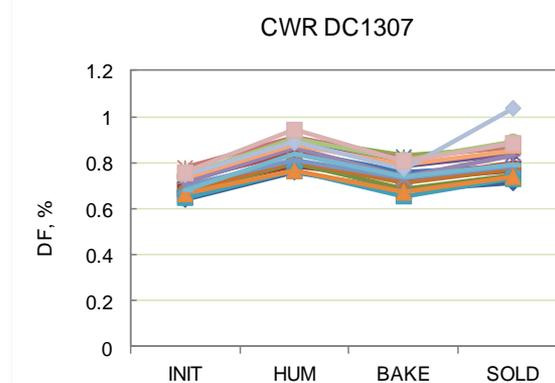
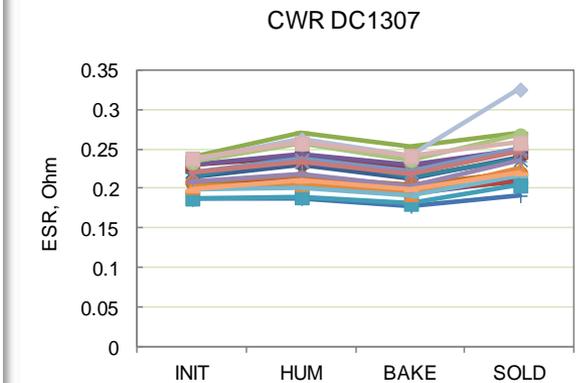
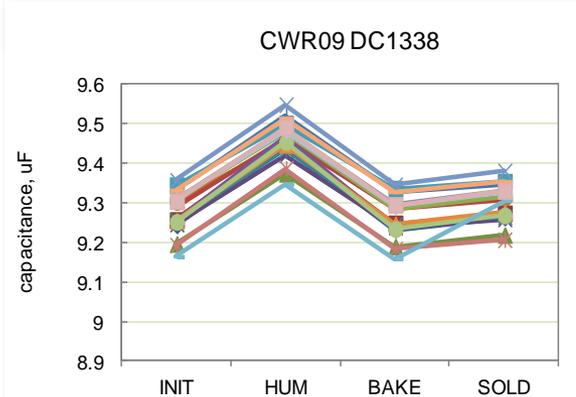
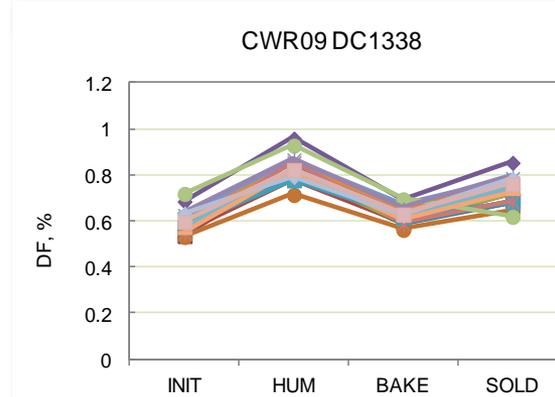
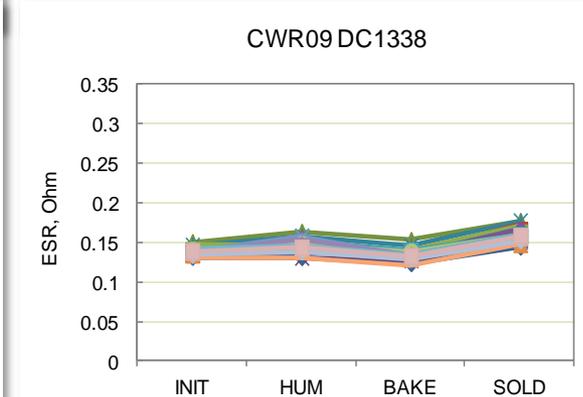
Effect of Preconditioning and Soldering on AC Characteristics of Gr.III Capacitors

- All 160 capacitors passed electrical measurements for C, DF, and ESR.
- No substantial variations through preconditioning and soldering (ESR raise ~16%).
- An increase of capacitance after moisture soak (0.41% for CWR29 and 2.1% for Ref.) is consistent with literature data [12] and indicates good coverage during MnO₂ impregnation.

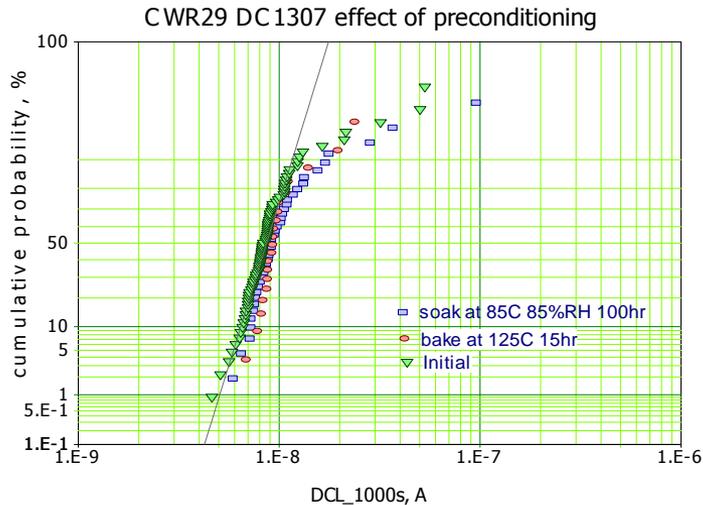
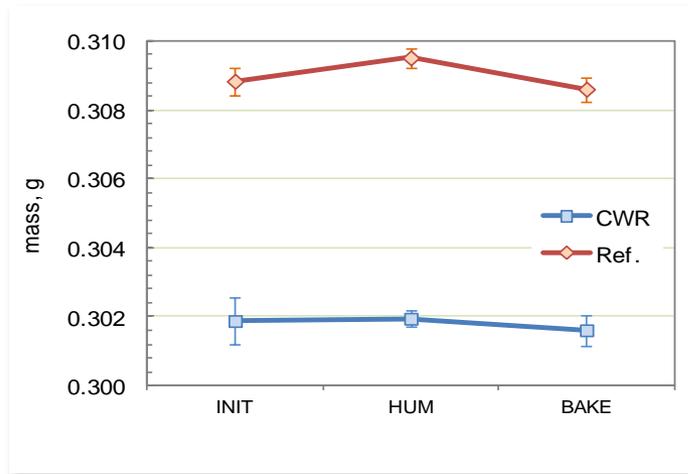
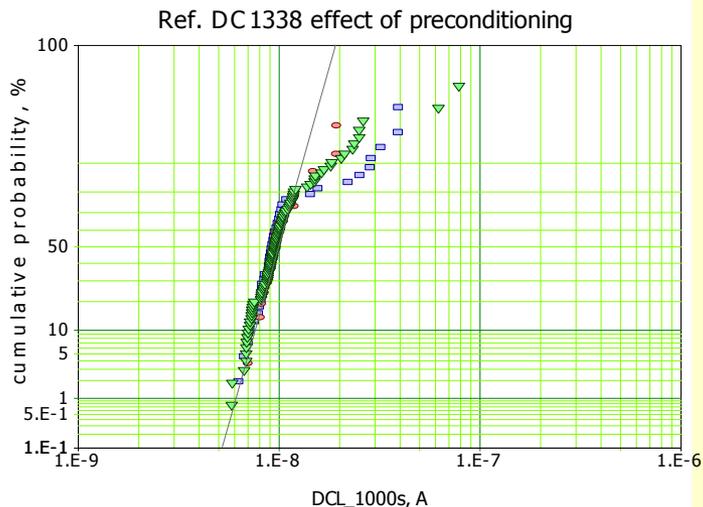
Effect of Preconditioning on DCL and Moisture Uptake

Effect of preconditioning on average mass of the parts (error bars = STD).

- ✓ Moisture soak and bake did not affect DCL.
- ✓ Moisture uptake after soak was ~0.067mg for CWR29 and 0.68mg for ref. parts indicating that CWR29 capacitors were close to saturation.
- ✓ Baking resulted in mass loss of 0.27mg for CWR29 and 0.23mg for CWR09 (ref.) capacitors suggesting similar moisture content in “as is” condition.
- ✓ Moisture uptake in humidity chamber was greater in ref. parts (0.91 mg vs. 0.33 mg for CWR29). This might indicate a larger volume of micropores in ref. parts.

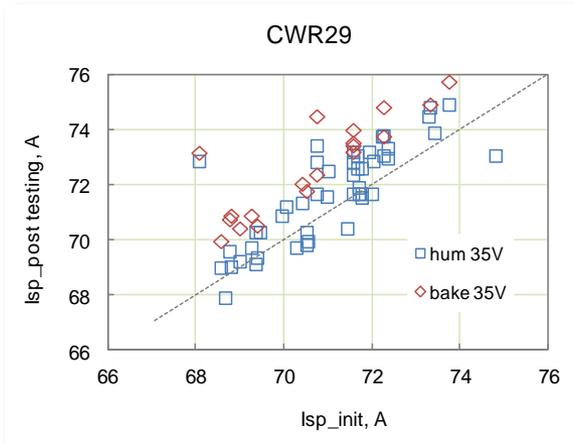
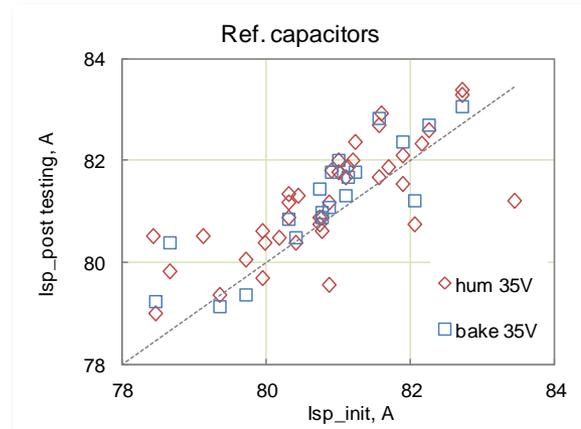
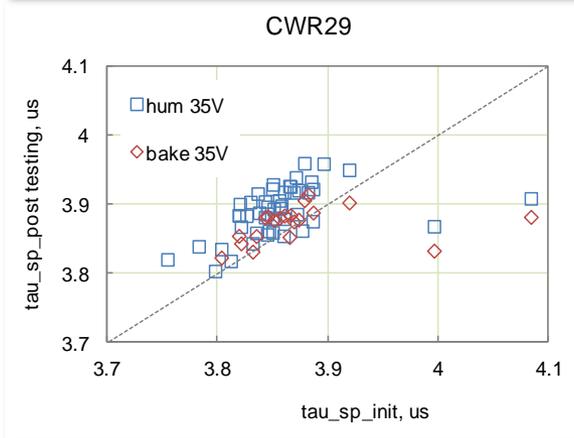
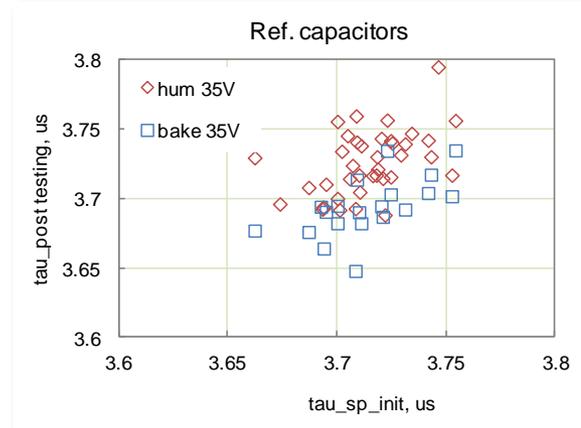
Effect of Preconditioning on SCT

- ✓ SCT was repeated after moisture soak and then after bake.
- ✓ All parts passed the testing and no significant effect on the amplitude and width of the current spikes was observed.
- ✓ Some increase in I_{sp} after bake for CWR29 corresponds to ESR variations.

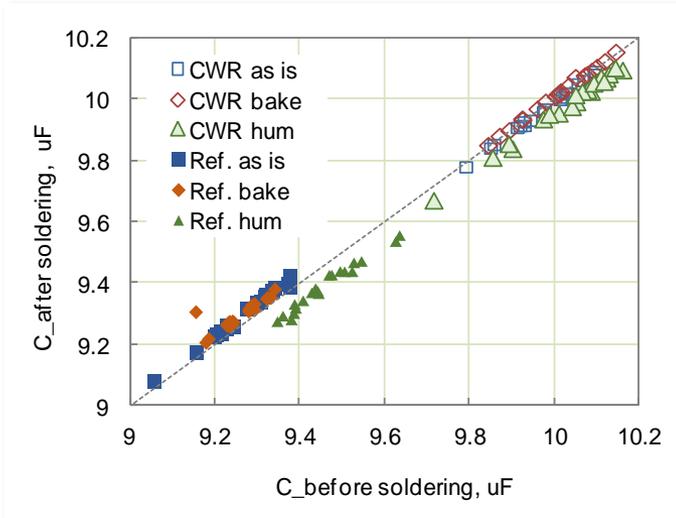
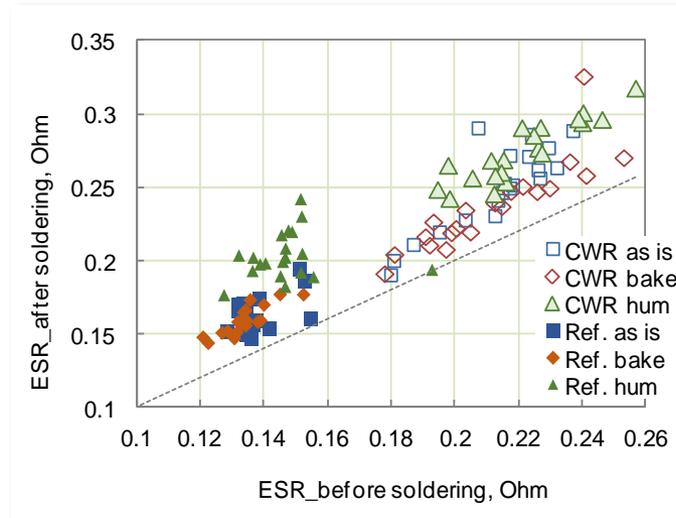
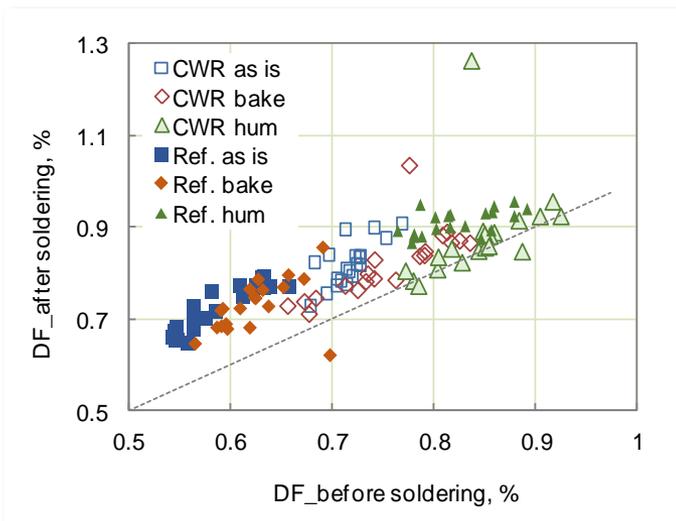
Effect of Reflow Soldering on AC Characteristics

- ✓ All post-soldering AC characteristics were within the specification limits.
- ✓ Minimal changes occur for parts after baking.
- ✓ Parts soaked in moisture had decreased C.
- ✓ ESR increases as a result of soldering for all types of preconditioning; however, degradation was greater in capacitors after moisture soak.

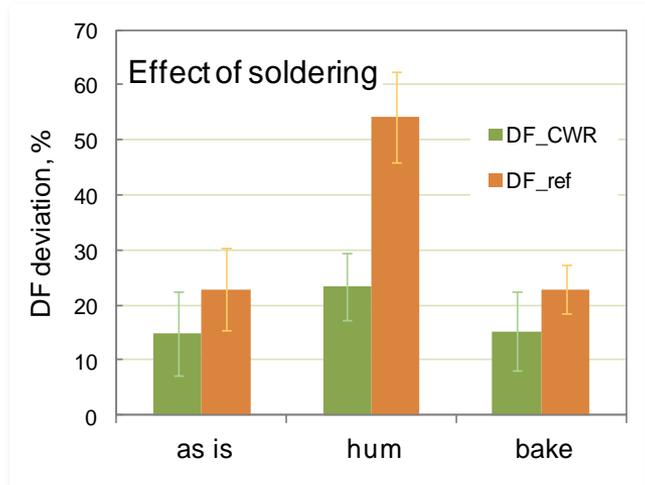
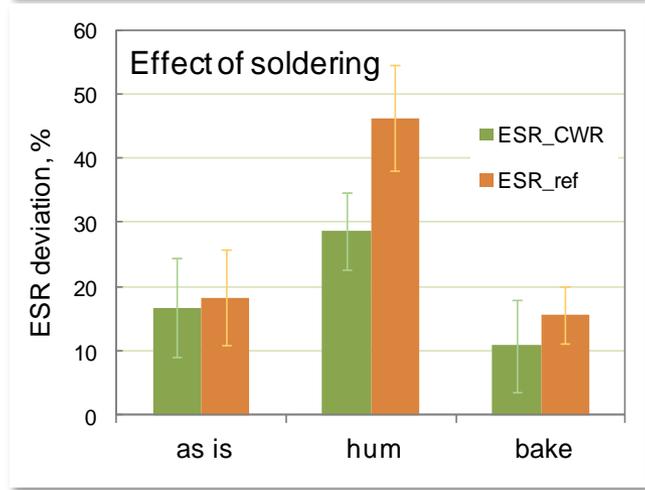
Effect of Reflow Soldering on AC Characteristics, Cont'd

Changes in AC characteristics as a result of soldering compared to the initial values measured on loose parts

- ✓ No substantial changes in capacitance.
- ✓ Degradation of DF and ESR is greater for reference parts for all types of preconditioning.
- ✓ Parts after baking increase ESR on 10% to 16%, but in the presence of moisture the increase is 29% to 46%.

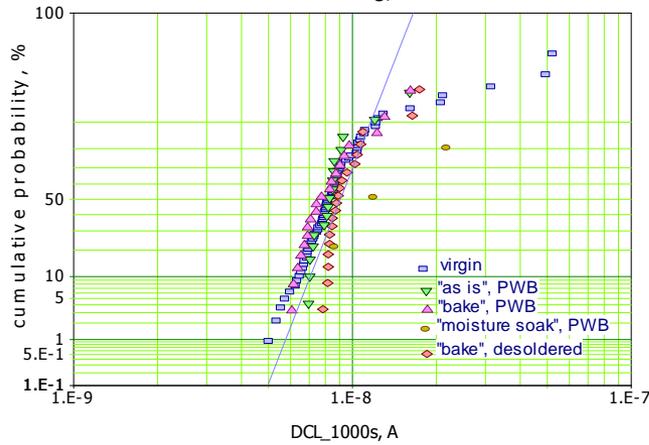
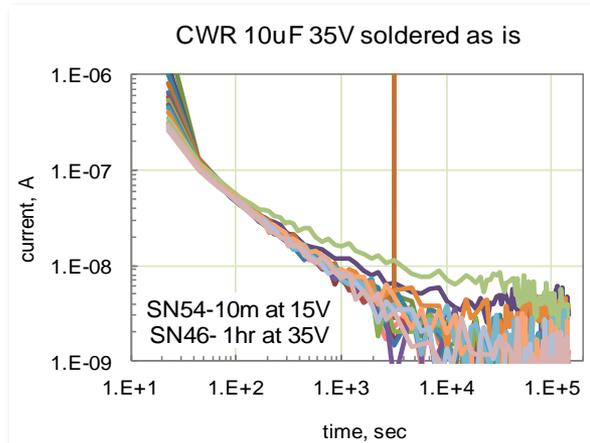
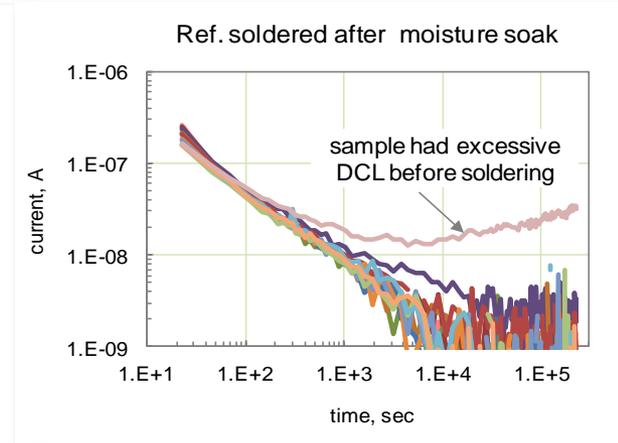
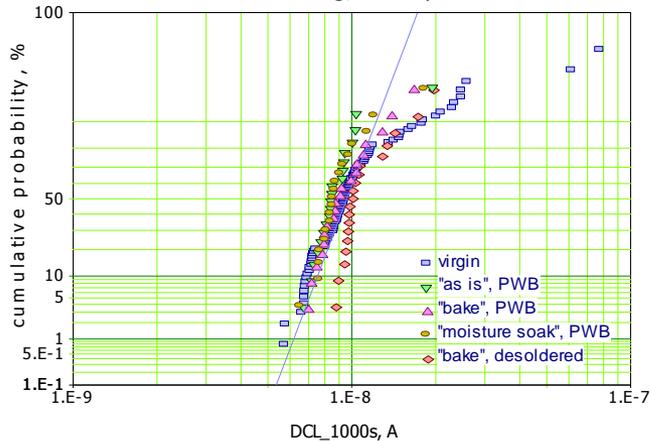
Effect of Reflow Soldering on DCL

Effect of soldering, CWR29

Effect of soldering, ref. capacitors

- ✓ One CWR29 sample from Gr.II (“as is”) failed after 10 min at 15V and another after 1 hr at 35V.
- ✓ No difference in distributions of leakage current for not-failed capacitors with different preconditioning.
- ✓ Non-failed CWR29 samples from the group that was soaked in moisture before soldering had low leakage currents.
- ✓ Desoldering of baked capacitors did not change DCL distributions.

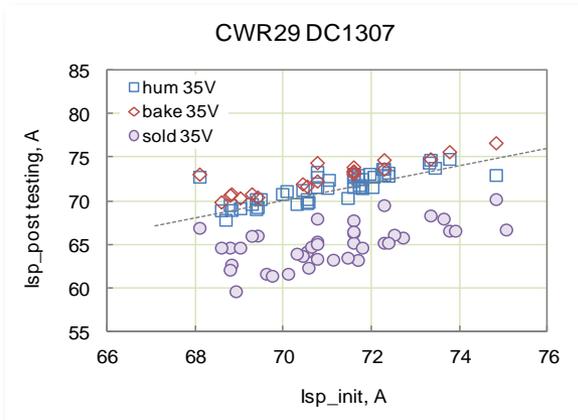
Correlation between current spike amplitudes measured initially, after different preconditioning, and after soldering

- ✓ SCT of soldered samples resulted in current spikes of a lesser amplitude (decrease ~10%) and greater width (increase ~30%).
- ✓ The result are due to increased ESR, and to using ~4" wires to interconnect the parts with the set-up that increased inductance of the circuit.

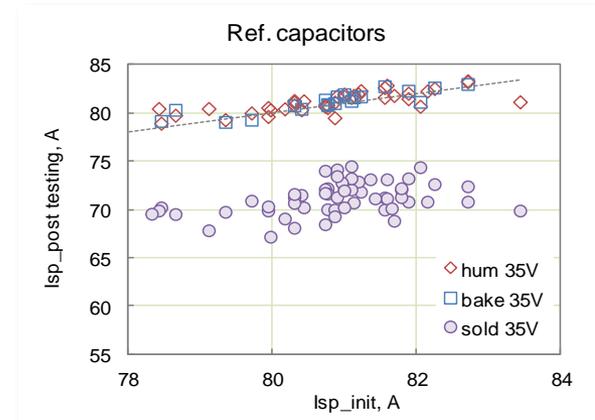
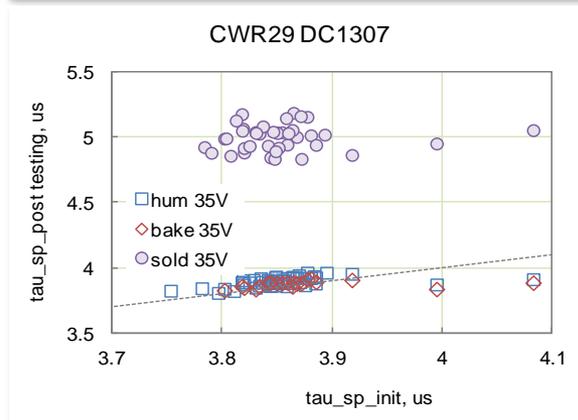
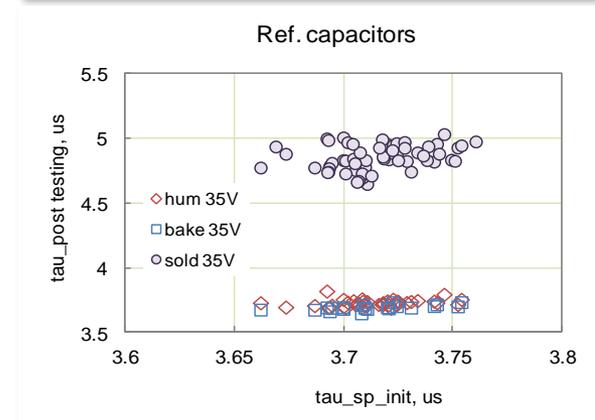
Similar correlation for current spike width

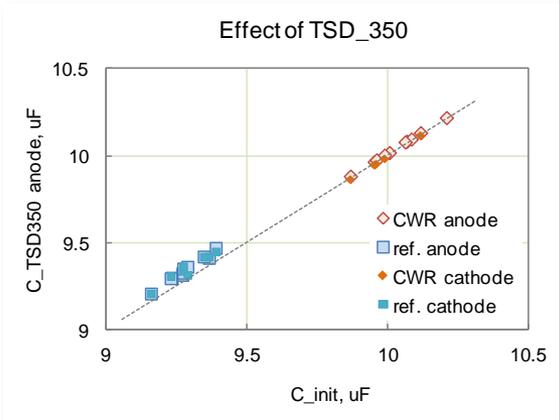
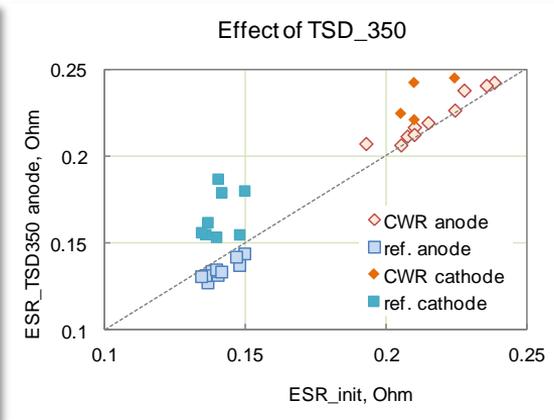
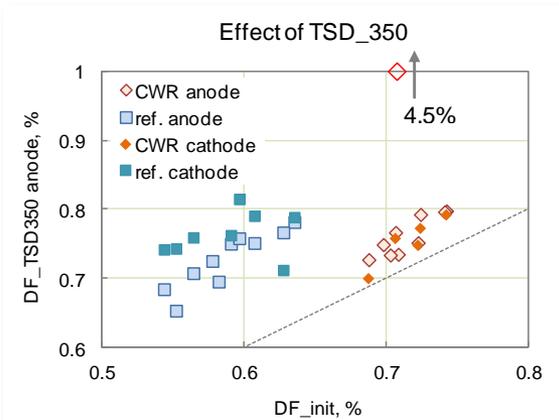
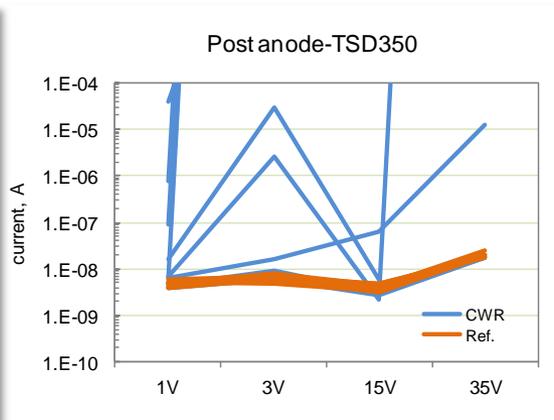
Effect of TSD350 on AC and DC Characteristics

- ✓ All AC characteristics were within the specification.
- ✓ One CWR29 part increased DF almost an order of magnitude (this part had also large DCL at 1V).
- ✓ Anode-side TSD practically did not change ESR; whereas ESR increased on 11% in CWR and 18% in ref. capacitors (similar to the effect of reflow soldering).
- ✓ Two CWR29 parts failing DCL at 3V recovered at 15V, but then failed again at 35V.
- ✓ No degradation of DCL for the reference capacitors.

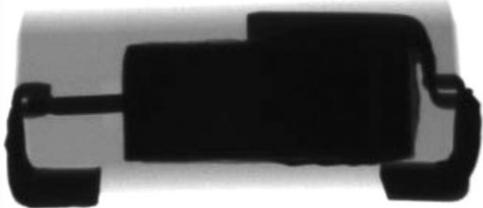
Three CWR29 samples soldered in “as is” condition and 6 reference capacitors soldered after moisture soak were examined after VBR testing.

Typical X-ray view showing location of internal part of cathode terminal

✓ After breakdown tested CWR29 capacitors had damage at the anode side, whereas all reference capacitors had damage at the cathode side.

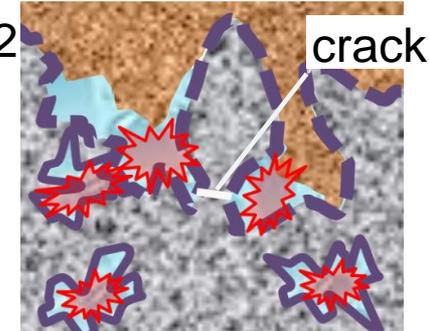
- ❑ During soldering, moisture condensed in cracks, pores, or MnO₂ evaporates rapidly creating high local pressure in the sponge-like structure of Ta anode and increasing delamination between MC and slug. When this pressure is applied to a mechanically weak site of the slug, a fracture of Ta₂O₅ dielectric occurs. This effect can be defined as internal popcorning.

- ❑ In some cases damage can be self-healed (e.g. by oxidation of Ta, or increasing resistance of MnO₂). This might improve temporarily characteristics of the part, but reliability of such a part is compromised.
