# Testing the Tester: Lessons Learned During the Testing of a State-of-the-Art Commercial 14nm Processor Under Proton Irradiation

**Abstract**— Testing of an Intel 14nm desktop processor was conducted under proton irradiation. We share lessons learned, demonstrating that complex devices beget further complex challenges requiring practical and theoretical investigative expertise to solve.

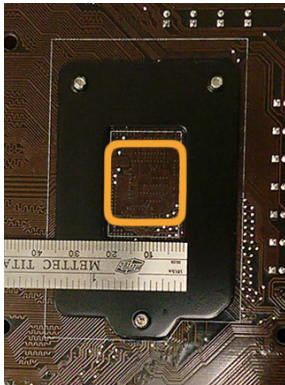
Fig. 4. Intended beam exposure target at backside of motherboard, at the underside of the DUT. Approximate beam area of 1 square inch, indicated by orange box, was requested at each facility.

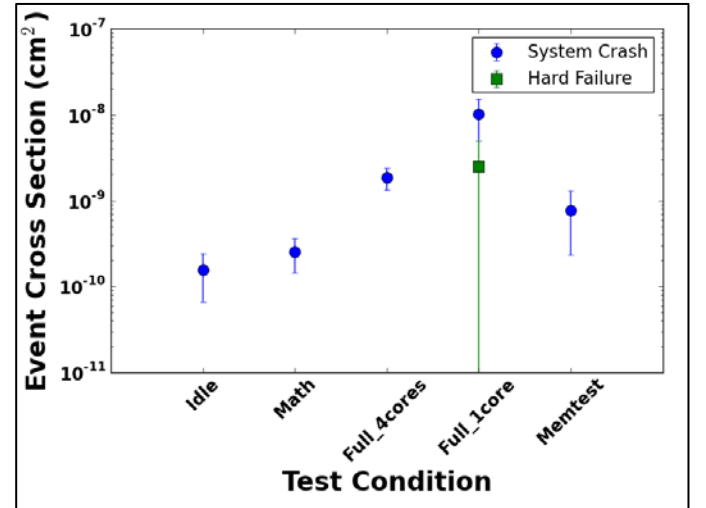
During our visit to TRIUMF, our team was able to conduct a limited amount of test runs on a candidate DUT. Of the 32 total runs, the first 26 were conducted with the aforementioned idle, math, and full test modes shown in Table 2. The final 6 test runs deviated from the aforementioned modes, with the addition of an ad-hoc execution of Windows Memory Diagnostic Tool [23] (2 runs), and a modified “full” testing mode, which executed solely on a single processing core. Testing concluded when a hard failure was observed on our device.

Fig. 5. Event cross sections for tests performed on the DUT at TRIUMF, as represented by Duncan, et al. [10].

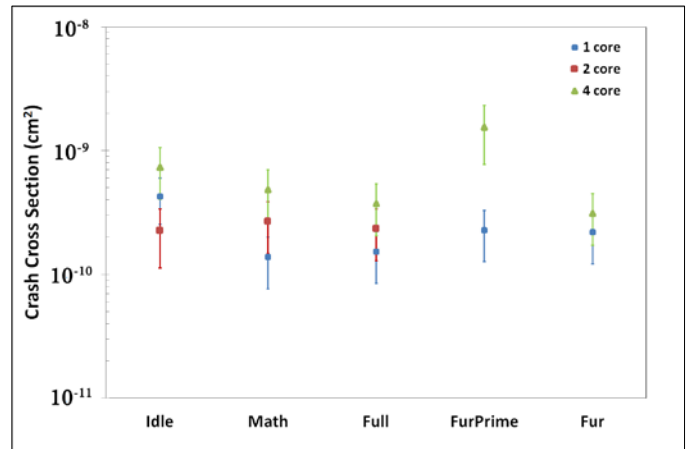
Fig. 6. Upset cross sections for tests performed on DUT at MGH.

Though intending to recreate the conditions that lead to failure at TRIUMF, we were unable to reproduce a single hard failure incident after 65 test runs. Stunned by this outcome, we returned the following day to exercise the DUT on the motherboard that had been involved in the original hard failure incident. As Table 6 reveals, we proceeded to cause not one, not two, but three DUTs to fail – quickly.
