Electrical Failure of an Accelerator Pedal Position Sensor Caused by a Tin Whisker and Discussion of Investigative Techniques Used for Whisker Detection

- Describe the failure of a Accelerator Pedal Position (APP) sensor caused by a **TIN WHISKER***
- Describe the failure analysis methods used to identify **TIN WHISKERS** as the root cause of failure
- Convey guidance to failure analysts/troubleshooters for improved techniques to electrically detect metal whisker-induced short circuits

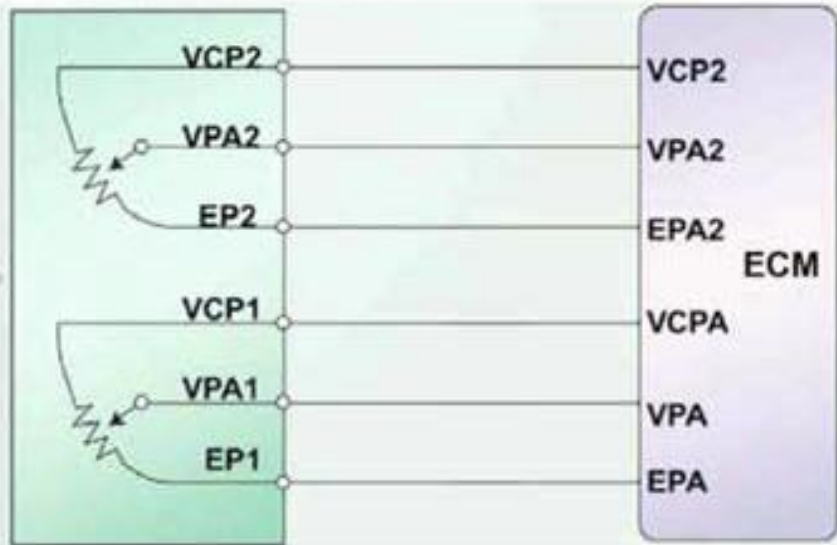
*Architecture Dual Potentiometer APP Sensor
For Camry MY 2002 - 2006*

Overview of a Dual Potentiometer-Based APP Sensor

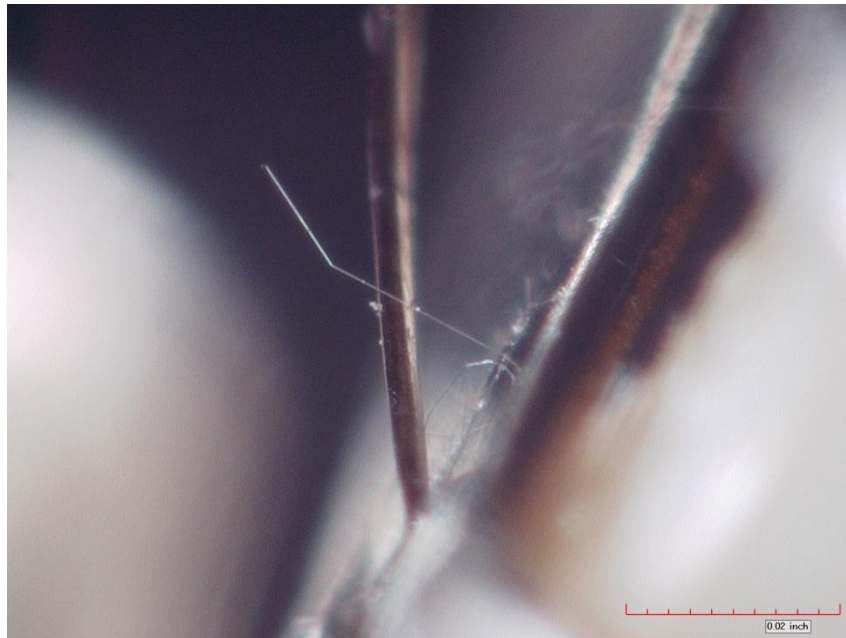
**Metal Whiskers are commonly
1/10 to <1/100 the thickness of a human hair**

**Optical comparison of
Human Hair vs. Tin Whisker**

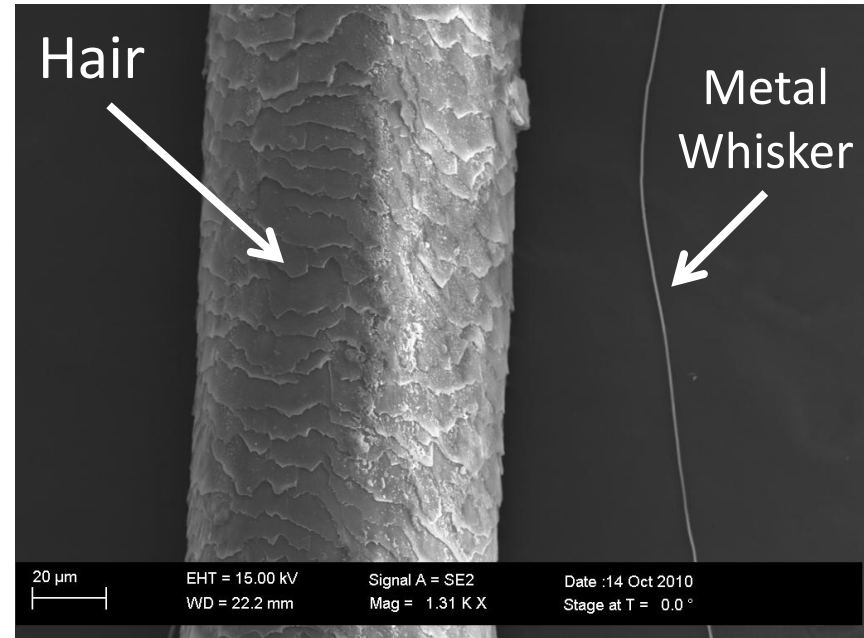
**SEM comparison of
Human Hair vs. Metal Whisker**

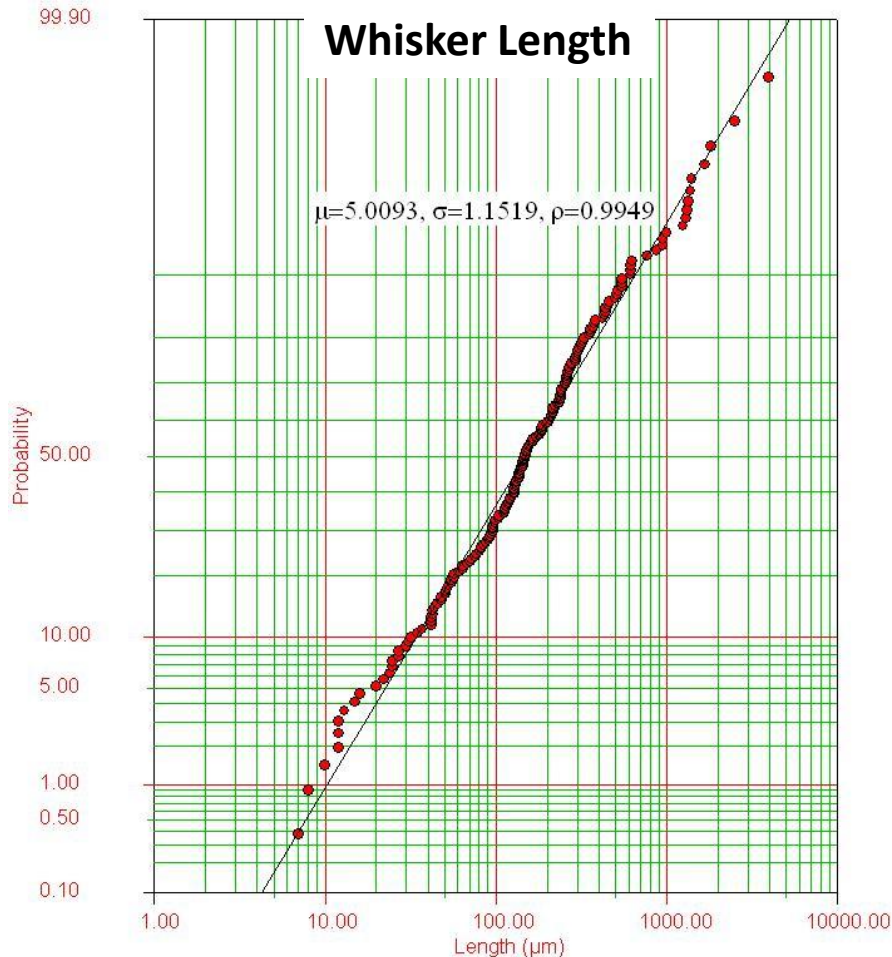
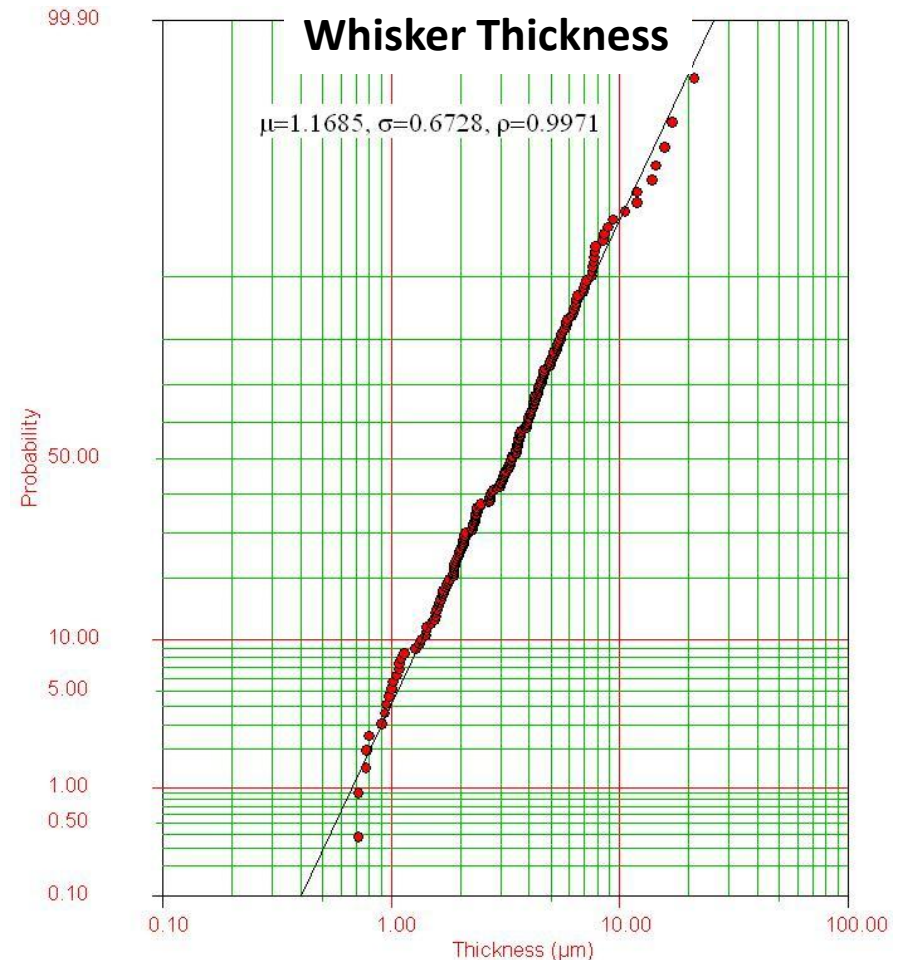
Example of Tin Whisker Length and Thickness Distributions

Collected for 187 whiskers on tin-plated brass that grew over 11 years of ambient storage

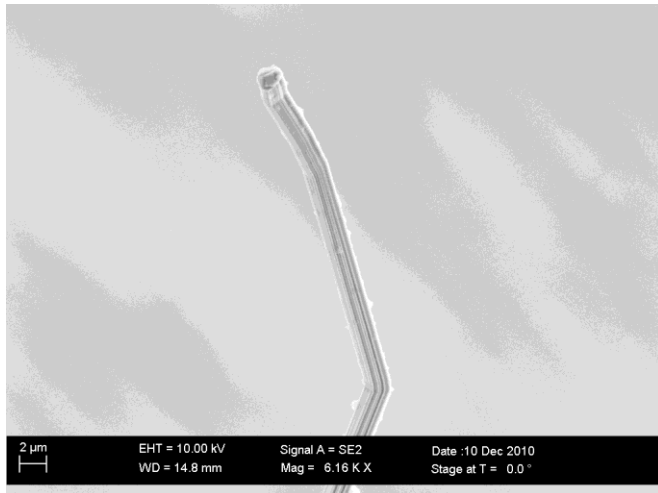
Illustration of How a Whisker may Snag

- Long, thin whiskers are ductile. Without breaking they can bend, flex through very large angles under the influence of air, vibration, shock, electrostatic forces
- After significant movement, whisker tip may be caught by the irregular surface of the tin plating on an adjacent conductor
 - Mechanical shock or air movement may dislodge the whisker tip
- **Insulating films may prevent immediate electrical continuity**
 - See next slide for more detail

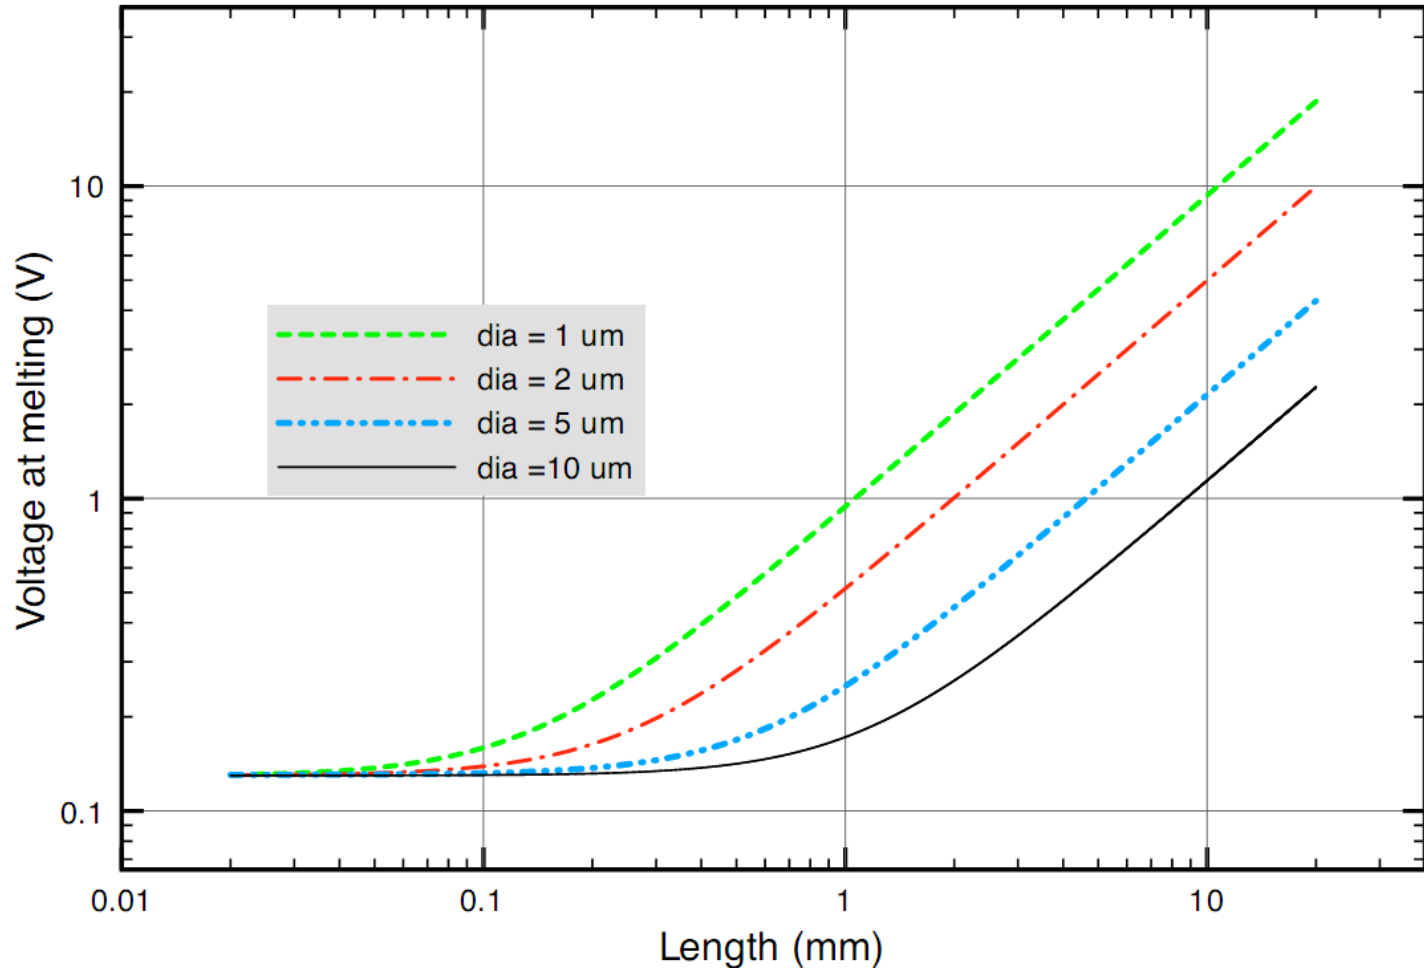
Melting Voltage vs. Length for Selected Whisker Diameters
