# NASA GSFC EEE Parts: DPA and FA Summary

Lyudmyla Ochs

NASA GSFC Code 562 EEE Parts, Photonics and Assembly Branch

June 16, 2022

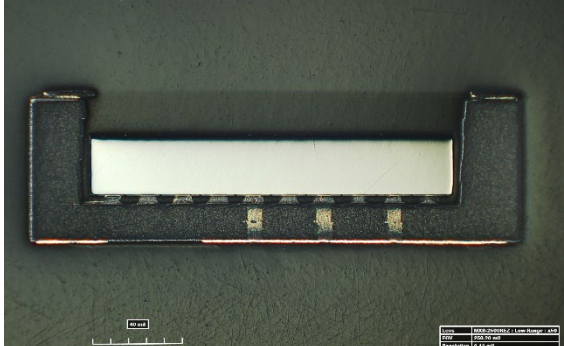
Optical view of device in cross-section

- Part:
  - Commercial microcircuit inside a hermetic package
- DPA failure:
  - Observed Au-Sn intermetallics along both sides of the solder bump
  - Some bumps showed a separation of solder bump along the intermetallics
  - Parts were solder dipped in an uncontrolled manner by user, which may have contributed to the separation
- Disposition:
  - Not recommended for flight use
  - Attention should be paid to presence of Au-Sn intermetallics in future lots

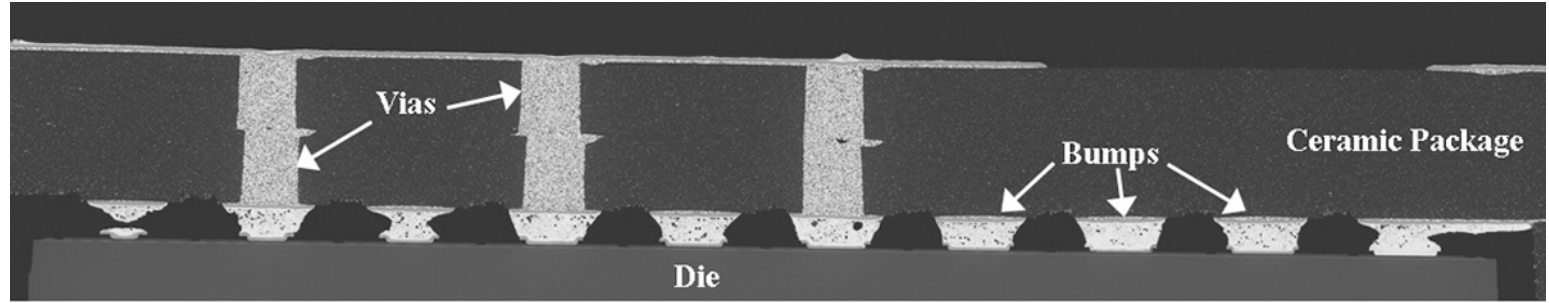
SEM view of device in cross-section, focusing on package and underbumps

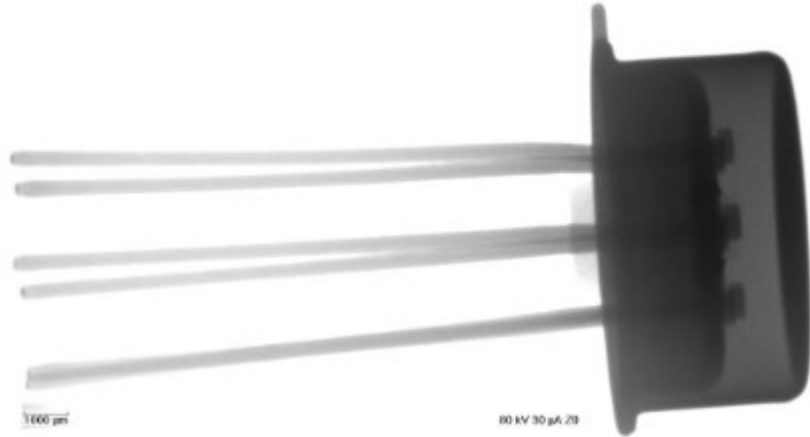
*X-Ray overview of the transistor package*

- Part:
  - Transistors in TO-can packages
  - Part is commercial, rad-hard, manufactured on MIL-PRF-38535 Level V (with modification)
- DPA failure:
  - 1/3 failed for Particle Impact Noise Detection (PIND)
  - Particle capture attempted, but unsuccessful
- Disposition:
  - Remainder of the lot subjected to PIND with no failures
  - Recommended use-as-is due successful completion of PIND

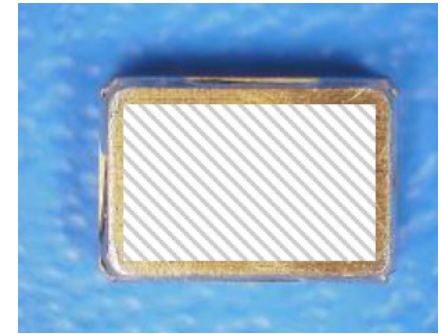
- Background of parts
  - A commercial device screened to MIL-STD-883
  - Package style: UBA
  - Hermeticity test at manufacturer results: fine leak (147 passed/1 failed) and gross leak (147 passed/0 failures) passed.
  - X-Ray of 30 received units showed all units with lid seal voids in excess of 75%, with many units showing lid seal voids spanning 95% of the seal
- Test Plan
  - 30 units with lid seal voids in excess of 75%, and 5 control units with lid seal passing MIL-STD-883 TM2012 criteria

*Optical image of the device (part markings removed)*
