Metal Whiskers

Discussion for the UNOVIS Consortium

Jay Brusse / Perot Systems
Dr. Henning Leidecker / NASA Goddard
Lyudmyla Panashchenko / Univ. of MD-CALCE Graduate Student

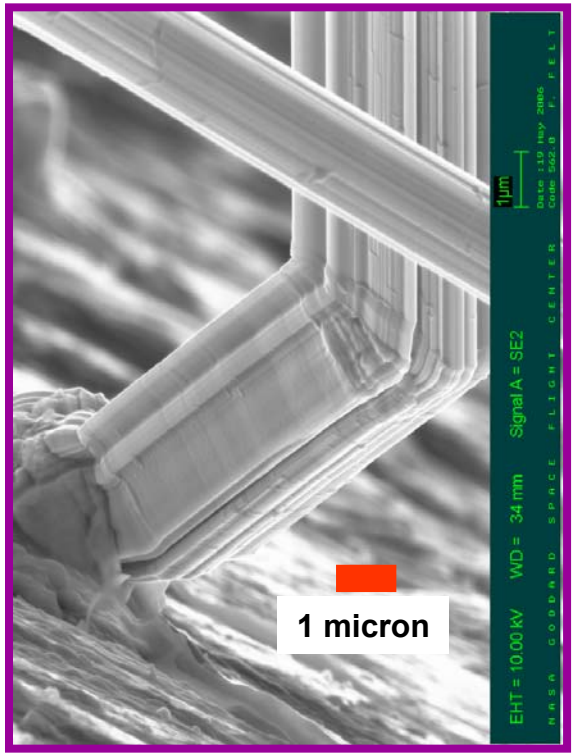
Tin Whiskers on Tin-Plated Electromagnetic Relay Terminals

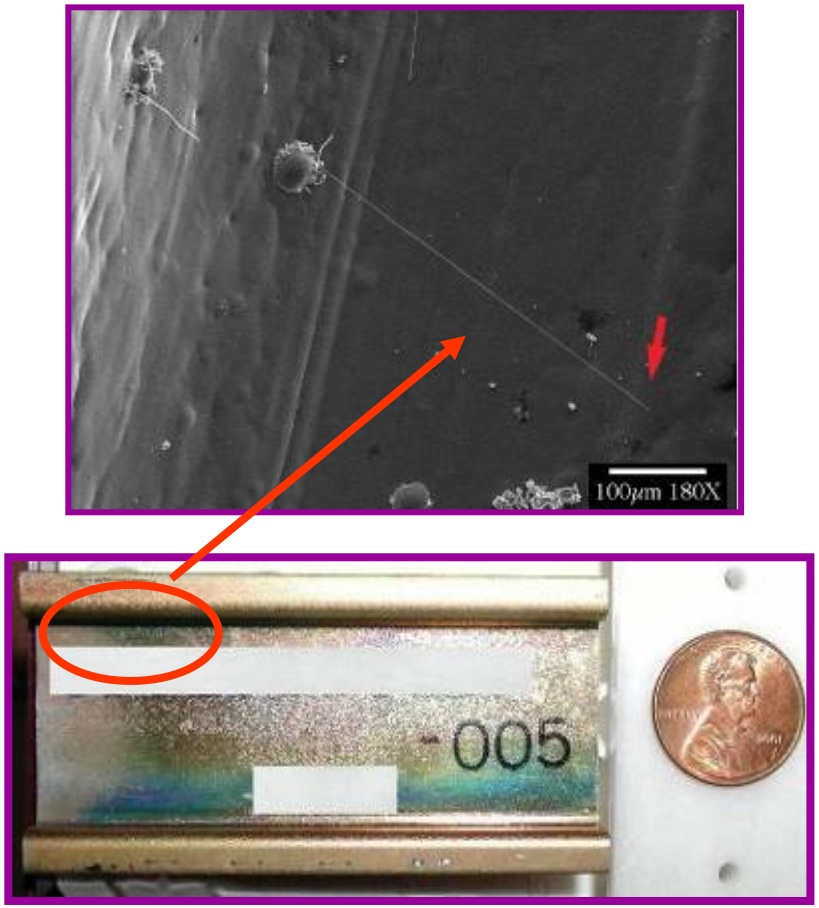
Zinc Whiskers Growing from Zinc-Plated Yellow Chromate Steel Bus Rail

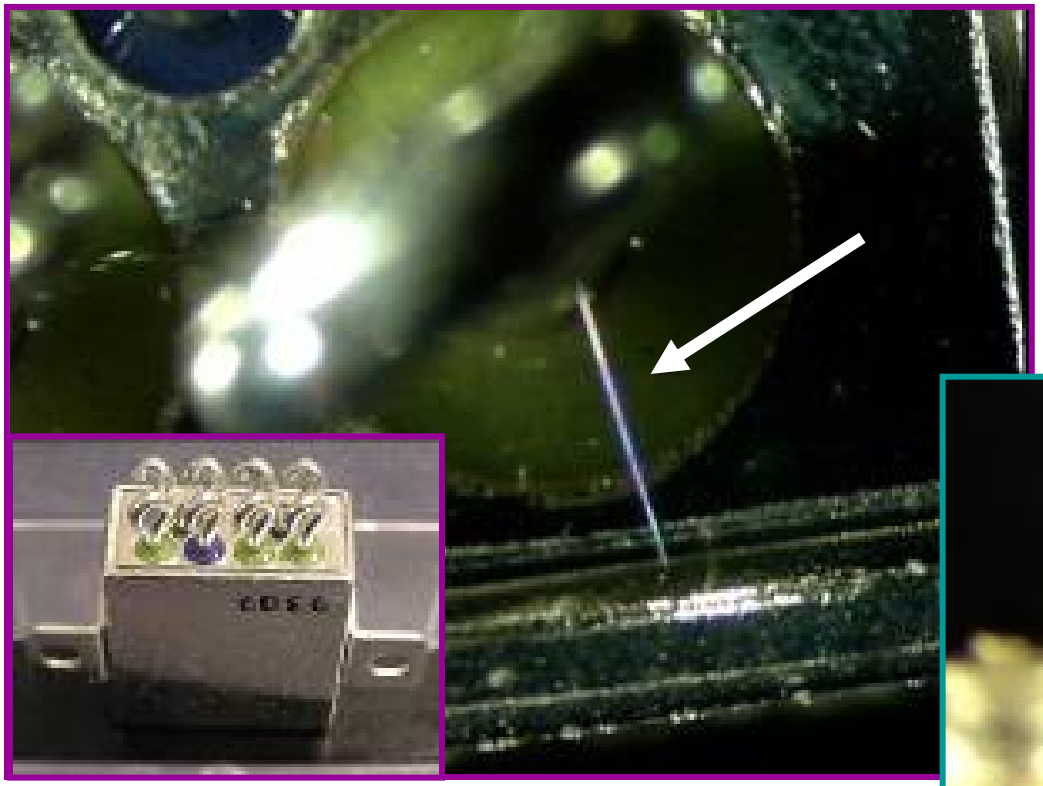
Tin Plated Electromagnetic Relay
Tin Whisker Shorting
Terminals and Case

NOTE: Procurement Spec PROHIBITED Tin-Plating!

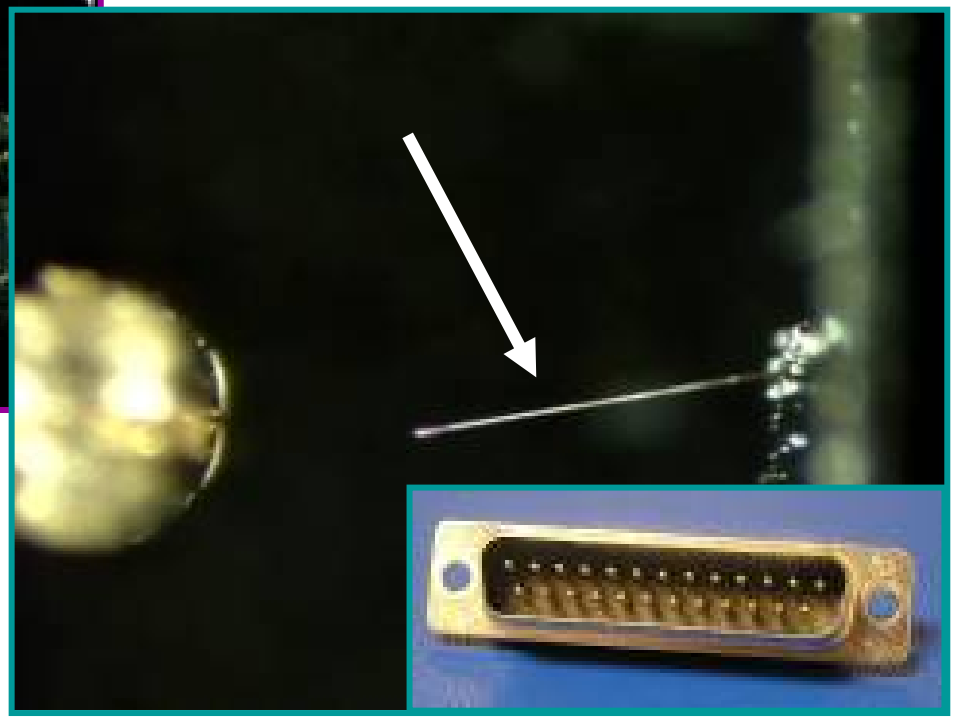
Tin-Plated D-Sub Connector Shell
Advertised as "RoHS Compliant"

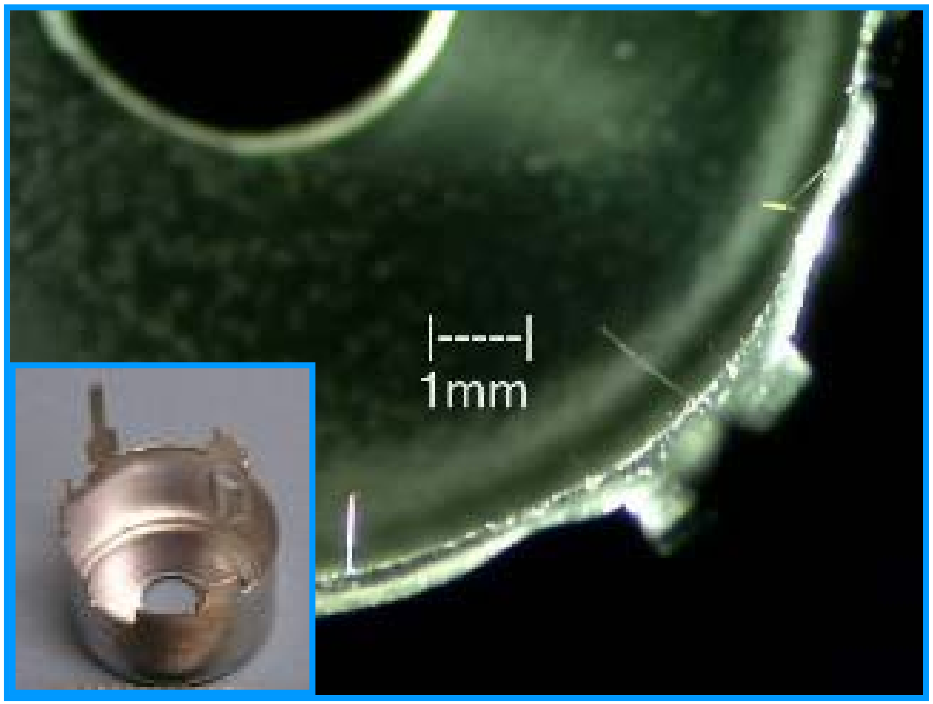
Tin-Plated Transformer Can
Tin Whiskers "As Received"

Note: Supplier Changed to Pure Tin WITHOUT Warning Customers

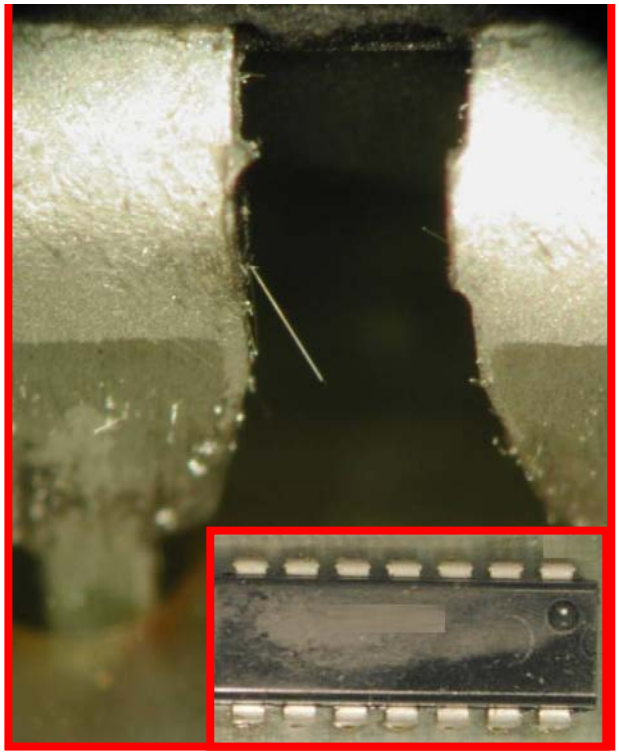
Tin-Plated DIP IC Leads
Tin Whiskers Produce Field Failure in Power Plant After 20 Years in Field!

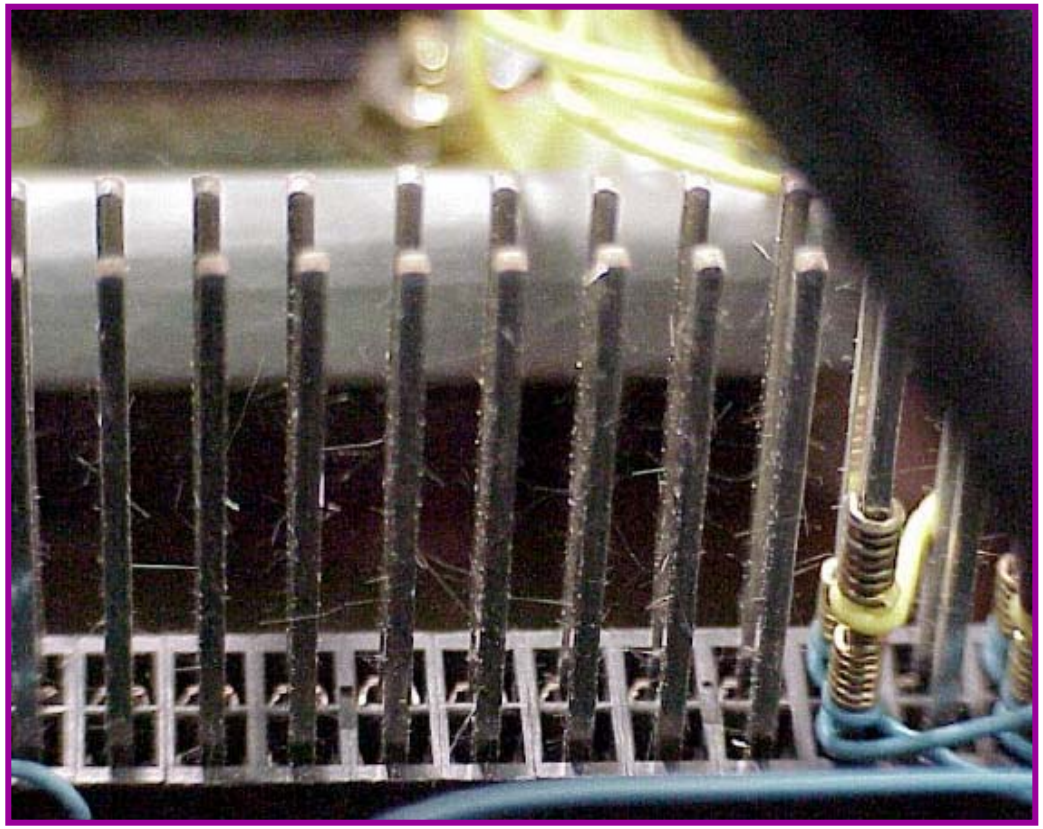
Tin-Plated Wire Wrap Pins
Tin Whiskers

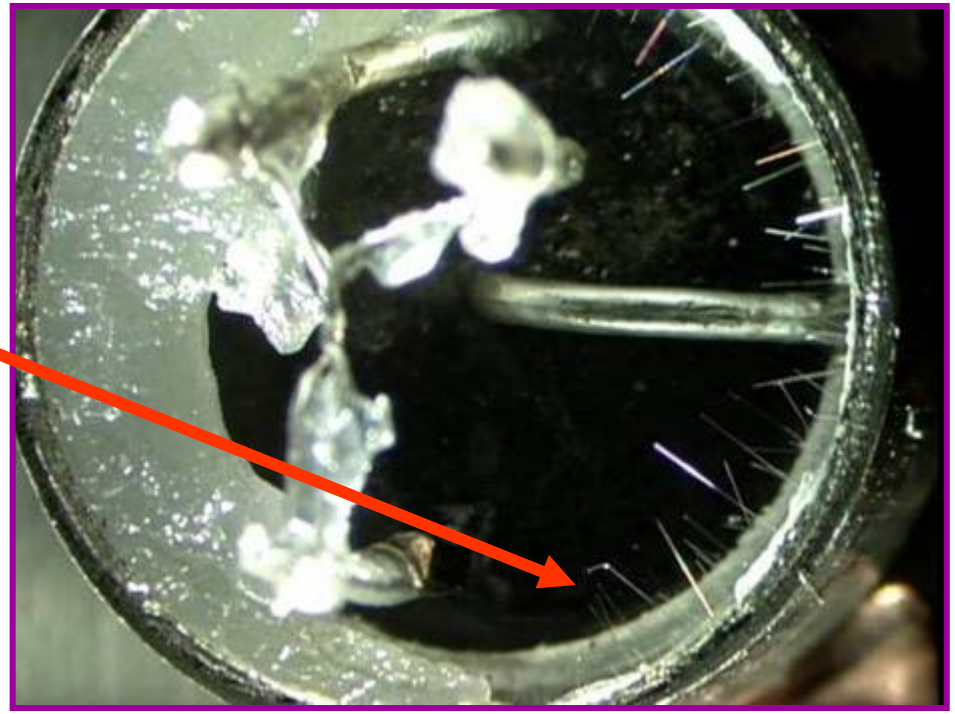
Transistor Package is Tin-Plated Inside.

Many Radio Malfunctions Have Been Attributed to Whiskers Shorting Case to Terminals

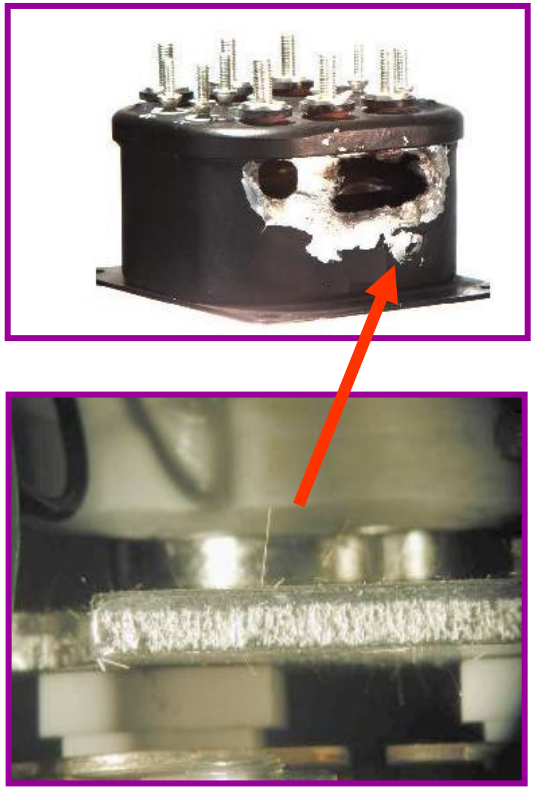
Tin Whiskers Growing on Armature Of Relay Produced Metal Vapor Arc

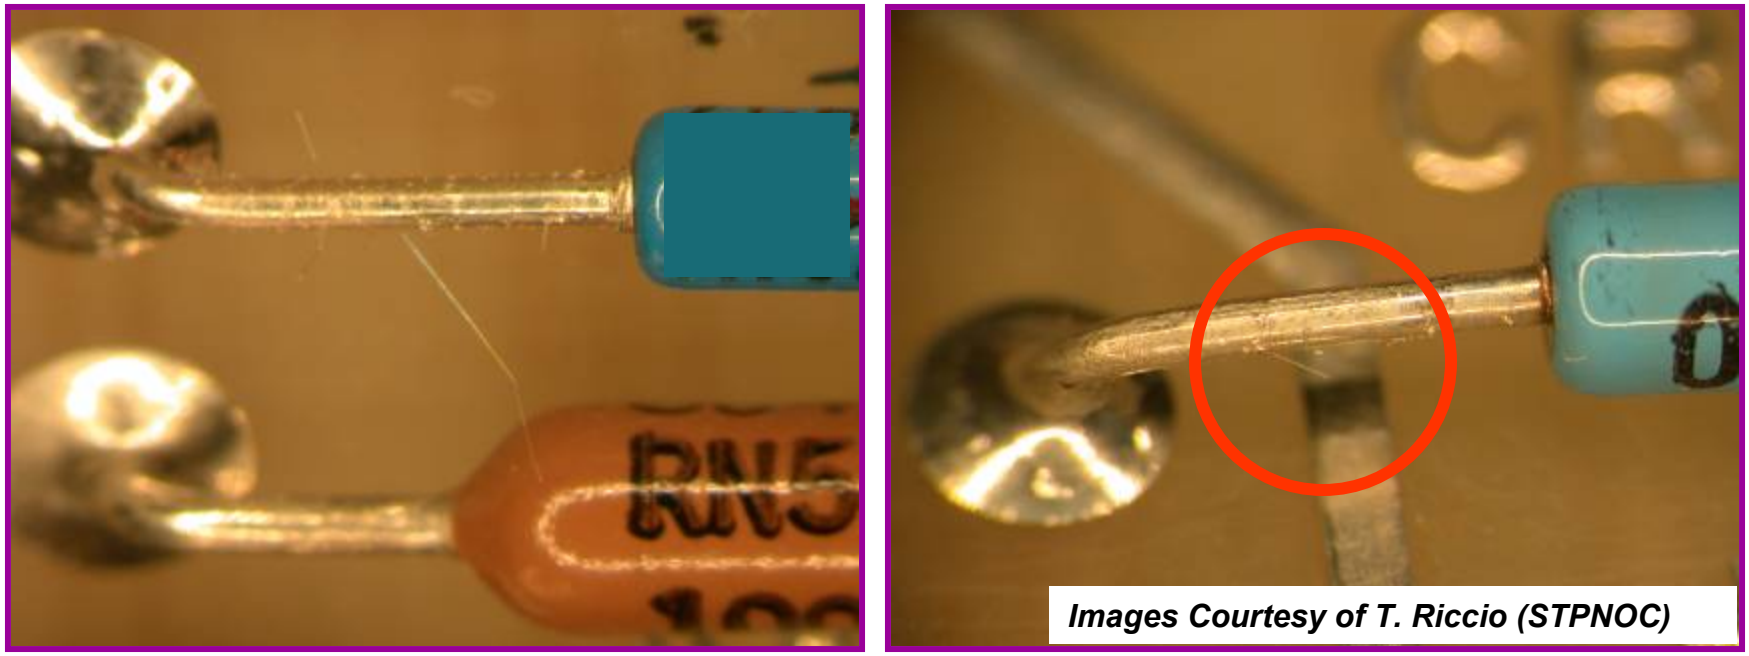
Tin Whiskers on Tin-Plated Axial Leaded Diodes

- Diode Leads were **NOT Hot Solder Dipped** prior to assembly; thus leaving large surface area of pure tin coating prone to whisker growth
- PWB and components were **NOT Conformal Coated**; thus leaving adjacent conductors exposed to bridging by whisker growth

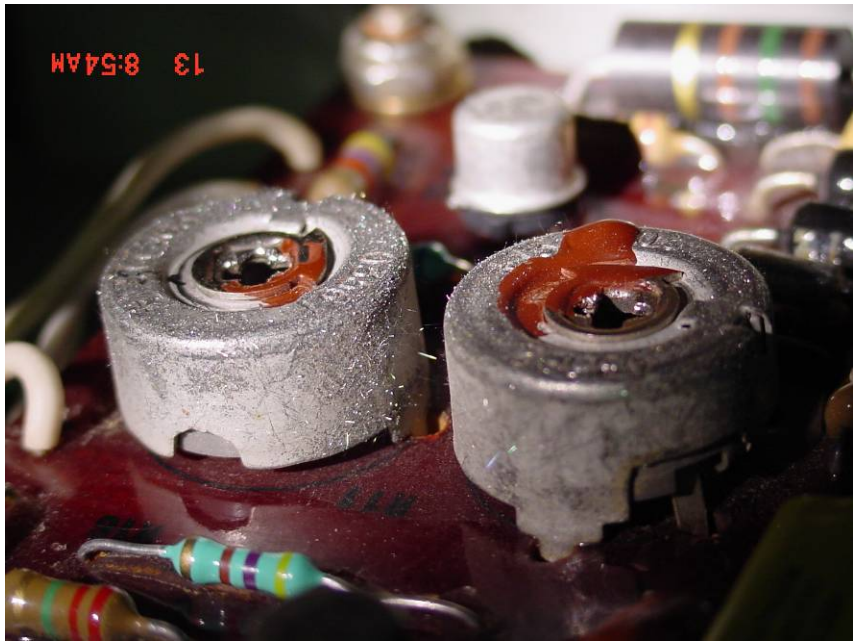
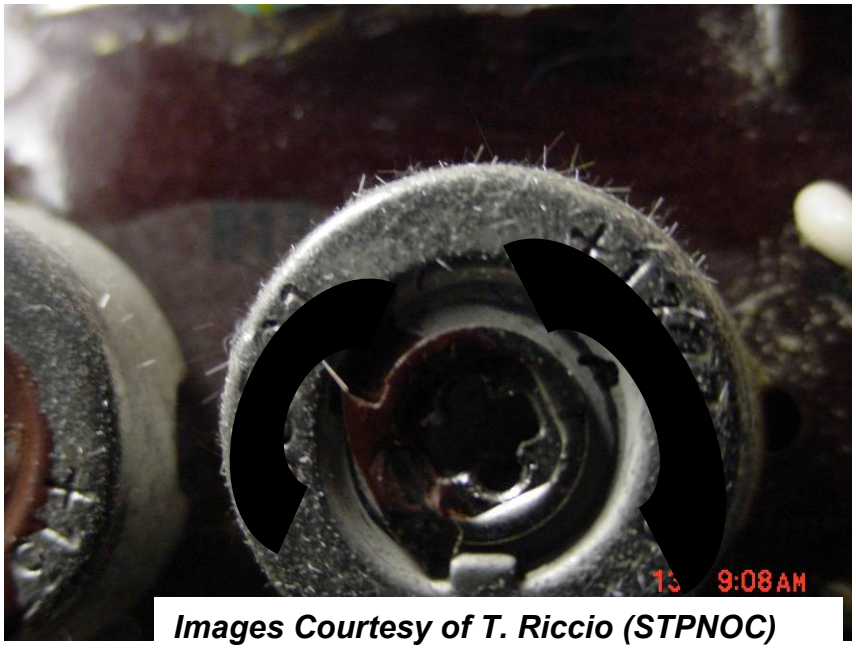
Metal Whiskers on External Case of Potentiometers

- No electrically insulating materials were used on the metal cases
- Metal whiskers bridging between the cases or from case to adjacent components can cause circuit malfunction

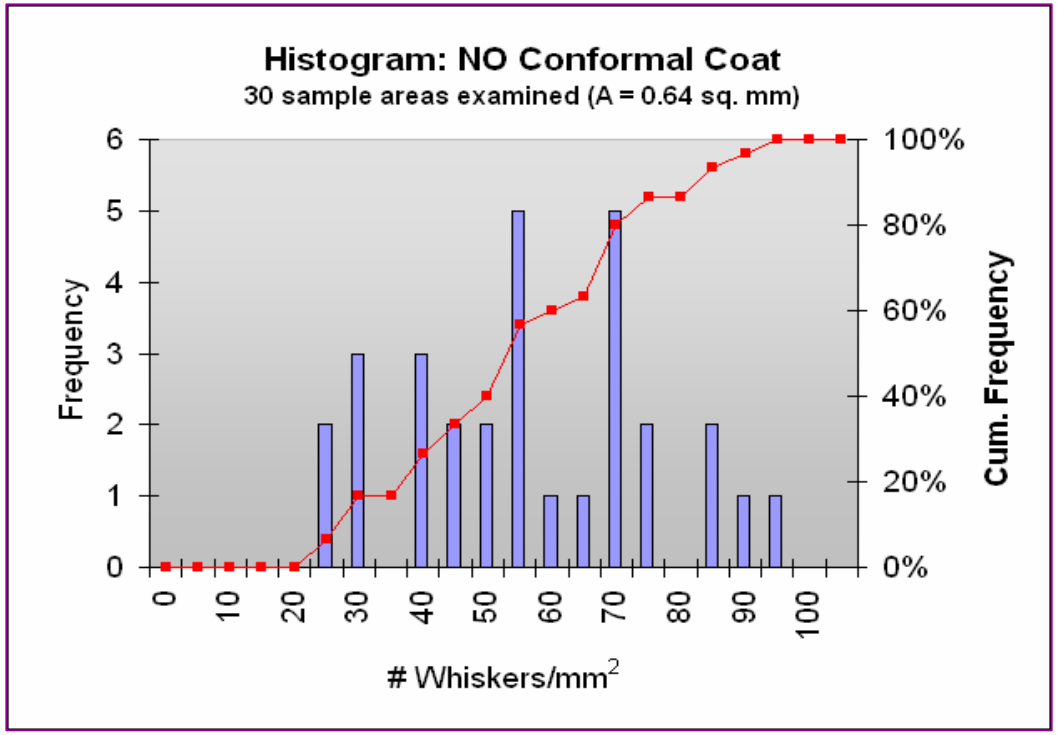
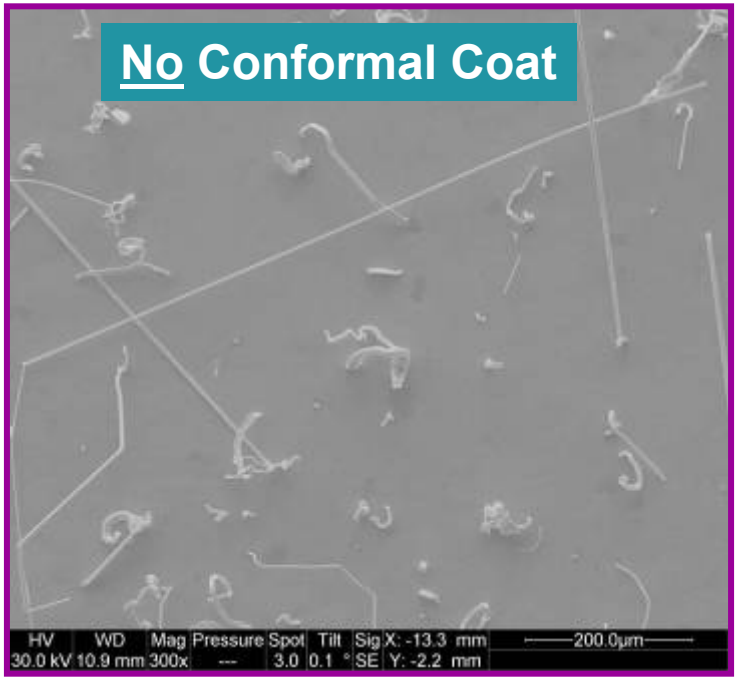
NASA Goddard Whisker Mitigation Study
Control Areas – No Conformal Coat
9-Years of Office Ambient Storage

- **Control Areas Grew Whiskers Abundantly within the First Year. After 9 years of storage we found the following:**
  - **30 areas each 0.64 mm² were randomly examined for whisker density**
  - **Avg: 55 ± 19.6 whiskers / mm²**
  - **Range: 23 to 95 whiskers / mm²**

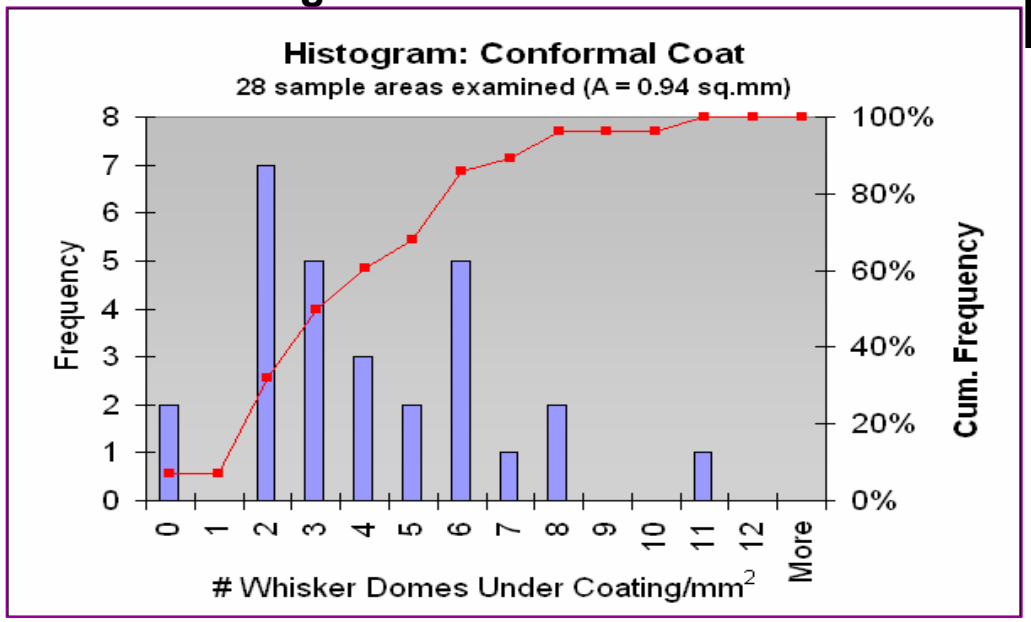
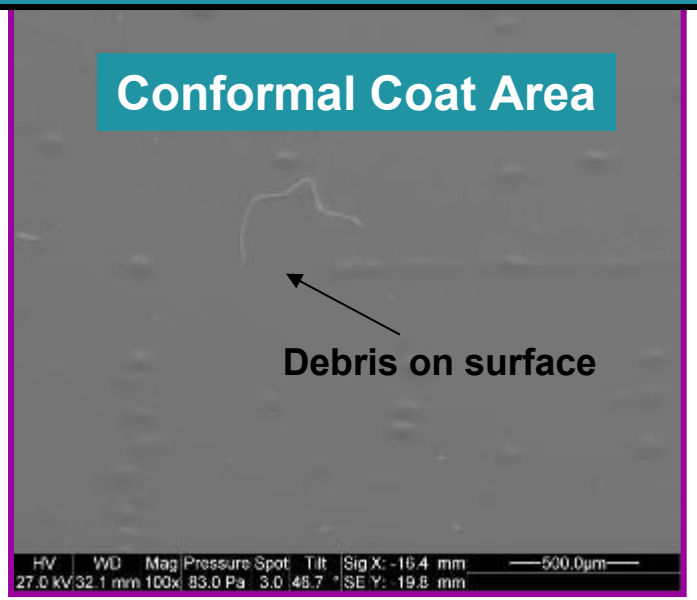
NASA Goddard Whisker Mitigation Study
Uralane 5750 – 2 Mils Thick
9-Years of Office Ambient Storage

- **Conformal Coated Areas Grew Whiskers Too within the First Year. After 9 years of storage we find the following:**
  - ***To date ALL whiskers are contained beneath the coating that is 2 mils thick***
  - ***SEM cannot see INTO coating. Thus we see only "domes" caused by whiskers that lift coating slightly***
  - **Avg: 3.4 ± 2.6 domes / mm²**
  - **Range: 0 to 10.6 domes / mm²**

We suspect we are only counting "thick" whiskers in this statistic because the "thin" ones mechanically buckle before they can lift the coating enough to produce visible "domes"

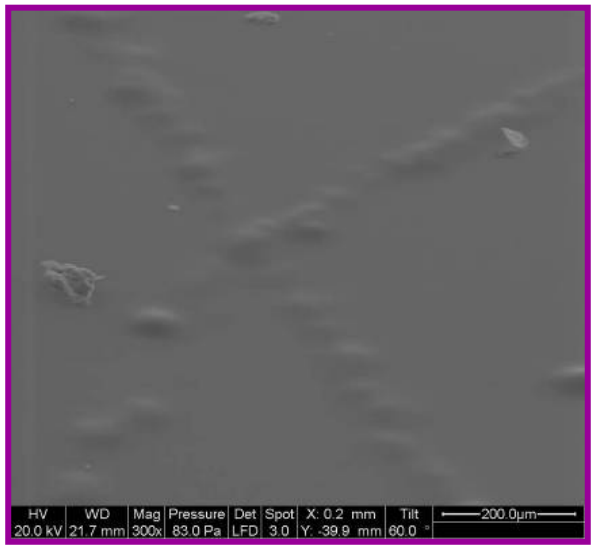
2 Mils Uralane = Very Effective

Whiskers Completely Entrapped Under the Coating → Euler Buckling

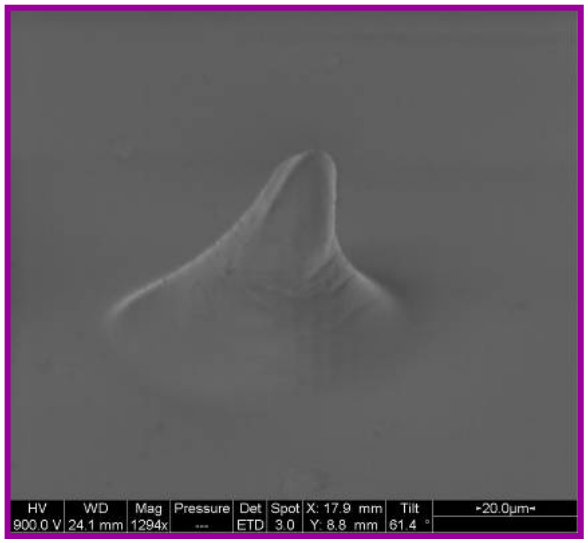
~0.5 Mils Uralane = Less Effective

Whisker "Lifting" Coating into Shape of Circus Tent, But Not Yet Penetrating

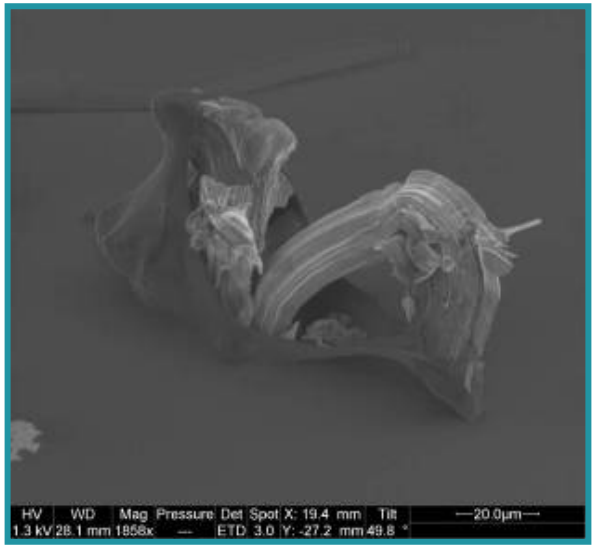
~0.1 Mils Uralane = Not Effective

Whiskers Breaking Through "Thin" Coating

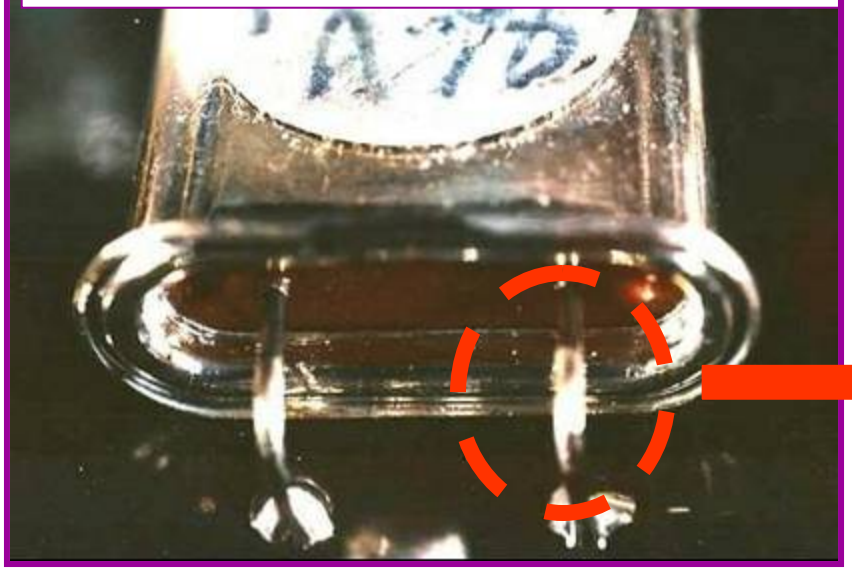
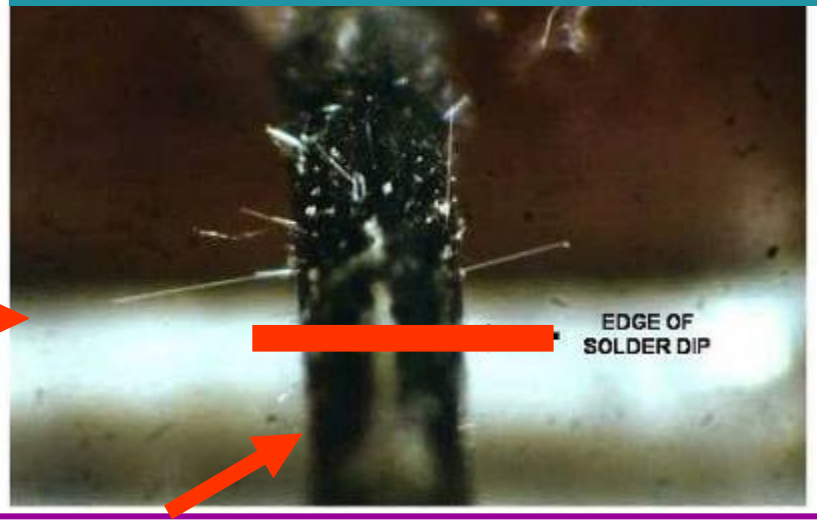
***Field Failure ONE Year* After Assembly**

Crystal with Tin-Plated Kovar Leads (with Nickel Underplate)

Tin Whiskers (~60 mils) Grew on *NON-Dipped* Region Shorting to Case Causing Crystal to Malfunction

- Leads were *Hot Solder Dipped* (Sn63Pb37) *within 50 mils* of Glass Seal BEFORE Mounting to enhance solderability
- Dip was not 100% of leads due to concerns of inducing harm to glass seal

- No Whiskers on Hot Solder Dipped Surface
- ABUNDANT whiskers on the Non-Dipped Surface

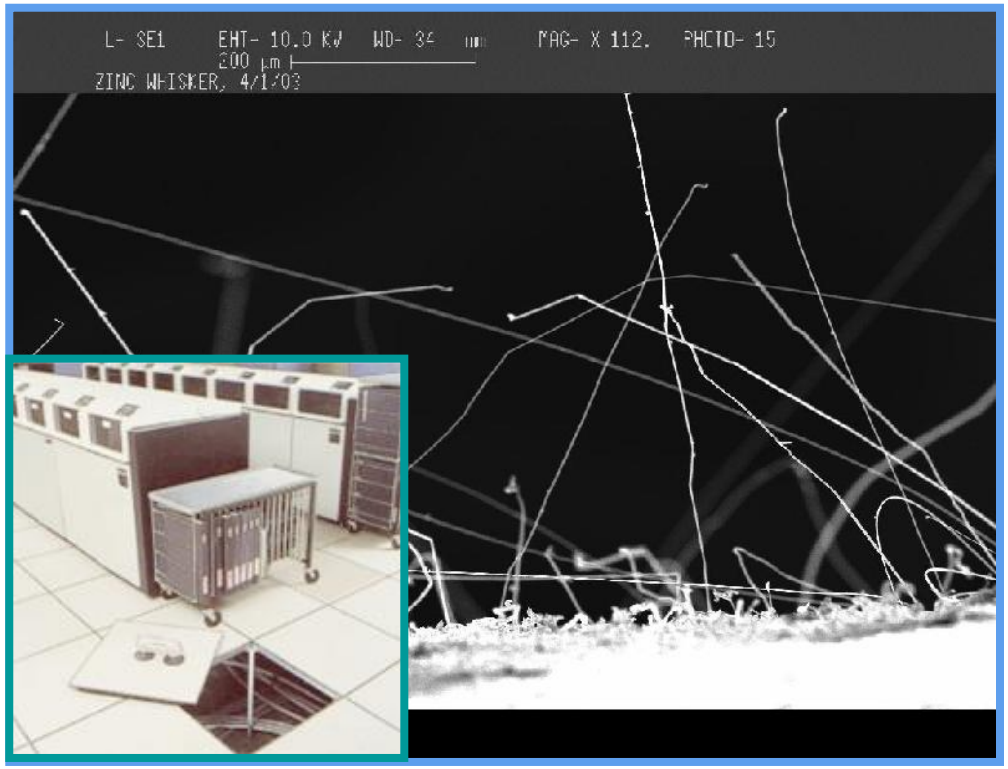
Zinc-Coated Computer Room Floor Tiles
Zinc Whiskers

Cadmium-Plated Connector Shell
Cadmium Whiskers

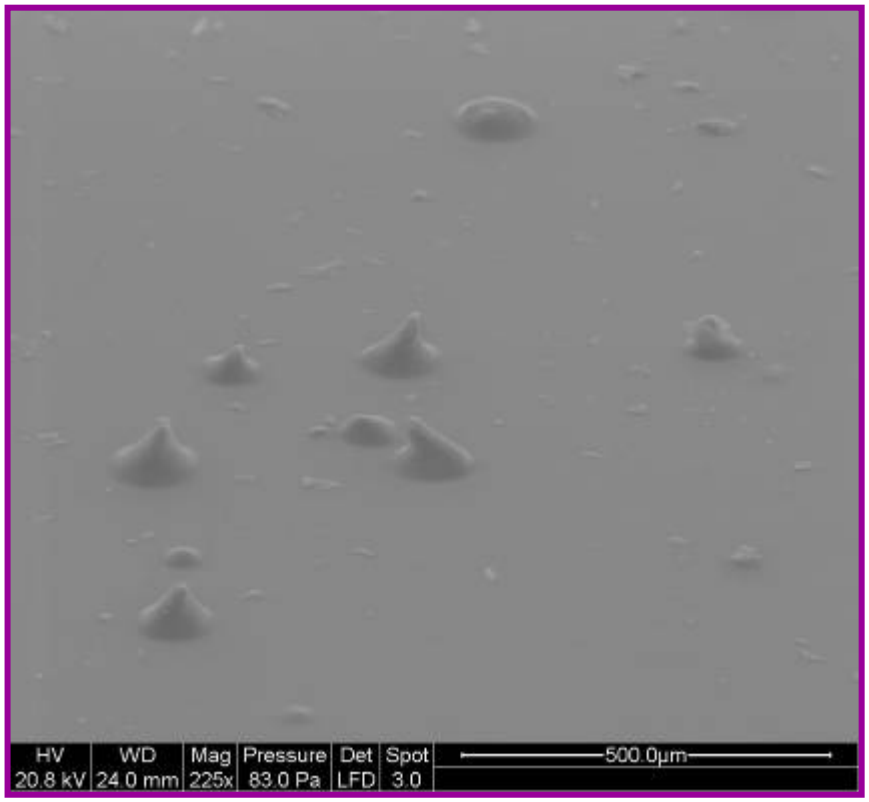
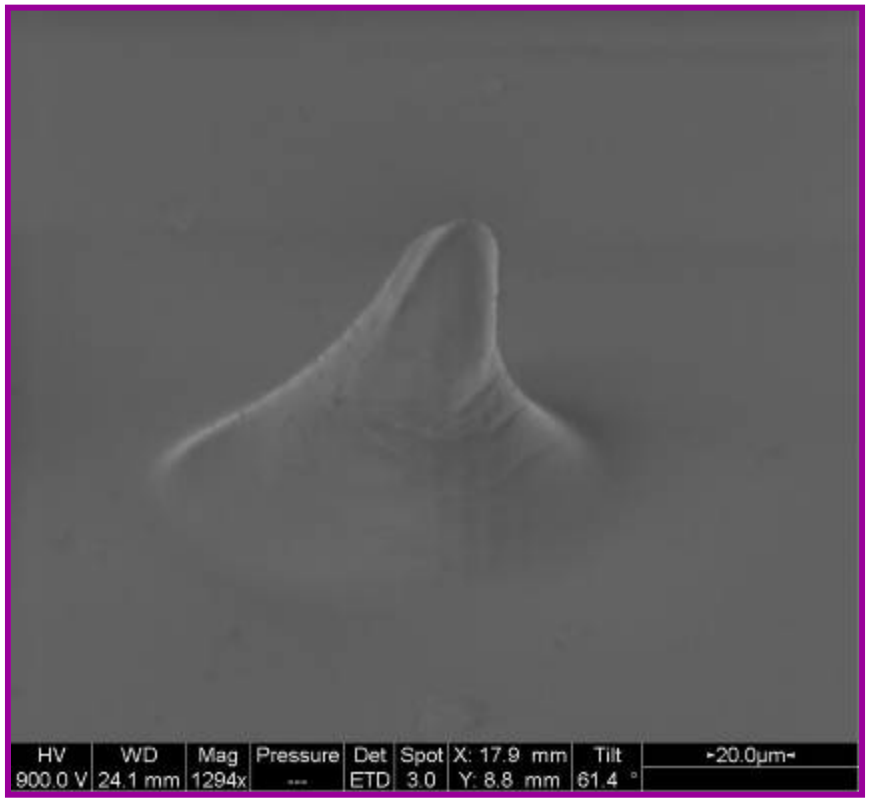
Tin Whiskers Forming "Circus Tents" in Thin Uralane 5750 Conformal Coat - 9-Years of Office Ambient Storage

Coating Thickness < 0.5 Mil

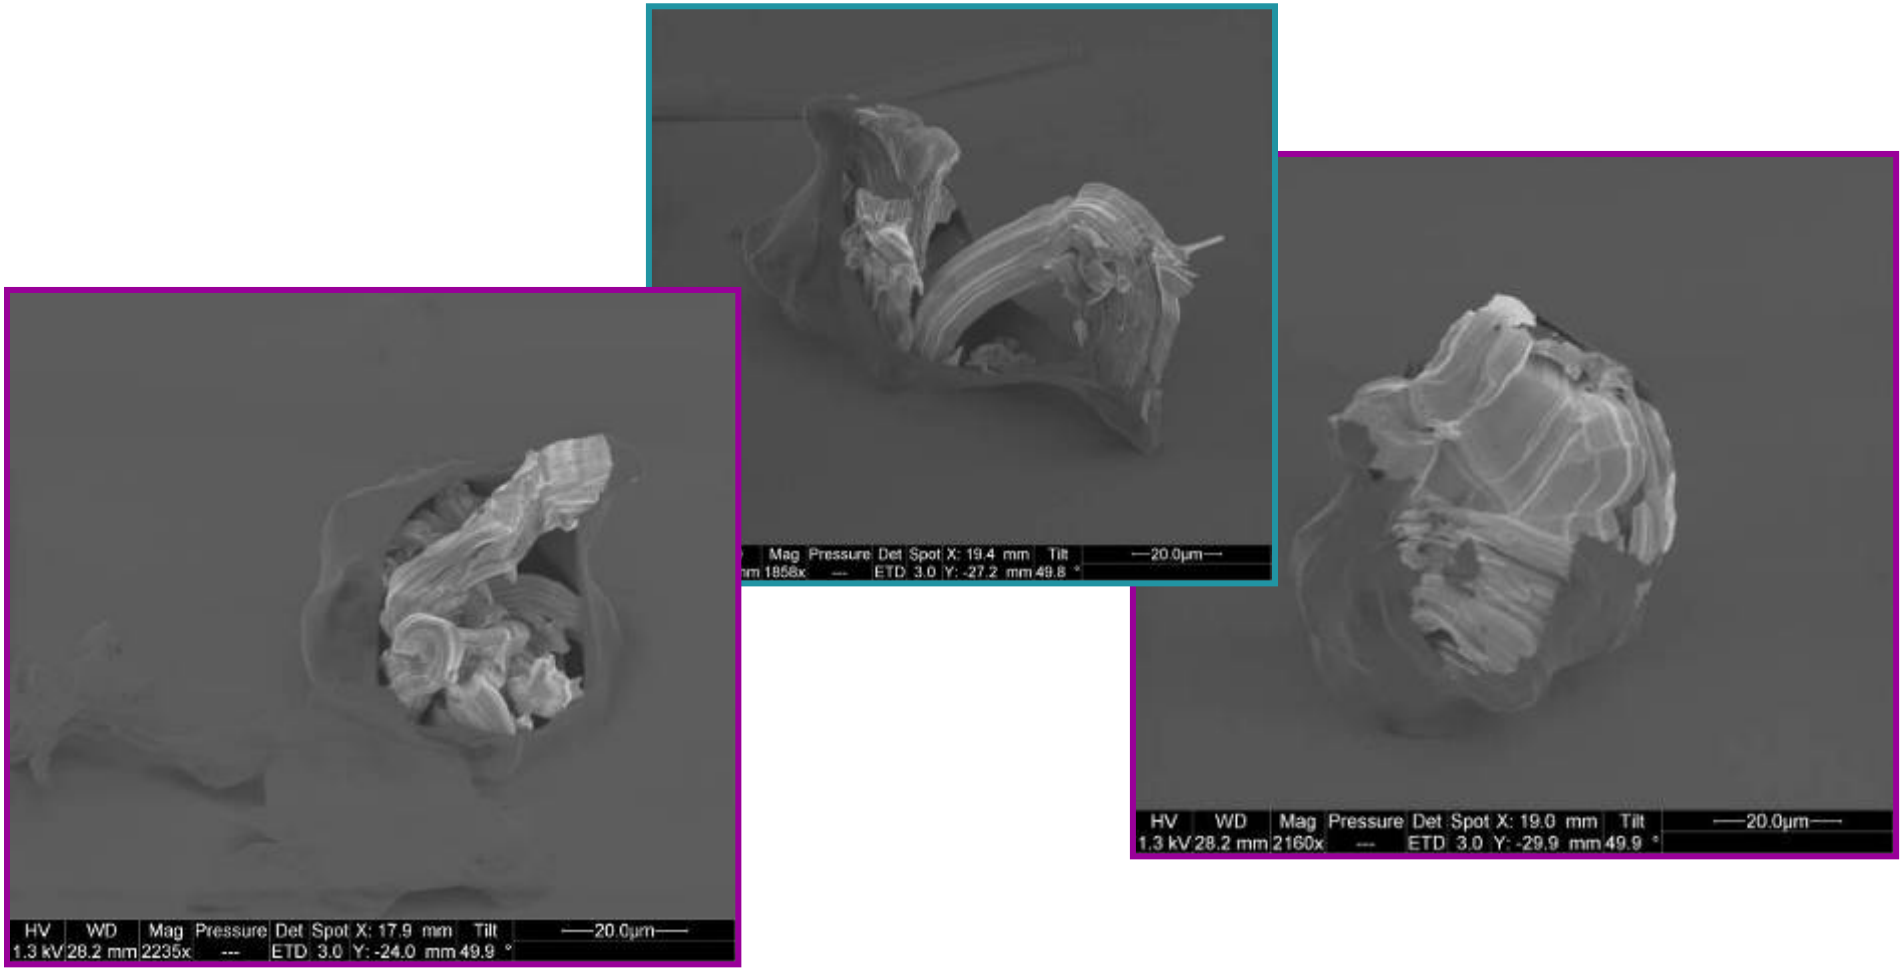
Tin Whiskers Rupturing THIN Coating
~0.1 to 0.2 Mils Uralane 5750 Conformal Coat
9-Years of Office Ambient Storage

Thank Goodness for Euler Buckling and Conformal Coat on this PWB!!!
