# **Body of Knowledge Guideline Document on Commercial MNOS EEPROM in Space Applications**

NEPP 2005 Task Final Report

Task Manager  
Yuan Chen  
JPL

April 7, 2006

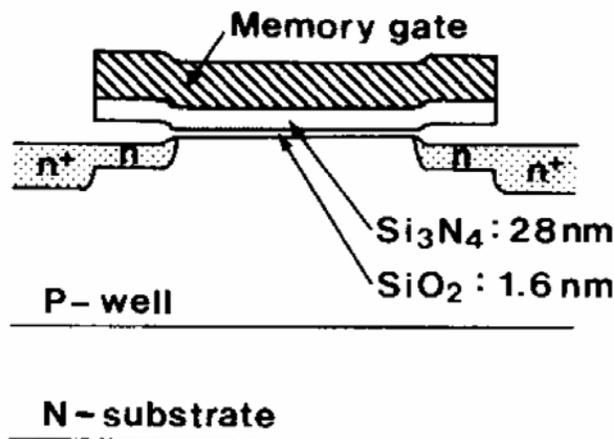
MNOS EEPROMs [1] utilize a metal-nitride-oxide-silicon (MNOS) transistor and two MOS switch transistors as a memory cell. For a 2- $\mu\text{m}$  CMOS fabrication process, the cell area is  $118 \mu\text{m}^2$  and the MNOS structure has a tunnel  $\text{SiO}_2$  layer of 1.6 nm and a  $\text{Si}_3\text{N}_4$  layer of 28 nm in thickness, shown in Figure 1 [1].

Figure 1. Schematic of the MNOS memory transistor.

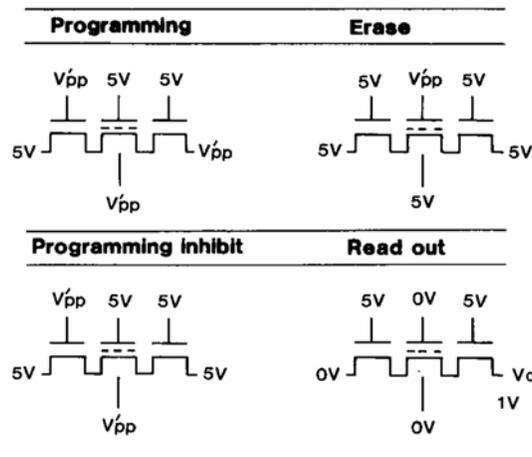
Figure 2 [1] gives the basic operations of the MNOS memory cell.  $V'_{pp}$  is an internally generated negative high voltage with a typical value of -10V.  $V_d$  is a readout drain voltage of approximately 1V.

Program (Write) inhibit: 5V is applied to the drain of the de-selected memory cell, and voltage potential between the gate and channel is zero.

Read: 0V is applied to the gate of the selected memory cell, then erased states (ONE's or "1") or written states (ZERO's or "0") are read out, according to the channel current varied with the threshold voltage of the MNOS transistor.

Figure 2. Basic operation schematics for the MNOS EEPROM memory cell.

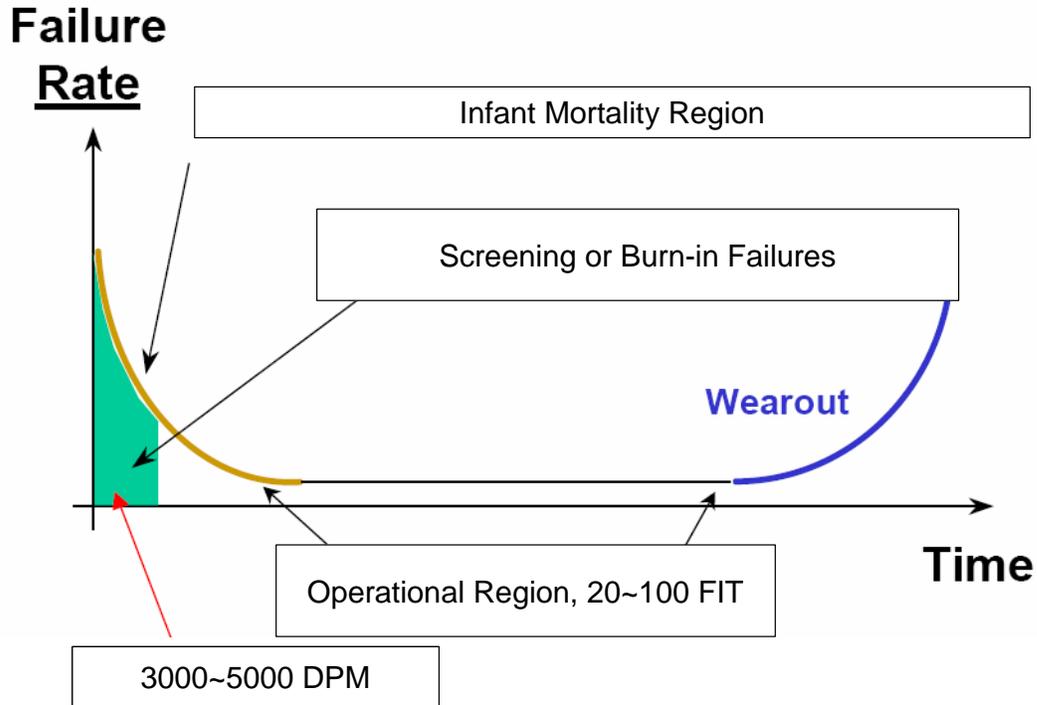
**First**, the purpose of an effective and successful screening testing is to eliminate the infant mortality failures and, therefore, the devices which have passed the screening testing should be operating at the bottom portion of the bath tub curve, shown in Figure 3. Compared to infant mortality region and wearout region, the failure rate of the operational region, i.e. the bottom portion of the bath tub curve, is much lower. The typical failure rate for the operational region is around 20 to 100 FIT, which is 20 to 100 failures per  $10^9$  device hours. The failure rate is low, but it is NOT zero.

Figure 3. Bath tub curve.

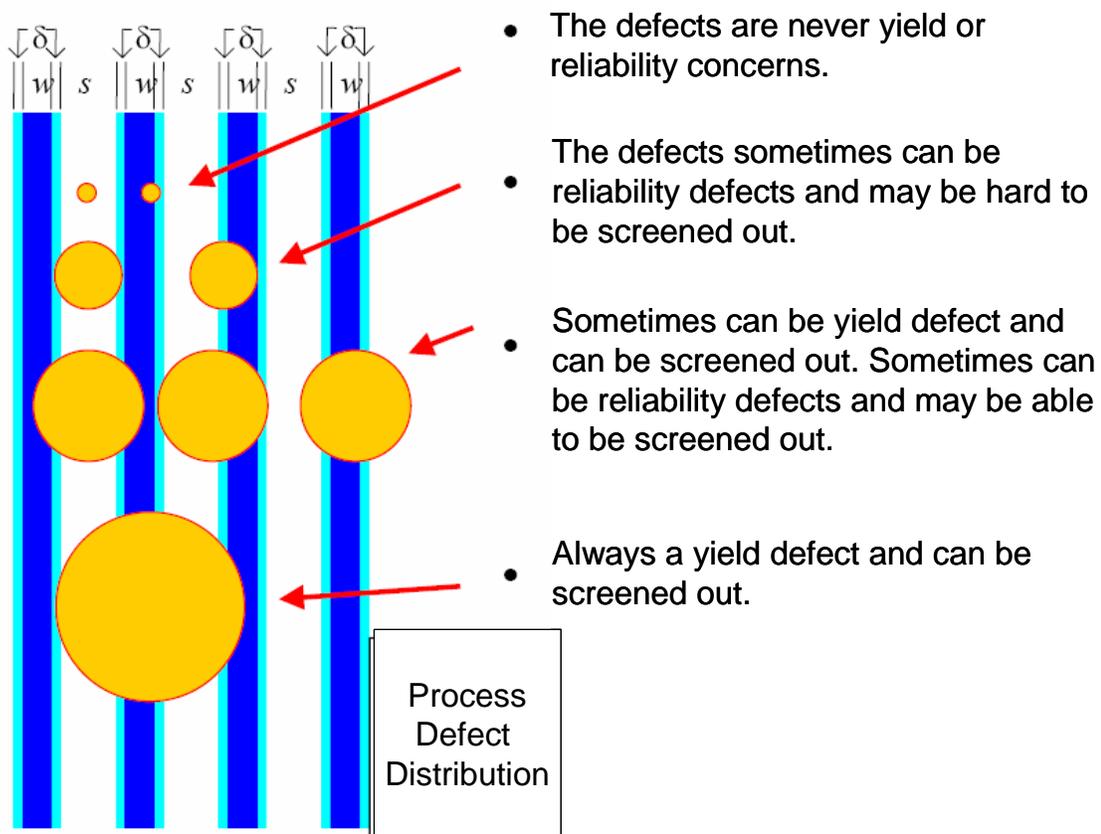
Shown in Figure 4, process defects can be categorized by four groups depending on their sizes and locations on the circuits:

1. Defects which are smaller enough or in locations where they will never be yield or reliability concerns.
2. Potential reliability defects: defects are smaller enough or in locations where they may not be yield concerns, but can cause reliability failures in applications. In this case, time-dependent nature of some failure mechanisms can contribute to the potential reliability field failures.

3. Potential yield defects: defects are smaller enough or in locations where they do not cause initial yield failures, but can potentially cause parts to fail if parts are tested under an accelerated condition. In this case, the defects can be detected during screening testing.
4. Yield defects: defects are large enough or in locations where they cause yield failures, i.e., functional failures during wafer level or package level initial electrical testing.

As we can see, screening testing can reduce the failure rate by screening out the yield defects (category 4) and some of the potential yield (category 3) and reliability defects (category 2). But no screening testing can guarantee to screen out ALL the reliability failures for ALL parts. Therefore, in order to achieve a possible near-to-zero failure for mission, redundancy at different levels i.e. bit, page or image, is needed for the EEPROMs.

Figure 4. Defect distribution – schematics of yield and reliability defects.

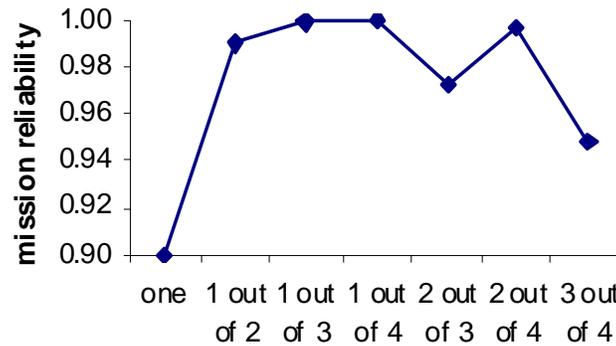
Image redundancy also has a big impact on improving overall mission reliability from the perspective of the MNOS EEPROM. Again, assuming that equation gives a 90% reliability for one image, then a mission reliability will be 90% for no image redundancy, 99% for redundancy

of two images with only one needed to achieve mission objectives, 99.9% for redundancy of three images with only one needed to achieve mission objectives, 97.2% for redundancy of three images with two needed to achieve mission objectives, 99.63% for redundancy of four images with two needed to achieve mission objectives. This indicates that the image redundancy will greatly improve the system/mission reliability.

Figure 5. Impact of image redundancy on mission overall reliability.
