January 2010 • Volume 2 • Issue 1

Special Edition: Because electronic parts packaging is frequently discussed on Domestic and International NEPAG telecons, we bring you this article by JPL's Phil Zulueta.

Inspection of Area Array Package Interconnections

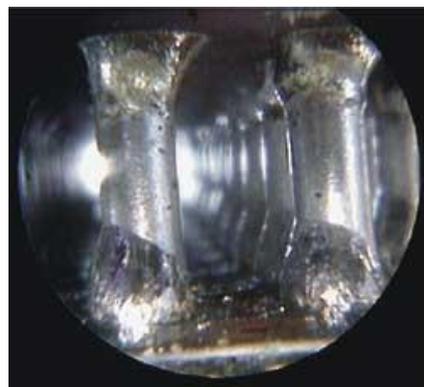
Endoscope image of CGA Interconnects (Courtesy Advanced Packaging)

This inspection can be accomplished with either an optical endoscope (a fiber-optic tube) or a rotating prism system attached to a viewing device.

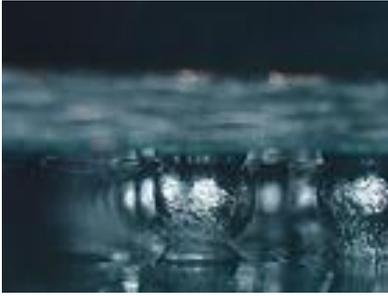
Rotating Prism image of BGA interconnects (Courtesy Hirox)

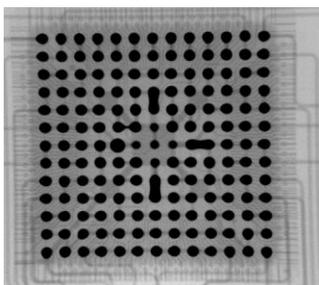
2D X-ray of a BGA on a PCB shows solder bridges, excess solder and insufficient solder reflow defects. (Courtesy FeinFocus)

2D X-ray, providing a top-down image of the board or package area being viewed, or more advanced systems offering the ability to examine samples for defects at oblique angles, can distinguish a variety of solder defects such as voids, shorts, excess solder or insufficient solder reflow.

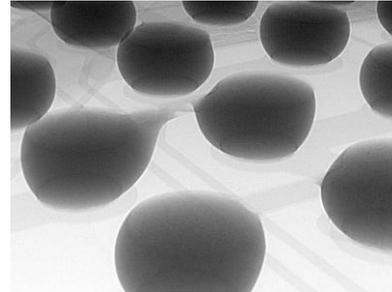
Oblique 2D X-ray view of BGA (Courtesy Xylon)

In this case, oblique angle imaging can reduce this problem, depending on the complexity of the assembly inspected. Overall, 2D X-ray inspection of area array interconnects is a quick, economical inspection method, but also has its limitations.

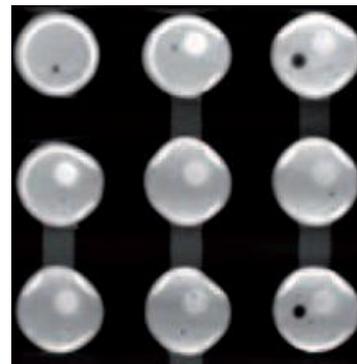
Solder voids (Courtesy Xylon)

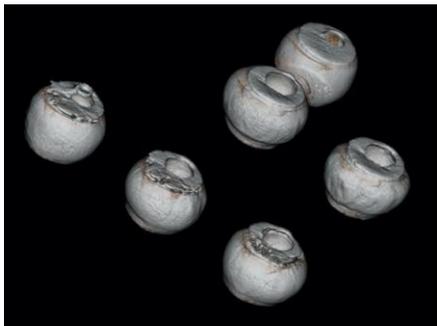
3D view of BGA balls with voiding close to pad and small fractures (Courtesy Xylon)

For example, solder balls on the underside of BGAs can be viewed from all sides, and defects such as insufficiently wetted or cracked balls can be easily identified.

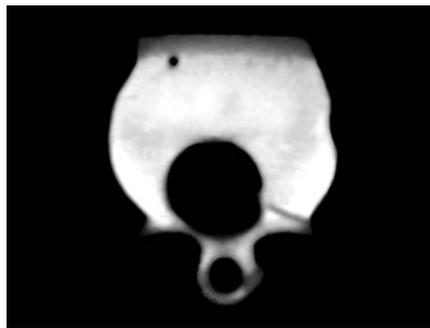
3D slice of single BGA ball with μ -via showing micro-crack and various voids (Courtesy Xylon)

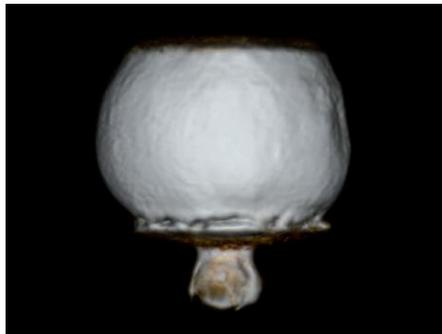
3D view of single BGA ball with μ -via (Courtesy Xylon)
