# TID and SEE Response of Advanced 4G NAND Flash Memories

T. R. Oldham, *Fellow, IEEE*, M. Suhail, M. R. Friendlich, M. A. Carts, R.L. Ladbury, *Member, IEEE*, H. S. Kim, M. D. Berg, C. Poivey, *Member, IEEE*, S. P. Buchner, *Member, IEEE*, A. B. Sanders, C. M. Seidleck, and K. A. LaBel, *Member, IEEE*

**Abstract-- We present total dose and SEE responses for 4G NAND flash memories by three different manufacturers. The SEE response is scaled to predict the response to atmospheric neutrons at aircraft altitudes and at sea level using the Figure of Merit.**

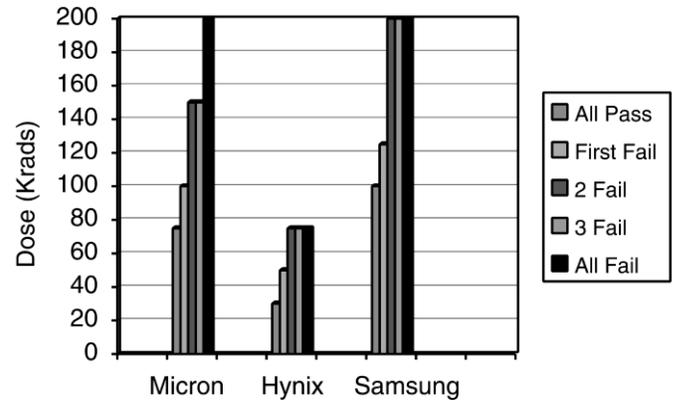
Fig 1. TID response for Micron, Hynix, and Samsung 4G NAND flash memories.

TID results are summarized in Fig. 1. For the Hynix parts, all passed at 30 krad (SiO<sub>2</sub>), the first part failed at 50, and the rest failed at 75 krad(SiO<sub>2</sub>). For Micron, all parts passed at 75 krad (SiO<sub>2</sub>), one failed at 100, two more failed at 150 krad (SiO<sub>2</sub>), which was the next exposure level. At this point, the test was terminated, with one part still working. The chart assumes it would have failed at the next level, 200 krad (SiO<sub>2</sub>). For Samsung, which is shown here for comparison, all parts passed at 100 krad (SiO<sub>2</sub>), one failed at 125, and the other seven failed between 150 and 200 krad (SiO<sub>2</sub>).

In the zero bias test, the irradiations were performed with the parts mounted on conducting foam. The Samsung parts had no failures through 400 krad (SiO<sub>2</sub>), although some errors had to be reset. First failure was at 500 krad (SiO<sub>2</sub>), with the last two parts failing at 700 krad (SiO<sub>2</sub>). The first Micron part failed at 200 krad (SiO<sub>2</sub>) (passed at 150), because errors could not be reset completely. Others failed at 300 krad(SiO<sub>2</sub>), because the write operation was not successful. Before failure, there were other errors that could be reset. The first Hynix part failed at 200 krad (SiO<sub>2</sub>), because errors could not be reset completely. Others did not fail until 500 krad (SiO<sub>2</sub>), when the write operation failed. However, all the parts had errors before total failure, which were reset successfully. This test was performed because the use of cold spares is sometimes considered as a way of extending system lifetime. Parts from all three manufacturers survived past the point where they failed in the biased test, which suggests that cold spares can be used successfully, in general.

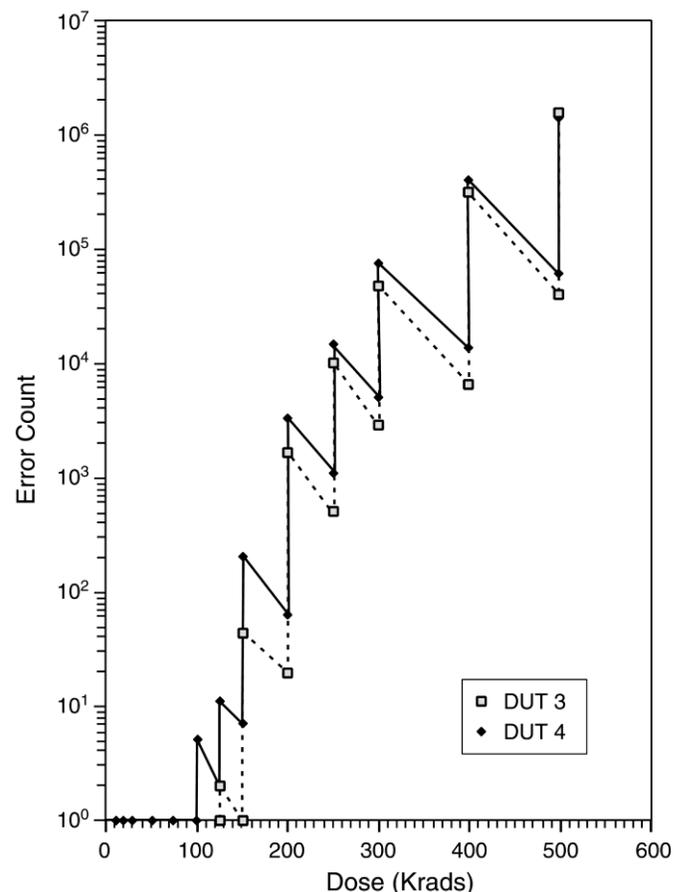
Fig 2. Error count for Samsung 8G NAND flash as a function of dose, showing recovery during irradiation, and new errors from reprogramming.

For the single chip 8G parts from Samsung, we observed a failure mechanism different from most other flash memory we have previously tested. The high voltage charge pump never failed, even at 700 krad (SiO<sub>2</sub>). Consequently, the high voltage program (write) and erase operations never failed.

The failure mechanism was that the write circuit was actually working too well—the control logic that was supposed to turn off the write circuit eventually failed. There were no errors of any kind through 50 krad (SiO<sub>2</sub>). At 75 krad (SiO<sub>2</sub>), one read-only part, and one fully exercised part had errors in the initial read operation after the exposure. (Other parts had no errors of any kind). These errors were zero-to-one errors, where radiation-induced positive charge neutralized (or compensated) the negative charge stored on the floating gate. Often, errors of this kind can be erased and rewritten, so they are not considered fatal. In this case, the rewrite operation introduced errors of the opposite polarity. That is, the part was successfully erased, but, in the write operation, negative charge was injected in locations that were not supposed to be injected. The errors are distributed in a highly non-random manner, which also points to the control logic. For the fully exercised part, for example, in the AA pattern, there were 22 consecutive errors in blocks 3884 and 3885, where column 275 contained the error. Page numbers differed by four or a multiple of four from one error to the next, and the same bit was in error in each word. Chances of such a regular error pattern occurring from a random variation of the individual bits are vanishingly small. These two parts could have been considered to have failed at this point, because they had errors that could not be corrected. However, they continued in the test, to see what would happen next. At the 100 krad (SiO<sub>2</sub>) level, there were no errors in the parts that had not had errors before. In the two parts that had errors from the reset operation after the previous exposure, the radiation actually corrected most of the errors. In subsequent exposures, this turned out to be a typical result—the radiation-induced positive charge was enough to correct half to three quarters of the incorrectly written zeroes. That is, it was enough to turn them back into ones. Normally, however, it was never enough to corrupt any of the correctly written zeroes. Apparently, the errors are only partially written. When these two parts were rewritten after this exposure, the number of errors increased again. At 125 krad (SiO<sub>2</sub>), one more fully exercised part started to have errors when rewritten. The parts with errors before had fewer after irradiation, but more when reset. At 150 krad (SiO<sub>2</sub>), the last fully exercised part started to have errors when rewritten. The last read-only part had large numbers of errors at 200 krad (SiO<sub>2</sub>), which could be erased but not rewritten. All the parts received several more dose increments, with qualitatively similar results—number of errors decreased with irradiation, but increased with rewriting. These results are summarized for two of the exercised parts in Fig. 2.

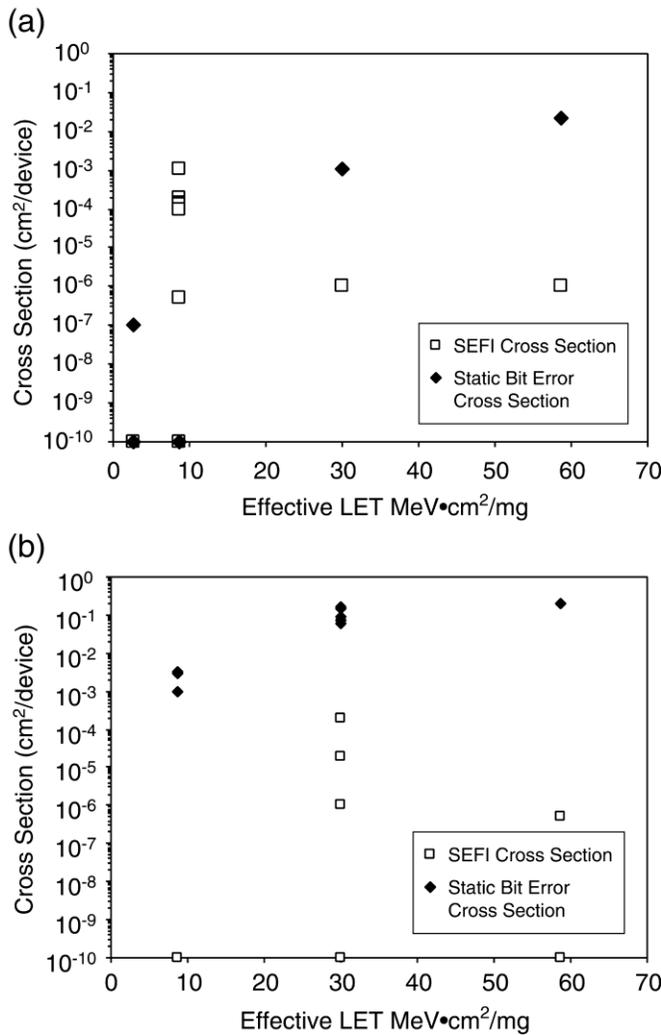
Fig 3. Static mode bit error cross-section, and SEFI cross-section (a) Micron; and (b) Hynix.

During testing, the DUTs were irradiated with the ions indicated in Table I. The DUT was oriented normal to the incident beam, except as noted. The errors observed in static testing are shown in Fig. 3a for the Micron part, and Fig. 3b for the Hynix part.

Even for the static case, bit errors and Page/Block errors were evident in the patterns of upsets observed. It is likely that the Page/Block errors arise due to upsets in configuration registers in the memory array. Because the DUT was not actively exercised during the exposure, we could not determine exactly when a page/block error occurred, so cross sections are approximate for these error modes. Here and in the following discussion, bit errors are taken to be single bits, which are flipped, as a result of the interaction with incident ions, normally from zero to one. We do not have the physical to logical address mapping, which would allow us to look for multiple bit errors (error clusters) for these parts. However, in the overwhelming majority of cases of bit errors, there is only one error in a page, or one error in an entire block, which makes it extremely unlikely that there will be multiple errors from a single ion. This result is consistent with previously published results on the upset mechanism in flash memory—an ion passing through a floating gate creates a dense charge column, which creates a conducting path between the gate and substrate, which allows charge to leak off the floating gate. Since the ion only hits one gate at normal incidence, only one bit is affected. This situation is far different from that in

volatile memories, where charge generated in the Si substrate can be shared across multiple nodes. The only apparent multiple bit errors are cases where an entire page or a block (or a large part of one) upsets simultaneously—these page and block errors are attributed to errors in the control logic, rather than to the individual bits. These are counted as SEFIs (Single Event Functional Interrupt). In general, a SEFI is any event where the entire DUT, or a large part of it, stops working, presumably from an interaction with a single ion. As a practical matter, most of the SEFIs recorded here are either page errors or block errors, although some involve multiple pages or multiple blocks. Some are also watchdog errors, where the DUT simply stopped responding to commands.

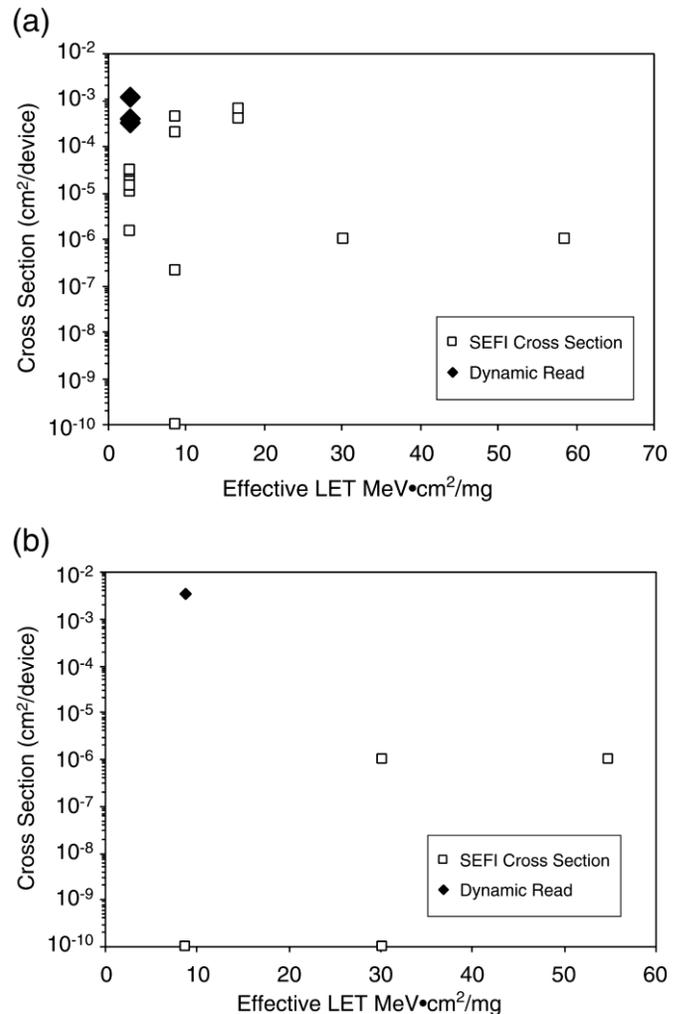
Fig 4. Dynamic read error cross-sections: (a) Micron; (b) Hynix.

For the Dynamic Read condition, the parts showed exhibited transient read errors in addition to the bit and Page/Block errors, and other SEFIs, which are plotted in Fig. 4. For Ne and Ar ions (LET up to 9.74), there were no static bit errors at any LET, detected after the beam was turned off. There were transient read errors, as shown in Fig. 4, at these LETs, which are thought to be due to noise in the read circuit. At higher LETs (Cu, Kr, and Xe ions), SEFIs were observed on all shots for the Micron part, and many shots for Hynix parts, which made it difficult to count the transient errors—if

the DUT stops responding to commands, it is hard to say what errors were not counted. And most of the errors that were counted, were due to control logic, and not associated with individual bits. After the DUT was restored to operating condition, it could still be checked for static bit errors, however. The transient results are shown in Fig. 4. Static results are not shown in Fig. 4, but they are consistent with results in Fig. 3. In Fig. 4, we have attempted to count SEFI events, despite the obvious difficulties of doing so. For example, one can count block errors, but it is often unclear whether multiple events are independent or not. We have assumed that block or page errors at widely separated addresses are independent events, and block or page errors at consecutive addresses are one event. Of course, if the DUT stops responding to commands, there may be other events that were missed completely. The number of SEFI events is small in any case. As always, the statistical uncertainty associated with rare events is large.

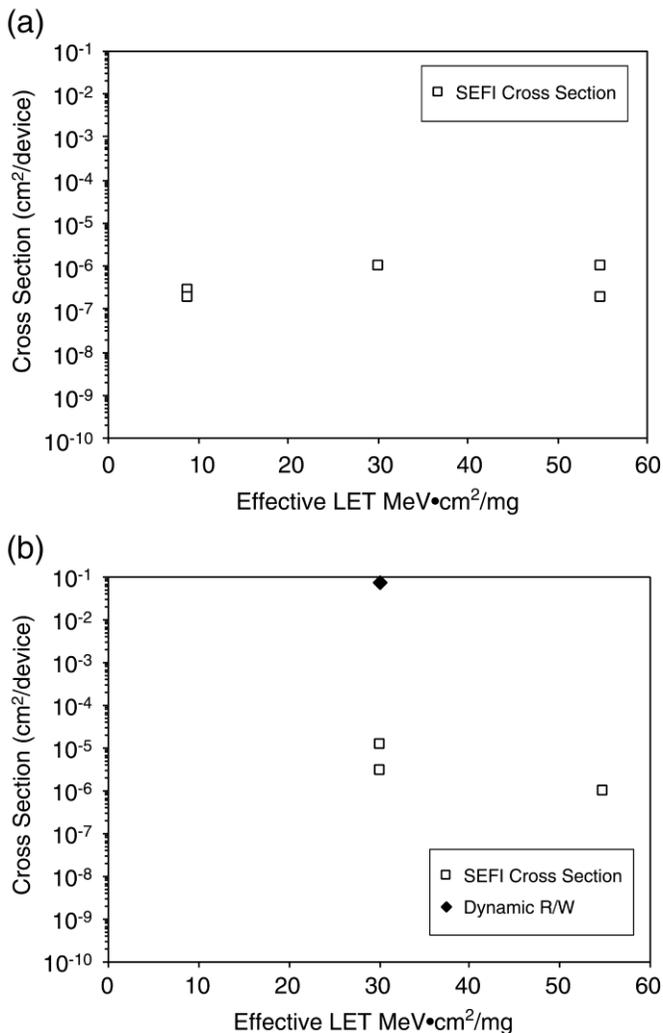
Fig 5. Dynamic R/W error cross-sections: (a) Micron; (b) Hynix.

Results of the dynamic R/W tests are shown in Fig. 5. Generally these results are unremarkable, because the usual zero-to-one errors are rewritten as they occur. For this reason, there are fewer errors indicated than in Fig. 4. The main reason for including this test was the expectation that the high voltage write operation would contribute to more errors in the control circuits, but this appears not to have happened, at least not on a large scale. Probably, this is because the write operation is performed only when a zero-to-one error is detected. For this circuit, four thousand such errors are still only one part per million of the entire memory, so the write circuit duty cycle is a very small number. Where a static cross section is given, it is based on the number of errors detected after the exposure and resetting of the DUT. The transient cross section is based on errors detected during the exposure. But some of the transient errors are probably really static bit errors that were rewritten during the test.

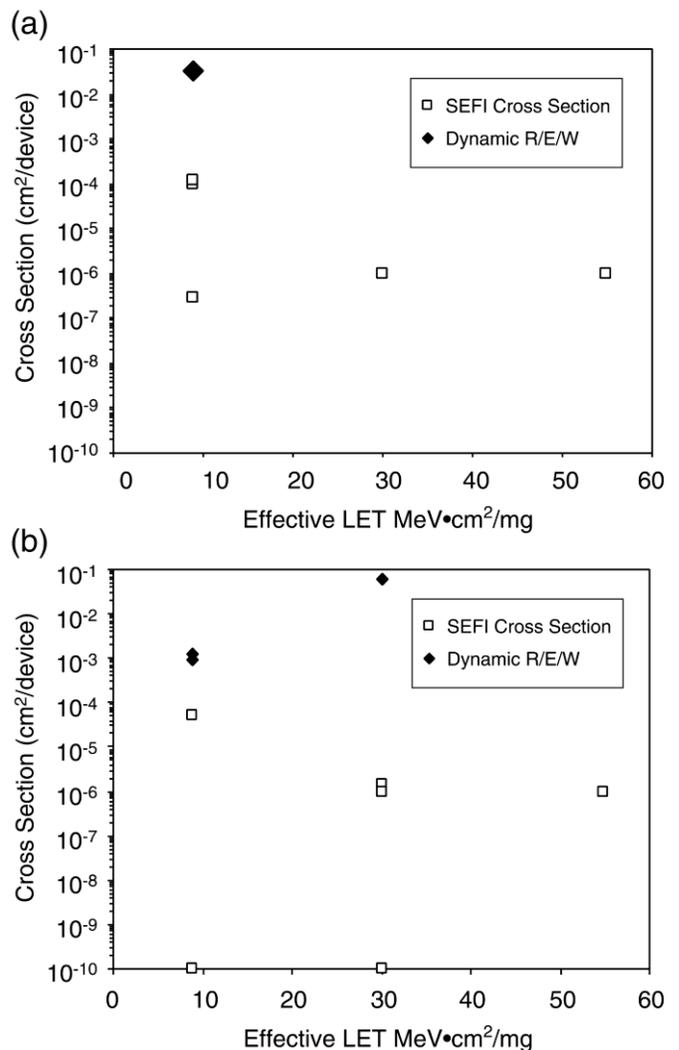
Fig 6. Dynamic R/E/W error cross-sections: (a) Micron; (b) Hynix.

Results for the dynamic R/E/W tests are shown in Fig. 6, to the extent that they can be determined. For this condition, there were many more SEFIs than in the R/W (without erase) mode, which is probably due to the fact that every block is erased and rewritten on every cycle, so that the duty cycle for

high voltage operations is much higher. As a practical matter, there are many page and block errors, which usually appear to be independent, on almost every shot with LET at or above 9.74 (Ar). With many large chunks of the memory completely knocked out, it becomes impossible to determine static or transient errors affecting only single bits.

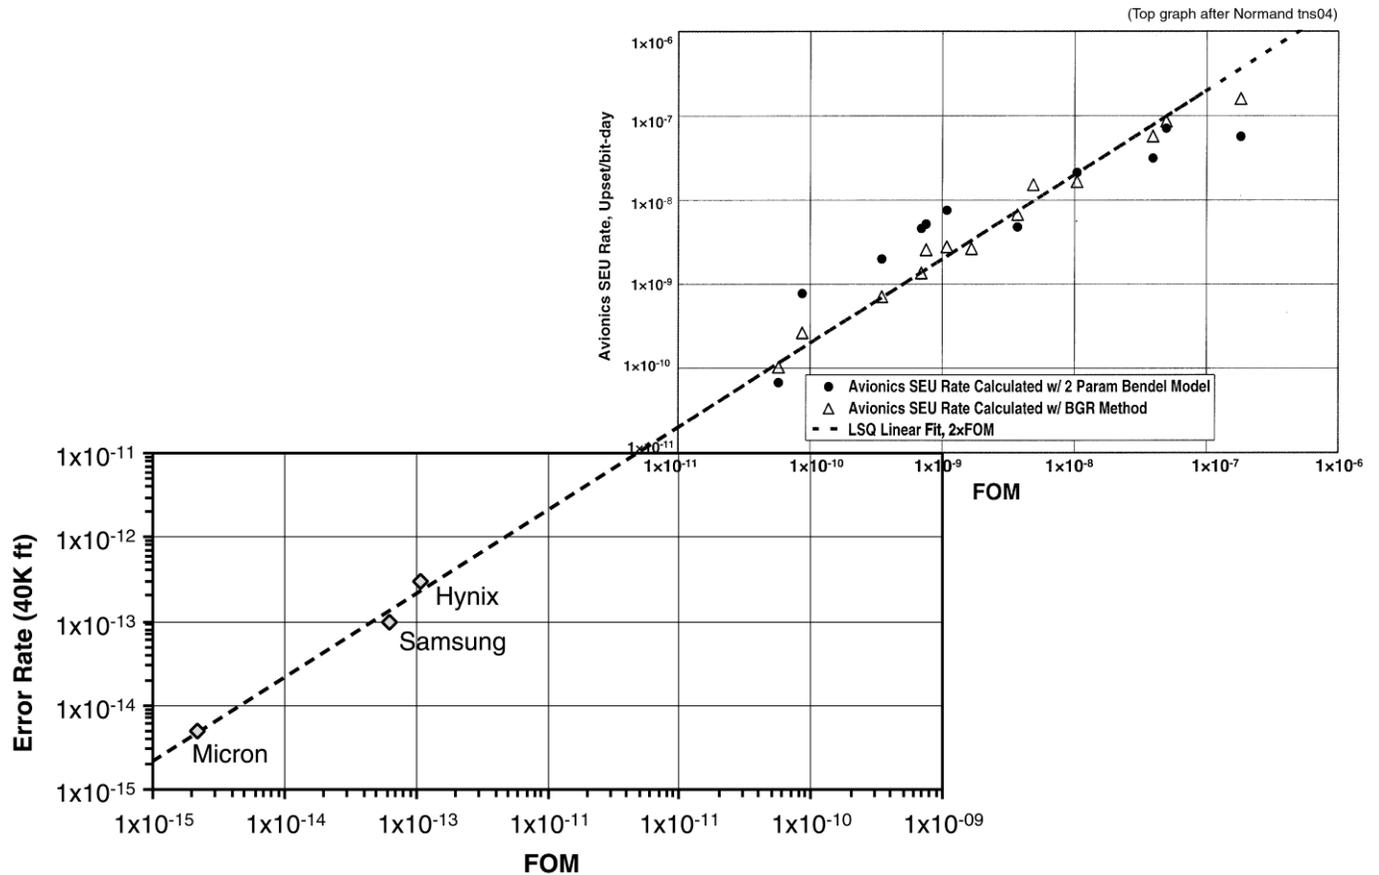
Fig. 7. Floating Gate Technology Radiation Damage.

making plausible assumptions of the “true” saturation, and the uncertainty seems to be a factor of two or less. On a log-log plot like Fig. 7, covering nine decades on each axis, this difference would be barely perceptible.
