Heavy Ion SEE Test Report for the Micron 4Gbit NAND Flash Memory for MMS

Tim Oldham, Perot Systems Government Services, Inc./NASA-GSFC
 Mark Friendlich, MEI Technology Inc./NASA-GSFC
 Anthony B. Sanders, NASA GSFC
 Hak Kim, MEI Technology Inc./NASA-GSFC
 Melanie Berg, MEI Technology Inc./NASA-GSFC

Test Date: 3-4 Nov 2008

Report Date: 27 Jan 2009

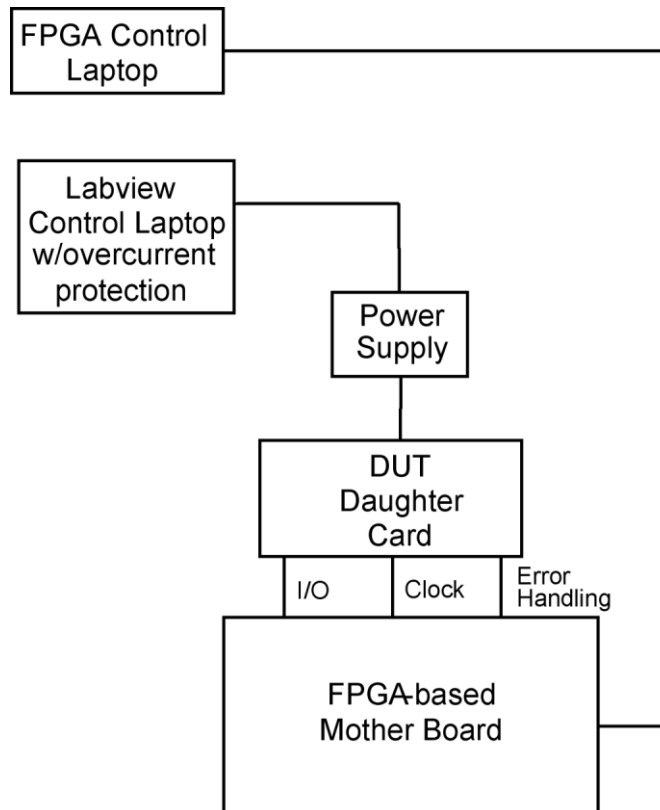
Figure 2. Overall Block Diagram for the testing of the NAND Flash.

The Block diagram for control of the DUT is shown in Figure 2. The FPGA based controller interfaces to the FLASH daughter card and to a laptop, allowing control of the FPGA and uploading of new FPGA configurations and instructions for control of the DUT. Power for the flash is supplied by means of a computer-controlled power supply. The National Instruments Labview interface monitors the power supply for over-current conditions and shuts down power to the DUT if such conditions are detected.

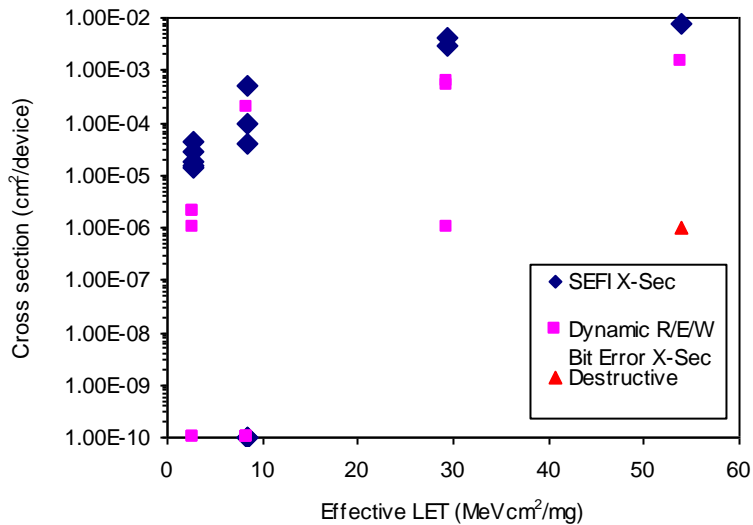
Fig. 8. Dynamic Read/Erase/Write results.

Results for the dynamic R/E/W tests are shown in Fig. 8, to the extent that they can be determined. For this condition, there were many more SEFIs than in the R/W (without erase) mode, which is probably due to the fact that every block is erased and rewritten on every cycle, so that the duty cycle for high voltage operations is much higher. As a practical matter, there are many page and block errors, which usually appear to be independent, on almost every shot with LET at or above 8.4 (Ar). With many large chunks of the memory completely knocked out, it becomes difficult to determine static or transient errors affecting only single bits. The one destructive failure was a latchup, with current jumping to about 80 mA almost as soon as the beam was turned on and staying there until power was cycled, about two minutes later. Afterwards, the DUT could be read normally, but the erase function had been destroyed. This exposure was performed at $T=70^{\circ}\text{C}$, and $V_{dd}=3.6\text{ V}$.
