Total Dose Test Report for Micron
4G NAND Flash Nonvolatile Memory

Test Date: 22-29 Oct 2008

Report Date: 18 Feb 2009

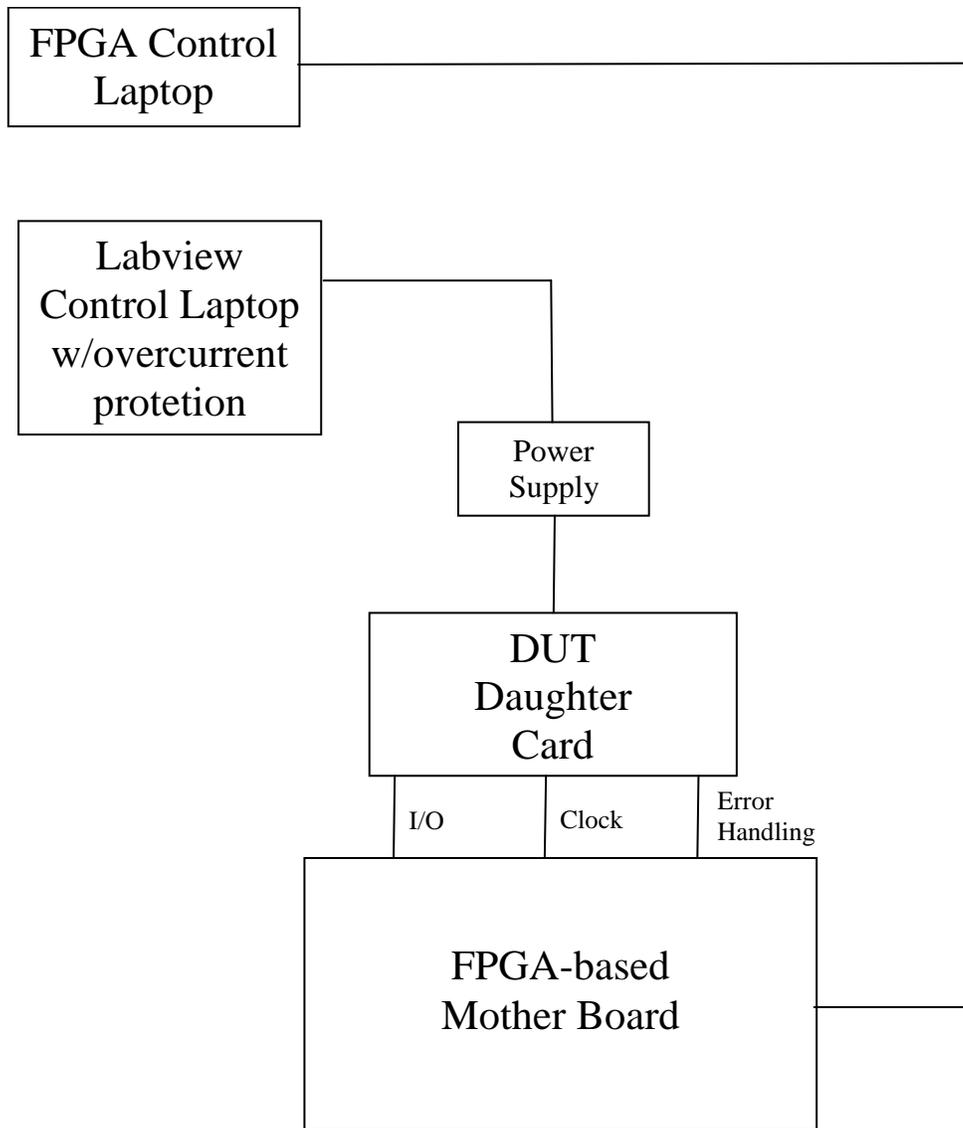
Fig. 1. Block diagram of the flash memory test apparatus.

The test devices were programmed with a checkerboard pattern (AA) during exposures, and biased at 3.6 V (3.3 V nominal power supply, plus 10%), but the devices were not actively exercised during exposures. Four parts were read (only) between exposures, to look for problems related to the integrity of the individual bits. The other five parts were exercised between exposures—read, erased, and written into four different patterns. The patterns were checkerboard (AA), checkerboard complement (55), all ones, and all zeroes. In each of these tests, the entire memory is read, or erased, or programmed in one operation, with the commands entered manually. There is also a dynamic test mode, where each block is read, erased, and programmed, then the next block, and so on until the entire memory is completed. A block diagram of the test apparatus is shown in Fig. 1.
