# Single-Event Effect Report for EPC Series eGaN FETs: EPC1001, EPC1010, EPC1014, EPC1012

Leif Scheick, Ph.D. Jet Propulsion Laboratory Pasadena, California

JPL Publication 13-4 2/13

NASA Electronic Parts and Packaging (NEPP) Program Office of Safety and Mission Assurance

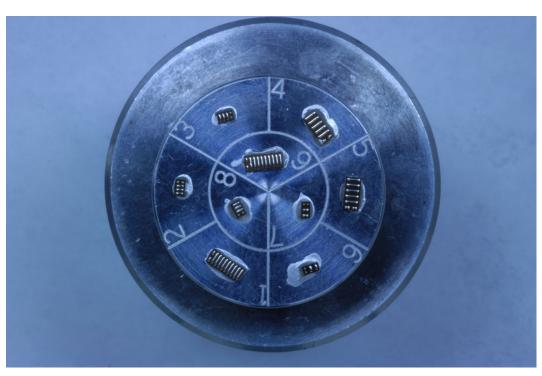
Figure 3-1. Picture of the EPC DUTs. All the available EPC devices are shown.

The DUT listed in Table I were acquired commercially and stored under flight ESD conditions per D-57732. Since these devices were so small and the package was atypical for SEE testing, the parts had to be irradiated through the solder bumps in a dead-bug configuration. Figure 2.1 shows the various devices acquired, as prepared for a focused ion beam (FIB) analysis. An EPC1014 was selected for FIB analysis to test the feasibility of irradiation through the solder bumps. Figure 2.2 shows the pin-out of this configuration and a 25x SEM micrograph before FIB cutting. Figures 2.4–2.7, show the results of the FIB and SEM scanning. The solder varies in thickness, but it is never larger than 50 um, so ions at TAMU could easily penetrate the entire transistor volume. Figures 2.8 and 2.9 show the results of an element map done to evaluate the properties of the DUT, identify the sensitive SEE and dose volumes, and aid in future modeling efforts. All these data allowed for the ions at TAMU to adequately irradiate the device; however, an ion transport analysis would have to be done to fully describe the experimental ion conditions.
