TID and SEE Response of Advanced Samsung and Micron 4G NAND Flash Memories for the NASA MMS Mission

T. R. Oldham, M. R. Friendlich, A. B. Sanders, C. M. Seidleck, H. S. Kim, M. D. Berg,
and K. A. LaBel

Abstract— SEE and TID results are presented for two advanced commercial flash memories, Samsung and Micron 4Gb. Both have very good TID response, and very good SEU bit error rates, but the Samsung parts have lower SEFI rates and lower rates of destructive failures.

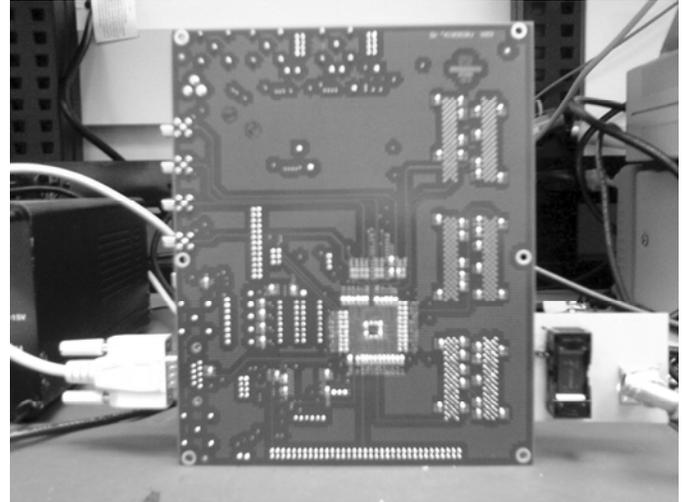
Fig. 1. LCDT Test System

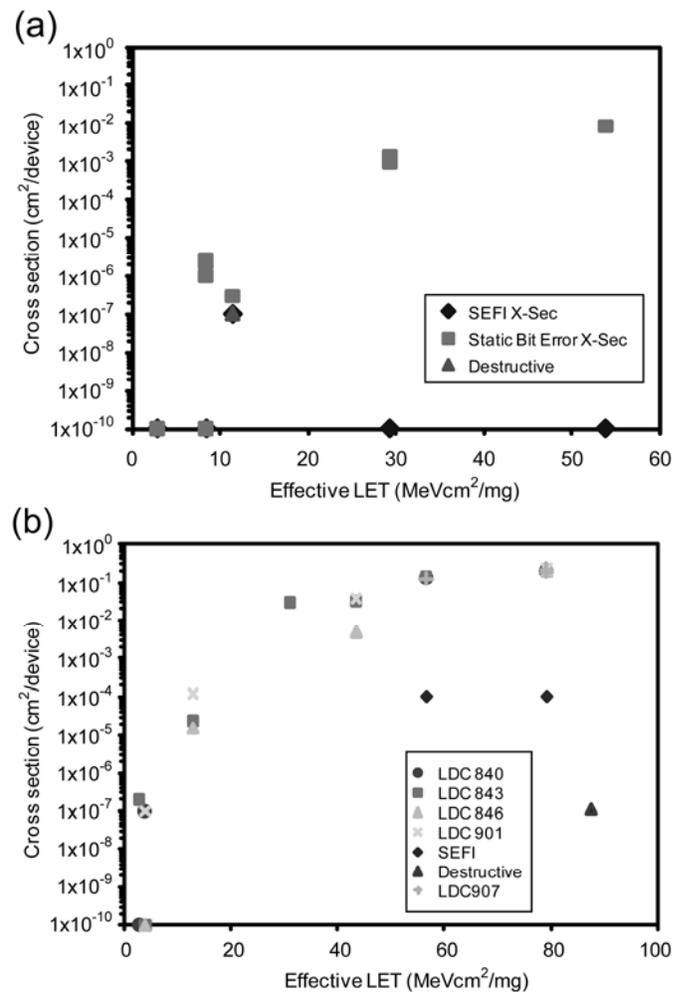
Fig. 2. Unbiased static results: (a) Micron; (b) Samsung

During testing, the DUTs were irradiated with the ions indicated in Table I. The DUT was oriented normal to the incident beam, or at 45 degrees. The errors observed in static SEU testing are shown in Fig. 4, with no bias applied. The 45 degree data is plotted at the effective LET (LET/cos θ). This is done so that one can distinguish between the normal incidence shots and the 45 degree shots. It is not done because effective LET is expected to be a useful concept for other reasons.

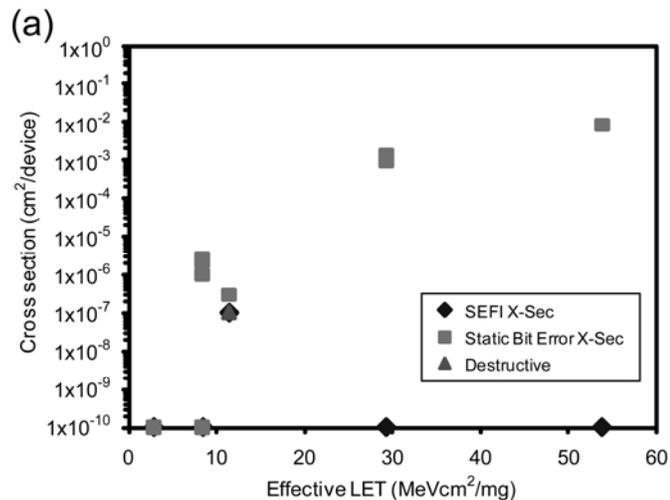
Fig 3a. Micron results for SEU, SEFI and destructive failures, in unbiased static mode.

In the unbiased static mode, there were two exposures at 45° incidence with Ar ions (LET=8.4), which produced two SEFIs and one destructive failure of the erase circuit. We did not have enough samples to destroy them at that rate, especially at such low LET, so we concentrated on getting normal incidence results. We intended to return to high angle exposures later, but ran out of beam time before we could do so. For the Samsung parts, many more exposures were required, because five different LDCs had to be tested separately. In all, there were 27 shots in this test mode for the Samsung parts. Fourteen of these were at high angle. There was only one destructive failure, with Au ions at normal incidence—that is, at LET about an order of magnitude higher than for the Micron destructive failure. The results for both manufacturers are summarized in Fig. 3.

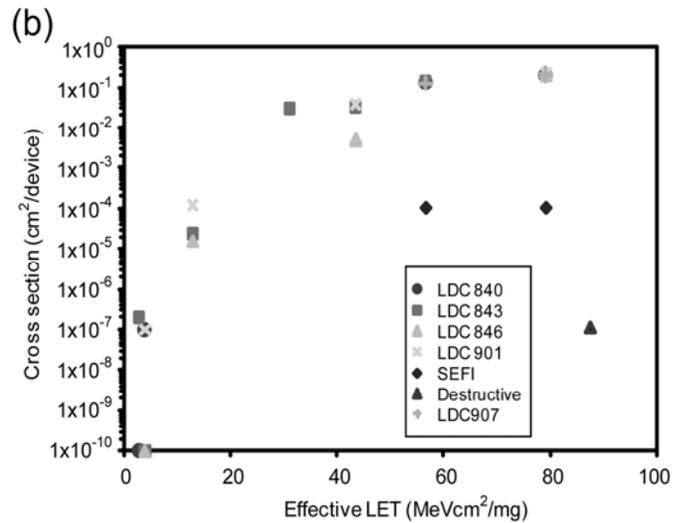
Fig. 3b. Samsung results for SEU, SEFI, and destructive failures, in unbiased static mode.

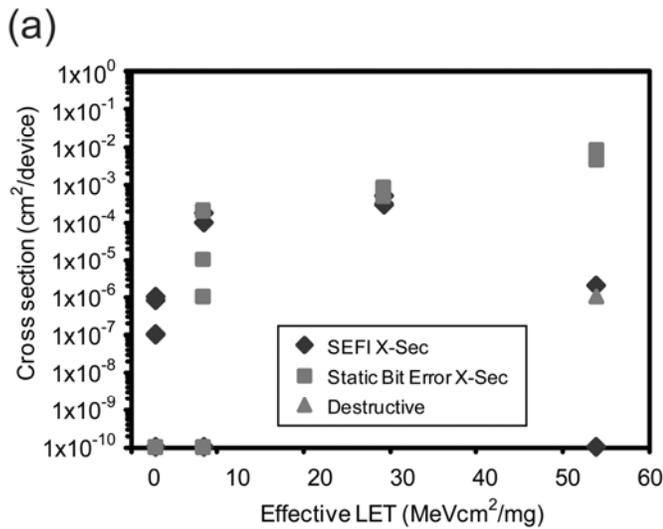
Fig. 4a. SEU, SEFI, and destructive failure results for Micron parts, in static mode with bias.

In the static mode with bias, for the Micron parts, there were 36 SEFIs due to block errors (where an entire block of 128Kx8 bits was lost, presumably due to a single ion), plus four other SEFIs, one of which was a destructive latchup (SEL). For the Samsung parts, there were a total of 27 shots, with 18 shots at oblique angles, with three SEFIs and no destructive failures. These results are summarized in Fig. 4.

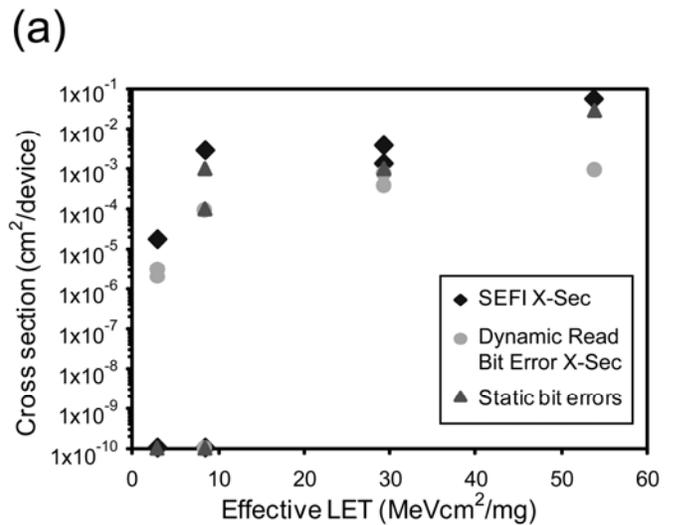
Fig. 5a. Micron dynamic read mode results for SEU, SEFI, and destructive failures.

For the Dynamic Read mode, results are shown in Fig. 5, for both manufacturers. Here, and also in the other dynamic test modes, transient errors are defined as those observed while the part is operating with the beam on. Static errors are the bits in error after the beam is turned off. For the Micron parts, there were a total of ten shots, with 36 block errors and two other SEFIs, with no destructive events. For the Samsung parts, there were 24 shots, including 17 at oblique angles, with two SEFIs and no destructive events.

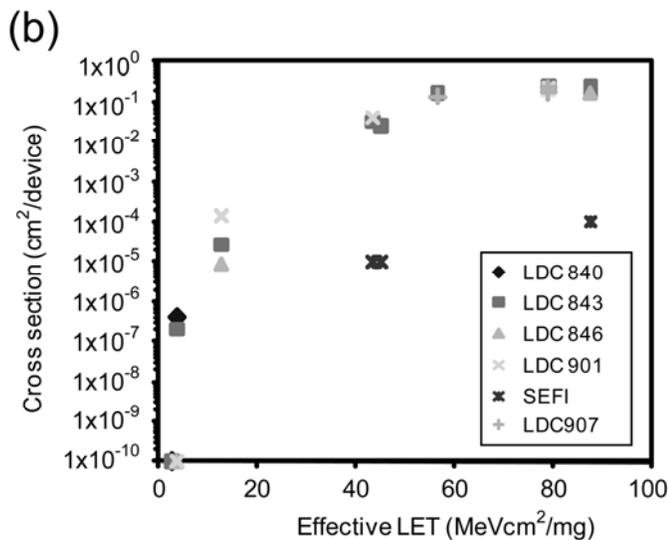
Fig 4b. Samsung results for SEU, SEFI, and destructive failures, in static mode with bias.

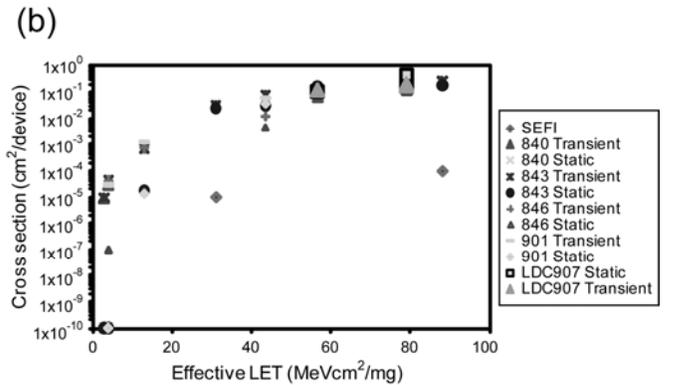
Fig 5b. Samsung dynamic read mode results for SEU, SEFI, and destructive failures.

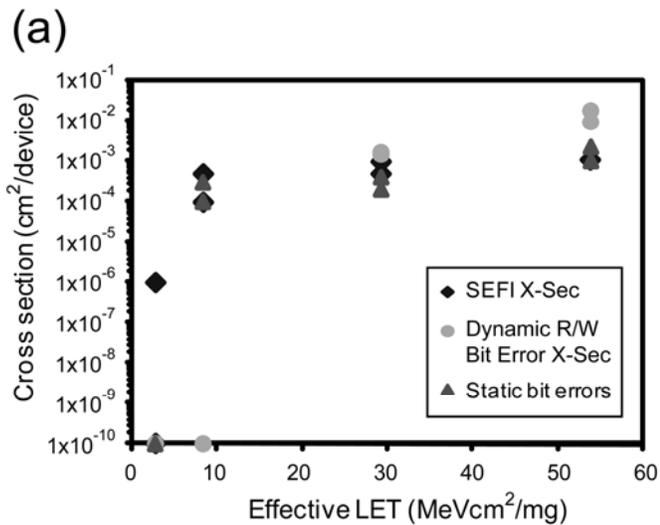
Fig 6a. Micron dynamic R/W mode results for SEU, SEFI, and destructive failures.

Results for the Dynamic R/W mode, for both manufacturers, are shown in Fig 6. For the Micron parts, there were ten shots in this test mode, there were 48 block errors and one other SEFI, and no destructive events. For the Samsung parts, there were 32 shots, including 24 at high angle, and nine at high temperature, with eight SEFIs and two destructive events. These were an erase failure with Au ions and a write failure with Xe ions.

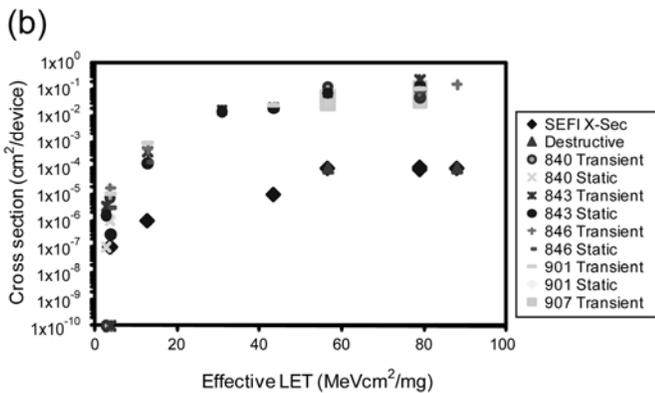
Fig 6b. Samsung dynamic R/W mode results for SEU, SEFI, and destructive failures.

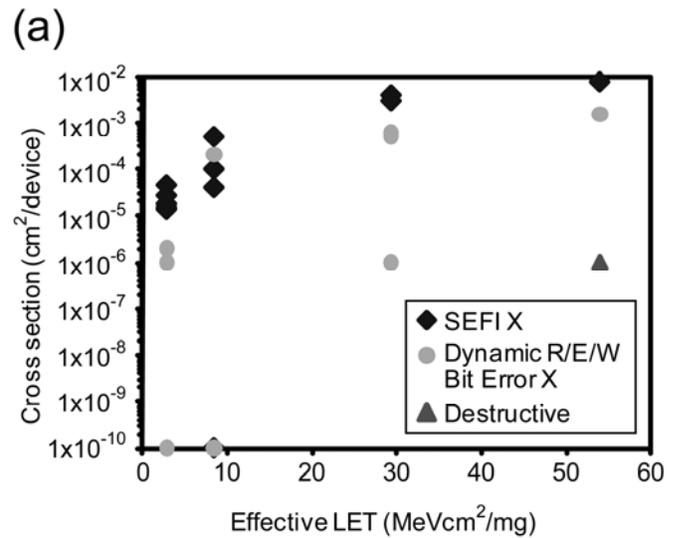
Fig 7a. Micron results in dynamic R/E/W mode for SEU, SEFI, and destructive failures.

Results for the Dynamic R/E/W test mode are shown in Fig. 7 for both manufacturers. In this mode, the high voltage erase and write operations are both being performed, so it was expected that this would be the worst case test condition for failures related to those operations. For the Micron parts, there were 15 shots, with 33 block errors and one other SEFI, plus one destructive latchup (SEL). For the Samsung parts, there were 77 shots in this mode, including 46 at high angle, and 54 at elevated temperature. In the first test trip, we found that the Samsung parts failed at high temperature (70° C) more often than at room temperature. Therefore, we made a second test trip to examine this temperature sensitivity in more detail. The Micron parts, on the other hand, failed at all temperatures, so we did not pay special attention to their high temperature response. The Samsung parts had 24 SEFIs and nine destructive events. These destructive events occurred only at normal incidence, even though most shots were at high angle. They occurred mostly (six of the nine events) at high temperature, and with high LET ions (eight of the nine with Xe or Au ions). The high temperature results FOR THE Samsung parts for all the test modes are summarized in Table II.

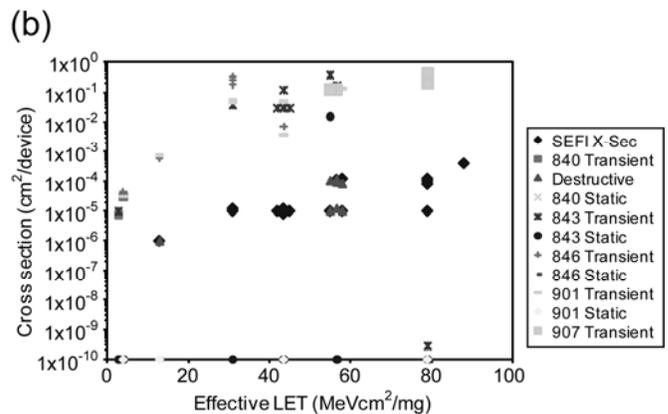
Fig 7b. Samsung results in dynamic R/E/W mode for SEU,SEFI, and destructive failure.

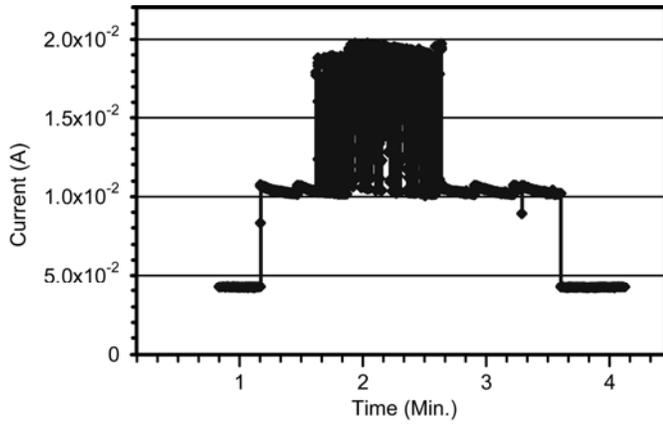
Fig. 8. Power supply current in R/E/W mode, Xe ions, at 25° C, with no permanent failure.

The power supply current was monitored on all shots, and representative sample traces are shown in Figs. 8-12. Typical power supply current traces are shown in Figs. 8 and 9 for two exposures using Xe ions in the R/E/W test mode. Fig 8 is at 25° C, and neither a permanent failure, nor a SEFI occurred. Fig. 9 is at 70° C, and both a SEFI and a permanent write failure occurred. For these parts, normal read current is about 10-11 mA, and write current in a fresh part is about 15-17 mA, although it increases as a part degrades over multiple shots. Erase current is 8-9 mA, and the current is about 4 mA, when the part is idling, not doing anything. In Fig. 8, the sample starts to read, and then the beam is turned on, and write pulses start, as errors are found. Write pulses continue after the beam is off, until all the errors are corrected, but the part continues to read after that, just to make sure. Finally, there is another read to verify the part is ready for the next shot. Fig. 9 shows the sample starting to read, then to have write pulses as errors begin to occur, but then the current increases to 20, 30, 40, 50 mA, and higher. When the beam is off, current stabilizes at about 57 mA. The write circuit had failed—the bit map showed the entire memory erased, because the erase circuit still worked, but none of the rewrite operations were successful. Fig. 10 shows the power supply current for a static (with bias) shot, where no SEFI occurred. The sample idles at 4 mA while the beam is on. After the beam is off, there is a read operation to count errors, and a second read to check for annealing, then an erase to prepare for the next shot, a read to verify the erase, a write to restore the test pattern and a final read to verify the write. Fig. 11 shows a similar power supply trace, for a Dynamic read mode shot. The sample reads while the beam is on, then there is another read to count static errors after the beam is off, followed by an erase, a write, and another read to verify the part is ready for the next shot. Fig. 12 shows results for a R/W mode shot. The sample writes while the beam is on, then reads static errors (twice), then erases, reads, writes, and reads again to verify the part is ready for the next shot. Note that in none of these current traces do we see the current spikes that have been reported elsewhere [1].

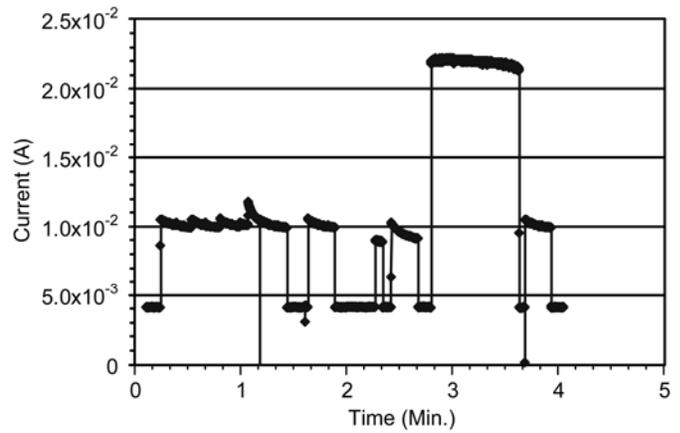
Fig. 11. Power supply current in Dynamic Read mode, Kr ions, with no failure.

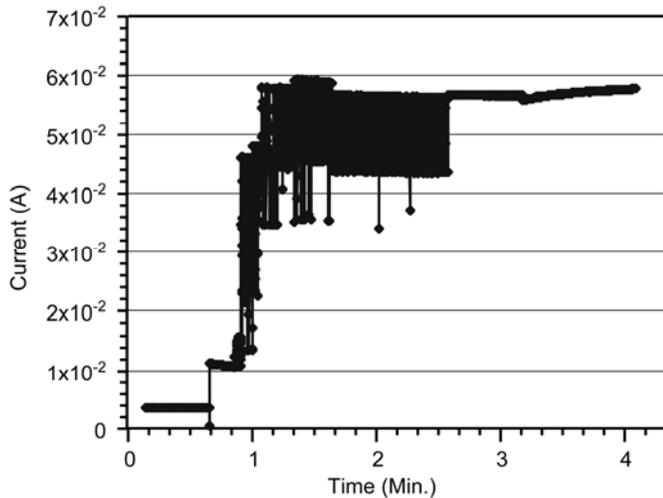
Fig. 9. Power supply current in R/E/W mode, Xe ions, at 70° C, with permanent write mode failure.

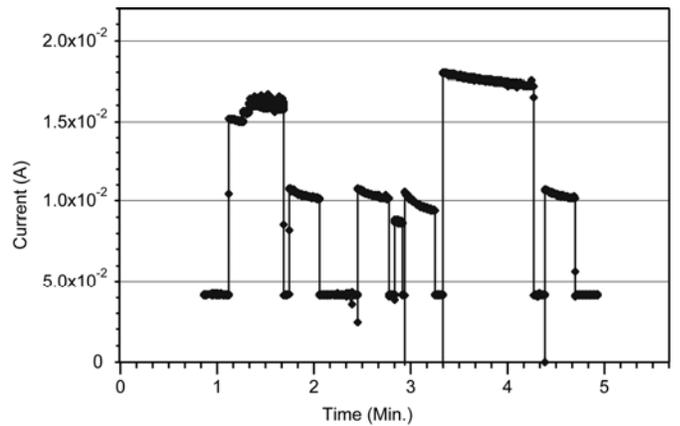
Fig. 12. Power supply current in R/W mode, Xe ions, with no failure.

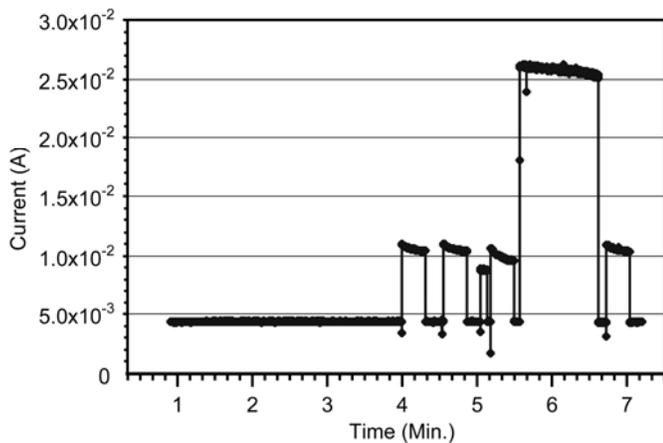
Fig.10. Power supply current in Static mode, with bias, Ar ions, with no failure.
