Fault Tolerant ICAP Controller for High-Reliable Internal Scrubbing

Jonathan Heiner, Nathan Collins, & Michael Wirthlin

Outline

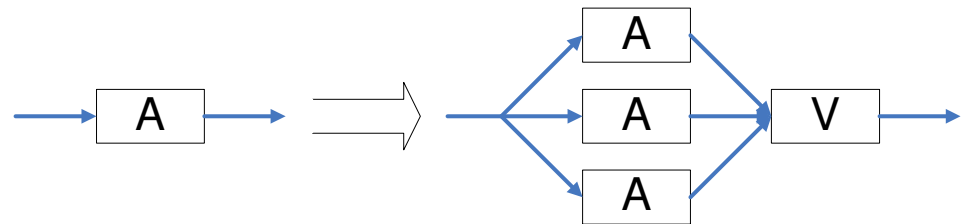
- Triple Modular Redundancy (TMR)

- Triplicate module to introduce redundancy
- Vote on outputs of triplicated module
- Use greatest common result

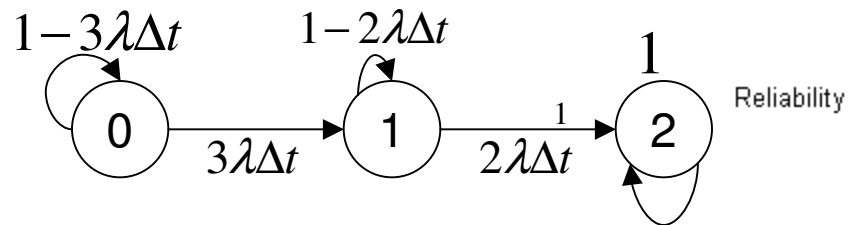
Non Redundant

Continuous Time Reliability

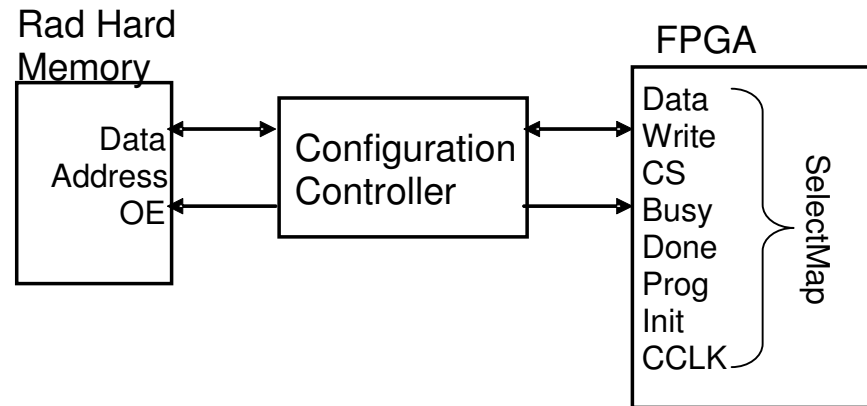
Traditional Scrubbing

- External Components
 - RadHard Memory
 - Configuration Controller
 - Dedicated IO
- External Scrubbers
 - Blind Scrubbing
 - Read-back Scrubbing

- Read-back Scrubbing Process
 - Reads each frame sequentially
 - CRC or original frame comparison is performed on read frame for detection/correction
 - Corrected frame data is written back to configuration memory through SelectMap Interface
- Blind Scrubbing Process
 - Reads original frame data from memory
 - Writes frame to configuration memory through SelectMap Interface

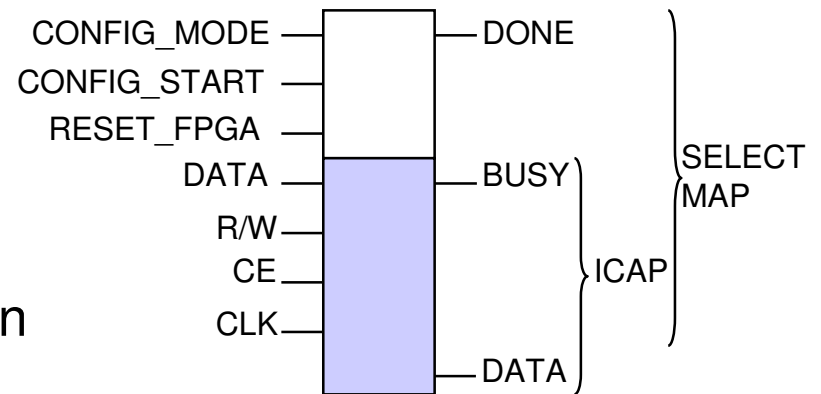
Internal Configuration Access Port (ICAP)

- Internal interface to configuration port
- Active readback and re-configuration
- Similar to SelectMap (separate I/Out data bus)
- Hard-wired Logic
- Current application usage
 - Dynamic Partial Reconfiguration
 - Encryption
 - Fault Tolerance/Injection

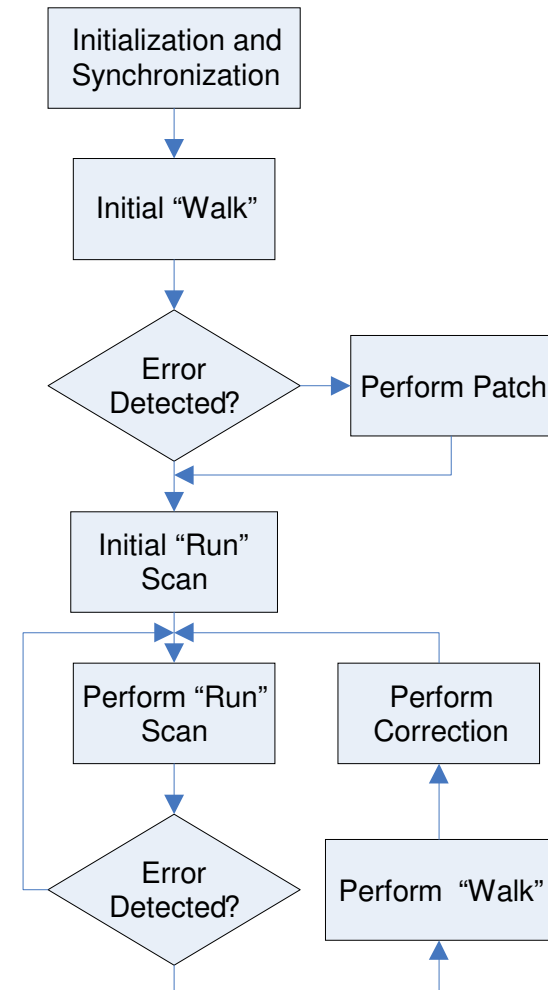
Scrubber Program

- Initializes devices
- “Walk” – slow scan
 - Approx. 24ms to 278ms @ 100Mhz
 - Actual Detection
- “Run” – fast scan
 - Approx. 1.2ms to 14.6ms @ 100Mhz
 - Quick Detection (is there an error somewhere)
- Patch – Ignore SEU by modifying parity bits
- Correction – Correct SEU

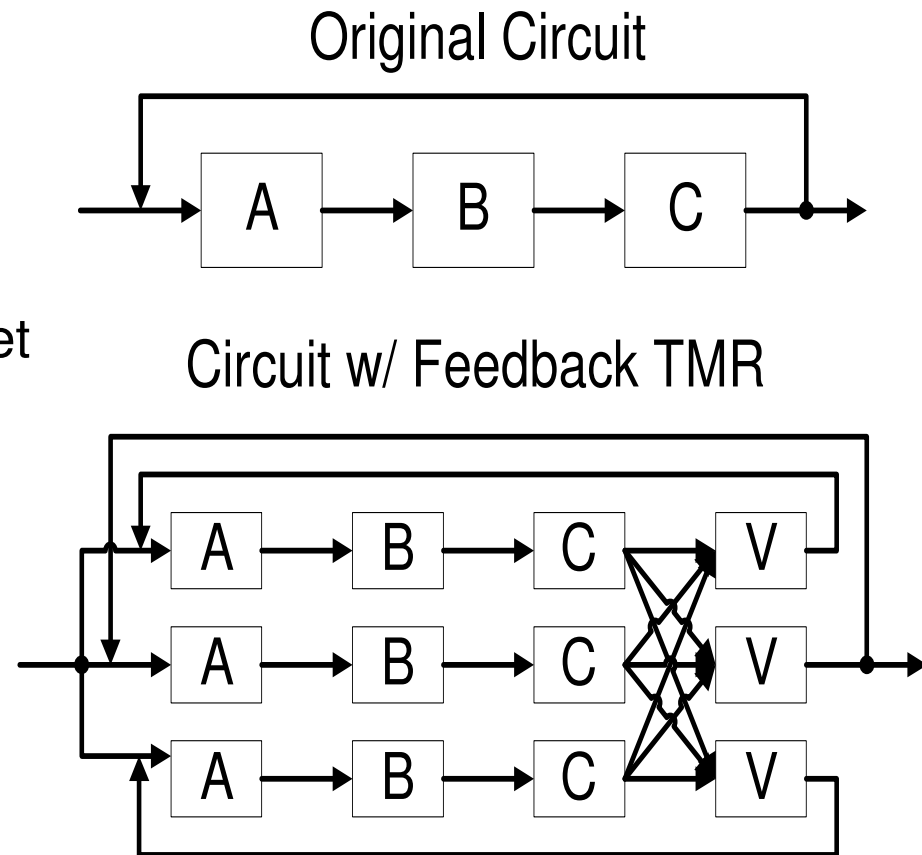
Triple Modular Redundancy (TMR)

- Mitigates all single bit upsets
- Allows scrubber to operate in presence of upsets
 - Scrubber will repair upset
- BL-TMR tool applied to circuit for selective mitigation

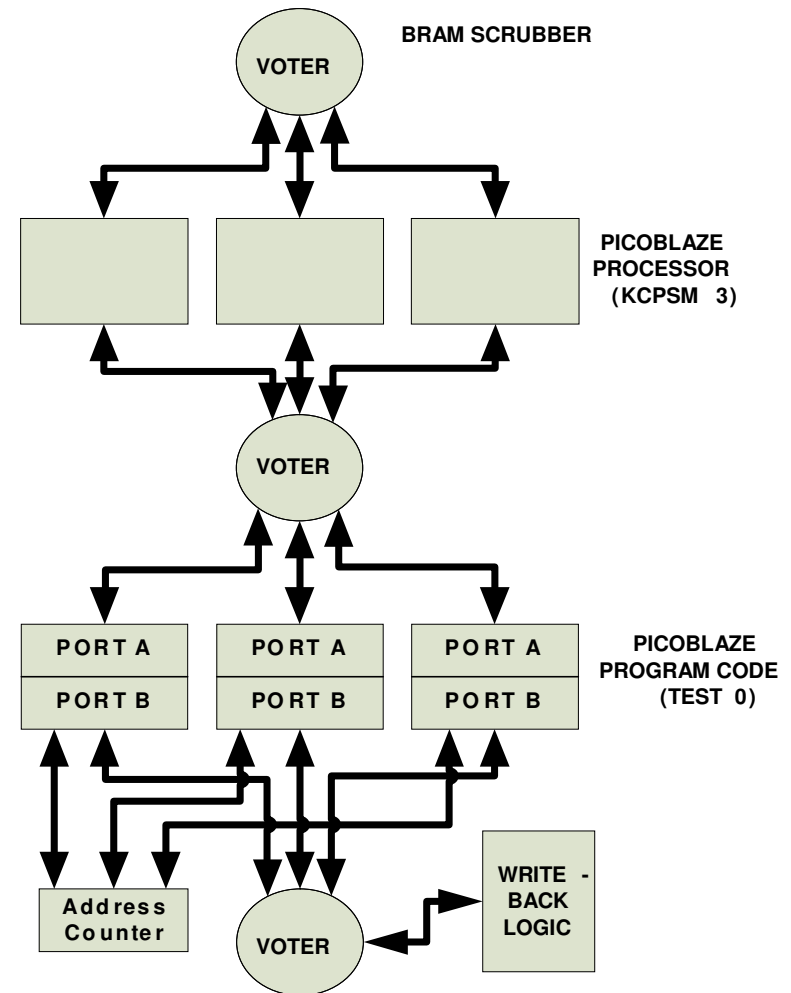
BRAM Scrubber

- Specialized BRAM scrubber for Picoblaze memory
- Continuously read and repair upsets within the memory

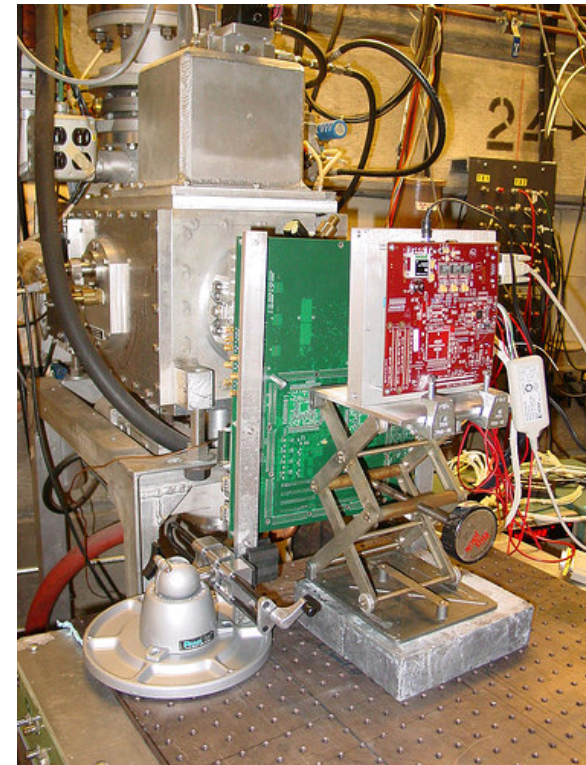
Radiation Test

- Determine the reliability of ICAP scrubber
 - Measure reliability of non-TMR scrubber
 - Measure reliability of TMR scrubber
- Test limitations
 - Operated behind another test
 - Did not have control over beam flux
 - Had to reconfigure with beam on

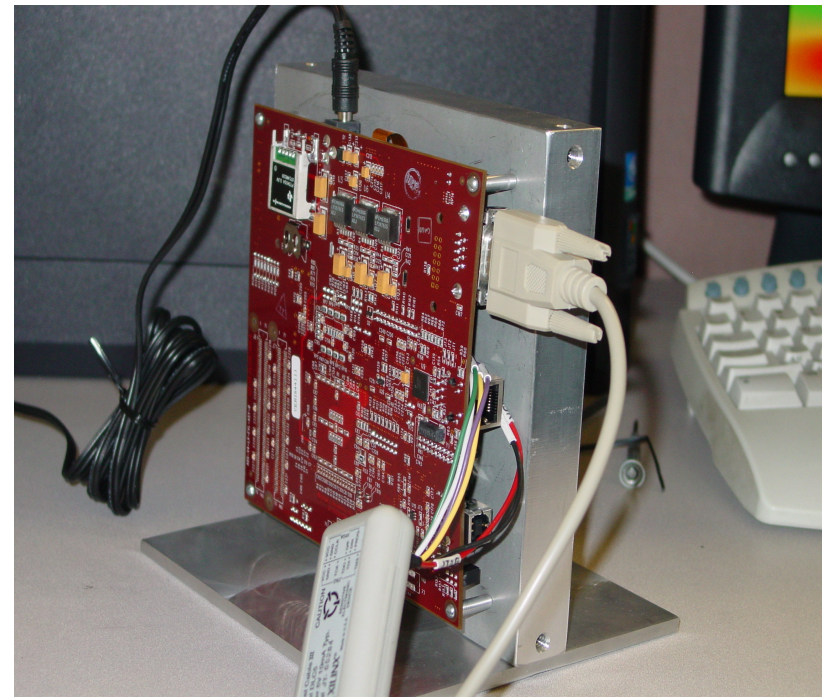
Radiation Test

- Board
 - Avnet Virtex-4 LX-25 Evaluation Board
 - 100Mhz Clock (50Mhz used)
 - RS232 port
- Shielding
 - 1" Aluminum Shield w/ 1"x1" Perforated Hole to expose FPGA
- Designs
 - Internal ICAP based Scrubber w/out TMR
 - Internal ICAP based Scrubber w/ TMR

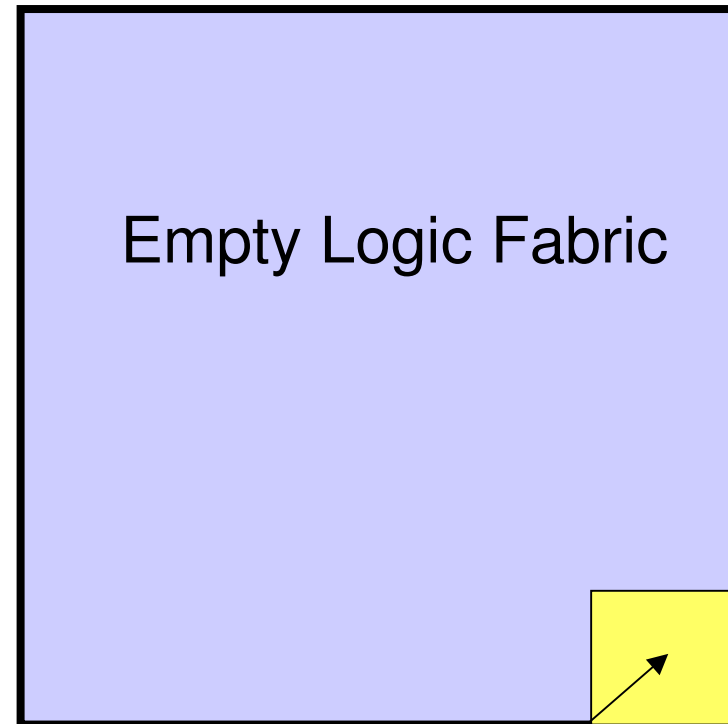
Radiation Test Design

- ICAP controller
 - TMR design
 - Non TMR design
- No other FPGA circuitry
 - FPGA mostly empty
- Detect and repair upsets in all areas of FPGA
 - Unused logic
 - ICAP controller logic

ICAP Controller
(both TMR and non TMR)

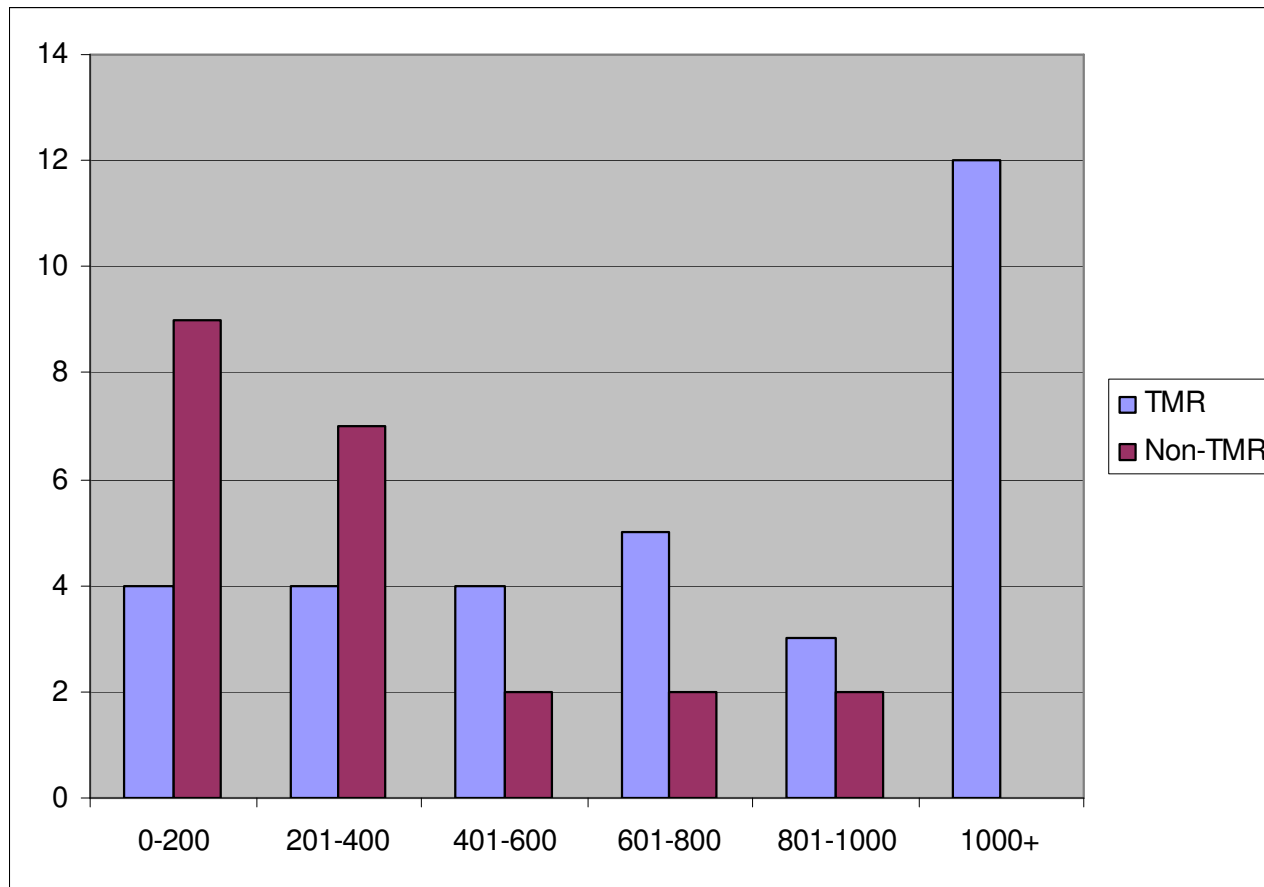
Configuration Upsets between Failure

TMR: 1682 SEUs between failure

Non-TMR: 309 SEUs between failure

- ICAP scrubber worked correctly as expected
 - Detected upsets within FPGA fabric during operation
 - Repaired SEUs within the device
- Hi-Rel scrubber provided improved reliability
 - 5.4x higher SEU to failure than non-TMR
 - 1.4x higher MBU to failure than non-TMR
- ICAP hi-rel scrubber reliability limited by MBUs
 - Cannot remove MBUs
 - Failure due to accumulation of MBUs

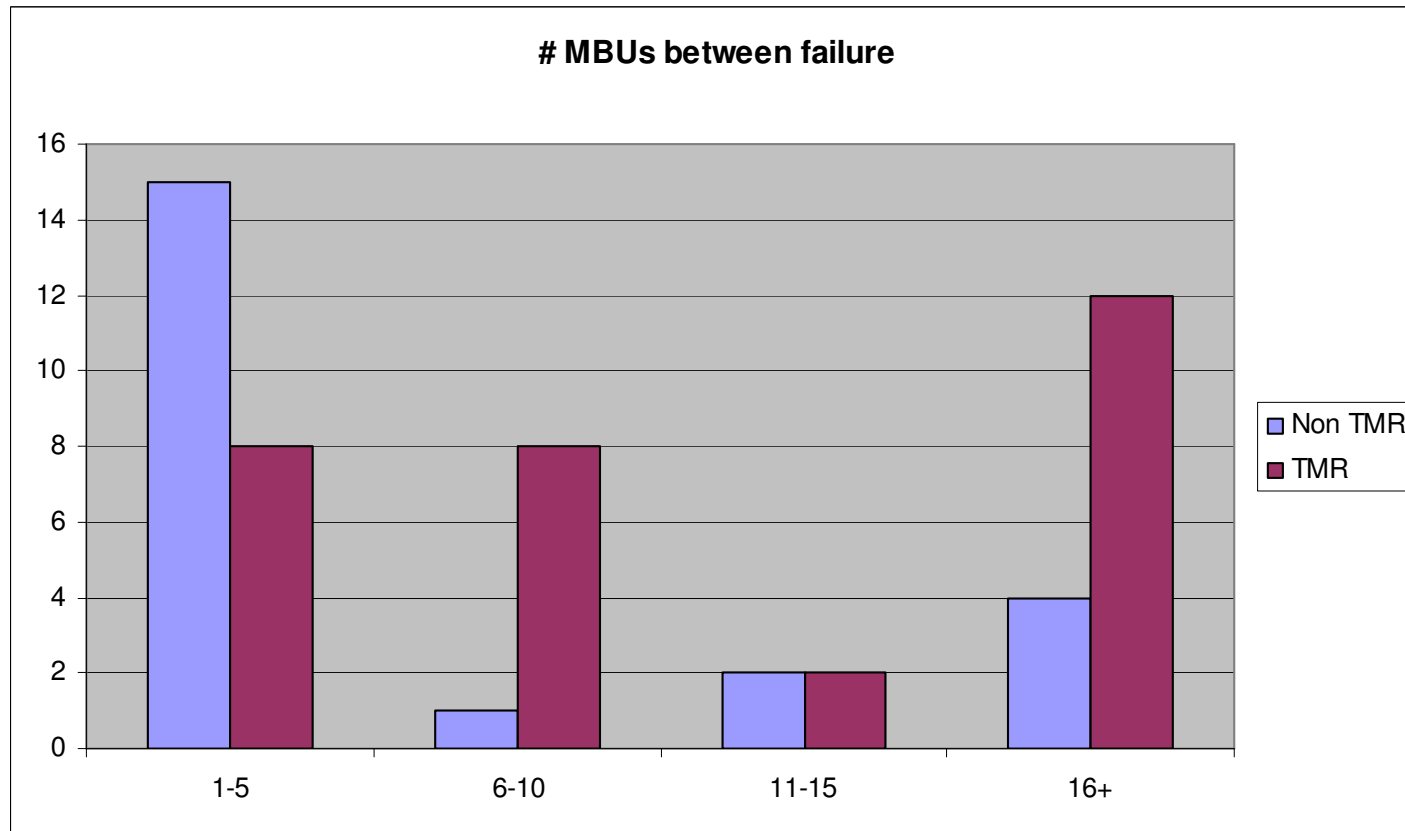
Multiple Bit Upsets Between Failure

TMR: 10.4 MBUs between failure

Non-TMR: 7.6 MBUs between failure

- FRAME ECC does not identify location of failure with multiple upsets within frame
 - Single Error Correction, Double Error Detection
 - Syndrome can not locate failures
- MBUs were detected but could not be corrected
 - MBUs accumulated during the test
 - Failures often occurred due to MBU accumulation
- Presence of MBU significantly slowed down scrubbing
 - Performed configuration “walk” with MBU
- 1.7% of upsets were intra-frame MBUs
