# **Results of Screening and Qualification Testing of COTS PEMs for Space Applications and Lessons Learned in 2004**

Alexander Teverovsky, Chris Greenwell /QSS Group, Inc.,  
Ashok Sharma /GSFC/NASA,  
Nick Virmani /SWALES Associates

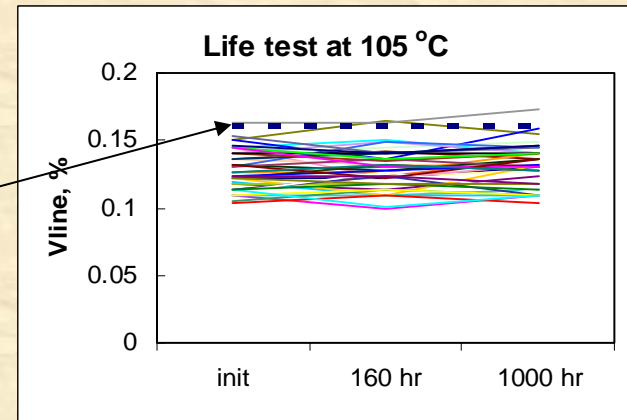
- Marginal parametric failures did not degrade further.
- Qualification testing of COTS PEMs can be performed on unscreened parts.

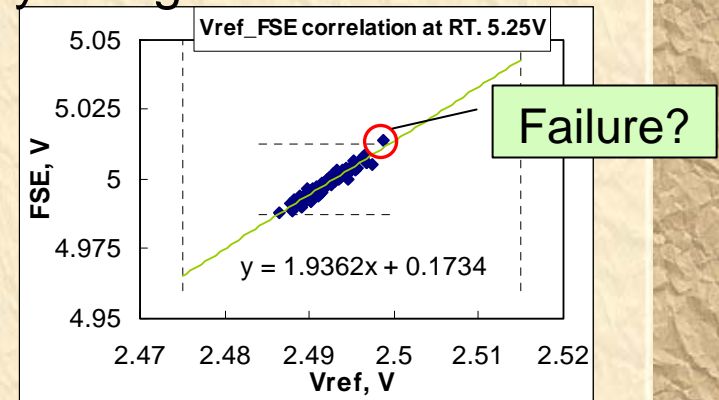
Correlation between full scale error and voltage reference measurements (dashed lines are the limits)

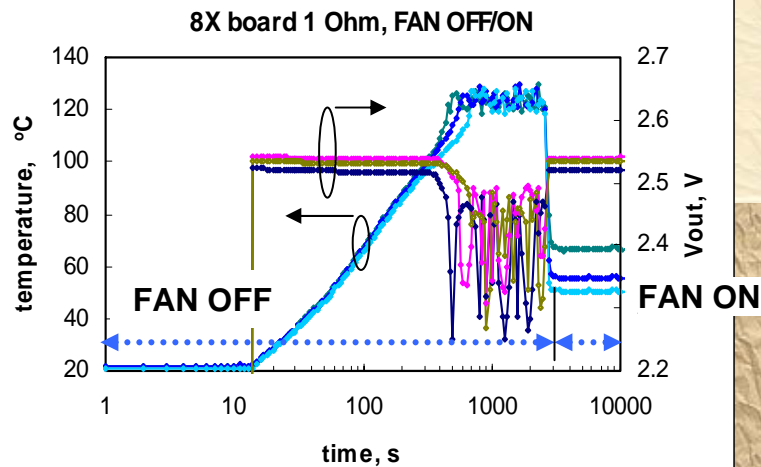
Life test conditions used by manufacturer

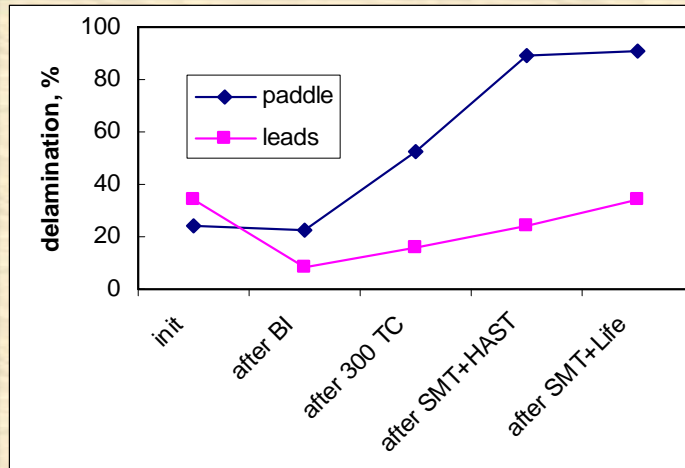
Evolution of delaminations

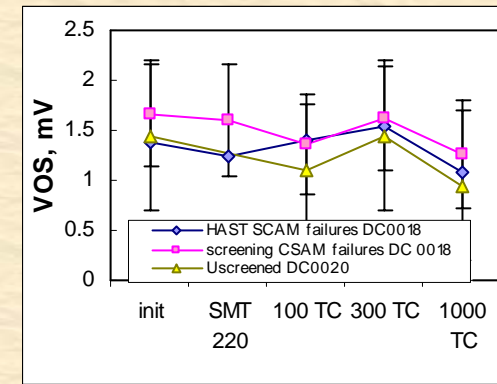
No failures and/or substantial parametric changes during testing

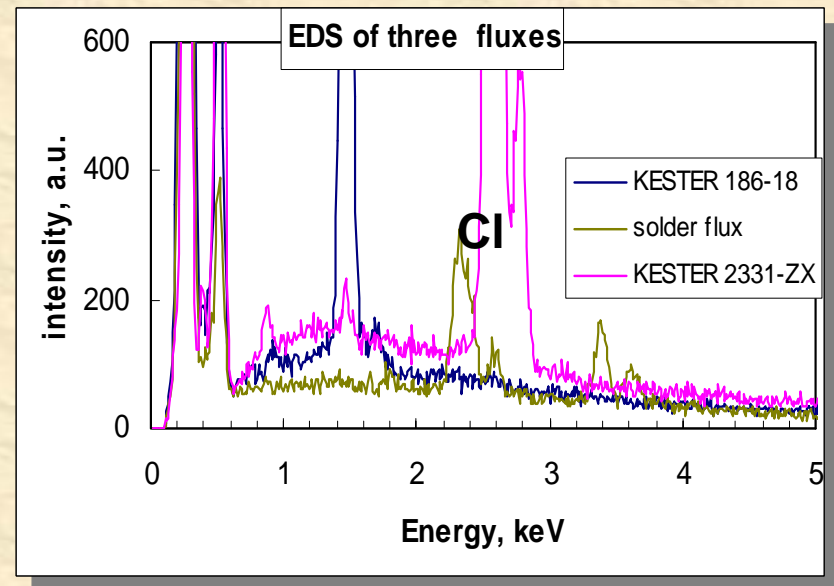
Preconditioning per JESD22-A113D regarding flux application is inadequate to hi-rel parts assembly conditions and might result in failures, which would never occur in real applications.

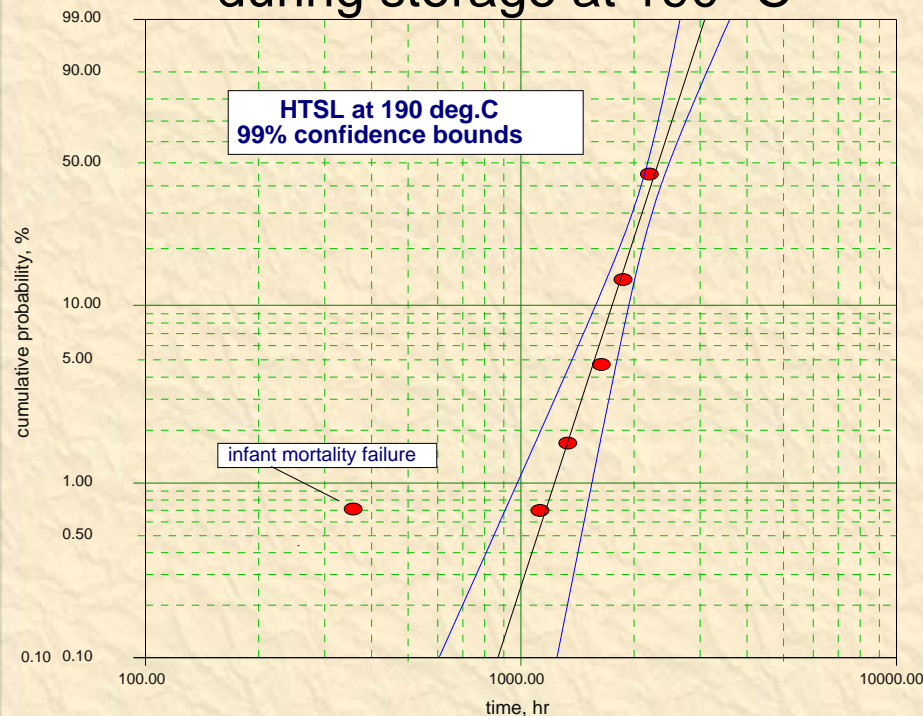
Examples of WB failures after HAST

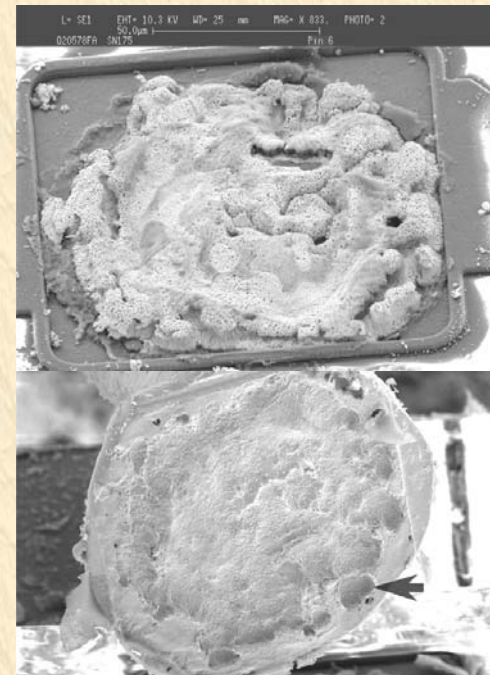
- A technique for WB reliability evaluation is currently under development at the GSFC PA Lab.
- This technique is non-destructive and does not require full electrical characterization of the part.
