Synopsis V5.0
Heavy Ion Single Event Effects Testing of the
Intel Pentium III (P3) Microprocessors[†]

Test Dates: October 12-15, 2001.

Report Date: January 21, 2002.

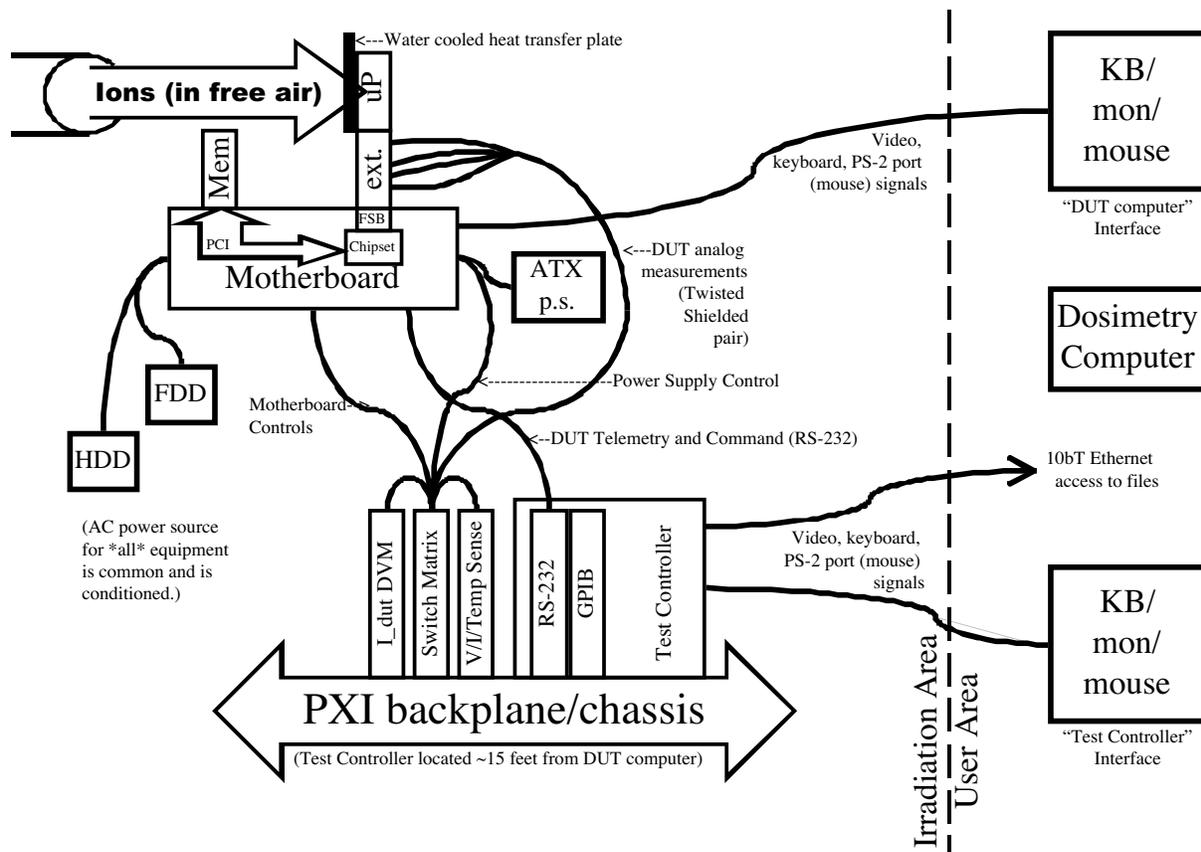
Figure 1. Block diagram illustrating the overall test configuration.

The system hardware consists of two subsystems, the Test Controller and the DUT computer subsystems (DUT cooling is discussed later as another subsection under this,

Test Hardware, section). Any cabling not required for the operation of the DUT computer is considered part of the Test Controller subsystem. These subsystems are described below. Following that is a description of the DUT processors. Figure 1 illustrates the overall test configuration. This has not changed dramatically from previous tests, but has evolved. The current (as of TAMU testing in October 2001) state of the test is described.

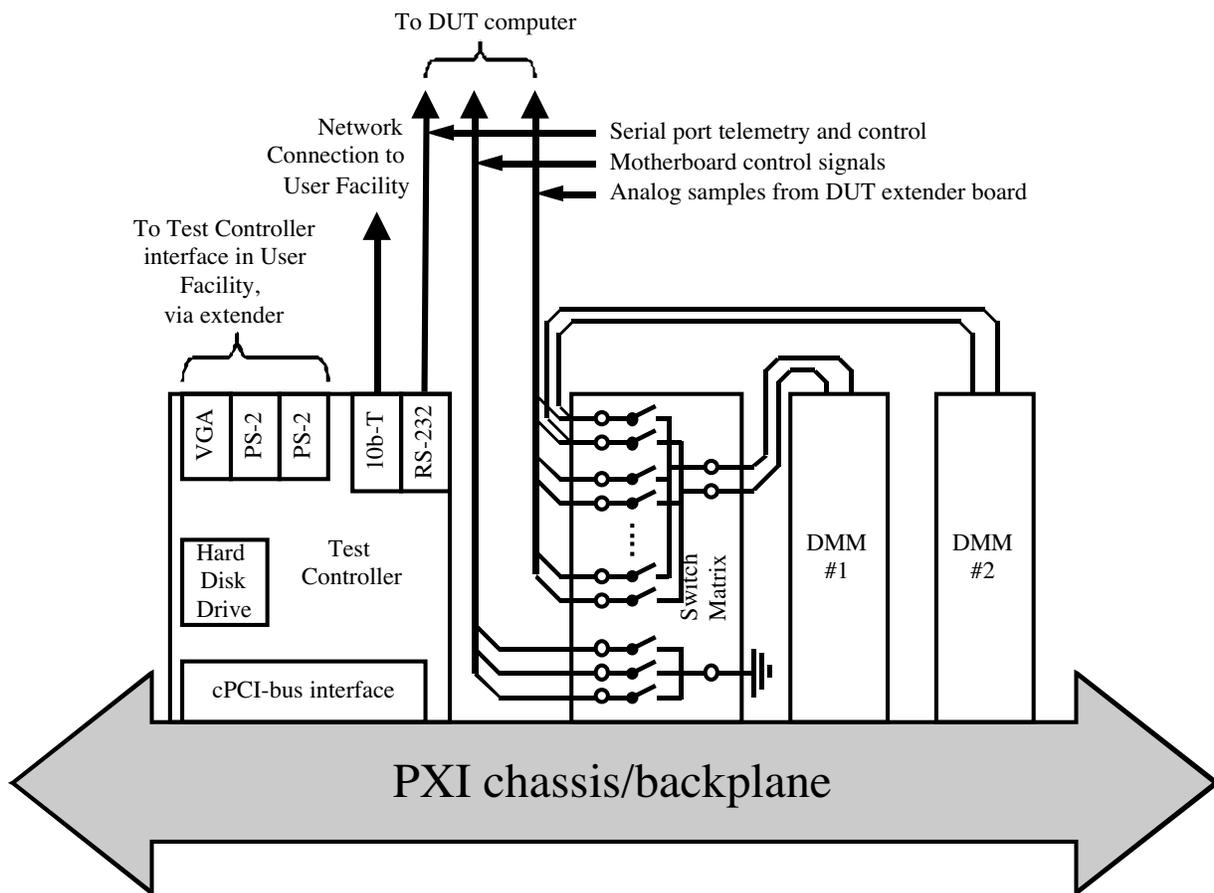
The PXI subsystem, as shown in Figure 2, resides outside the irradiation area and is connected to the DUT at the irradiation point by cabling ~40' long. It consists of the PXI components, the PXI Computer <-> DUT Computer cabling and the user interface.

Figure 2. Block diagram of the PXI subsystem.

The PXI components include the PXI chassis, which contains an embedded controller (running Win98, Labview (LV) environment and a custom LV application), a signal switch matrix, and two digital multimeters (DMMs) in the voltage measurement mode. The switch matrix provides two functions--The multiplexing of analog signals to one of the DMMs, and contact closures (pulling signal levels to ground). One DMM measures all analog values except the value read most frequently or as most important to not be delayed by switch settling time. The other DMM is dedicated to monitoring that value.

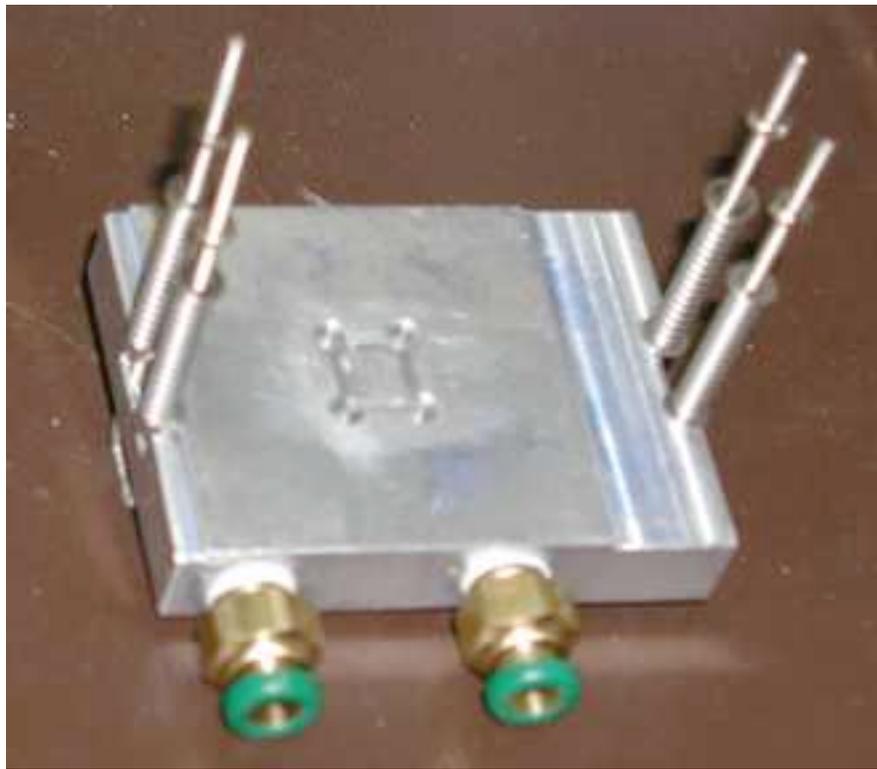
Figure 4, the die-side of the plate, shows two cutouts to avoid motherboard components and a shallow recess in which the top of the die makes contact with the plate.

Figure 4. The heat transfer plate, die-side (with springs unfortunately mounted on the wrong side).

Also shown in Figure 4 is the attachment system. #4 allthread is bent to a square-bottom U, with the threads ground smooth at the bottom to reduce abrasion of the white plastic socket's heat sink attachment hooks (The top hook is visible in the picture). A pair of holes in the plate allows the mounting of each of these U's. One pair of holes is round; the other is a rounded slot to allow for the rotation of its U during mounting/dismounting of the heat sink. The springs allow force-balancing ensuring that the cooling plate lies flat and evenly loaded, upon the DUT die. The four nuts are adjusted until the desired spring compression is achieved. The springs have a constant of about 25 lb/inch, so a compression of 0.2" on each of the four screws provided the rated compression force of 20 lb well centered on the die.

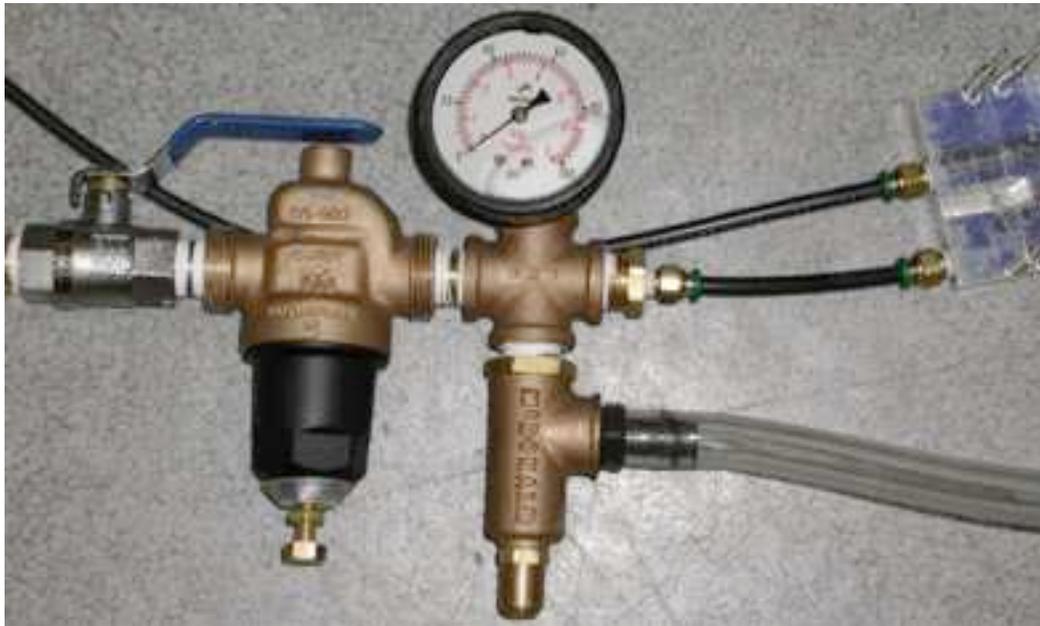
Figure 5. Water pressure regulator with overpressure relief valve.

The alternative source of water is tap water, which is available at a relatively low (but quite useable) pressure, has zero back pressure (it exits the cooling plate down to a floor drain), is at ground temperature (which is somewhat cooler than ambient most of the year), and any conceivable flow rate is not an issue. In addition to these benefits, a simple setup of plumbing components can be used to provide this water source, in preparation and proofing of the water-cooling system; thus, tap water was chosen as the source. Figure 5 shows the plumbing used for setup. The input has a shutoff valve and a pressure regulator in series that feeds a cross. The three other ports of the cross hold a pressure gauge, an overpressure relief valve (set to ~10 psi over the regulator pressure), and the output to the DUT cooler. The return flow from the cooler passes back by this plumbing and travels with the overpressure valve output tube to the floor drain.

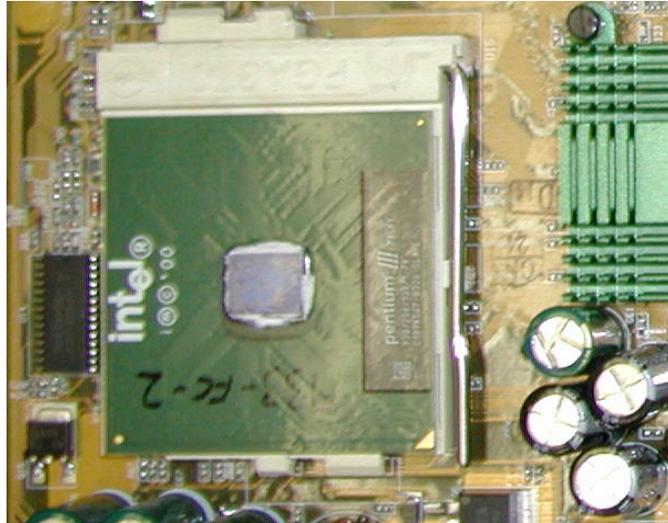
Figure 6. FC-PGA form factor P3, in a ZIF socket, without heat sink.

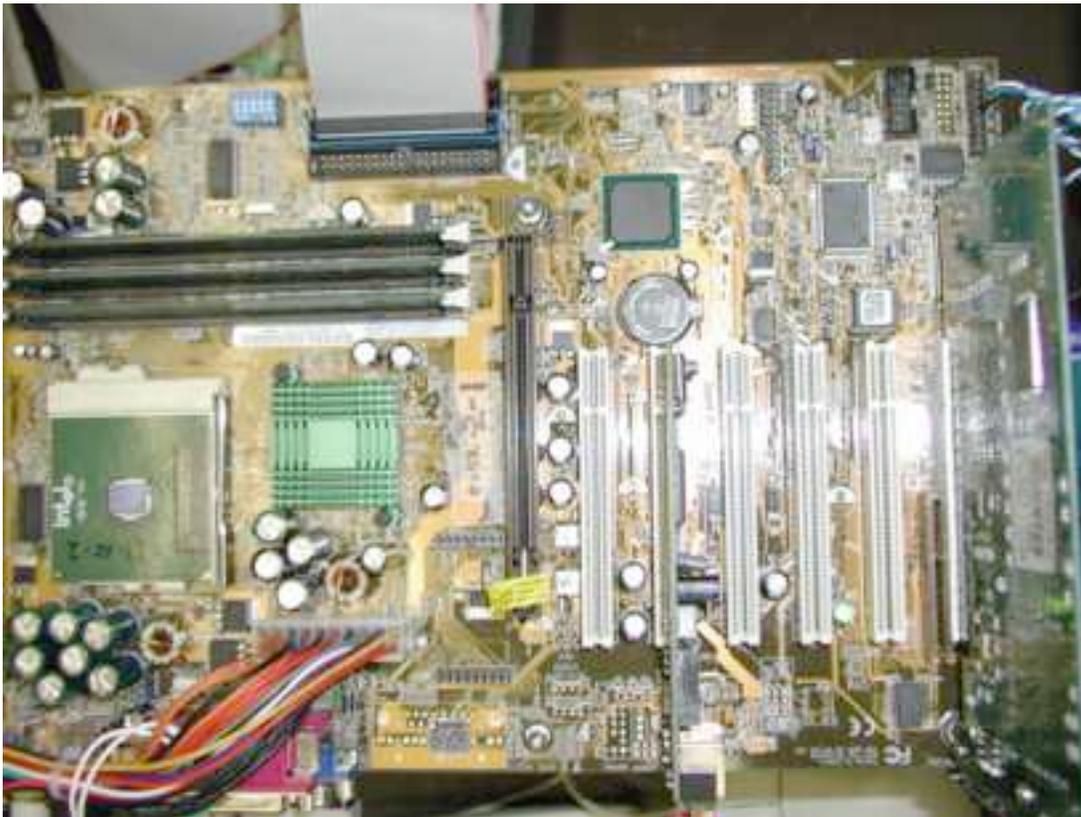
An FC-PGA370 DUT mounted into its motherboard socket is shown in Figure 7. White thermal grease is visible around the edges of the DUT die, at the center of the green pin-spreading PCB. The ZIF socket lever is visible immediately to the right of the DUT. Tabs extending from the side of the white ZIF socket on the two sides adjacent to the ZIF lever are used by the cooling solution attachment, in this case, the sprung U-

shaped clamps. Mounted to the underside of this PCB is a dense packed 370 pins. The center of the underside, immediately under the DUT die, does not have pins; a few supply bypass capacitors reside there. These are not expected to be affected by any irradiations.

Figure 7. Photograph of the PGA-370 motherboard with DUT in place.

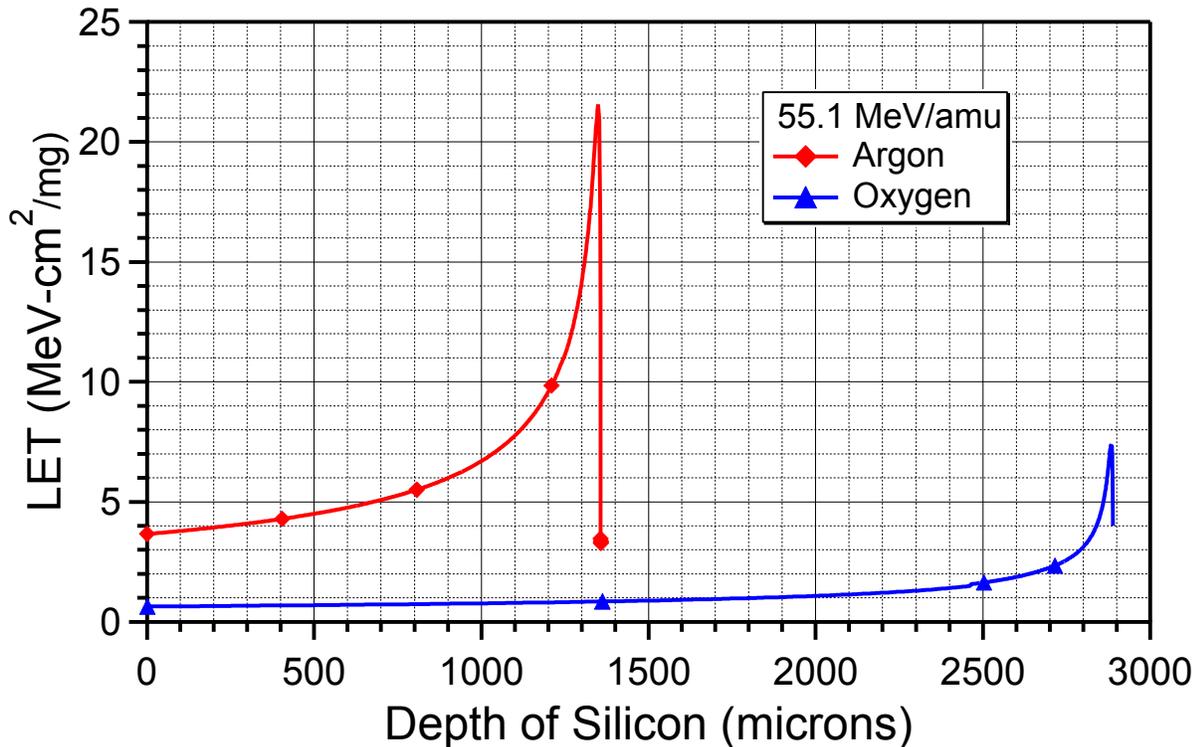
Figure 8. Plot showing the two ions used at TAMU for heavy ion testing. The zero point on the x-axis represents the Silicon surface on the backside of the die.

As can be seen from Figure 8, at the 800-micron depth into the die, the LET curve for Argon curve is heading towards the Bragg peak. Therefore, for the Argon ion, the LET will not be constant over the sensitive regions. That, combined with not knowing exactly where the sensitive regions begin, makes the determination of the LET in the sensitive regions problematic. For the remainder of this report, it has arbitrarily been chosen to take the 800-micron depth point as the defining depth for LET. It should be noted that this value should have associated error bars based on this depth and location on the Bragg curve. It would be best, though to utilize experimental information for a more accurate determination. This can be done using the roll off in cross sections curves with increasing LETs and through the use of charge collection spectroscopy (currently under investigation). Therefore, for the Argon beam, effective LETs of approximately 5, 8, 11, and 15 were used.

The material conditions used in the TAMU testing were 25.4 microns of aramica (output window of the cyclotron), 80 millimeters of air (testing was done in air for

thermal considerations), 10 mils of Aluminum (water-cooled jacket) and 900 micron of silicon (P3 die thickness). The first two of these were stationary, whereas the latter two would rotate with the device (for getting effective LETs). Figure 8 shows a plot of the LET in silicon as a function of the depth in silicon (the aramica and air degradations have been accounted for as well as a normal incident ion through the Aluminum).

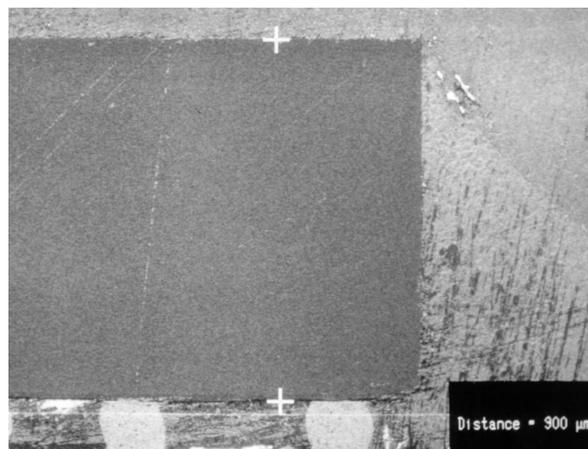
Figure 9. Photograph showing a close up cross section of the P3 die. Depicted here is the die thickness (900 microns) between the backside of the die and the front edge where the solder bubbles are clearly visible.

As pointed out above, these parts are flip chip solder bubble bonded die. This places the sensitive regions of the processor approximately 900 microns deep in the silicon die with respect to the heavy ion incidence point (See Figure 9). Thermal issues compound this by requiring cooling material in the beam line, as well. Therefore, only high energy and high Z beams are capable of penetrating and giving higher Linear Energy Transfer (LET) values in the sensitive regions.

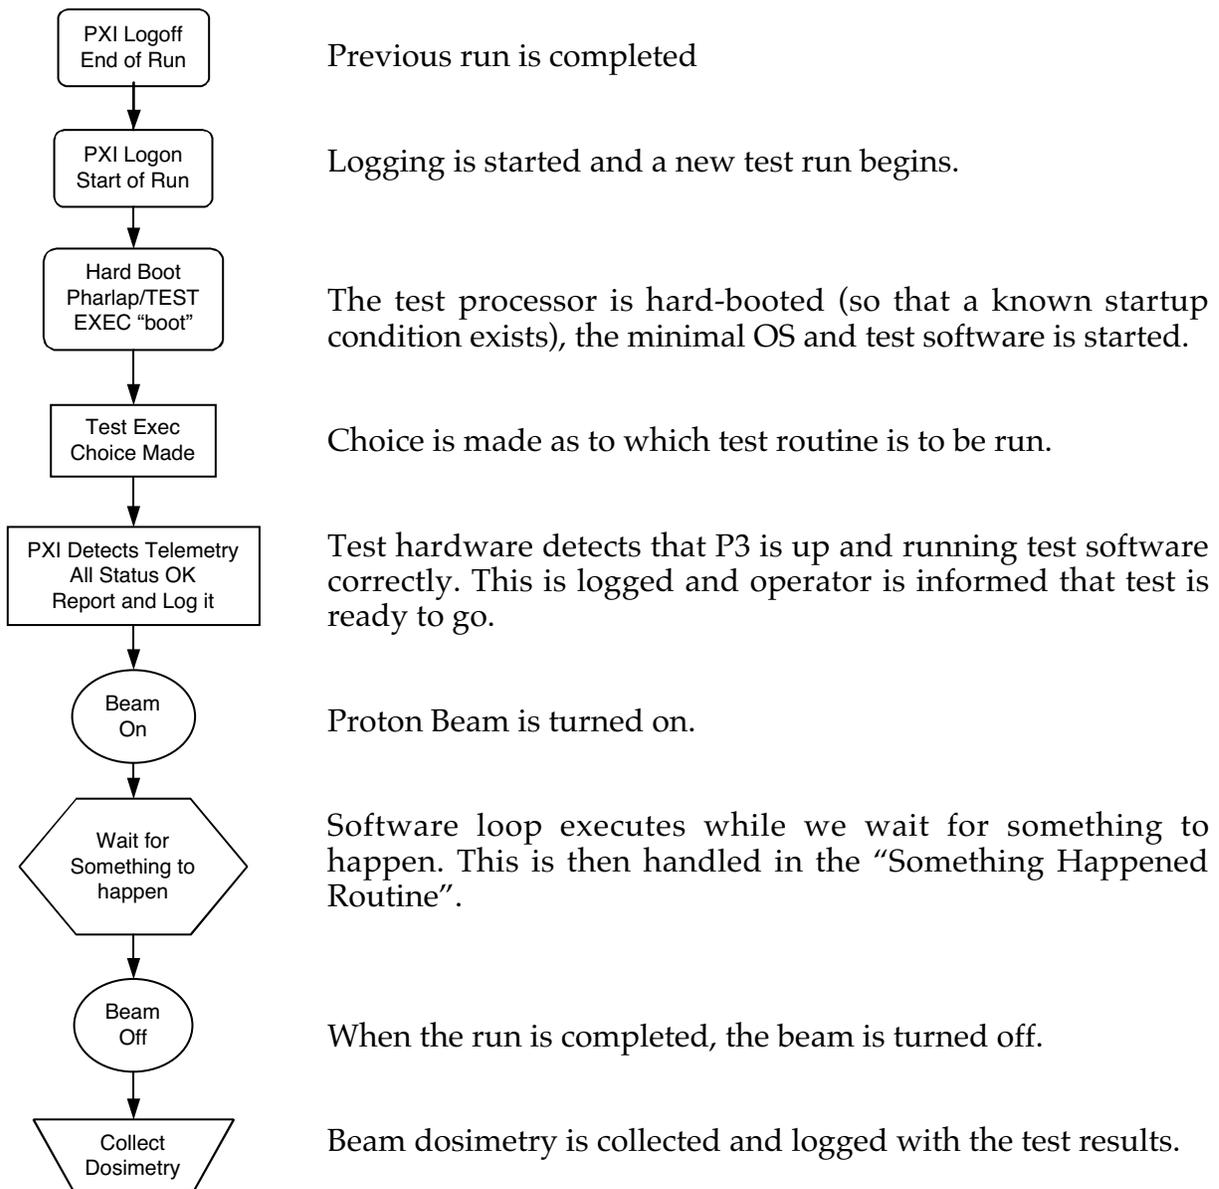
The SEE test process must include methods to test for all aspects of single event effects (latchup, functional interrupts, upsets, etc.). As a number of these effects are sensitive to the software being run and may be sensitive to numerous other conditions, detailed control of the DUT is required. To this end, an extensive operating system would serve no purpose other than a software overhead that is uncontrollable. Therefore, the boot process is done into a minimal operating system (Pharlap) and a test executive is run that allows testing of the DUT at a very low level. A flow diagram of the main testing process is shown in Figure 10.

Figure 10. Flow diagram and description for main testing loop.

The main part of this flow process, after the DUT is placed in a known operating state, is waiting for something to happen and then dealing with it. The flow describing this process is shown in Figure 11. Four general categories of events are expected: functional interrupts, latchup, system resets (radiation induced), and non-fatal errors (some error is produced but it does not immediately induce a functional interrupt or system reset. The remainder of the flow for all of these conditions shows the steps required to gain information about what exactly happened and to recover the DUT to a known state. The “Reboot Testing” in this routine is simply trying a soft reboot three times. If at that point the system has not recovered, a hard boot is then done. If a soft reboot is successful, then a “Memory Grab” routine is executed that recovers the telemetry stored in the Memory Card.

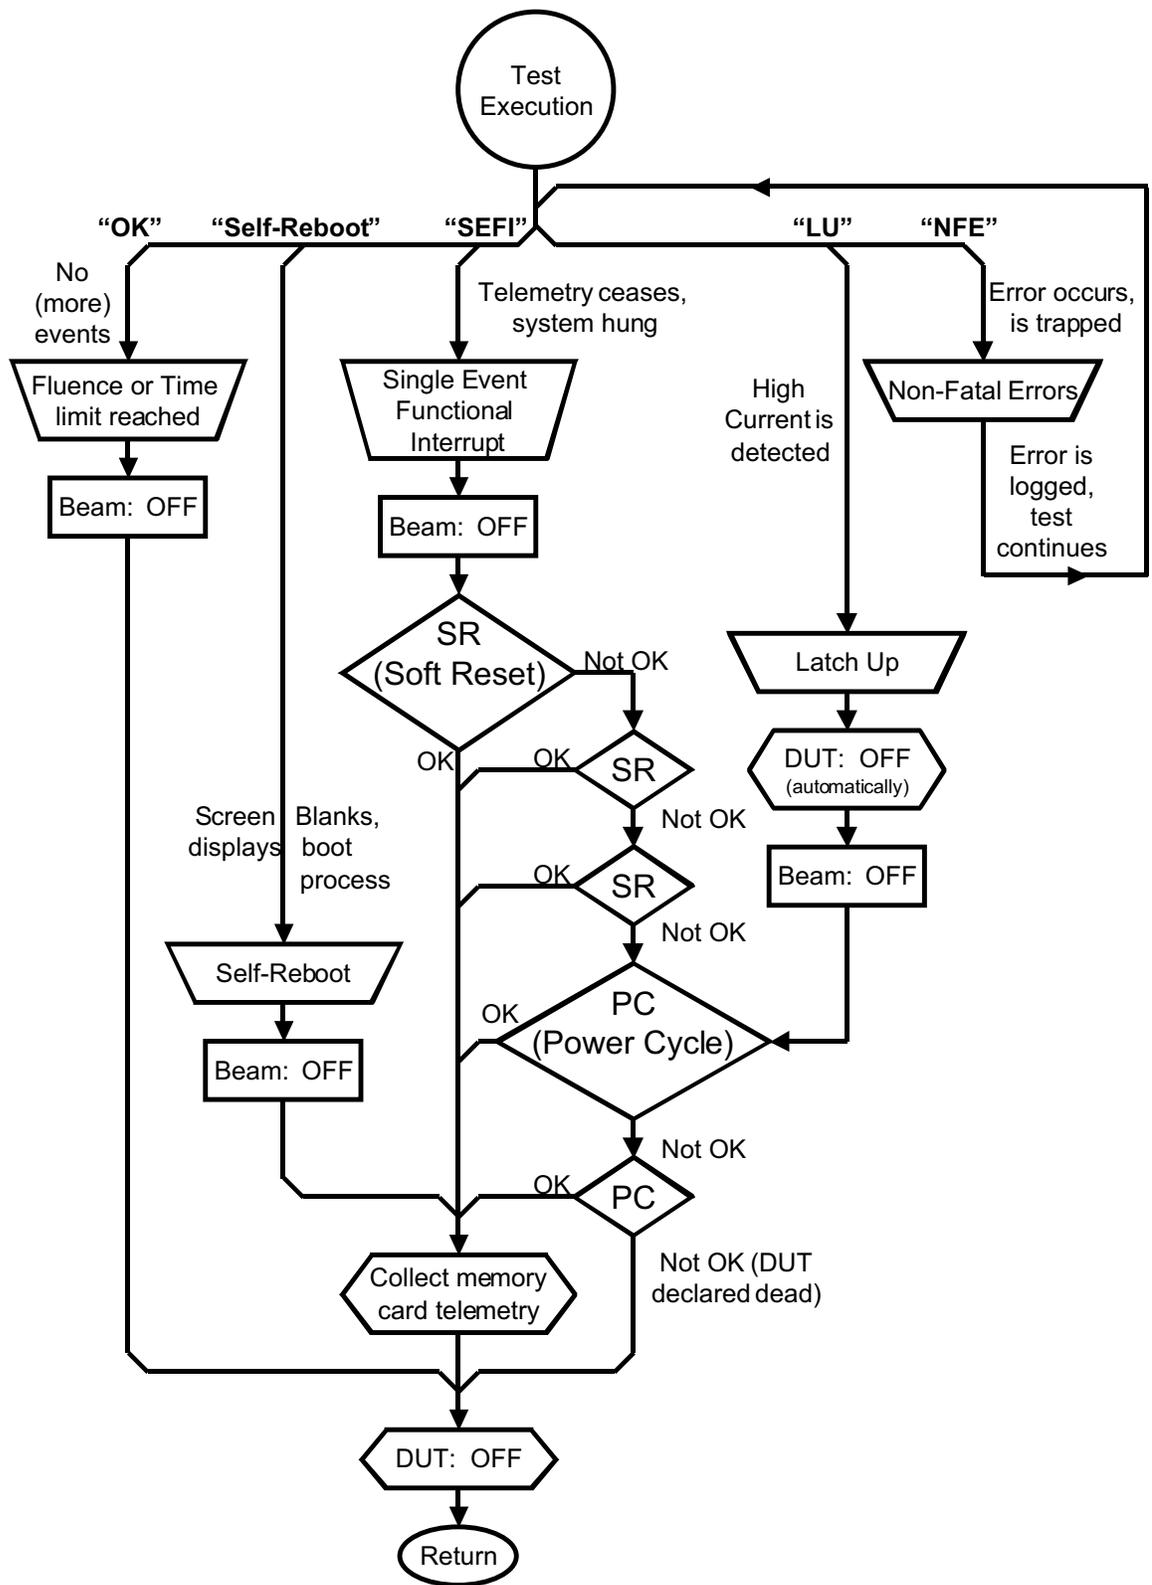
Figure 11. Flow process after an event has been detected.

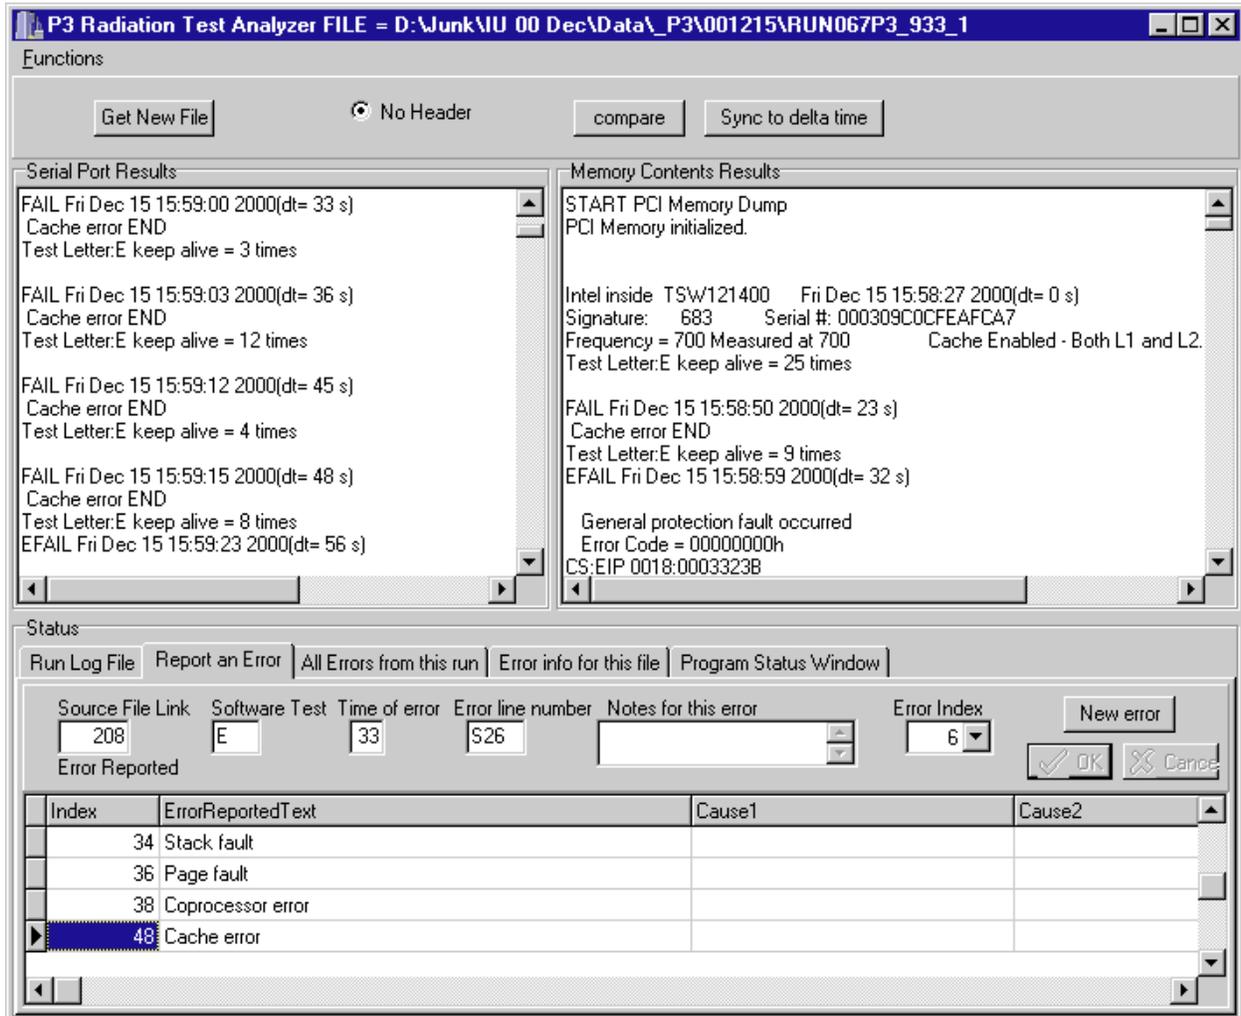
Figure 12 and Figure 13 show a sample screen shot for the telemetry file analysis and the SQL data extraction process, respectively.

Figure 12. Screen shot of the telemetry analysis software.

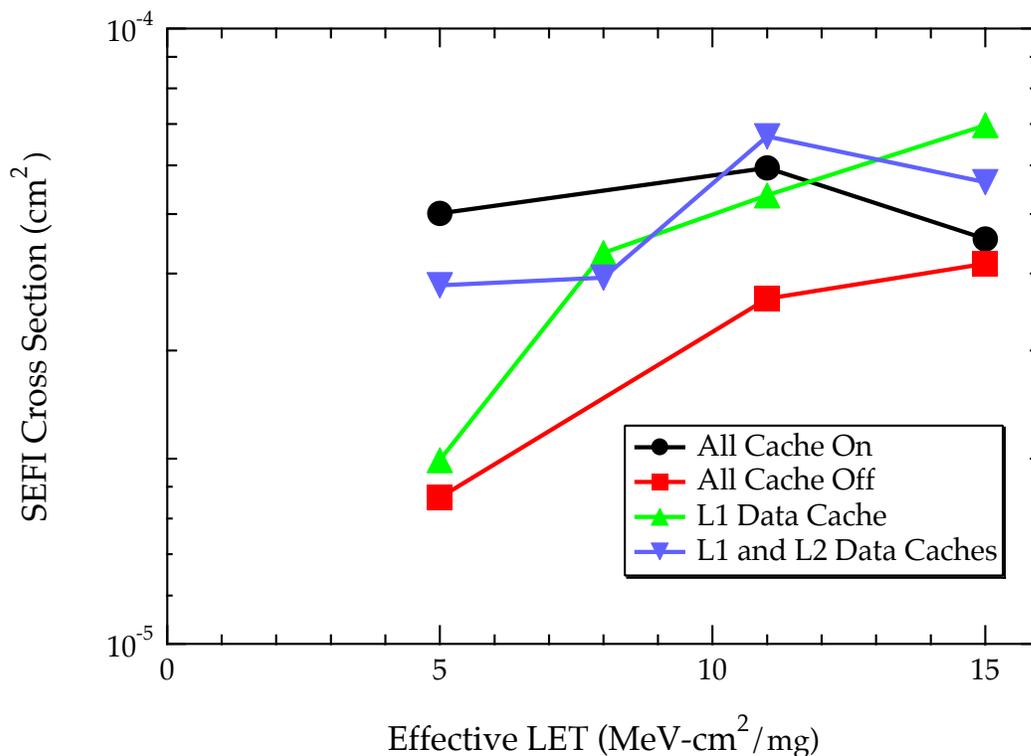
Figure 14 shows the SEFI cross section for all the parts tested as a function of the effective LET. Shown are four curves representing the four cache conditions that were tested: All cache on, All cache off, L1 Data on only, and L1 and L2 Data cache on only. The first observation to make is that to first order the cross sections for all cache conditions are in the same order of magnitude. While the "All Cache Off" case is consistently below the other cases, it is not significantly below. This data seems to indicate that the primary mechanism that leads to a SEFI event is not generated with an error event in the cache. The cache may play a role in a second order effect, however.

Figure 14. SEFI cross section as a function of effective LET for varying cache states.

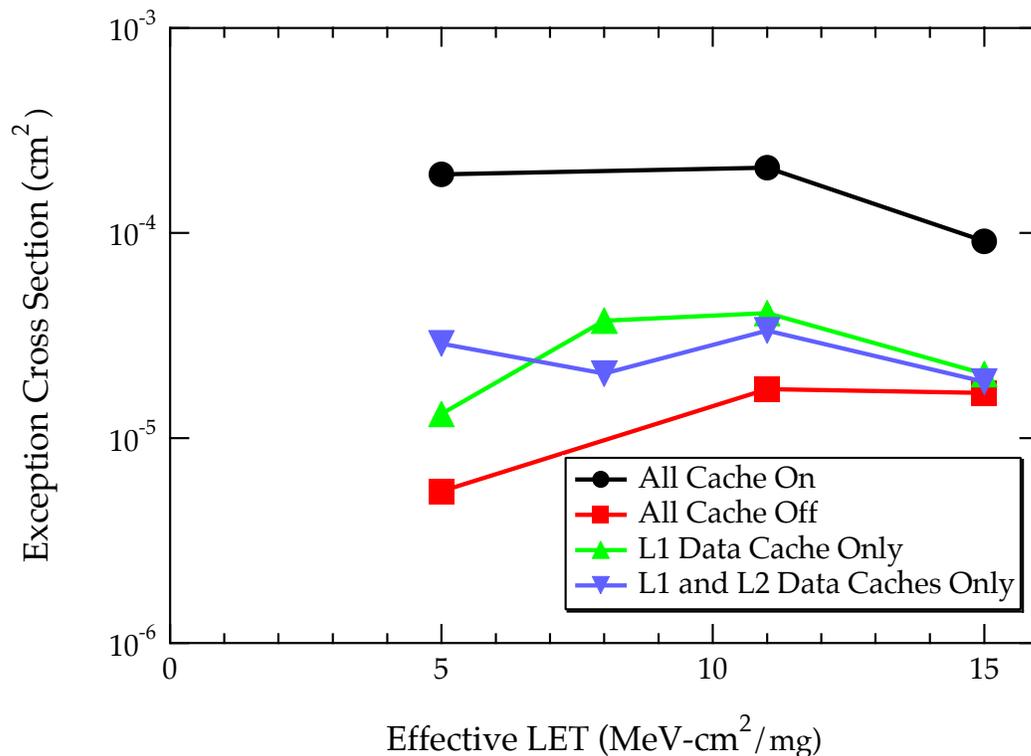
Unlike the SEFI cross section, it can be seen in Figure 15 that there is a strong dependence on the cache state for the exception rate. There is over an order of magnitude difference between the cases of “All Cache Off” and “All Cache On”. There is a small difference when the data caches are enabled, but the primary effect is seen when the instruction cache is enabled.

One final item to note from Figure 15 is that all of the cross sections decrease between the LET 11 and 15 points. While variation can be expected in this type of testing, this is also the LET regime where roll-off is expected

Figure 15. Exception cross section as a function of effective LET for varying cache states.

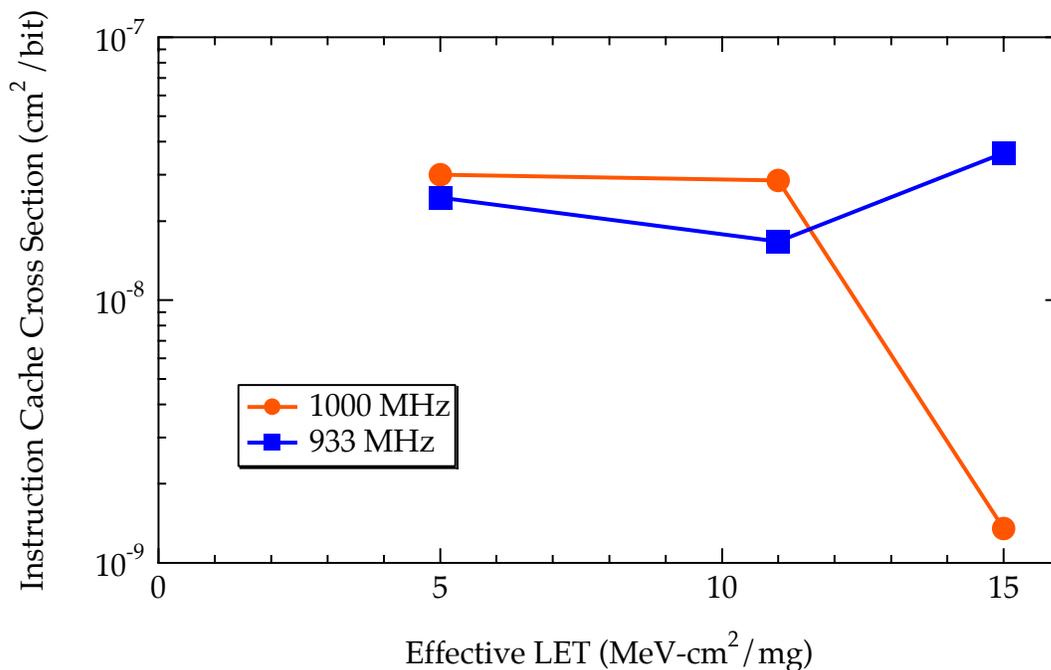
We can say with some confidence, though, that the threshold LET will be less than one and the saturation cross section is on the order of $2 \times 10^{-8} \text{ cm}^2/\text{bit}$.

Figure 16. Data from Test E showing the instruction cache per-bit cross section as a function of the effective LET. Shown is the data for both the 933 and 1000 MHz parts.

Tests C and E test the data and instruction caches, respectively. These areas of the die do show a high sensitivity to upsets and will be dealt with separately. The first to be considered in the instruction cache test, Test E. Figure 16 shows the per-bit cross section for the instruction cache as a function of effective LET for the two device speeds tested. It is easy to observe in Figure 16 that the cross section is in the saturation regime over the LET range tested. The possible exception to this is for the 1000 MHz parts, roll-off may be coming into play for the effective LET 15 point. As in the SEFI and exception cases, it is difficult to say whether this is truly roll-off or just statistics. It should be noted, though, that the difference in the 933 and 1000 MHz parts shown in Figure 16 is not seen in the exception or SEFI data. That is why that data was not plotted as separate device speeds.

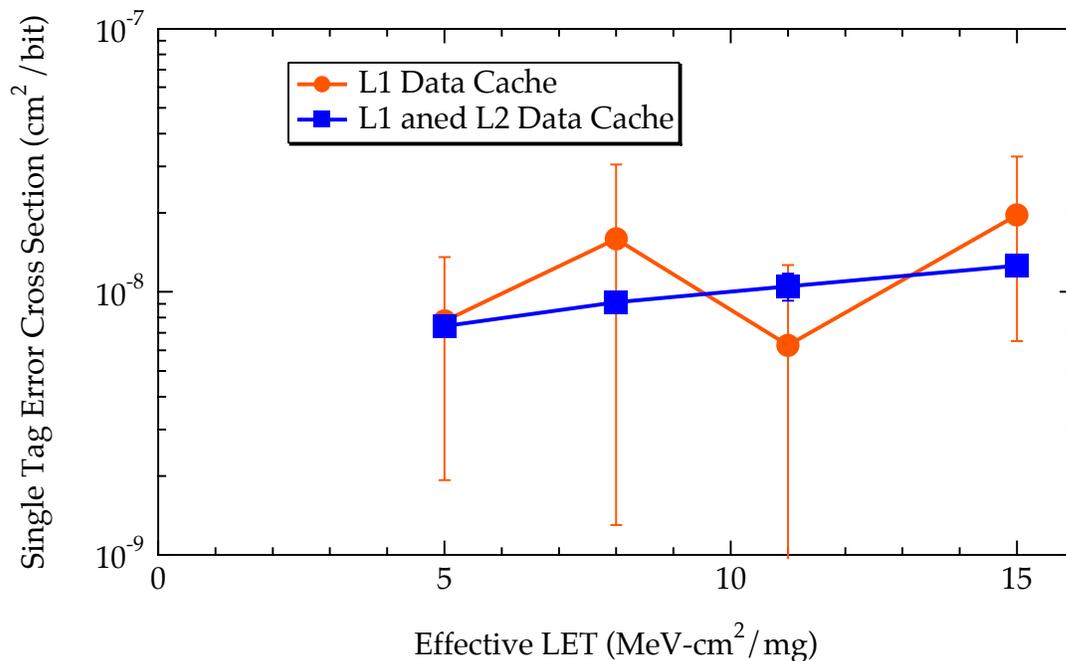
The final tag error case to consider is the single tag error. Figure 17 shows the per-bit cross section for a tag error as a function of effective LET for the two cache cases tested. The error bars on this graph are the one-sigma statistical variation across the parts tested (both part-to-part and speed differences). The error bars on the L1 only case are significantly larger than the L1 and L2 case (they almost fall within the plot symbol). This is due mainly to the much smaller number of errors seen in the L1 only case.

Figure 17. Data from Test C showing the per-bit tag cross section as a function of effective LET. Shown are the two cases of L1 data cache only and the L1 and L2 data cache.

It can also be seen in Figure 17 that the cross section is near, if not at, saturation levels across the entire range of LETs used. This would indicate that the threshold level will be small (< 1) and that the saturation cross section is in the range of $1 - 2 \times 10^{-8}$ cm^2 . These numbers are consistent with the data from the instruction cache test. Since the tag bits are physically the same technology and manufactured within the same array as the

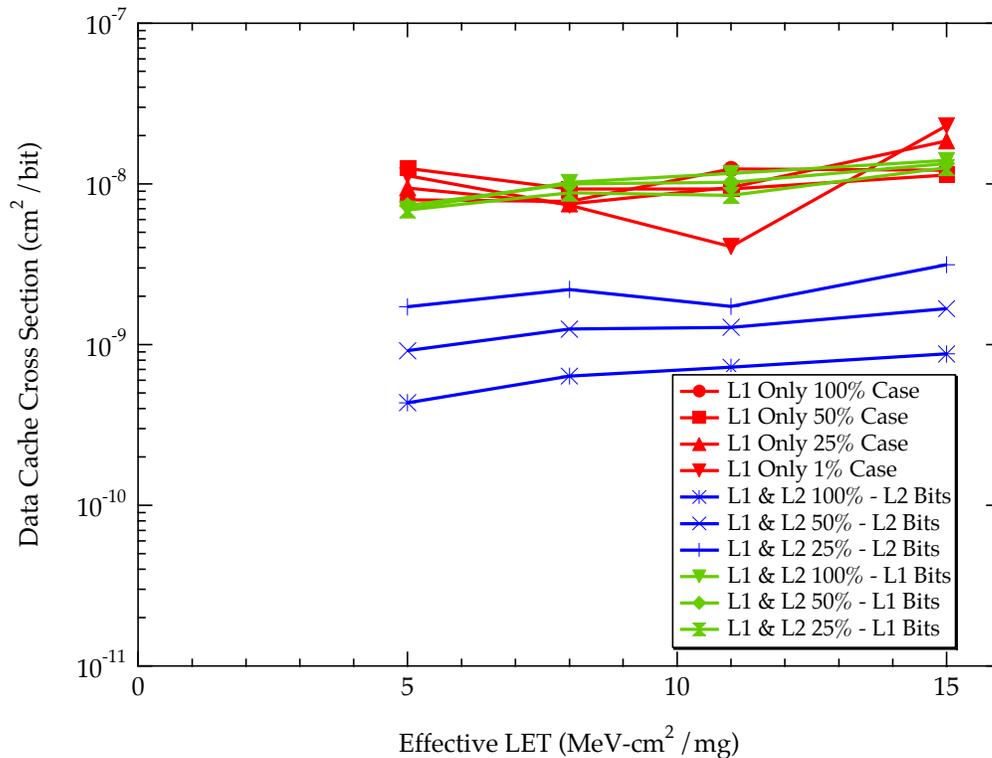
Figure 18. The per-bit cross section for the data caches is shown as a function of the effective LET. The data for L1 and L2 case is shown with two bit cases, the proportional L2 bits and the 100% L1 bits.

The four red traces represent the four percentage cases for the L1 only case. As can be seen in Figure 18, these show a saturation cross section trend across the effective LET region tested and a saturation cross section of approximately $1 - 2 \times 10^{-8} \text{ cm}^2/\text{bit}$. This number is in line with the results from Test E on the instruction cache and the results from the tag errors from Test C. This is what one would expect if all the caches are of the same technology and layout (as is typically done).

fraction of the total for each of the different percentage cases run. While this seems to be a good assumption for the L1 only case, Figure 18 seems to indicate differently for the L1 and L2 cache cases.

To investigate an alternative explanation, we can return to Figure 18. In this figure the three green curves represent the three percentage cases for the L1 and L2 data cache that have been made per-bit by dividing the cross section by the total number of bits in the L1 cache (L1 Data 100% case). It is easy to see that these curves now fall directly on top of each other and on top of the L1 only curves, indicating the same per-bit cross section for all of the caches, under all percentage cases and their respective tag bits as well. This situation makes the most sense. The problem is trying to explain why the 100% L1 data cache size is the correct number of bits to be dividing by. At present, we have no explanation for this but it is still under investigation.

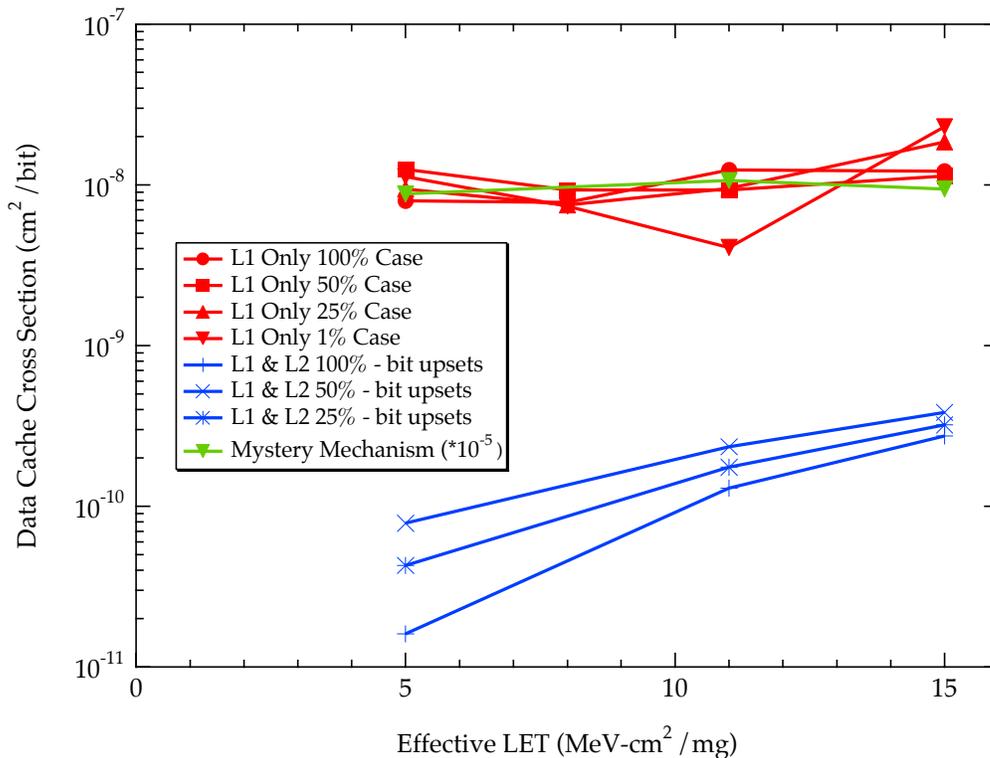
Figure 19. In this figure, the red curves are the same as in Figure 18. The single green curve is the mystery mechanism that has not bit number dependence. It is shown here at the same level as the L1 data for convenience only. The actual cross section values are five orders of magnitude larger, as it is a per-device cross section rather than a per-bit. The three blue curves in Figure 19 are the remainders of the three L1 and L2 percentage cases after subtracting out the mystery mechanism curve and dividing by the proportional number of L2 bits for the percentage case. While the curves have grown somewhat closer together, the grouping is still not very tight and the values are almost two orders of magnitude lower than for the L1 cases (and for that matter the instruction cache and tag bits). This difference does not seem to make a good fit or reasonable explanation.

Figure 19. Data cache per-bit cross section curves showing possible two upset mechanism for the L1 and L2 cases.

The problem arises when the per bit cross section is calculated for the L1 and L2 cases using the proportional number of bits based on 100% of the L2 cache test. These three percentage cases are shown in blue in Figure 18. As can be seen, the curves fall below the L1 only case by an order of magnitude or more. More significantly is the spread in the curves as a function of the percentage of the L2 cache tested. This could possibly be explained by having two mechanisms that lead to upsets, one that is not related to the number of bits tested (e.g., in the periphery circuits) and the bit cell upsets. An attempt was made to determine what single curve could be subtracted from each of the three total cross section curves for the L1 and L2 percentage cases that would lead to the three per-bit percentage cases falling on top of each other. While there is no physical basis for this methodology, for the postulate given above, this curve must exist. The best attempt at finding this curve and the resultant per bit curves is shown in
