**Space Parts Working Group
April 13 & 14 Hilton
Torrance, CA**

**One NASA
Review of COTS Plastic Encapsulated
Microcircuits (PEMs) for Space Applications**

**In Pursuit of Excellence in
Quality & Reliability**

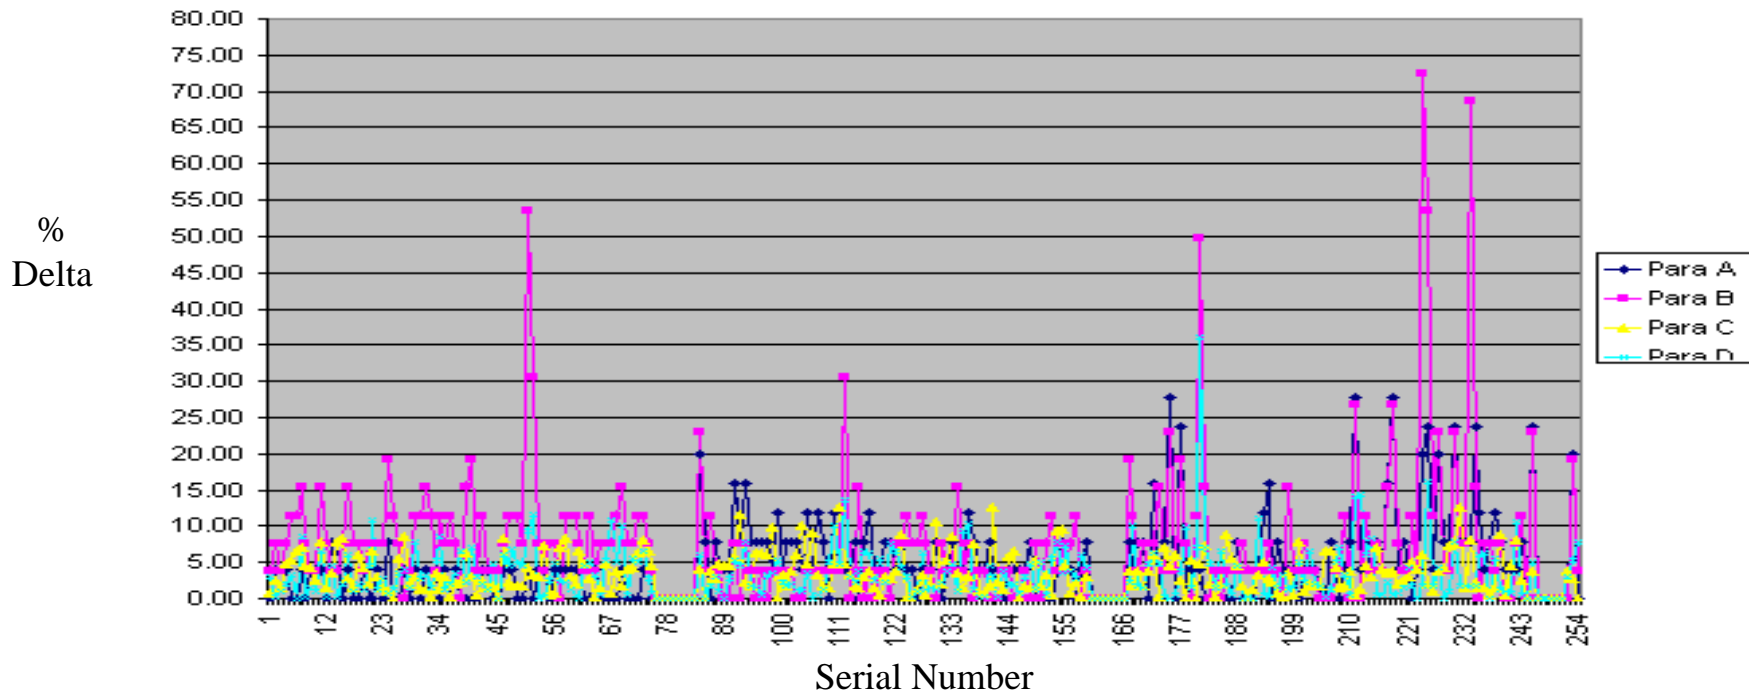
Parametric Degradation With Dynamic Burn-In

The part is advertised as a high precision reference device with an ultra low drift specification of 3 ppm/°C max. It is designed using precision thin film resistors and drift trimming. The graph below depicts some of the parameter changes measured at 25°C after burn-in. Some parts show significant change but the change does not always indicate the part did not meet specification. It is important that all designs be evaluated (*using a worst case analysis*) for tolerance to degradation and performance. Screening can eliminate unwanted devices.
