Basics of Failure Analysis

Lyudmyla Ochs, NASA GSFC 562

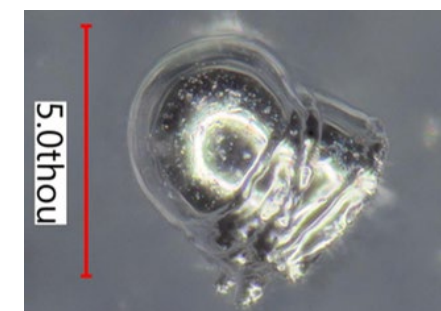
- Not very common in Failure Analysis, since aggressive shaking may dislodge a particle that is already causing a short

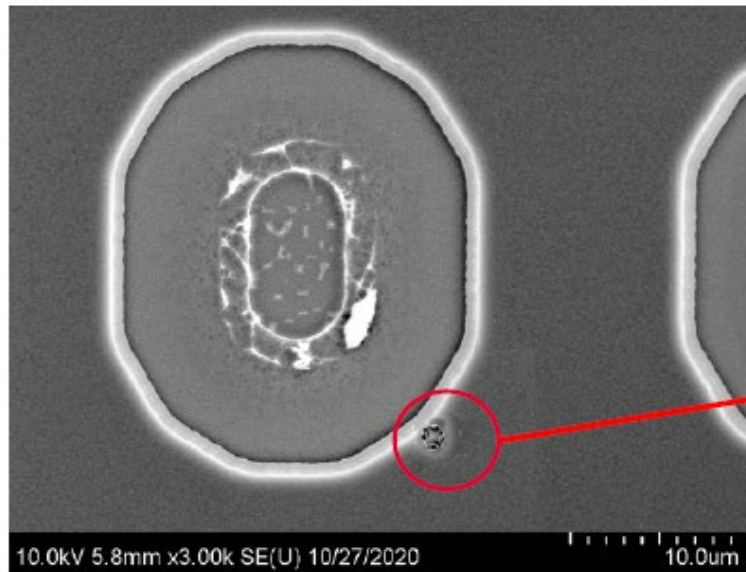
ESD damage on surface and cross-sectioned
