# SEU Mitigation Testing of Xilinx Virtex II FPGAs

**Abstract**—SRAM-based reconfigurable programmable logic is widely used in commercial applications and occasionally used in space flight applications because of its susceptibility to single-event upset (SEU). Upset detection and mitigation schemes have been tested on the Xilinx Virtex II X-2V1000 in heavy-ion and proton irradiation to control the accumulation of SEUs and to mitigate their effects on the intended operation. Non-intrusive upset detection and partial reconfiguration in combination with TMR can repair the design to maintain state information. In-beam results on a simple test design demonstrate the effectiveness of these methods when used together.

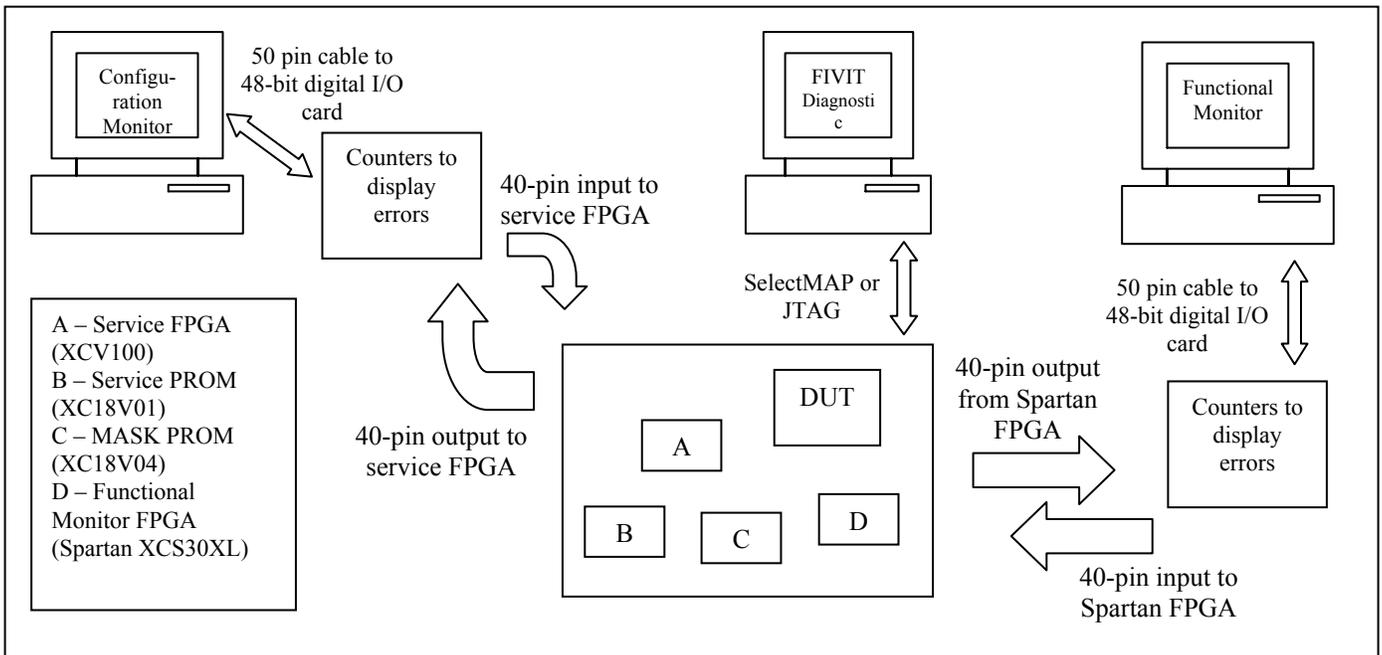
FIGURE 1

The test platform for the dynamic testing is shown in Fig. 1 and 2. It is composed of three primary components, the device-under-test (DUT), the Configuration Monitor and the Functional Monitor. The DUT is situated on a Xilinx HW-AFXBG256-200 development board incorporating a Xilinx XCV100 Virtex FPGA. The XCV100, also known as “service FPGA” acts as the “Configuration Monitor”, detecting and correcting configuration upsets under the control of a host computer. The service FPGA continuously detects and counts the number of errors in the DUT through the use of readback, a feature of Xilinx FPGAs that allow users to read the configuration memory post-configuration. The FPGA readback data from the configuration memory undergoes a bit-for-bit comparison with a mask file stored in a separate PROM, also known as “mask PROM”. Mismatches in the bit-for-bit comparison are classified as detected errors and a pulse is sent from the XCV100 to a host computer via custom Visual Basic software and 40 pin twisted-pair ribbon cables.

Once errors are detected, the service FPGA also has the ability to correct the upsets through partial re-configuration (PRC). This process, also known as “non-intrusive scrubbing”, will cause errors in the configuration memory to be corrected without interfering with the operation of the loaded design [6]. The custom Visual Basic program records and displays the errors as they occur. It also gives the user the option to continuously monitor, continuously scrub, or continuously monitor and scrub at 50% duty cycles.

The “Functional Monitor” is implemented using another FPGA, a Spartan XCS30XL, used to generate test vectors to the DUT and compare DUT outputs with expected values.

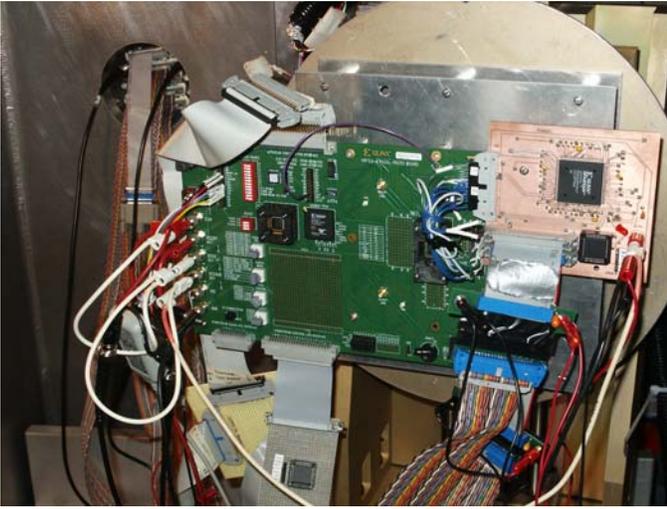
Fig. 2. A photo of the test vehicle in the vacuum chamber at Lawrence Berkeley National Laboratory 88" cyclotron.

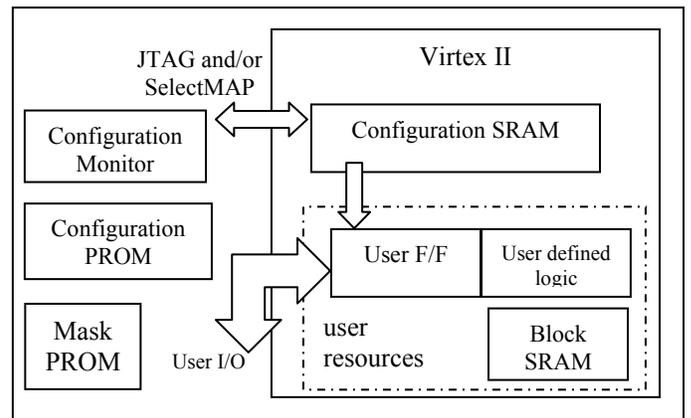
Fig. 3. A diagram of the device resources involved in configuration and partial reconfiguration. The configuration PROM contains the bitstream used to program the configuration monitor FPGA. The configuration monitor FPGA in turn, monitors and corrects errors as seen in the DUT's SRAM-based configuration memory through either the JTAG or SelectMAP port. The DUT's configuration dictates how the design will be implemented using the user resources. The mask PROM is used to flag the bits in the configuration bitstream that should not be changed by the Configuration Monitor.

The use of partial reconfiguration [6] in the Virtex and Virtex II devices repairs errors in the configuration bitstream without disrupting the operation of the device. Scrubbing non-intrusively allows individual configuration bits to be changed (back to their correct value following an upset) in individually addressable "frames". Prior to scrubbing, the user can choose whether to require a readback operation to determine if errors exist. A detailed picture illustrating the configuration method is found in Fig. 3.

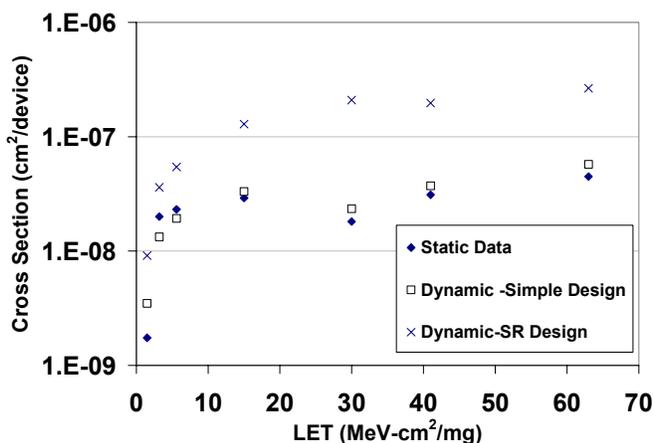
Fig. 4. The cross-section of combined configuration memory and block RAM bits for a static test and dynamic test without mitigation efforts.

Before comparing mitigated test results, it is interesting to compare configuration upsets in static and dynamic tests. Fig. 4 shows three cross-section curves for average configuration memory and block RAM upsets. Pure static test results from a simple single shift-register design are shown (solid diamonds). These are very close to the dynamic results where the configuration was being monitored continuously (the open square points). However, dynamic monitoring of the somewhat more complex eight-shift register (four with TMR) gives a significantly higher cross-section. This suggests a design dependence that is greater than the difference between static and dynamic testing (at least where dynamic is defined as continuously reading the configuration memory).

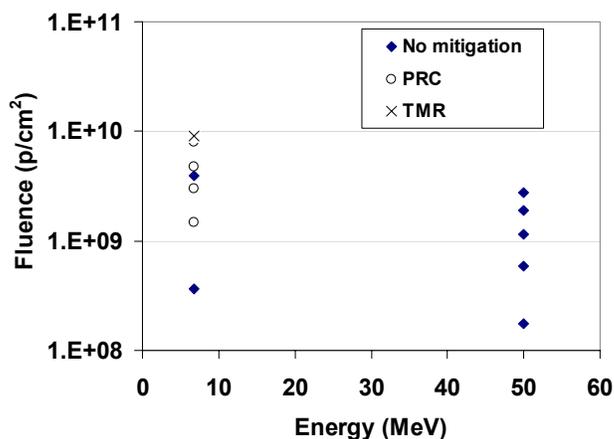
Fig. 5. A scatter plot of the fluence to first functional failure for protons. "PRC" represents data points where partial reconfiguration was used, "TMR" represents points where triple module redundancy was used in the design.

Before testing with heavy ions, the test vehicle was brought to the Crocker Nuclear Laboratory for proton testing to verify its functionality as well as to obtain preliminary results to compare with previous non-mitigated data. TMR and partial reconfiguration mitigation methods were tested at 6.8 MeV. A scatter plot of the fluence to first functional failure is shown in Figure 5. A slightly higher fluence is observed for runs employing partial reconfiguration and one run for TMR. The highest fluence level for a non-mitigated design is about twice than the highest fluence for other designs. No functional errors were recorded for the design using both TMR and partial reconfiguration.

A comparison of cross-section for first functional errors is given in Fig. 7. The varied scattering seen before in Fig. 5 is replicated here and is a function of Poisson's probability distribution, a mathematical computation of the probability of atypical events occurring in a given time period. Overall, a majority of the cross-sections for the non-mitigated design are slightly higher than all points for a design using TMR and a few points using scrubbing. The present data is constrained by limited statistics and would be helped by additional testing.

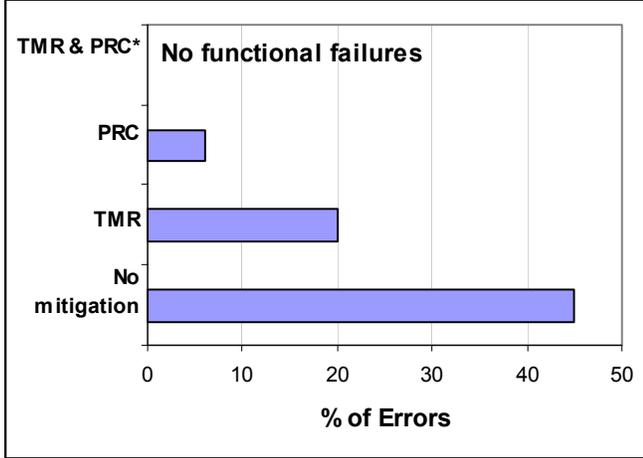
Fig. 6. A comparison of frequency of errors to total runs for four possible variations of the same shift register design shows the effectiveness of each method.

A summary of the test results from the heavy ion test can be seen in Figure 6. Five test runs with low upset rates from each mitigation category are compared. When mitigation such as TMR is used in the design, a decrease of roughly 25% in frequency of functional errors is seen. When partial reconfiguration is implemented, functional errors decrease by about 40%. When both mitigation methods are used in conjunction to repair configuration memory upsets as well as user logic upsets, no functional errors in the shift register were observed. However, it should be noted that a single bit error was seen in one shift register output during one of the beam runs where TMR and PRC was used. Some of the possible

causes of this event could be an unscrubbed single-event transient or an ion strike to the enable pin of the TMR minority voter [7]. Although the probability of seeing an error just prior to or following a scrub is also not impossible, a mitigated design is useful in controlling the upsets as they occur.

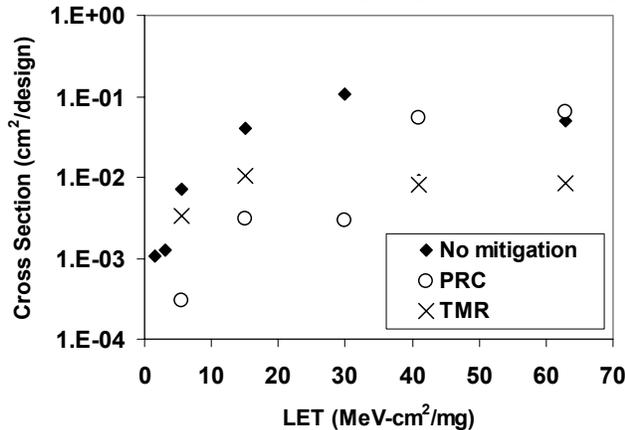
Fig. 7. Cross-section of first functional errors in heavy-ions. Poisson scatter is large due to the small number of runs at each LET.
