The Continuing Dangers of Tin Whiskers and Attempts to Control Them with Conformal Coating

Jong S. Kadesch
Orbital Sciences Corporation/NASA
Jong.S.Kadesch.1@gsc.nasa.gov
301-286-2785

Jay Brusse
QSS Group, Inc./NASA
Jay.A.Brusse.1@gsc.nasa.gov
301-286-2019

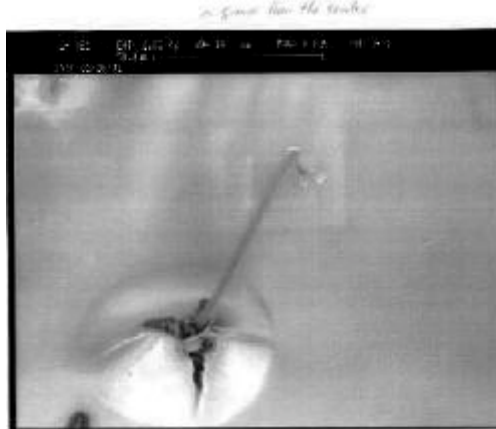
Figure 1. SEM photo of a tin whisker breaking out from beneath conformal coating (x625)

Figure 1 shows the most extreme observation we have recorded to date where a tin whisker has actually grown through the conformal coating approximately 2 years after application of the conformal coat. Attempts to measure the actual thickness of the coating at this location have been difficult because this area of the test specimen has a relatively thin layer of conformal coat. Estimates of the coating thickness in this location are on the order of 1/4 mil. After emerging from the coating, the tin whisker can become a risk for inducing short circuits. As noted previously, there are numerous other whisker growths beneath the thicker areas of conformal coating (~ 2 mil thick) that we anticipate will eventually penetrate the conformal coating. With some NASA missions extending over 10 years, and a few to 20 years, it is possible (but not confirmed experimentally) that coatings even as thick as 10 mils may not prevent whiskers from protruding.

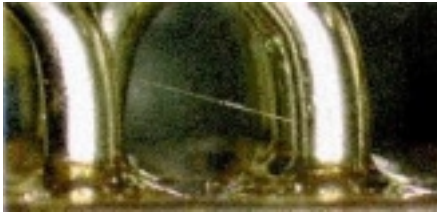
Electromagnetic relay terminals
Photo courtesy of NASA GSFC

Ceramic chip capacitor termination
Photo courtesy of Ericsson

Hybrid microcircuit lid
Photo courtesy of JPL

Figure 2. Examples of Tin Whiskers Growing on Pure Tin Plated Electronic Components

The growth of tin whiskers on pure tin plated electronic components and associated hardware has been documented for decades. Notable examples of pure tin plated components that have exhibited tin whisker formations include electromagnetic relays, transistors, hybrid microcircuit packages, terminal lugs and very recently ceramic chip capacitors. A few such examples are shown below in figure 2:

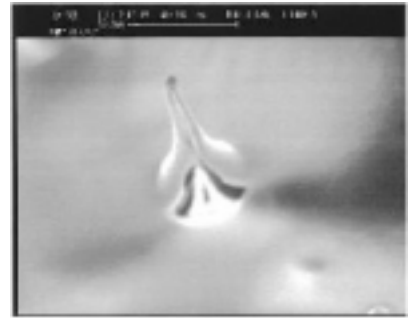
10X magnification

43X magnification

670X magnification

Figure 3. SEM photos of tin domes forming beneath conformal coating

Figure 3 shows the formation of tin nodules beneath the conformal coat on several specimens. Such growths under the conformal coating are common on all of the specimens regardless of storage conditions (room temperature vs. 50°C). In these SEM images the tin whiskers resemble a spike being pushed into a rubber membrane, deforming the surface into a sharp-tipped cone. It is interesting to observe that many of the whiskers in Figure 3 formed along a surface scratch or defect in the substrate that was NOT intentionally introduced. These minor defects were most likely present on the substrate prior to plating or were introduced through the handling of the specimens just prior to initiation of the experiments. This observation raises the concern that basic handling during manufacturing or user assembly may impart stresses to the plating surface which become nucleation sites for whisker growths.

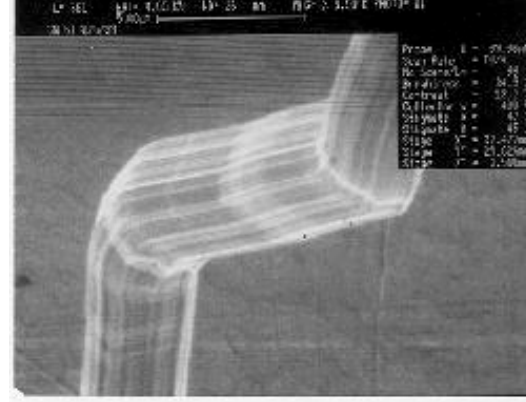
D. Kinked area of a whisker (x6500)
