Metal Whiskers:

Failure Modes and Mitigation Strategies

Jay Brusse / Perot Systems

Dr. Henning Leidecker / NASA Goddard

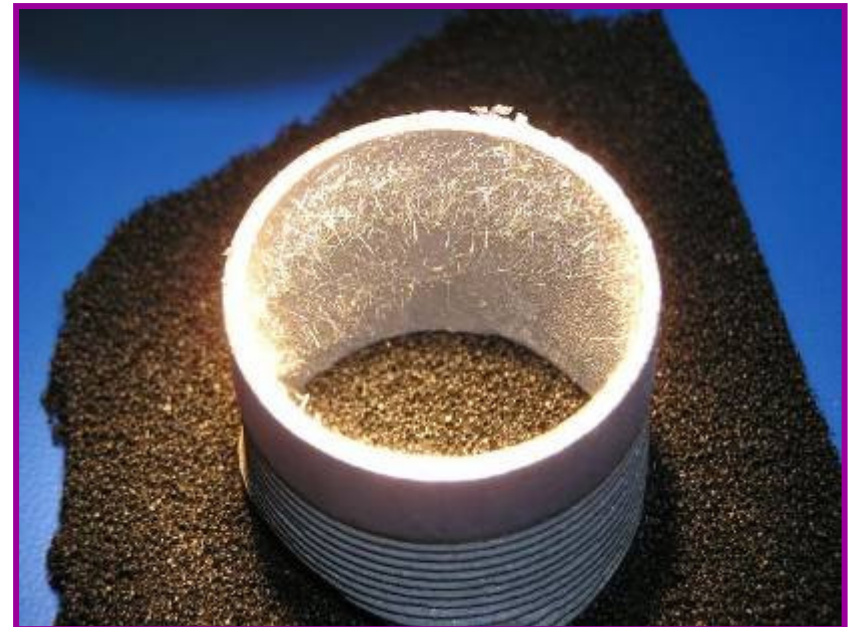
**Zinc Whiskers on
Hot Dip Galvanized Steel Pipe**

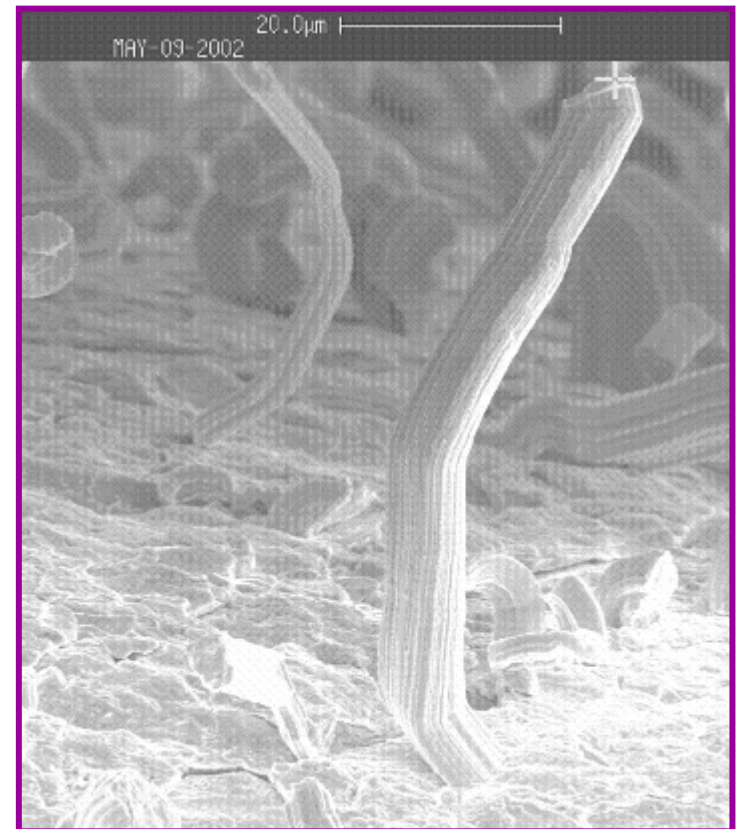
*Tin Whiskers on Tin-Plated
Ceramic Chip Capacitor*

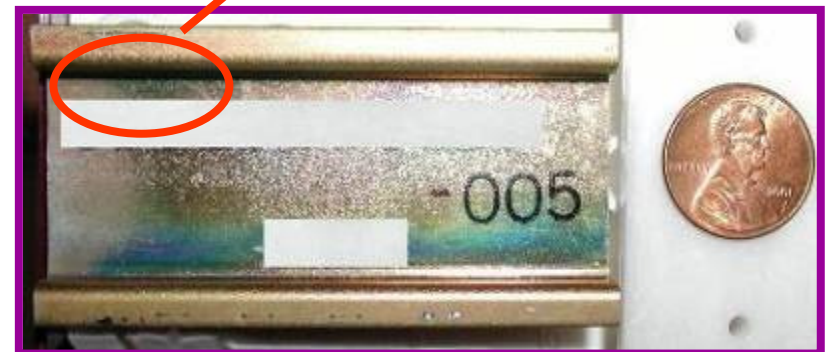
***Zinc Whiskers Growing from
Zinc-Plated Yellow Chromate
Steel Bus Rail***

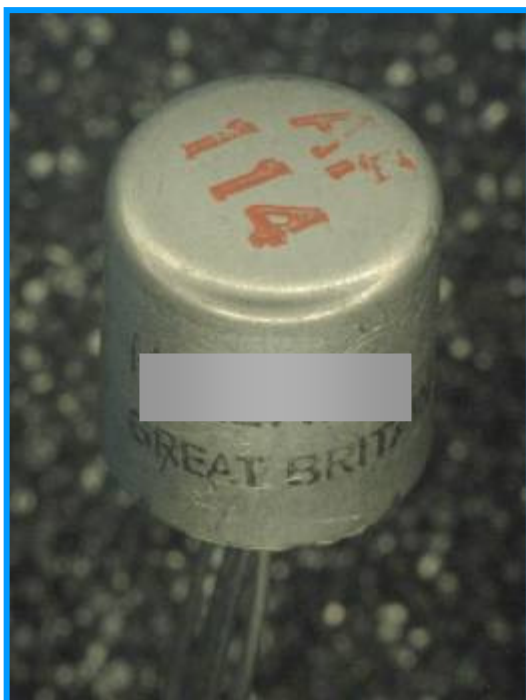
**1960's Vintage
Transistor**

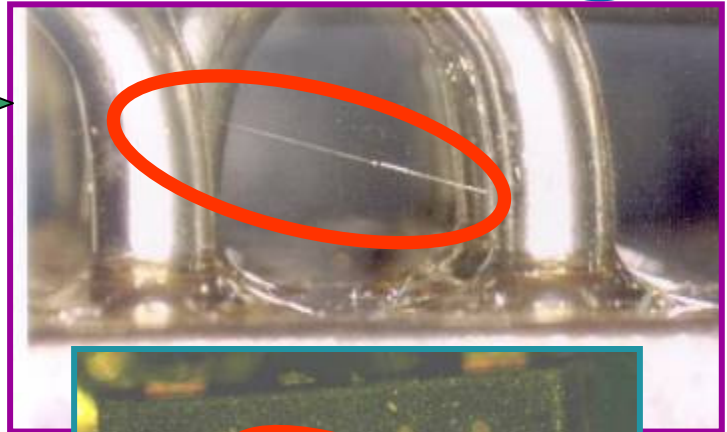
Electrical Short Circuits

- Continuous short if
- Intermittent short if

$$I_{whisker} < I_{melt}$$

$$I_{whisker} > I_{melt}$$

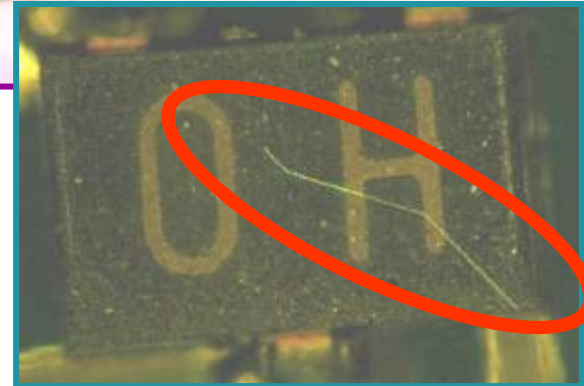
Debris/Contamination

- Interfere with Sensitive Optics or MEMS
- Produce Shorts in Areas REMOTE From Whisker Origins
(Zinc Whiskers on raised flooring are a PRIME Example)

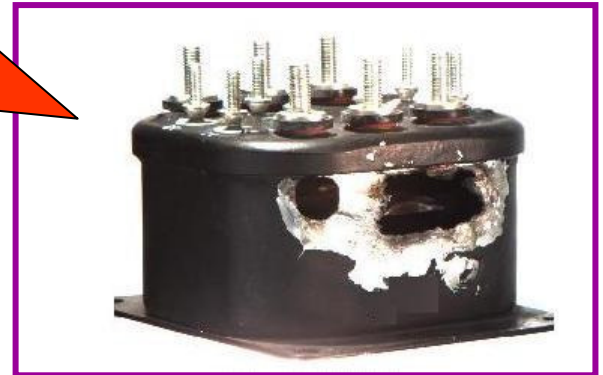
METAL VAPOR ARC

- If $I_{whisker} \gg I_{melt}$ Whisker Can Vaporize into a Metal Gas
- If EMF is sufficiently high, then the metal gas can be ionized into a conductive PLASMA of Metal Ions
- Plasma Can Form an Arc Capable of Carrying **HUNDREDS OF AMPS!** Depends on arc gap length, voltage, current, pressure, etc.

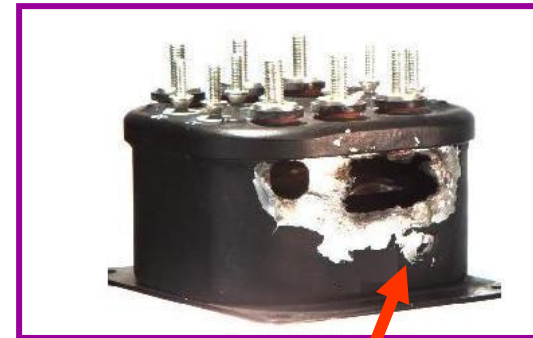
Tin Whiskers Growing on Armature Of Relay Produced Metal Vapor Arc

- Gaps shorter than a few tens of microns can support a sustained arc at potential differences of 12 to 14 volts, and currents of 0.1 to 0.3 amperes.
 - See “Electrical Contacts” by Paul G. Slade, part three
- However, as the arc gap increases, the EMF needed to sustain the arc increases, as does the current.
 - GSFC testing of FM08 style fuses with metal filaments ~5 mm long finds ~ 75 volts at more than 30 amperes is needed to generate a sustained arc across this arc gap when P ~1 torr

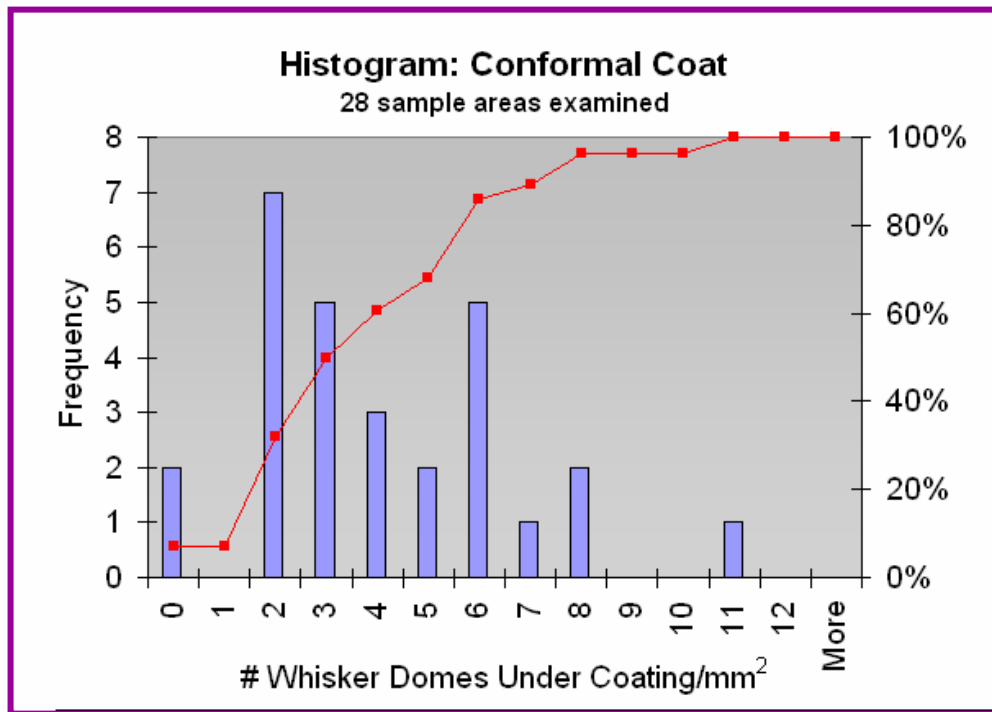
Uralane 5750 – 2 Mils Thick 9-Years of Office Ambient Storage

- **Conformal Coated Areas Grew Whiskers Too**
 - *To date ALL whiskers are contained beneath the coating that is 2 mils thick*
 - *With SEM we cannot see into the coating. Instead we see “domes” caused by whiskers that lift coating slightly*
 - **Avg: 3.4 ± 2.6 domes / mm²**
 - **Range: 0 to 10.6 domes / mm²**

We suspect we are only counting “thick” whiskers in this statistic because the “thin” ones mechanically buckle before they can lift the coating enough to produce visible “domes”

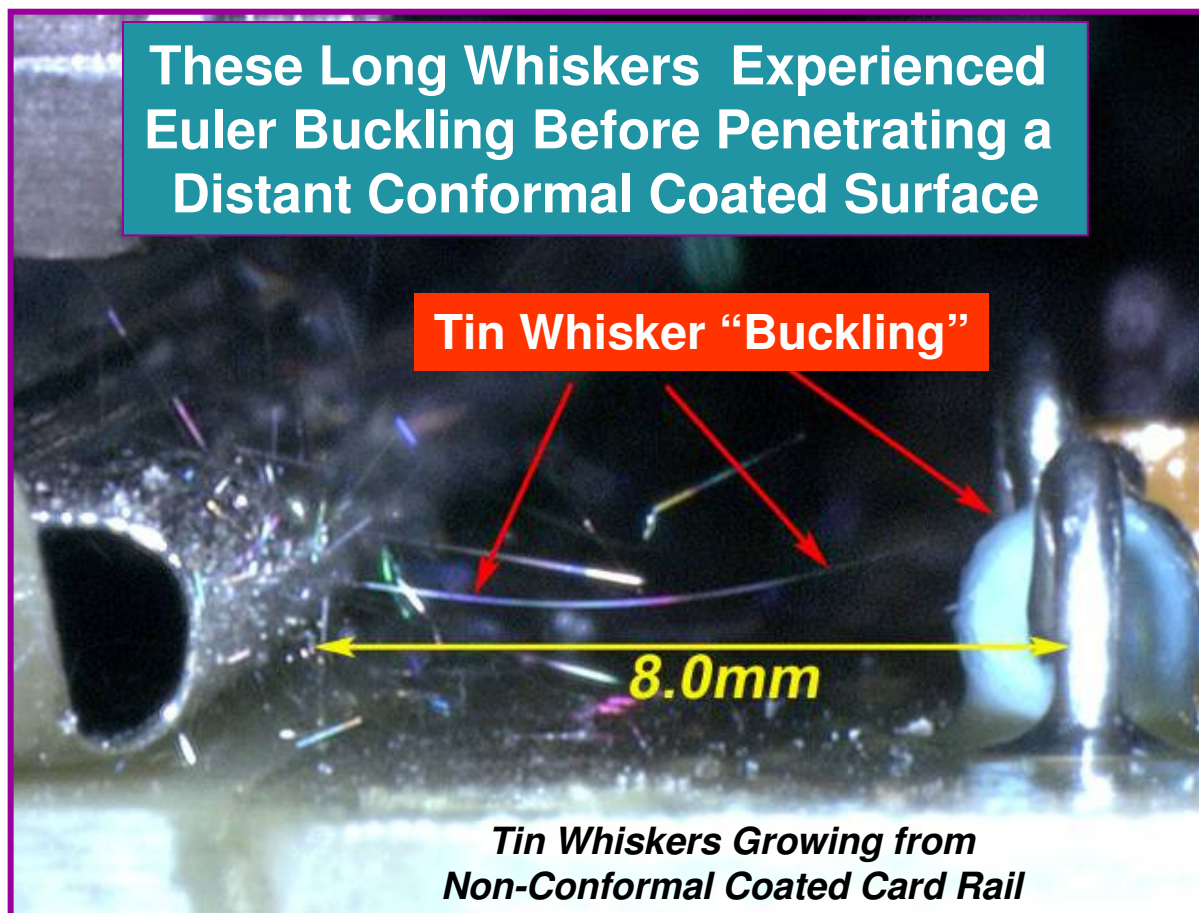
Thank Goodness for Euler Buckling and Conformal Coat on this PWB!!!

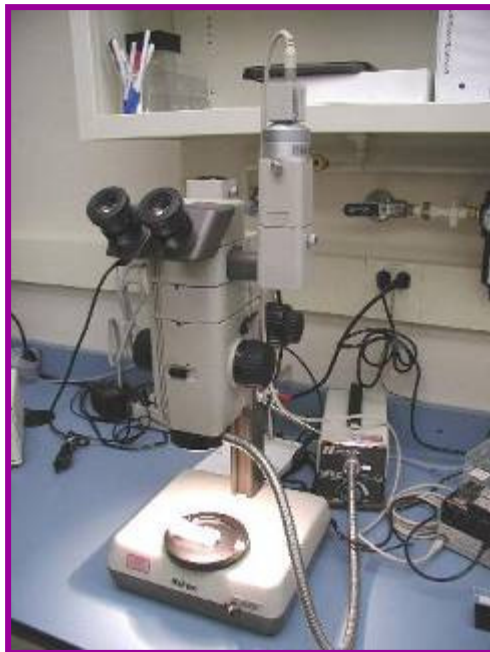
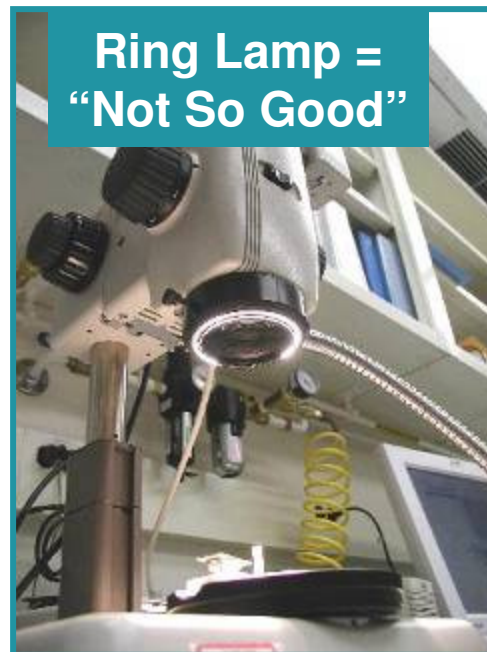
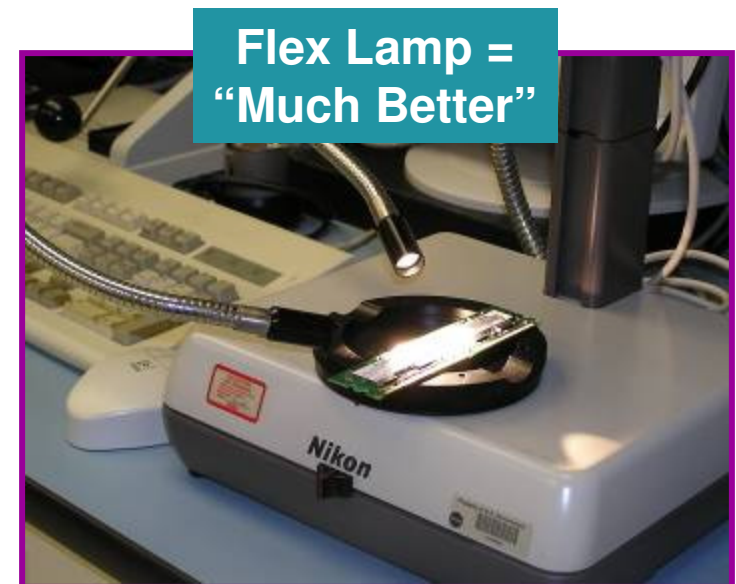
Optical Inspection for Metal Whiskers

- Basic Equipment:
 - Binocular Microscope
 - Light Source: Flex Lighting PREFERRED over Ring Lamp
- Freedom to tilt sample and/or lighting to illuminate whisker facets is VERY IMPORTANT

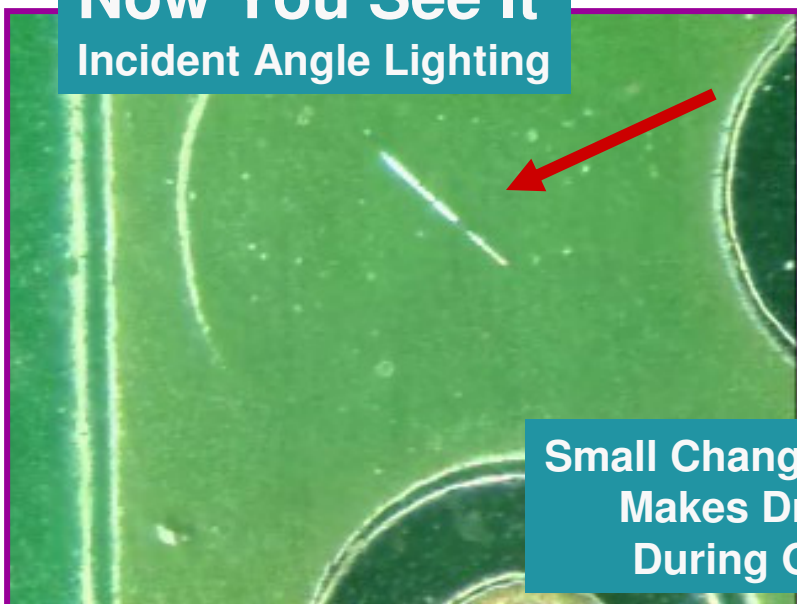
Now You See It
Incident Angle Lighting

**Small Change in Angle of Lighting
Makes Dramatic Difference
During Optical Inspection**

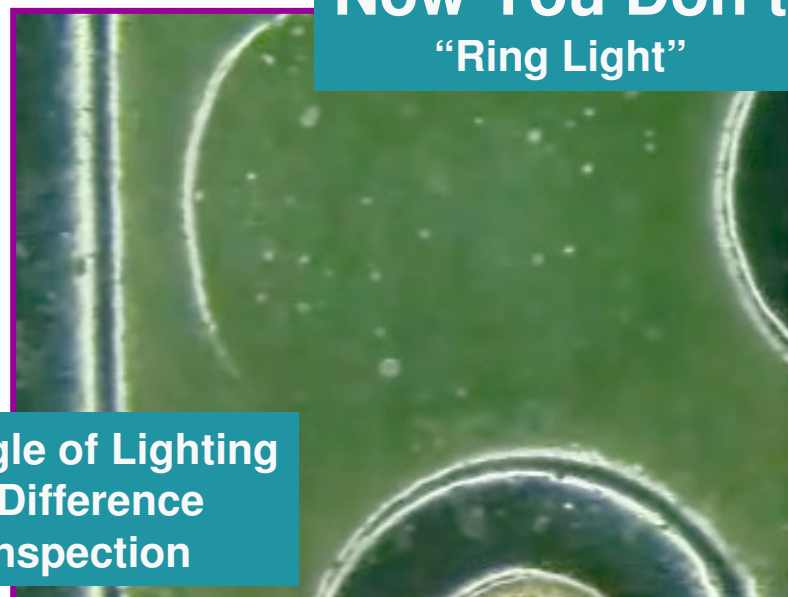
Now You Don't
"Ring Light"
