# Effects of Conformal Coat on Tin Whisker Growth

Jong S. Kadesch  
Orbital Sciences Corp./NASA  
Greenbelt, Maryland, USA  
e-mail: jkadesch@pop300.gsfc.nasa.gov

## Abstract

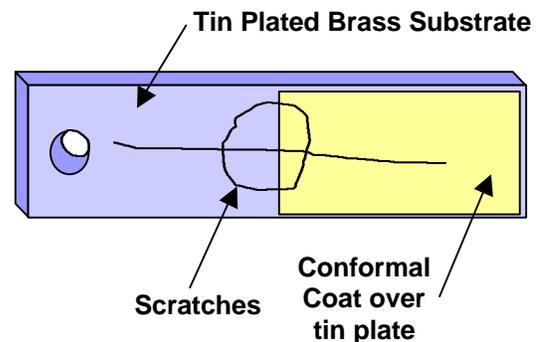
Figure 1. A specimen

The literature reports that the bright tin plating process is most susceptible to whisker formation and suggests that this is caused by residual stresses in the surface material [5], [6]. The thickness of the tin plating plays a significant role to whisker formation as well. Tin plating that is too thin (less than  $0.5\ \mu\text{m}$ ) or too thick (more than  $10\ \mu\text{m}$ ) does not promote whisker formation [8], [9]. For this experiment, several brass substrates (some with copper flash) have been plated using a "bright" tin finish. The brass substrates were coated with  $5\ \mu\text{m}$  ( $0.2\ \text{mil}$ ) of tin plating, which has been suggested to be the optimum thickness for whisker formation [8]. To further promote whisker formation, the plated samples were scratched using a knife blade, since scratches also create localized stresses that may promote whisker formation (Figure 1).

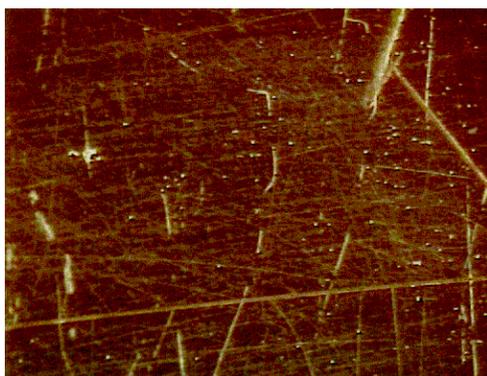
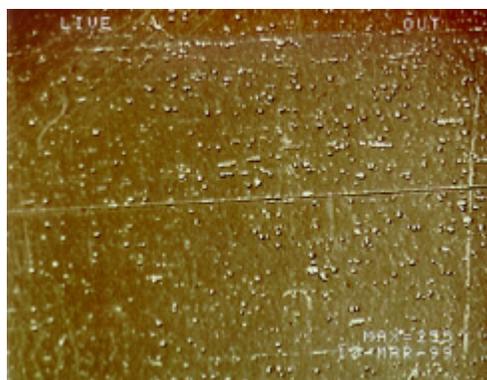
**Figure 2. Density of Nodules**

All samples are periodically examined using both an optical microscope and a Scanning Electron Microscope (SEM). The inspection was performed every two weeks for 3 months, and then once a month. Both tin nodules and tin whiskers were observed in less than a month following plating. Surprisingly, more nodules formed under the coating than on the non-conformally coated side. Figure 2 shows the nodule density on the coated side and the non-conformally coated side.

A. Non-conformally coated Side (x13)

B. Conformally Coated Side (x13)

our observations that more tin nodules formed under the conformal coat than on the exposed tin surface, we hypothesize that oxidation of the tin surface (exposed side) increases the incubation period for whisker formation.

The tin surface under the coating has been protected from oxidation whereas the exposed surface has been free to oxidize. Based upon

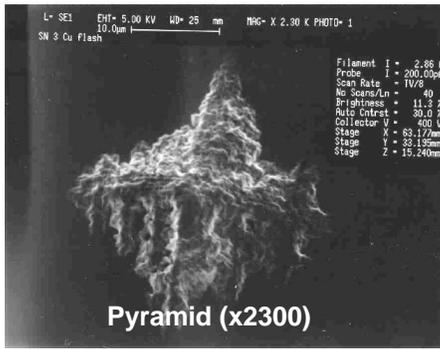
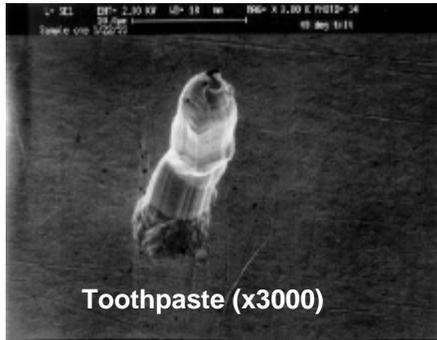
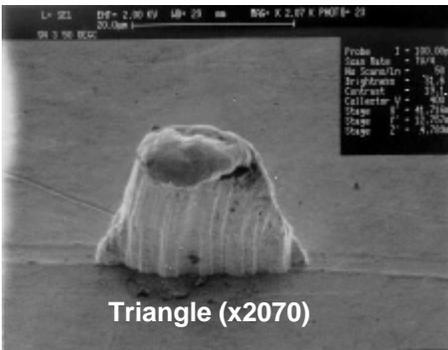
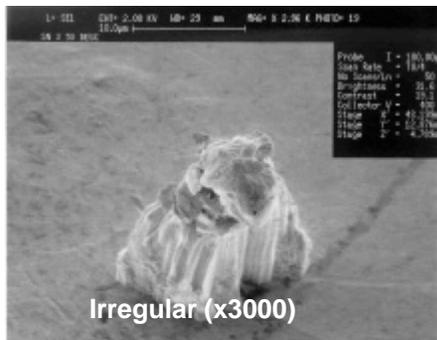
**Figure 3. Four Typical Shapes of Tin Nodules**

On the non-conformally coated side, nodules formed in various shapes, shown in Figure 3. Most of these nodules formed along surface scratches in the tin plating. These thin, tiny scratches are not the scratches that were made intentionally. In fact, relatively few whiskers were observed from the scratches that were made intentionally. Rather, the thin, tiny scratches, possibly resulting from abrasion by the paper within which the specimens were wrapped for shipping by the company that performed the electroplating process, promote almost 90% of the whisker formation observed.

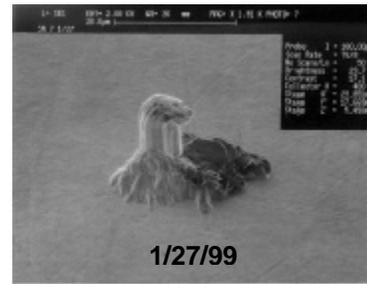
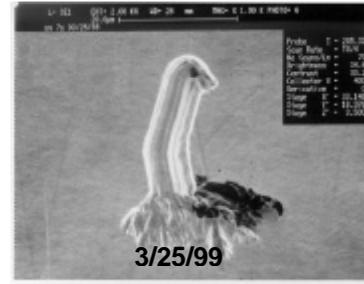
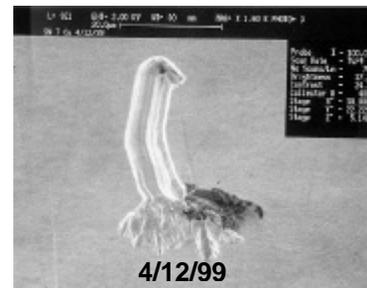
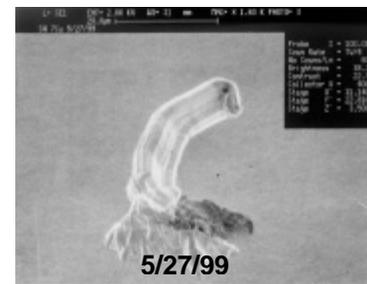
**Figure 4. Nodule Pictures Taken Periodically (x1700)**

Selected nodules were reinspected on a regular basis to determine the growth rate and to monitor the nodule formation process. Figure 4 depicts several stages of the formation of one specific tin whisker nodule.

This particular nodule had an average growth rate of 0.06 mm/year measured at 6 months, which can be compared to the reported growth rate value of 0.92 – 7.3 mm/year [4]. This nodule stopped growing after 6 months.

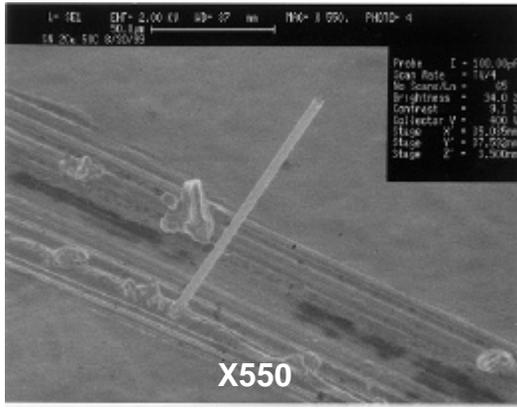
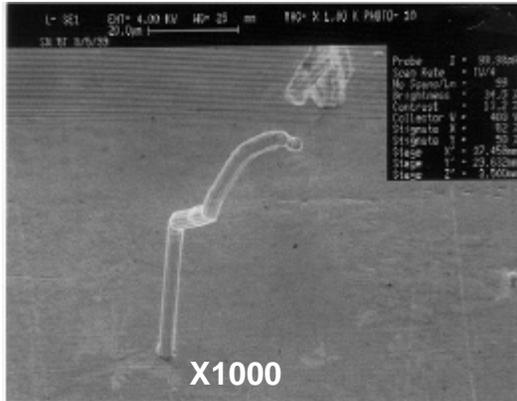
**Figure 5. Tin Whiskers on the Non-conformally Coated Side**

Some of these nodules are growing straight whiskers while other nodules grow whiskers with kinks (Figure 5).

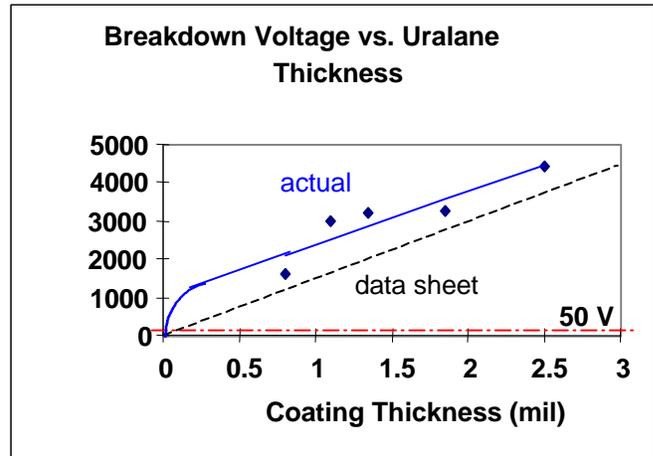
**Figure 6. Breakdown Voltage from the Experiment**

The dielectric strength of Uralane 5750 was reported to be 1500 V/mil by the manufacturer. However, this is for a uniform applied electric field. The field around the tip of the whisker is non-uniform, and so we performed some new breakdown tests. To simulate a tin whisker, a tungsten carbide probe tip (6  $\mu\text{m}$  in diameter) was brought into contact with the Uralane conformal coat. The DC voltage was increased until dielectric breakdown was detected. The breakdown voltage from the experiment was measured to be higher than the value reported (see Figure 6). The Uralane coating would have to be extremely thin (less than 1/10 mil) for the breakdown voltage to even approach 50V, which was the

application voltage in the commercial satellite that failed.

Since the thickness of the Uralane coating on the NASA boards would be approximately 50 to 75  $\mu\text{m}$  (2 to 3 mils), dielectric breakdown will not happen even when the whisker touches the surface of the coating, so long as the potential difference is less than a few thousand volts. Furthermore, the tin whisker will buckle when it pushes against the coating, rather than penetrate it. This is shown by comparing the buckling force with the force required to dimple the surface of the coating.

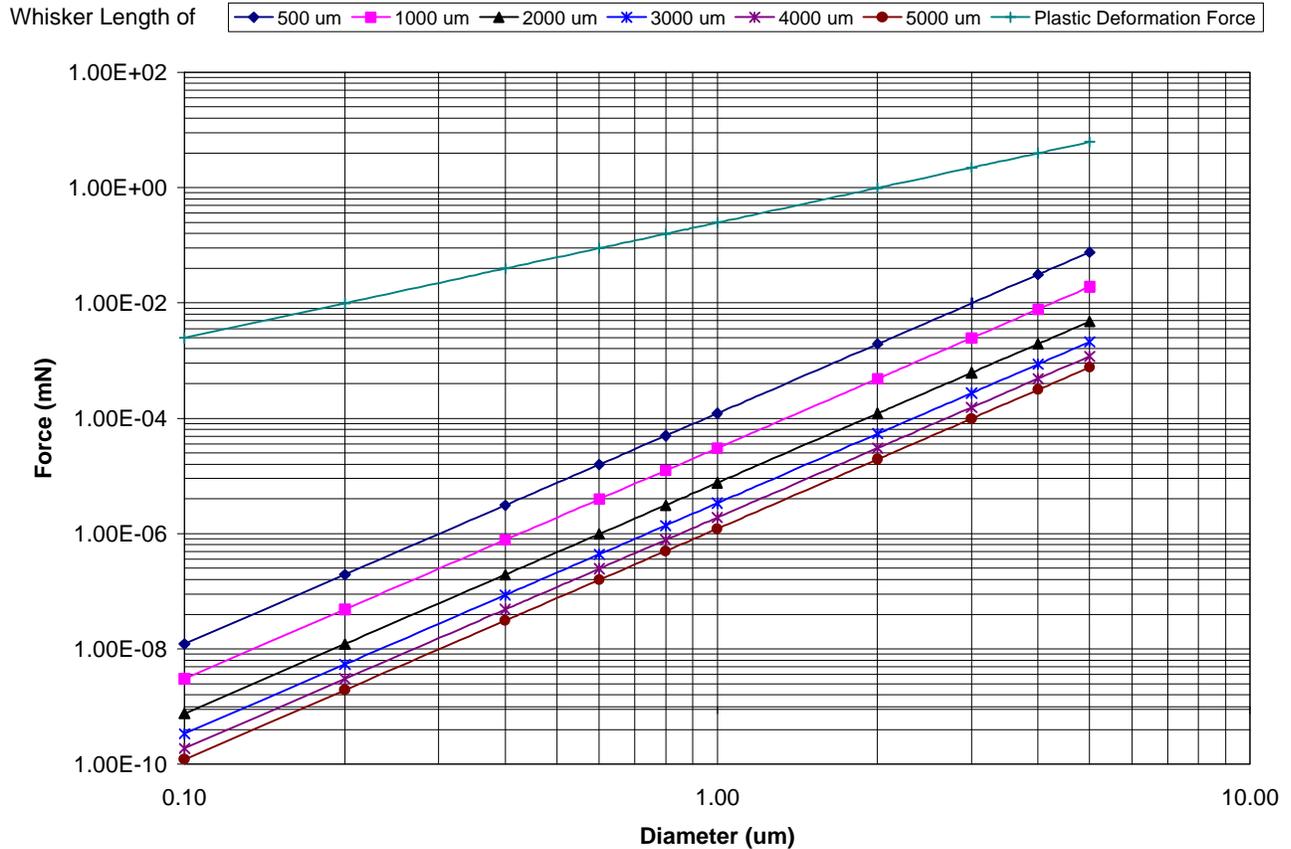
**Figure 8. Tin Whisker Buckling Force Calculation**

Figure 8 shows the buckling force of the tin whisker as a function of diameter and length.

Clearly, a long thin whisker would buckle more easily than a short, thick whisker. When the tin whisker tip is pushed against the Uralane, the coating will elastically dimple before it punctures.

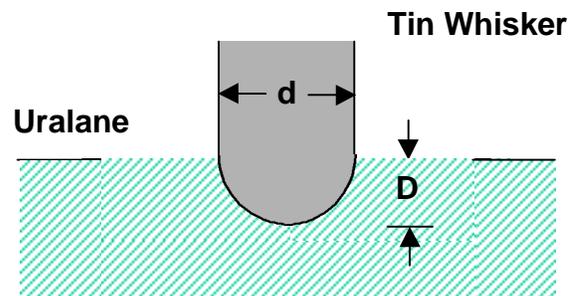
**Figure 9. Diagram of Tin Whisker Contact against Uralane**

The displacement of the surface due to the whisker pushing against the coating is:

$$D = \frac{(1 - \nu^2) F_B}{E d}$$

- $D$  = Displacement of the surface
- $\nu$  = Poisson's ratio for Uralane
- $E$  = Young's Modulus for Uralane
- $d$  = Diameter of the tin whisker

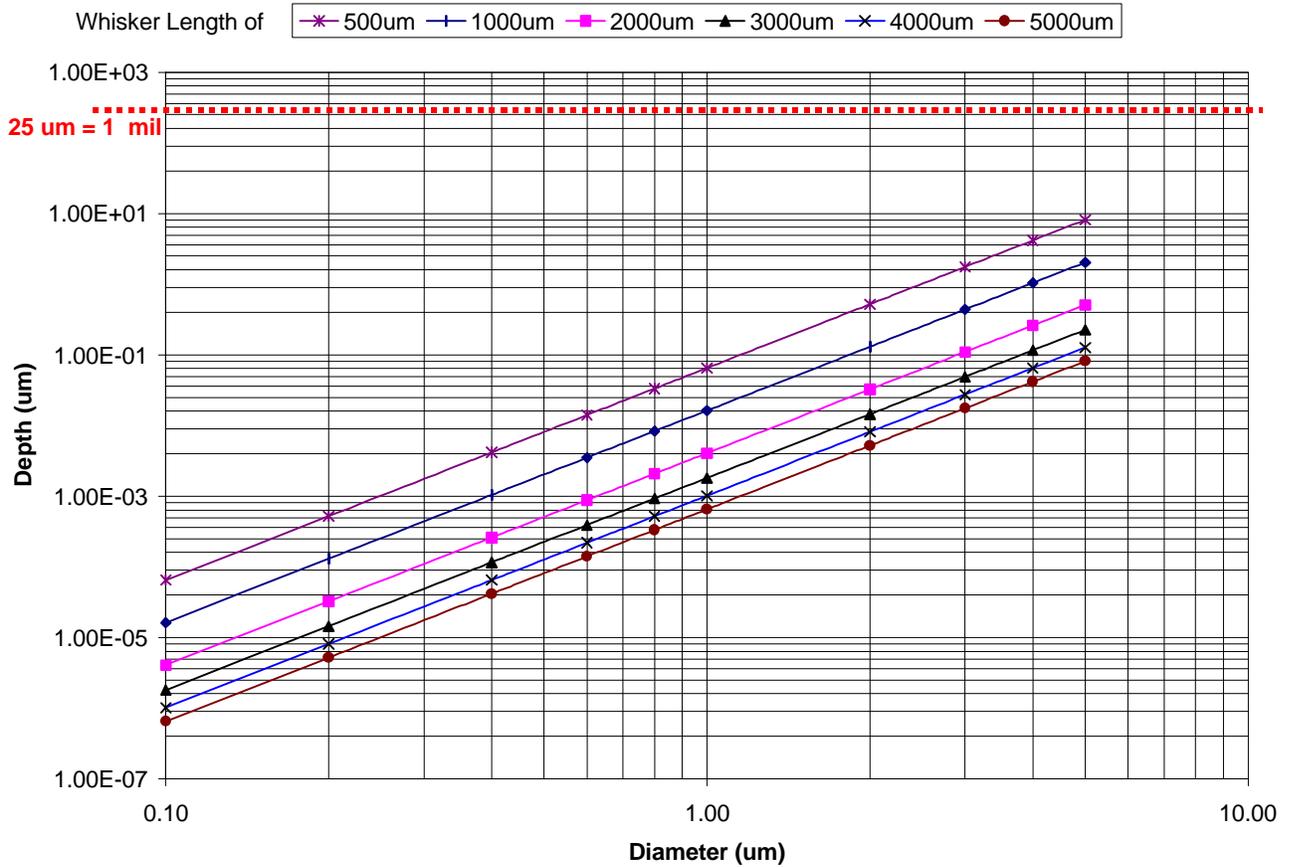
Figure 10. Penetration Depth before Buckling

According to Figure 10, even a short, thick whisker would make a dimple that is 2 orders of magnitude less than the minimum coating thickness of the specimen. Consequently, the tin whisker would only make a small dimple on the coating before buckling occurs.

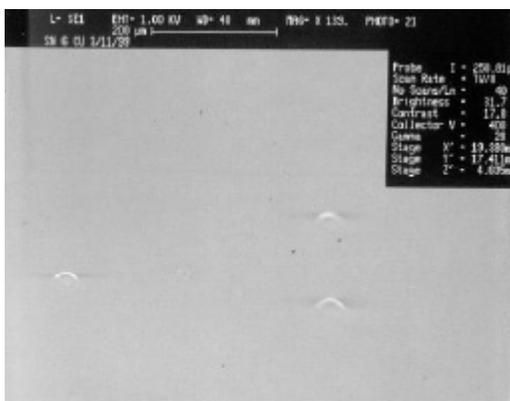
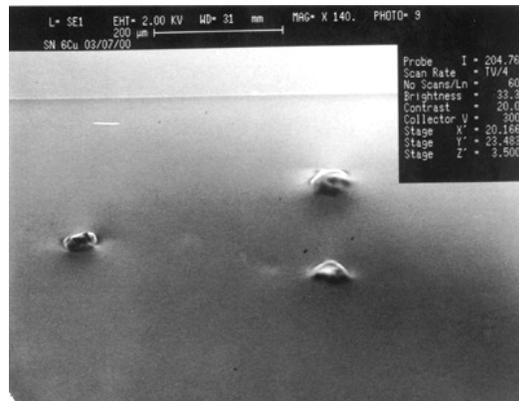
Figure 11. Whiskers Forming Under Coating

The latest observations indicate that tin whiskers under the conformal coat are pushing their way outward, causing dome shapes in the coating. As time progresses, these dome shapes are becoming larger and narrower at the top, which suggests that the whisker tips

are approaching the outer surface of the conformal coat. Figure 11 shows tin whiskers from the same location: Figure 11A is taken a year before Figure 11B. Similarly, figures 12A and 12B are photos of a whisker field taken 6 months apart.

A. Picture taken on 3/11/99 (x139)

B. Picture taken on 3/15/00 (x140)

Among 13 samples, only three specimens show these dome shapes. One is stored in the oven at 50 °C and two are kept at room temperature; one is copper flashed and the other is just pure tin over brass substrate.

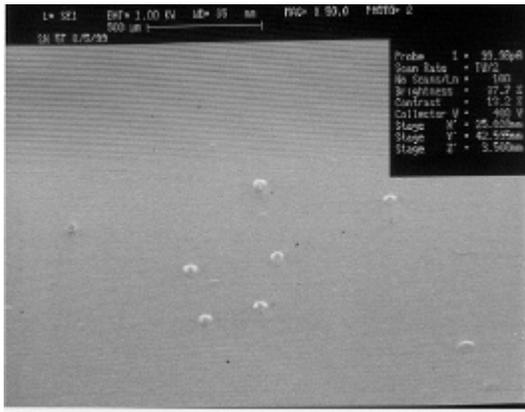
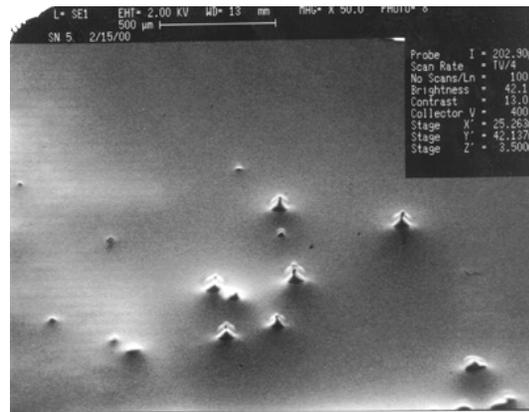
**Figure 12. Whiskers Forming Under Coating**

A. Picture taken on 8/5/99 (x50)

B. Picture taken on 3/15/00 (x50)

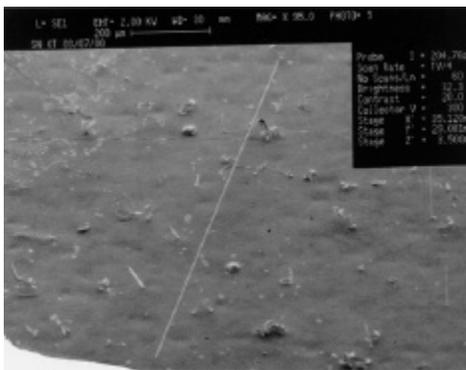
**Figure 13. Tin Whiskers of the Non-conformally Coated Side (x95)**

Figure 13 shows whiskers from a bare metal surface, without coating: some whiskers are growing faster than others. This one particular whisker grows at a rate of 0.64 mm/year. This whisker, which measured 0.8 mm in length (~31 mil) when the photo was taken, is long enough to cause short circuits between two leads having a standard 0.635 mm (25 mil) pitch.
