# **HALT/HASS and Thermal Cycling to Assess COTS Boards, GoPro Camera and Advanced PBGA/CCGA Virtex-5 Electronic Packages\***

**Rajeshuni Ramesham** Ph.D.

*June 26, 2015*

- ❖ Acknowledgment: This work is sponsored by the NASA Office of Safety & Mission Assurance
- ❖ \*Copyright 2015 California Institute of Technology. Government sponsorship is acknowledged.
- ❖ To be presented by Rajeshuni Ramesham at the NEPP Electronics Technology Workshop (ETW). June 23-26, 2015 at NASA/GSFC in Greenbelt, MD

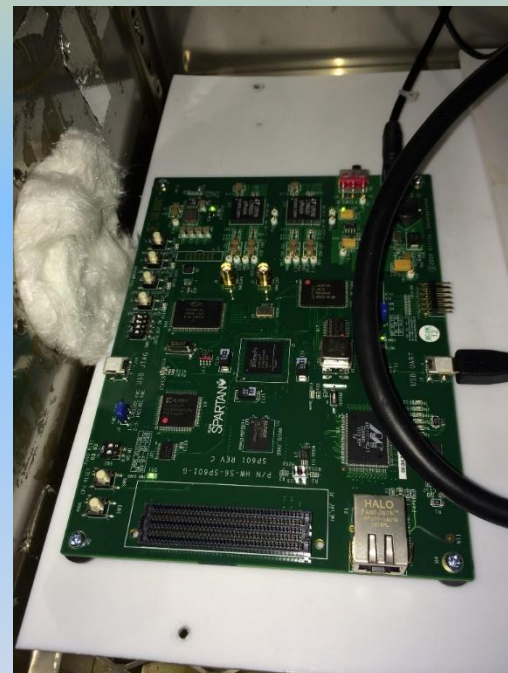
**Board mounted in the  
thermal Chamber During  
the Tests**

Xilinx SP601 FPGA Board-1 (Preliminary)													
		Tested ----->											
		Temperature, C											Remarks
Test #	Test Performed to Health/Functional Check	+25	+50	+75	+100	+125	+25	0	-30	-30±10	-65	-60±10	
1	Universal Asynchronous Receiver/Transmitter (UART)	PASS	PASS	PASS	PASS	PASS	PASS	PASS		PASS		PASS	Functional
2	Light Emitting Diodes	PASS	PASS	PASS	PASS	PASS	PASS	PASS	PASS		PASS	PASS	Functional
3	Timer Test	PASS	PASS	PASS	PASS	PASS	PASS	PASS		PASS		PASS	Functional
4	Flash Memory	PASS	PASS	PASS	PASS	PASS	PASS	PASS		PASS		PASS	Functional
5	Inter-Integrated Circuit (IIC) Electrically Erasable Programmable Read-Only Memory (EEPROM)	PASS	PASS	PASS	PASS	PASS	PASS	PASS		PASS		PASS	Functional
6	ETHERNET Lite Test	PASS	PASS	PASS	PASS	PASS	PASS	PASS		PASS		PASS	Functional
7	General Purpose Input/output (GPIO) Switches	PASS	PASS	PASS	PASS	PASS	PASS	PASS		PASS		PASS	Functional
8	Multi-Port Memory Controller (MPMC) Memory Test or External Memory Test	PASS	PASS	PASS	PASS	FAIL	PASS	PASS		PASS	PASS		MPMC test failed @125C and recovered when the temperature reduced..

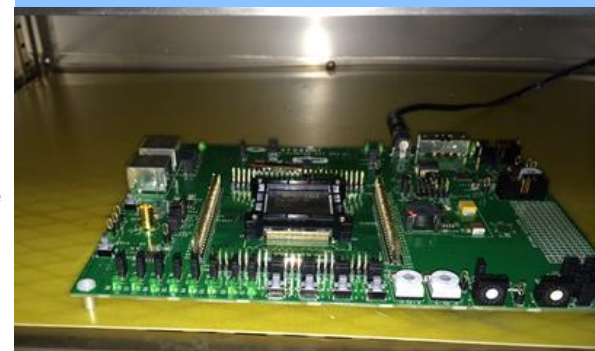
## Micro semi ProASIC3/E Evaluation FPGA Board

**208 PQFP; 208 Plastic Quad Flat Pack**

**Board mounted in the  
thermal Chamber During  
the Tests**

Microsemi ProASIC3/E Evaluation Board-1 (Preliminary)												
		Tested ----->											
		Temperature, C											Remarks
Test #	Test Performed to Health/Functional Check	+25	+50	+75	+100	+125	+25	0	-30	-30 ± 10	-65±10	-75±10	
1	Flashing Light Emitting Diodes (LEDs) Demo: Right to Left	PASS	PASS	PASS	PASS	PASS	PASS	PASS		PASS		PASS	Functional
2	Flashing Light Emitting Diodes (LEDs) Demo: Left to Right	PASS	PASS	PASS	PASS	PASS	PASS	PASS	PASS	PASS	PASS	PASS	Functional
3	8-Bit Counter -- Count Up	PASS	PASS	PASS	PASS	PASS	PASS	PASS		PASS		PASS	Functional
4	8-Bit Counter -- Counting Down	PASS	PASS	PASS	PASS	PASS	PASS	PASS		PASS		PASS	Functional
5	8-Bit Counter -- Counting Up or Down with Forced State	PASS	PASS	PASS	PASS	PASS	PASS	PASS		PASS		PASS	Functional

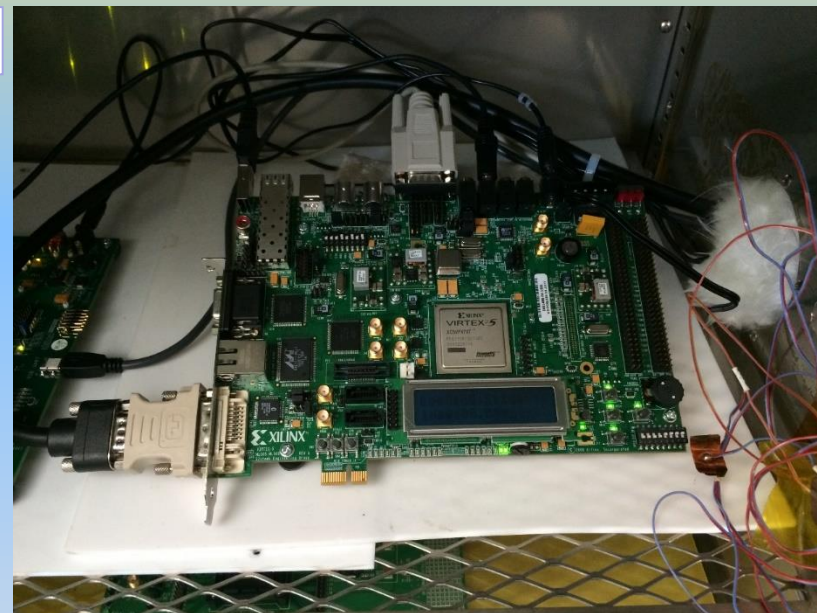
**Board mounted in the thermal Chamber During the Tests**

Xilinx ML507 FPGA Evaluation Board (Preliminary)												
		Tested ----->											
		Temperature, C											Remarks
Test #	Test Performed to Health/Functional Check	+25	+50	+75	+100	+125	+25	0	-30	-30±10	-65	-55±10	
1	Virtex-5 Slide Show	PASS	PASS	PASS	PASS	FAIL	PASS	PASS		PASS		PASS	Recovered
2	Test Universal Serial Bus (USB) Demo	PASS	PASS	PASS	PASS	FAIL	PASS	PASS		PASS		PASS	Recovered
3	Test Doulbe Data Rate (DDR) Random Access Memory ( RAM)	PASS	PASS	PASS	PASS	FAIL	PASS	PASS	PASS		PASS		Recovered
4	Test Zero Bust Turnaround (ZBT) Static Random-Access Memory (SRAM)	PASS	PASS	PASS	PASS	FAIL, LEDs Went Black or Board is Black	PASS	PASS	PASS		PASS		Recovered
5	Light Emirtting Diodes	PASS	PASS	PASS	PASS	FAIL	PASS	PASS	PASS	PASS	PASS		Recovered
6	Test Push Buttons	PASS	PASS	PASS	PASS	FAIL	PASS	PASS		PASS		PASS	Recovered
7	Test Dual in-line package (DIP) Switches	PASS	PASS	PASS	PASS	FAIL	PASS	PASS	PASS		PASS		Recovered

8	Test Character Liquid Crystal Display (LCD)	PASS	PASS	FAIL (Hard to Read)	FAIL (Gray)	FAIL	FAIL, Characters Missing	No Visible FAIL	No Visible FAIL	No Visible FAIL		No Visible FAIL	LCD did not recover fully. Characters missing.
9	Test Video Graphics Array (VGA) Output	PASS	PASS	PASS	PASS	FAIL	PASS	PASS	PASS		PASS		Recovered
10	Test Piezo Transducer	PASS	PASS	PASS	PASS	FAIL	PASS	PASS	PASS		PASS		Recovered

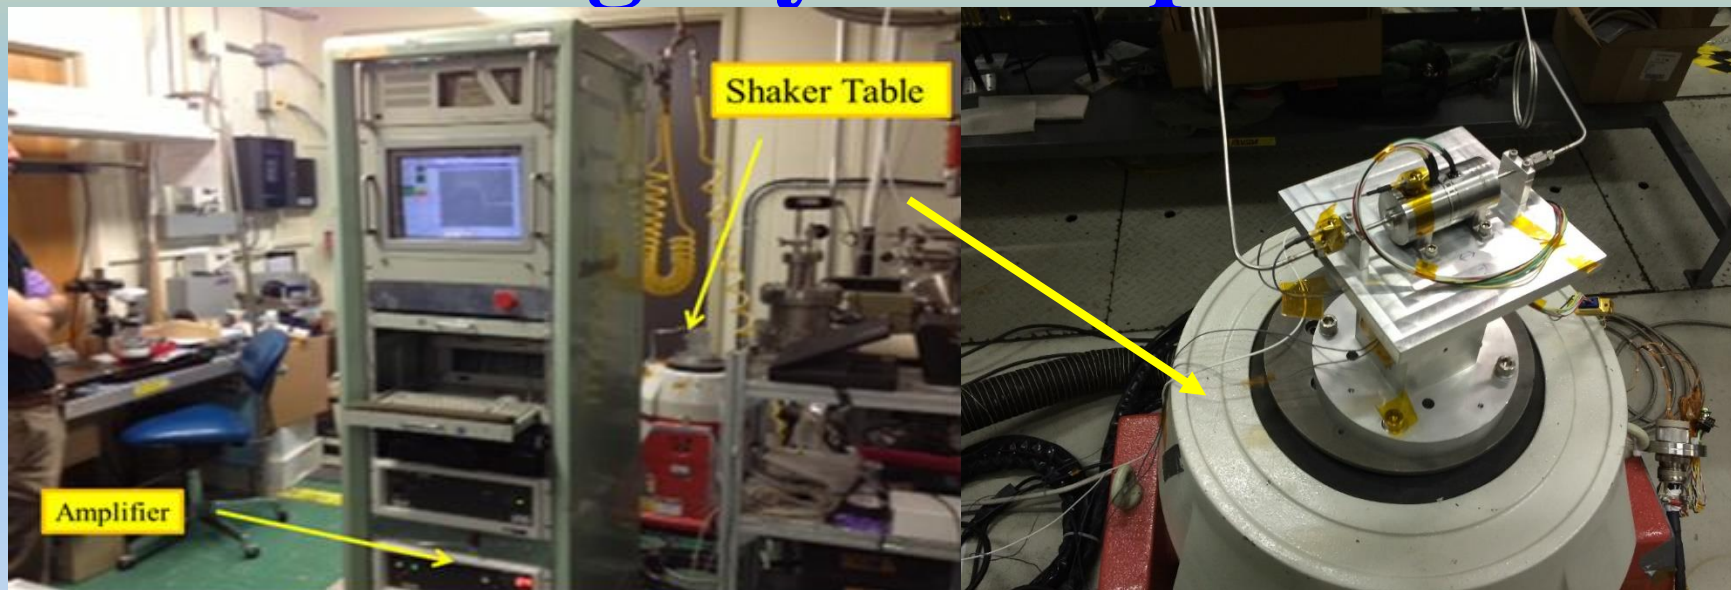
# Shaker table to implement Willoughby ESS spectrum

**Shaker Table**

- ❑ Designed and Manufactured the hot-cold plate for  $-65^{\circ}\text{C}$  to  $+125^{\circ}\text{C}$  during ESS spectrum implementation with shaker table

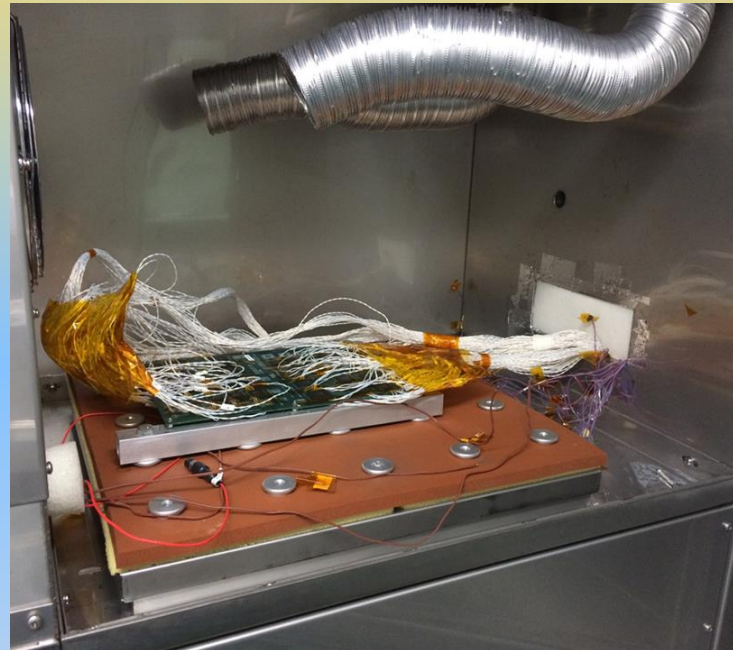
# Highly Accelerated Life Testing (HALT)

- ❑ Installed daisy-chained PBGA test boards in a HALT test chamber. HALT chamber has a thermal control ( $-55^{\circ}\text{C}$  to  $+125^{\circ}\text{C}$ ) and mechanical shock control up to 50g. Initial tests have already been begun.
- ❑ Data logging system has been completed and tested to monitor the resistance of daisy chained PBGA packages during HALT test.
- ❑ The tests will be conducted in a temperature range of  $-65^{\circ}\text{C}$  to  $+125^{\circ}\text{C}$ . Developing a DoE to implement with the HALT with the above set-up.
